Rail Accident Report

**Partial collapse of a bridge onto open railway
lines at Barrow upon Soar, Leicestershire
1 August 2016**

Report 10/2017
June 2017

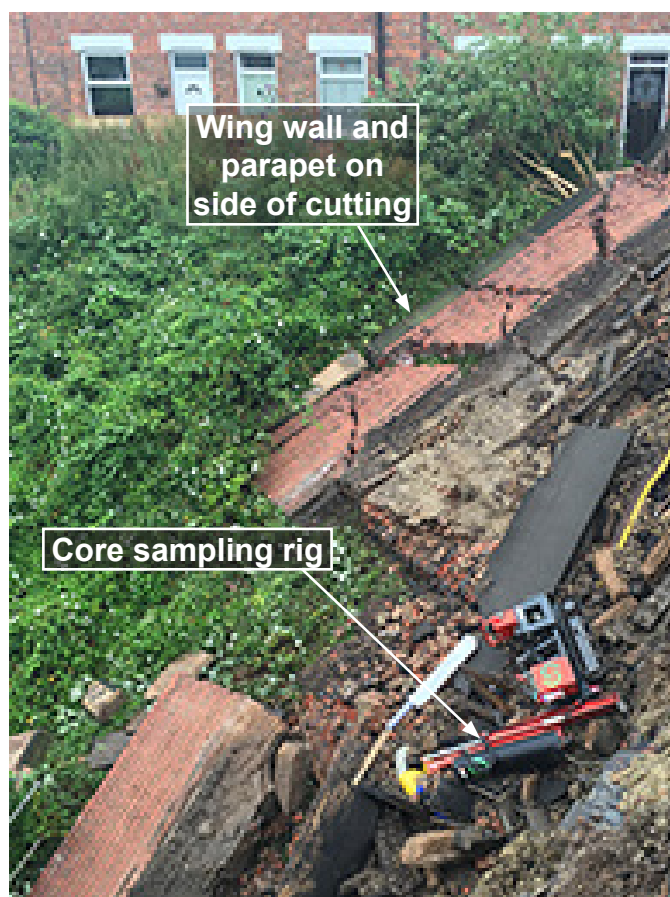
Figure 3: Masonry rubble post-incident (image courtesy of Network Rail)

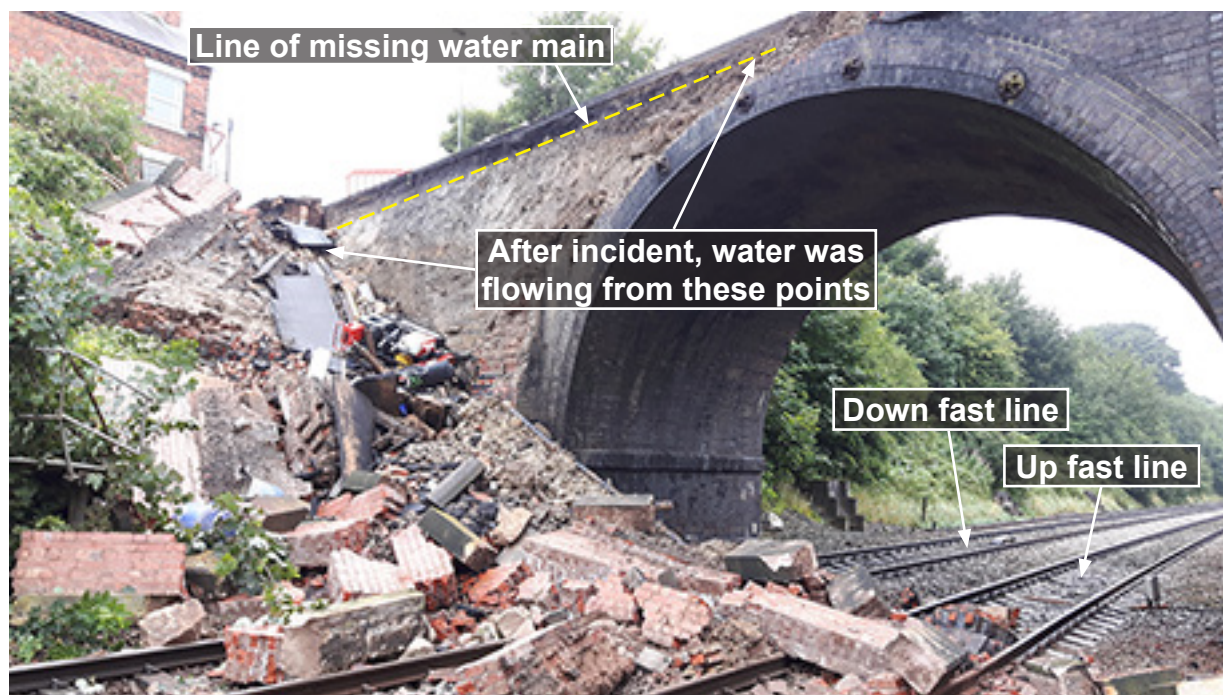
Figure 4: Extent of collapse and rubble obstructing the up and down fast lines

- 64 The strata exposed by the collapsed wing wall were analysed by Network Rail and found to be consistent with strata in the cutting face. The natural ground formation is largely Lias group³ mudstone clay with a layer of limestone about 300 mm thick, at approximately 2.6 metres below ground level. Above the limestone there was a layer of mudstone overlaid by clay-rich made ground about 1.5 metres deep. After the collapse the natural formation remained self-supporting with a near vertical stable face (figure 4).

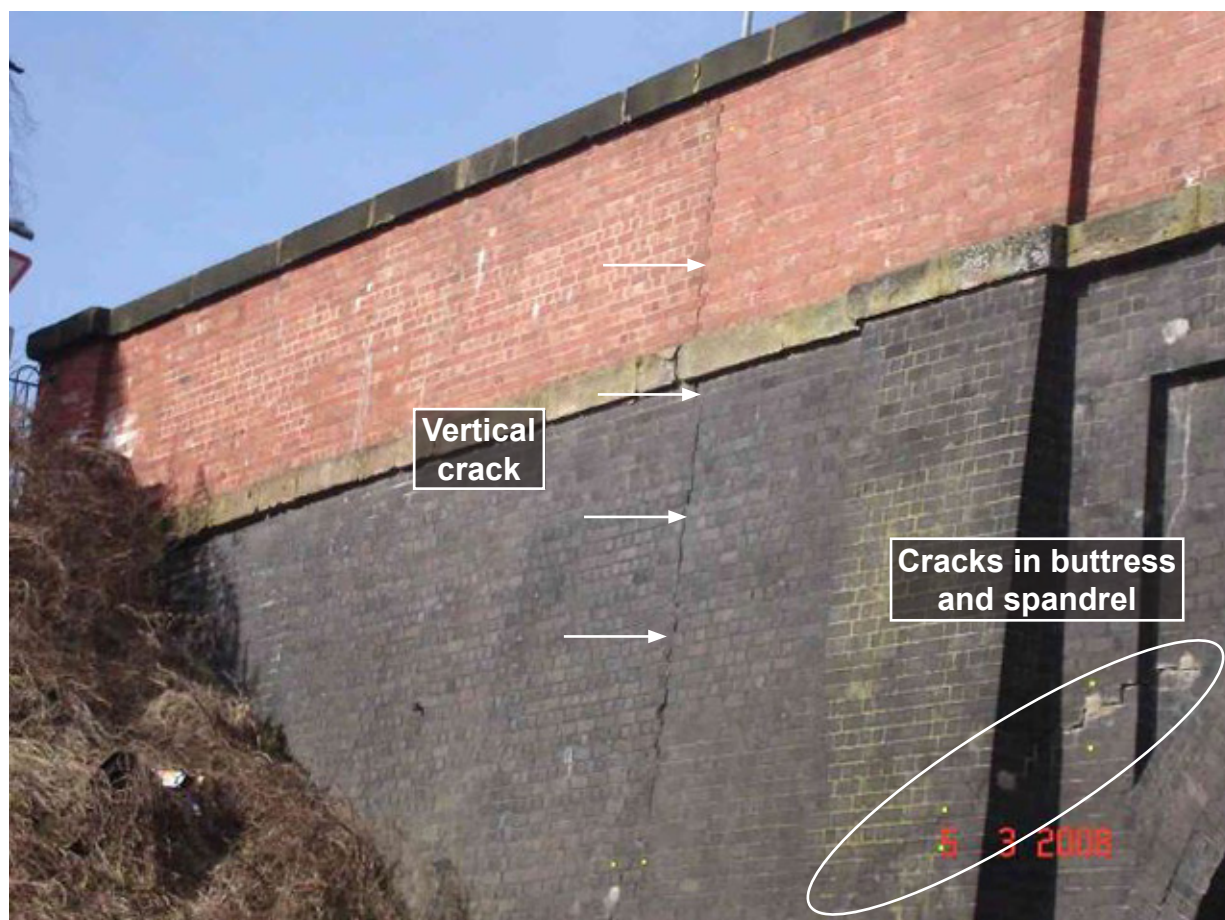
Figure 5: Vertical crack in Sileby wing wall and parapet (image courtesy of Network Rail)

- 70 The Sileby wing wall had a vertical crack extending its full height and continuing through the parapet (figure 5). It is not known when the full-height vertical crack first appeared in the wing wall; Network Rail's earliest record of the crack dated from a 1998 assessment report of the bridge's load capacity. This report also recorded a number of other cracks in the bridge masonry on both elevations.

- 71 The exact cause of these cracks is difficult to determine. The RAIB considers that the pattern is symptomatic of loading on the back of the spandrel and wing walls from the fill material and water ingress, combined with dynamic loading from the passage of road vehicles. The loading also appeared to be generating an outward tilt of the wing wall. The last additional monitoring report before the collapse recorded that the wall in the vicinity of the full-height vertical crack was leaning by almost two degrees towards the track.

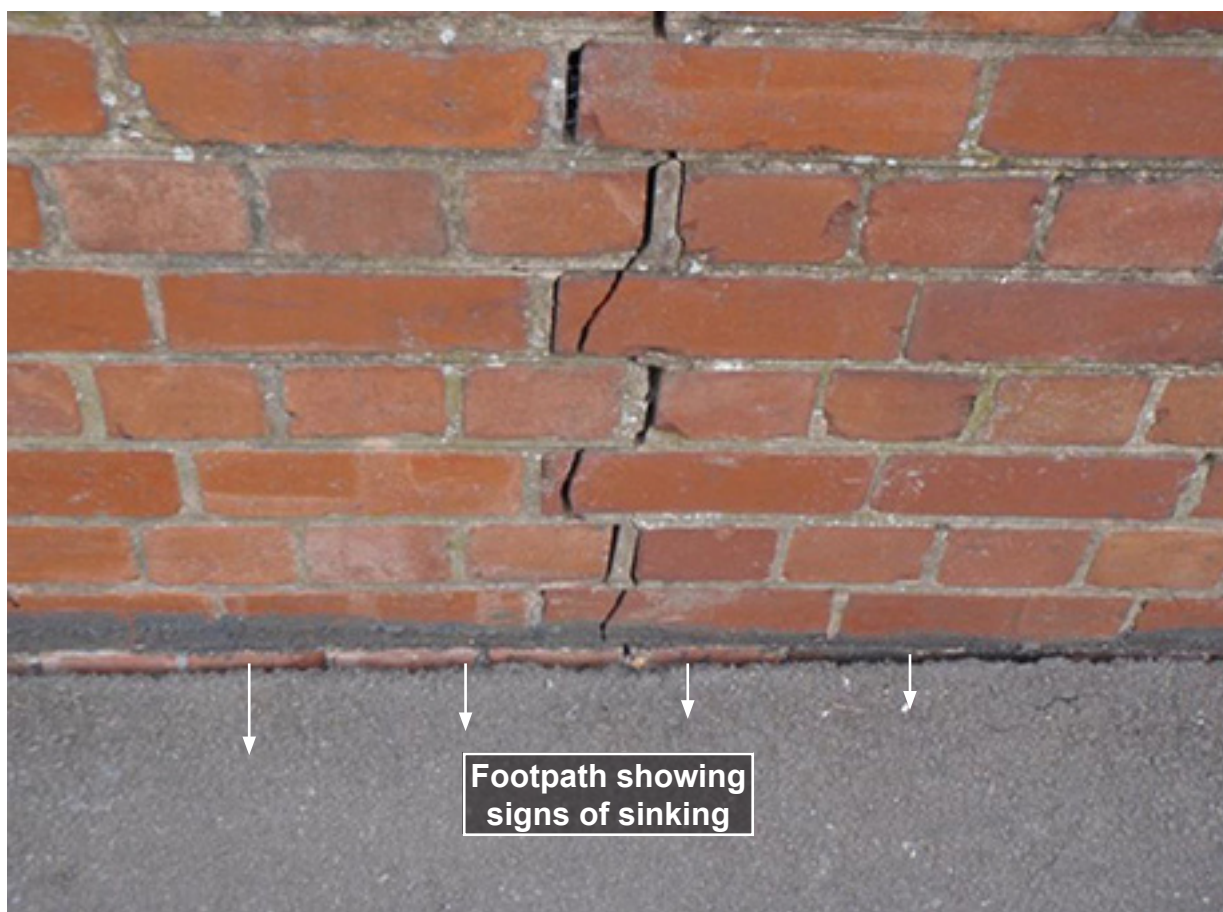
Figure 6a: September 2009 - first report of footpath sinking adjacent to the vertical crack (image courtesy of Network Rail)

- 85 In 2009, an examination report of the bridge by Network Rail's specialist contractor noted that the footpath was sinking slightly, close to the vertical crack (figure 6(a)).

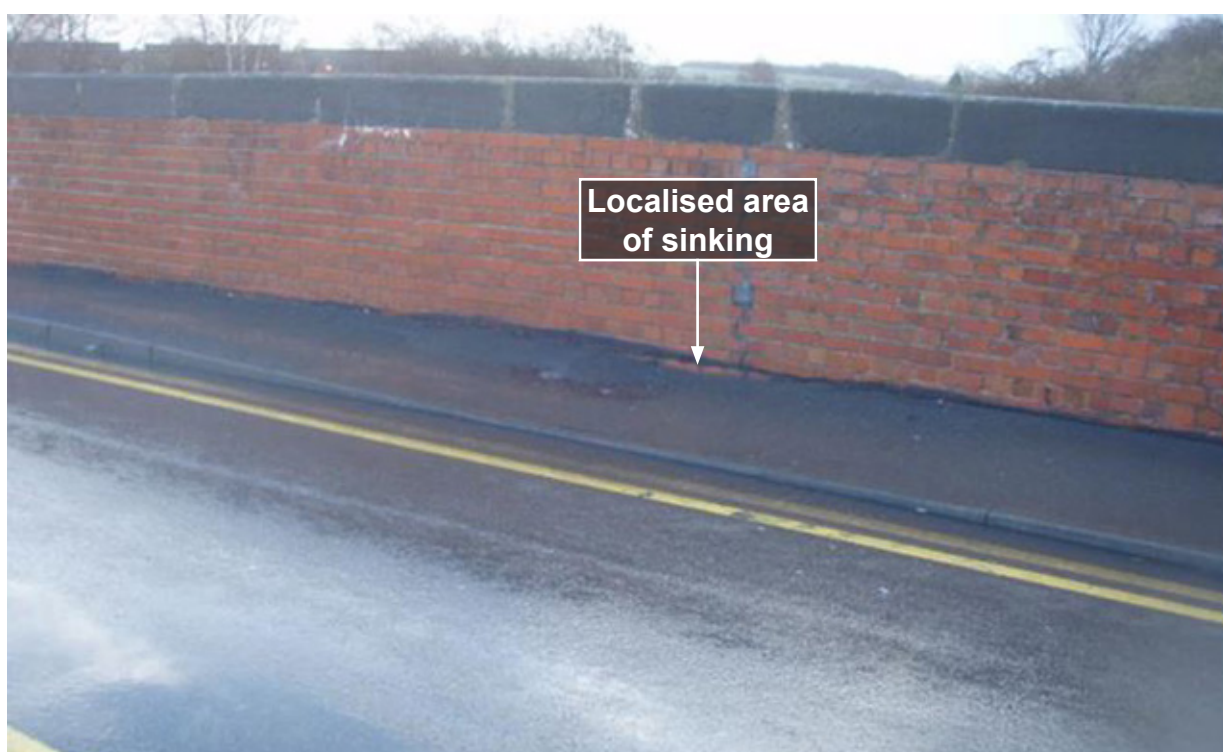
Figure 6b: January 2012 - subsidence continuing, with dips evident at both the parapet and the kerb (image courtesy of Network Rail)

- 86 By January 2012, and following a concern raised by a member of the public, it was found that the footpath had a dip of 100 mm adjacent to the vertical crack and a gap of up to 30 mm between the footpath and parapet (figure 6(b)). An excavation of the area of subsidence by a Network Rail contractor reportedly failed to find what was causing it and the area was made good. (Network Rail has no other records or photographs of the investigation.) The subsidence continued to occur (figure 6(c)) and in October 2014 a recommendation was made to Network Rail in an additional examination report that the subsidence be investigated again to discover the cause of the problem.

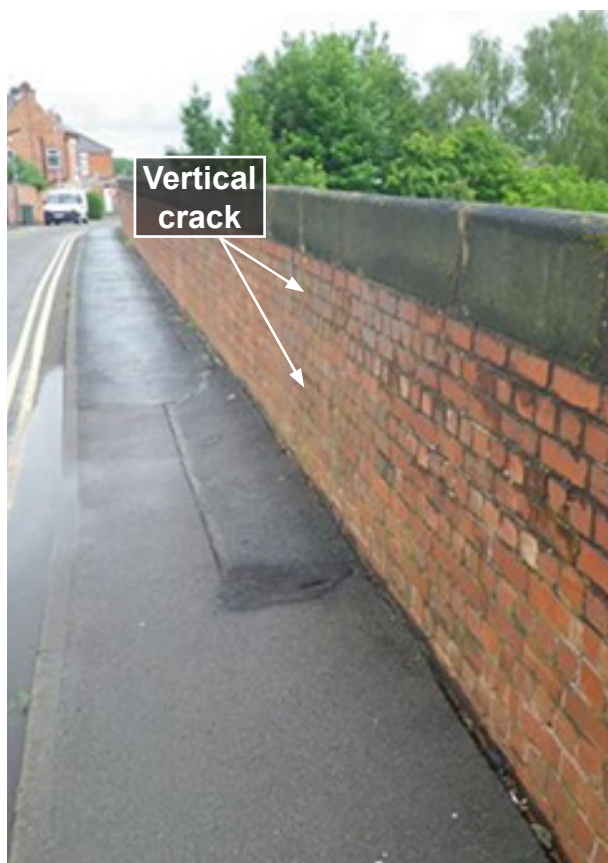
Figure 6c: June 2014 - the level of the footpath has been reinstated following the excavation in January 2012, but has continued to sink at the kerbside (image courtesy of Network Rail)

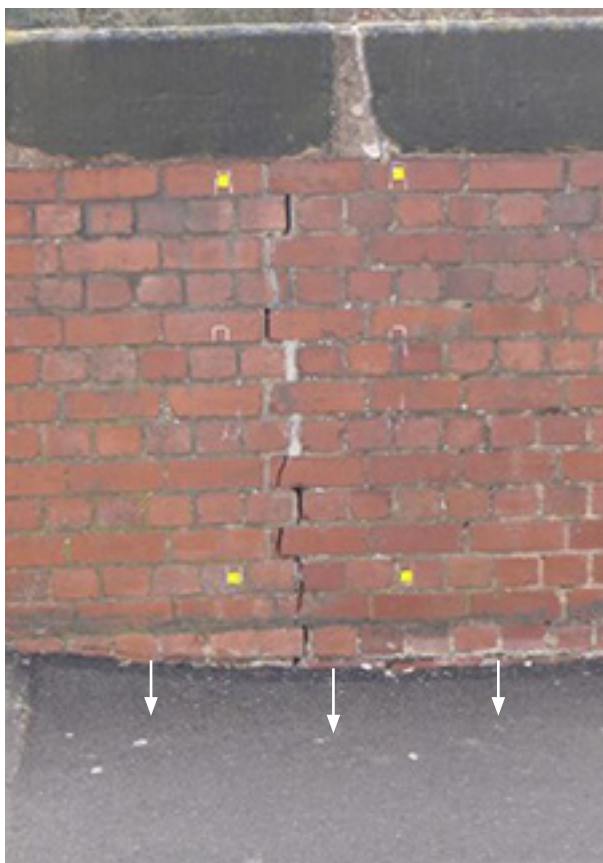
Figure 6d: March 2016 - the subsidence has recurred (image courtesy of Network Rail)

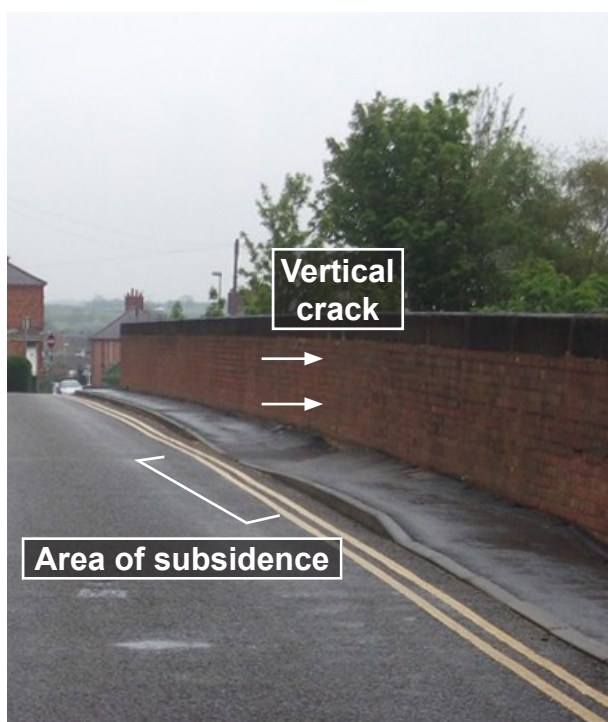
Figure 6e: May 2016 - area of subsidence in the footpath (image courtesy of Leicestershire County Council)

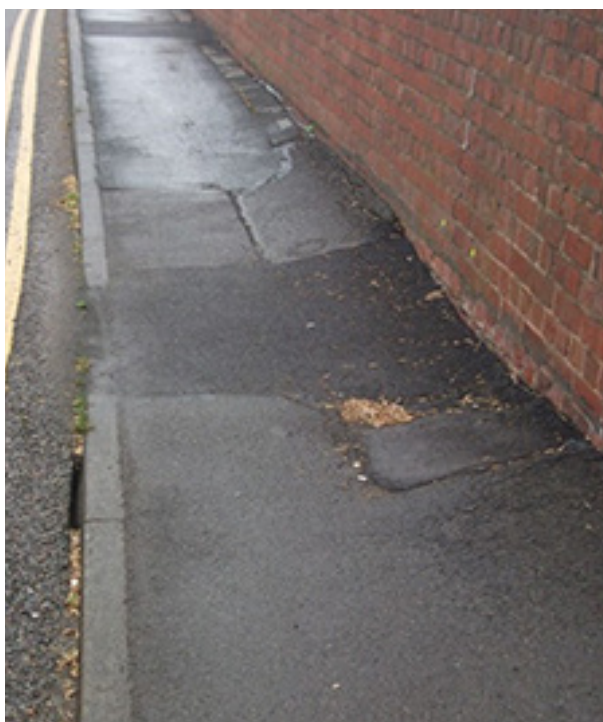
Figure 6f: May 2016 - close-up of area of subsidence (image courtesy of Leicestershire County Council)

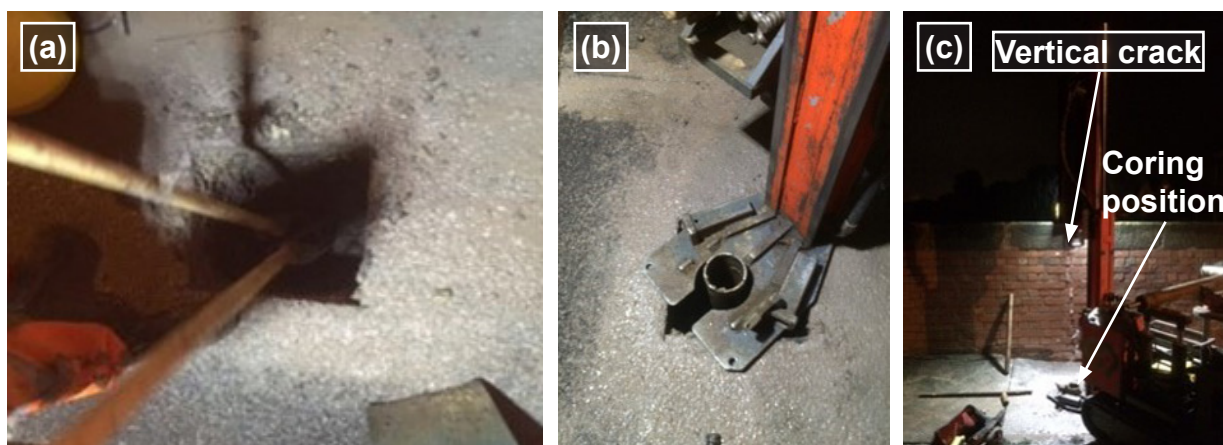
- 25 CML subsequently contracted with Central Alliance to undertake the core sampling works. However, CML was to provide the supervision, labour and equipment for identifying any underground services, breaking out the footpath and its reinstatement on completion.
- 26 On 1 August 2016, the CML supervisor and two operatives, and the Central Alliance sampling rig operator and assistant, arrived at Grove Lane bridge around 22:00 hrs. The supervisor stated that, after locating the area of work, he carried out a survey to locate any underground services using a cable avoidance tool and signal generator set (sometimes known as a 'CAT and Genny' (paragraph 106)). He then issued a 'permit to dig' for the digging of a trial hole in the footpath. The trial hole measured 300 mm by 300 mm by 800 mm deep and was reportedly centred 500 mm from the inside face of the parapet (figure 7).

Figure 7: Photographs from the day of the incident showing; (a) 300 x 300 mm trial hole being dug; (b) coring machine set over trial hole; and (c) proximity of coring to vertical crack in parapet (images courtesy of CML)

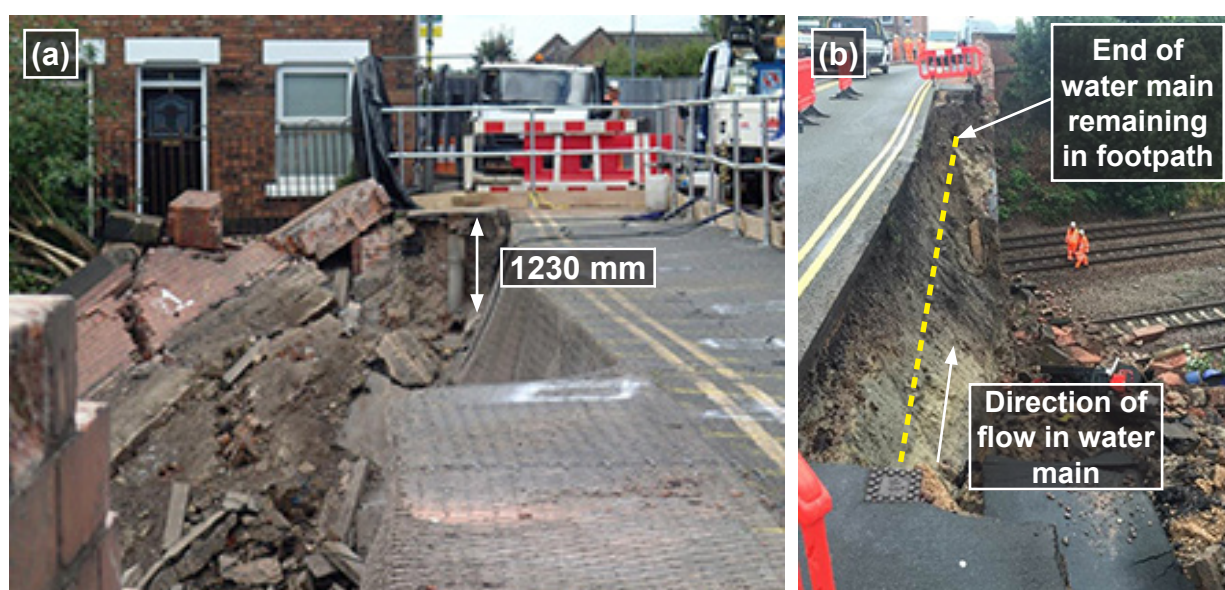
- 46 The bridge carried a 4" (102 mm) internal diameter (120 mm external diameter) cast iron water main, reported by STW to be around 70 or 80 years old, with a service life of over 100 years. The water main had an inner cement-mortar lining, which was thicker at the bottom of the pipe, indicating that it had been applied in situ and had slumped before setting. STW had no record of when the lining was applied.
- 47 The water main ran under the footpath adjacent to the Sileby wing wall. It was fitted with a sluice valve, accessed via a manhole in the footpath, approximately 2.6 metres from the end of the Sileby parapet and around 7.5 metres from the area of subsidence (figure 8(a)). The water main (to the top of the pipe) was 1230 mm below ground level at the sluice valve (figure 9(a)).

Figure 9: (a) exposed sluice valve and depth of water main; and (b) alignment of water main in footpath (image courtesy of Network Rail)

- 48 The water main was considered by STW to be a high pressure main. It was rated for a pressure of at least 10 bar³ and at the time of the incident the pressure in the main was reported by STW to be around 7 bar. The direction of water flow is shown in figure 9(b).

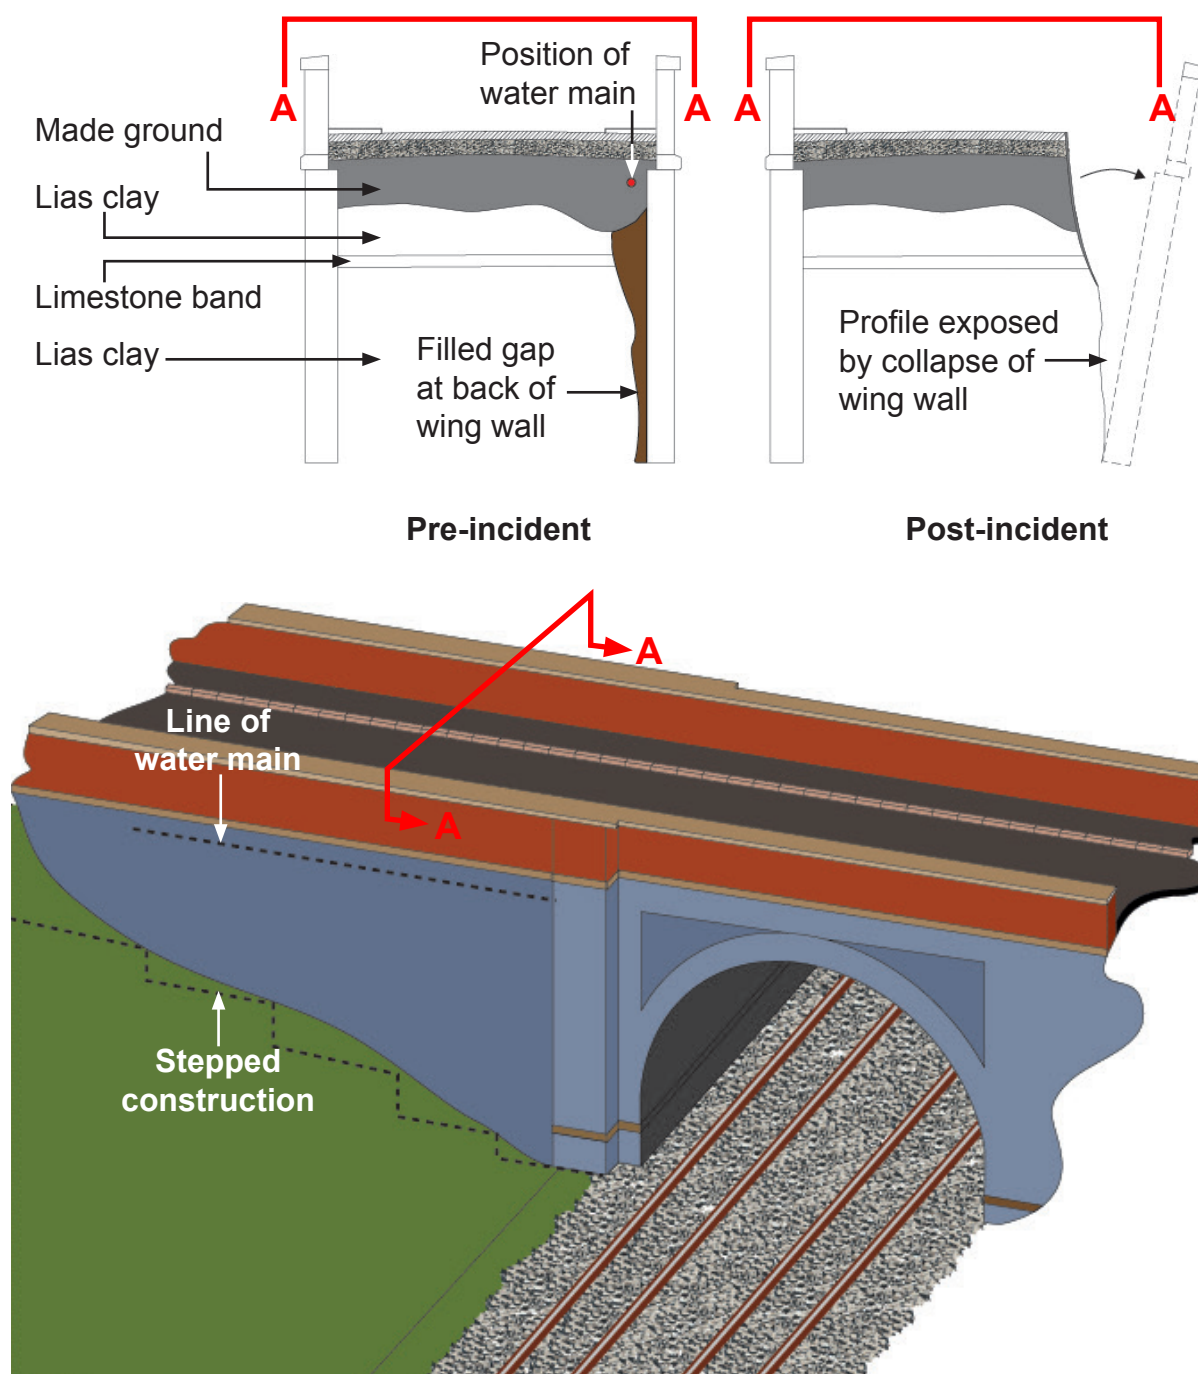
- 65 The investigation found that the Sileby wing wall was built as a free-standing wall, to 'face' the projecting formation. It was built as a stepped structure into the slope of the cutting and had little or no foundation (figure 10).

Figure 10: Schematic diagram showing section through bridge in area of collapse

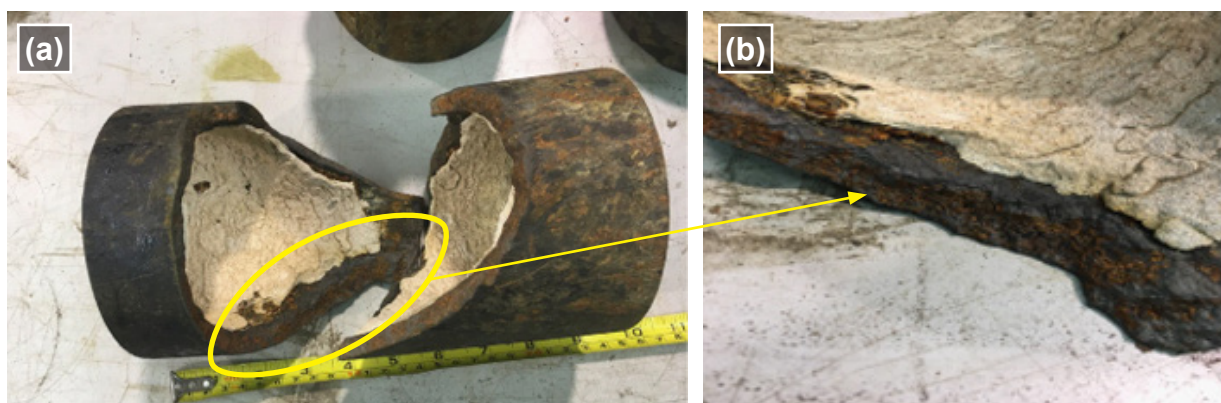
- 74 Examination of the water pipes, carried out by RAIB's forensic specialist, found that a section of water main under the area of subsidence in the footpath had corroded through the full thickness of the pipe wall. This combined with other evidence summarised below indicates that the pipe was probably leaking (figure 11).
- 75 The RAIB's forensic specialist reported that the tapered sides to the corrosion indicated that it had started on the inside of the pipe, possibly because of a defect in the lining at this location, and progressed through the pipe.
- 76 At the site of the leak there was also evidence of pitting on the outside of the pipe from oxygenated wet corrosion, suggesting that water had collected under the pipe.

Figure 11: (a) fractured ends of the two mating lengths of water main and area of corrosion. Note that some of the pipework is missing; and (b) close up of area of corrosion (images courtesy of SureScreen Scientifics)

- 77 The corrosion mechanism (known as graphitic corrosion⁵) is of a type that forms a labyrinth of small channels, through which water can pass and emerge as a slow leak. In the experience of the RAIB's forensic specialist, cast iron high pressure water pipes with corrosion of this type can survive without catastrophic failure for many years. This is because the remaining metal in the pipe retains some strength to hold the pipe together. The RAIB's forensic specialist estimated that the pipe had been leaking for approximately five years and possibly longer.

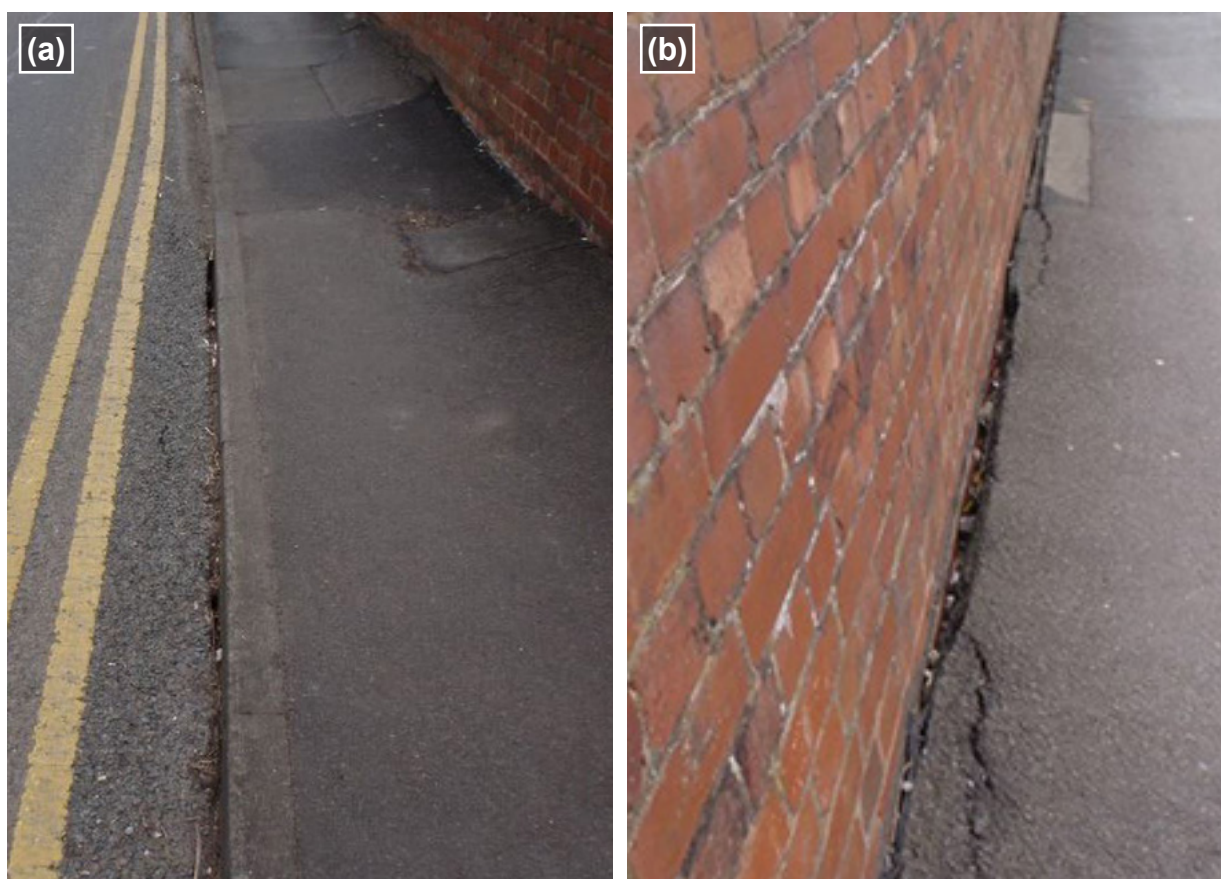
- 82 The footpath was sinking and there was relative movement between the kerb and the road and also between the footpath and the parapet, creating gaps through which water could ingress. The last additional examination of the bridge before the collapse, carried out in March 2016, recorded that the gap between the kerb and the road measured up to 30 mm wide by 500 mm long and varied from 100 to 200 mm deep (figure 12(a)). The gap between the footpath and parapet was typically between 5 mm and 50 mm wide with a maximum depth of 70 mm (figure 12(b)).

Figure 12: (a) March 2016 - void at kerbside; (b) May 2012 - gap opened up between footpath and parapet (images courtesy of Network Rail)
