Rail Accident Report

**Train travelling with doors open on the Jubilee
line
1 September 2018**

Report 06/2019
July 2019

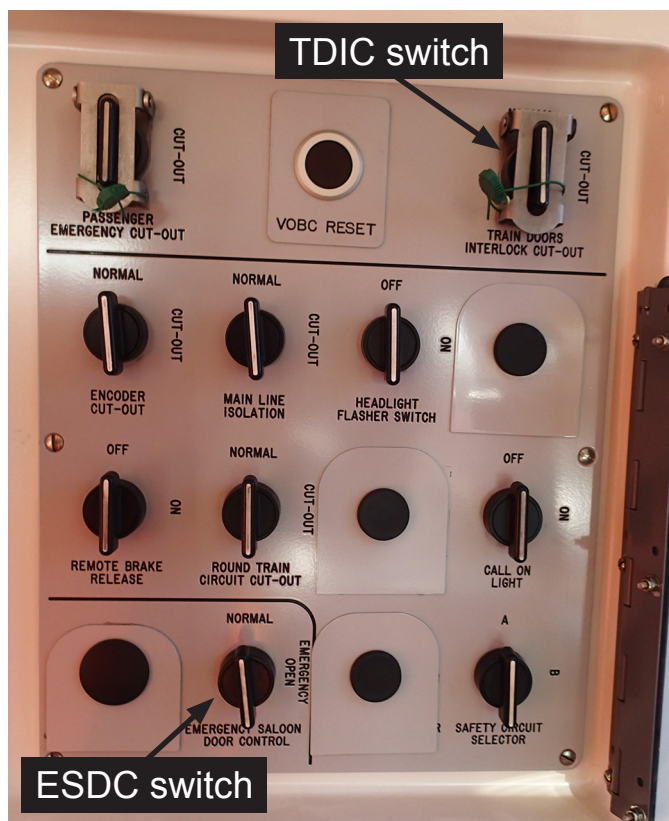
Figure 10: TDIC and ESDC switches on driving cab panel (location of panel shown on figure 5)

- 17 The banks of cut-out switches on the cab back wall include the 'train door interlock cut-out' (TDIC) switch (figure 10) which bypasses the safety system intended to prevent the train moving with doors open. The switch bank also includes the emergency saloon door control switch (ESDC, figure 10) which enables the train operator to open passenger doors using the door-open buttons on the driving cab back wall when normal door operation is disabled, for example if the train has not stopped close to the normal stopping point at a station (ie when the train has not achieved an accurate stop).

- 61 Both the ESDC and TDIC switches are part of the cut-out switch bank on the back wall of the driving cab, near the cab door which was adjacent to the platform (figures 5 and 10). However, there are significant differences between these switches; the TDIC switch is at a higher level and nearer the cab door than the ESDC switch. The TDIC switch is fitted with a flap and a seal in the form of a plastic tag which must be broken before the switch can be operated. The flap covers only the TDIC switch and must be lifted before the switch can be turned. The ESDC has no seal or individual flap. However, it can only be operated after opening a plastic door which covers most of the switch bank, but not the TDIC switch. This plastic door opens towards the driving cab door, which makes operating the ESDC switch from the doorway difficult.

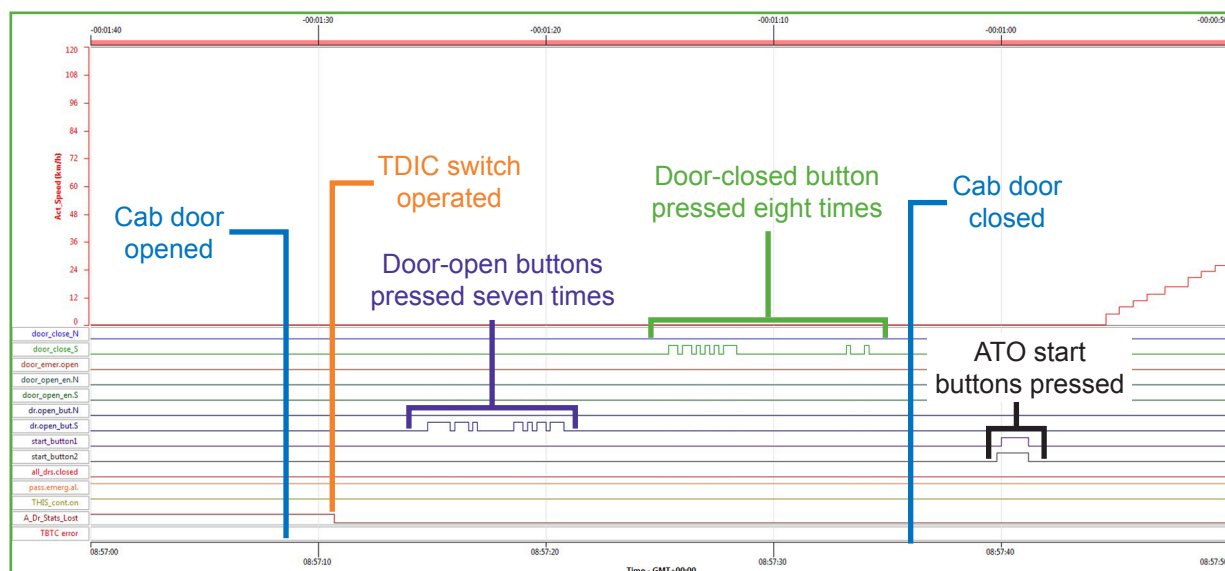
Figure 11: Annotated OTDR graphic showing TDIC switch operated, cab door operation, and operation of door-open and close buttons

- 29 The OTDR then recorded several operations of the passenger door-open and close buttons by the train operator while the cab door was open (figure 11). The OTDR does not indicate which buttons were used (console or back wall) but it is likely that the train operator remained at the cab door and so used the back wall buttons. The train operator stated that, between opening and closing the cab door, he looked through the peephole in the door leading from the driving cab into the saloon of the first car and saw that no passengers were standing at closed doors waiting to get off the train in the leading car (when looking through the peephole, only the interior of the leading car can be seen).

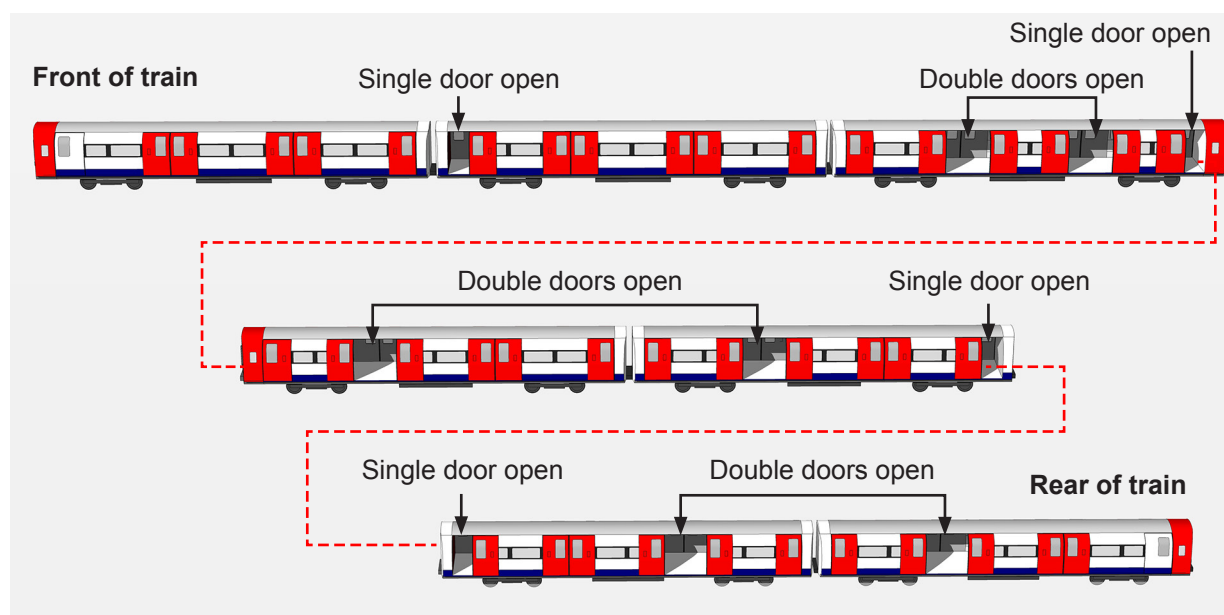
Figure 12: Location of open doors on the train (note some doorways have single doors and some have double doors)

- 32 During the 56 second journey to West Hampstead, internal train CCTV shows doors were open at 10 of the 28 passenger doorways (figure 12).
- 33 The train operator did not call control (ie the Jubilee line control room) while he was at Finchley Road station to tell them there was a problem with the train, and control did not call him. Control would not normally call a train operator unless a delay exceeded two minutes. The train was at Finchley Road station for less than two minutes and LUL train performance records show that it departed 1 minute 19 seconds later than timetabled.

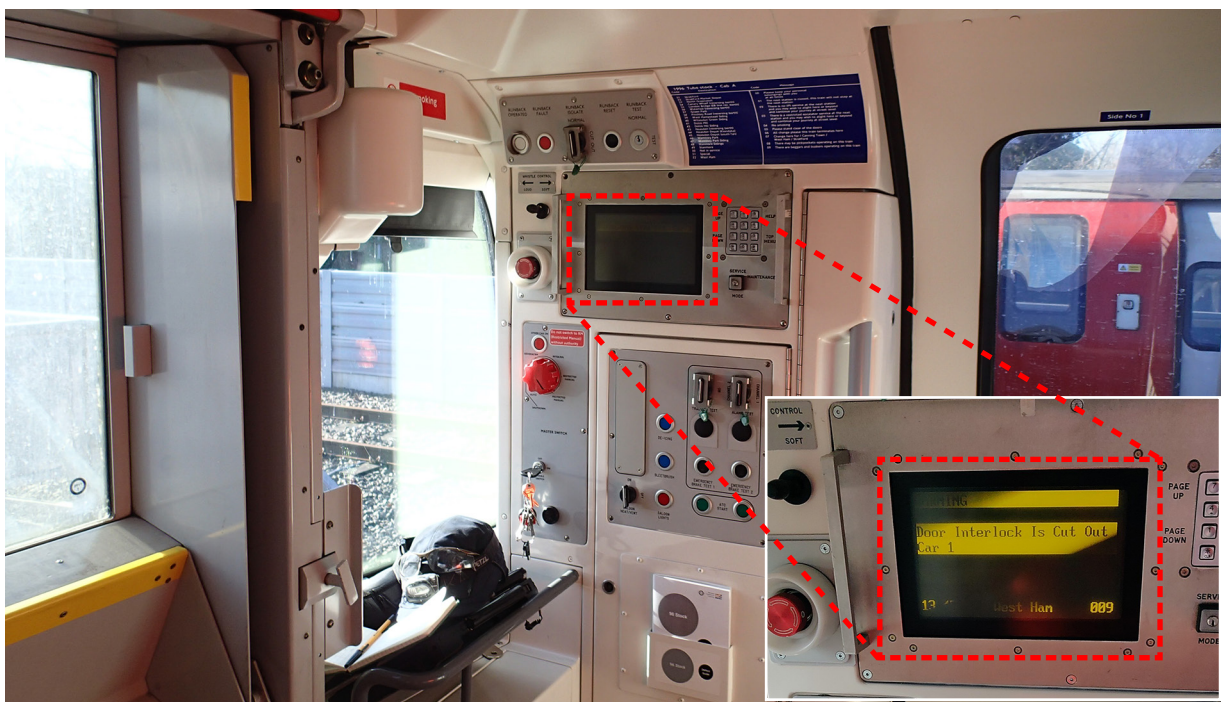
Figure 14: TMS display showing TDIC switch operated (not train involved in the incident)

- he may have relied on the ATO system, which he believed would not let a train depart with doors open (paragraph 86).
- 70 Operation of the TDIC switch resulted in the TMS display screen in the driving cab displaying a message saying '*door interlock is cut out car 1*' (figure 14). However, the train operator did not notice this, probably because this screen is on the opposite side of the cab and not in his direct line of vision when looking at the track ahead of the train (figure 4). As it was an information message it was not required to be brought to his attention by the sounding of a warning tone, and did not require any acknowledgement by him.

- 71 On some other types of London Underground train (table 6), when the TDIC switch has been operated either a reminder sounds in the driving cab and/or the ATO start function is disabled if the train operator attempts to start the train. Such a feature was not present on the train involved in the incident at Finchley Road (paragraph 93).

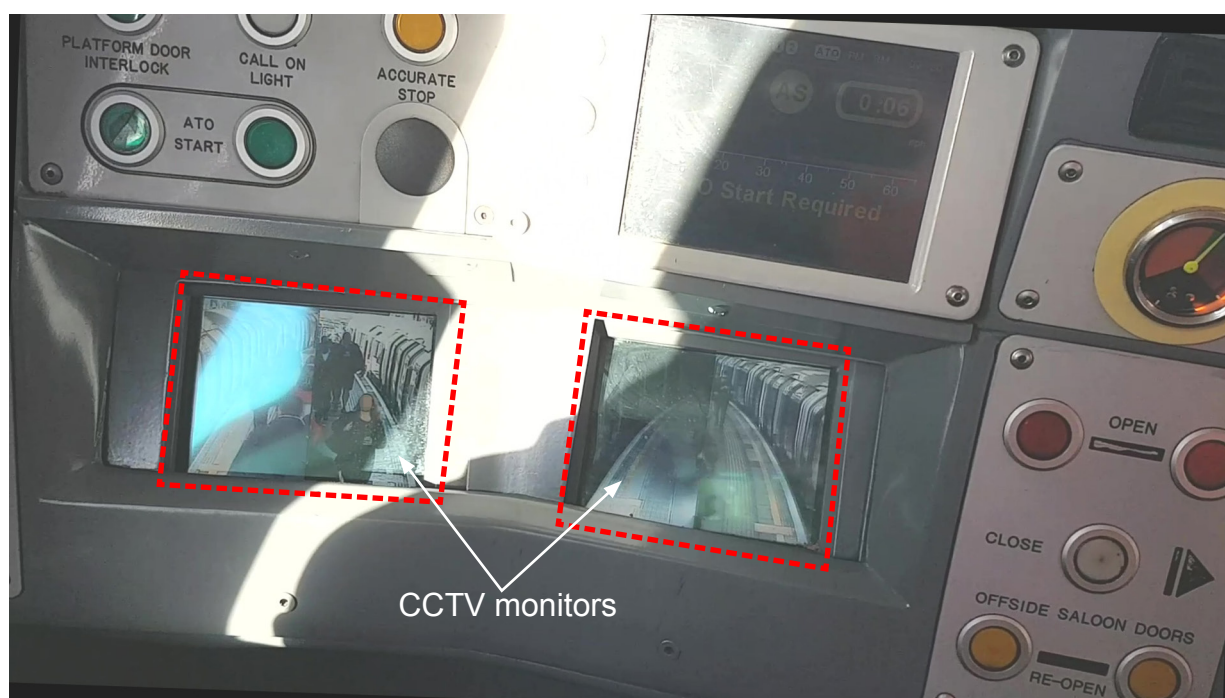
Figure 15: Sunlight shining onto the monitors (image taken with the sun in a similar position to that at the time of the incident)

72 The train operator recalled having to use his hands to shield the in-cab CCTV monitors from sunlight when checking if it was safe to start the train, and during the time the train was leaving the platform (paragraph 14). Post-incident observations by the RAIB at a similar time of day to that of the incident showed that sun glare made it difficult to see the side of the train on the CCTV monitors (figure 15).

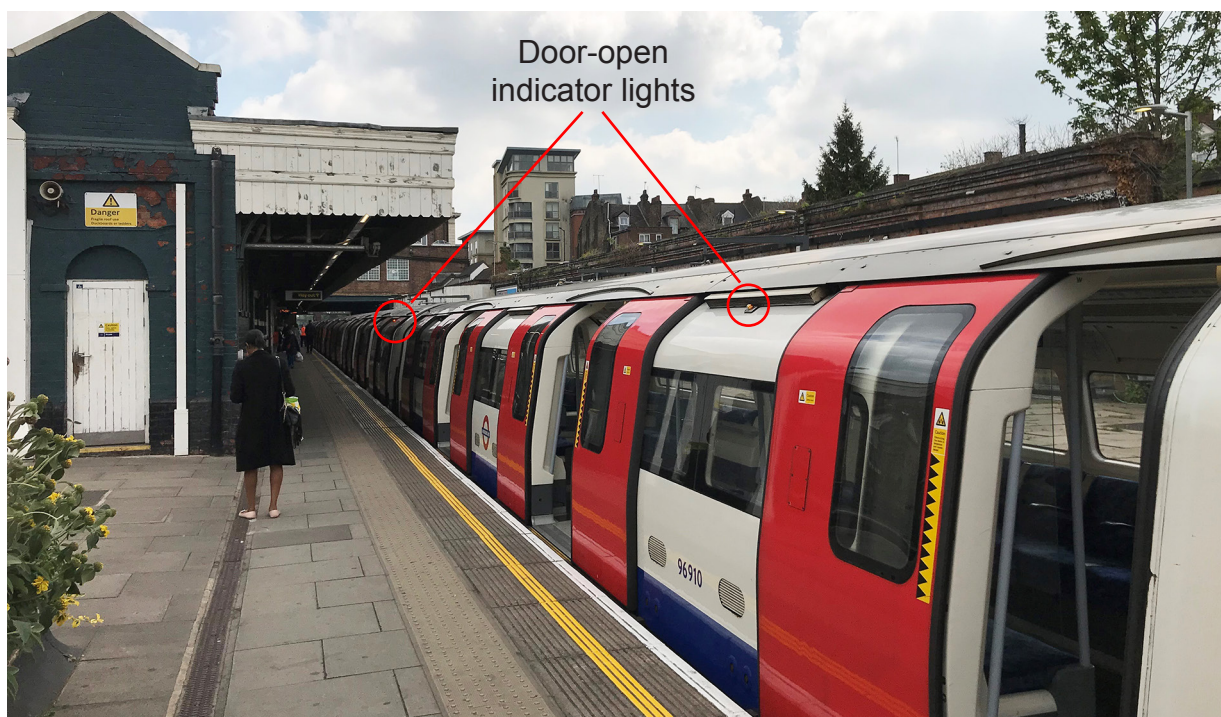
Figure 17: Door open indicator lights on outside of train

- 74 On the outside of the train an orange light is provided on each car (figure 17). These illuminate when the doors on that car are open and extinguish when the associated doors are closed. Post-incident observation by the RAIB showed that it was difficult to differentiate between their lit and unlit state on the in-cab CCTV due to a combination of their recessed design and sunlight shining on them. For these reasons they were not sufficiently conspicuous to draw the train operator's attention to the fact that some doors had not closed.
