# Rail Accident Report

**Runaway of ‘ironmen’ trolleys and subsequent  
near miss at Raven level crossing, Garnant,  
Carmarthenshire  
1 November 2014**

Report 13/2015  
August 2015

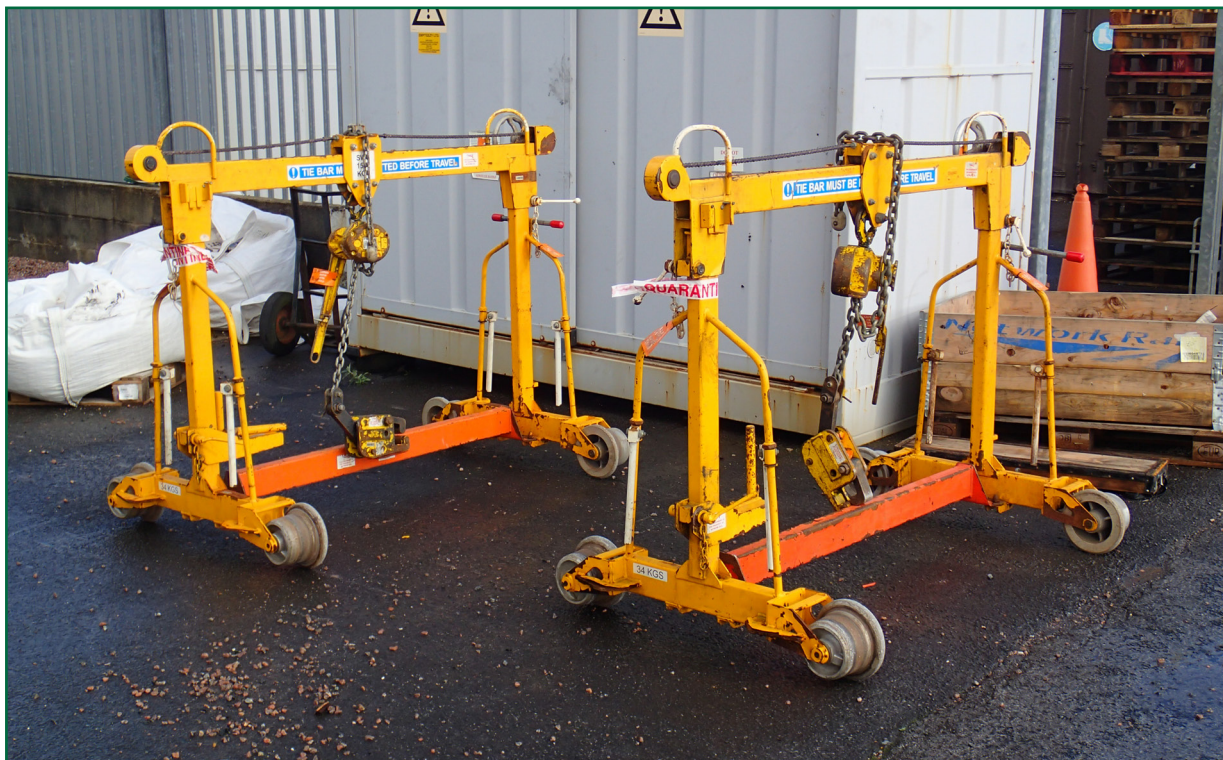
Figure 7: The runaway ironmen after the incident

- 13 The two ironmen that ran away (figure 7 and table 1) were allocated to Network Rail's Haverfordwest track maintenance depot and had been loaned to the Llanelli depot for the work planned to be carried out on the night of 1 November 2014.

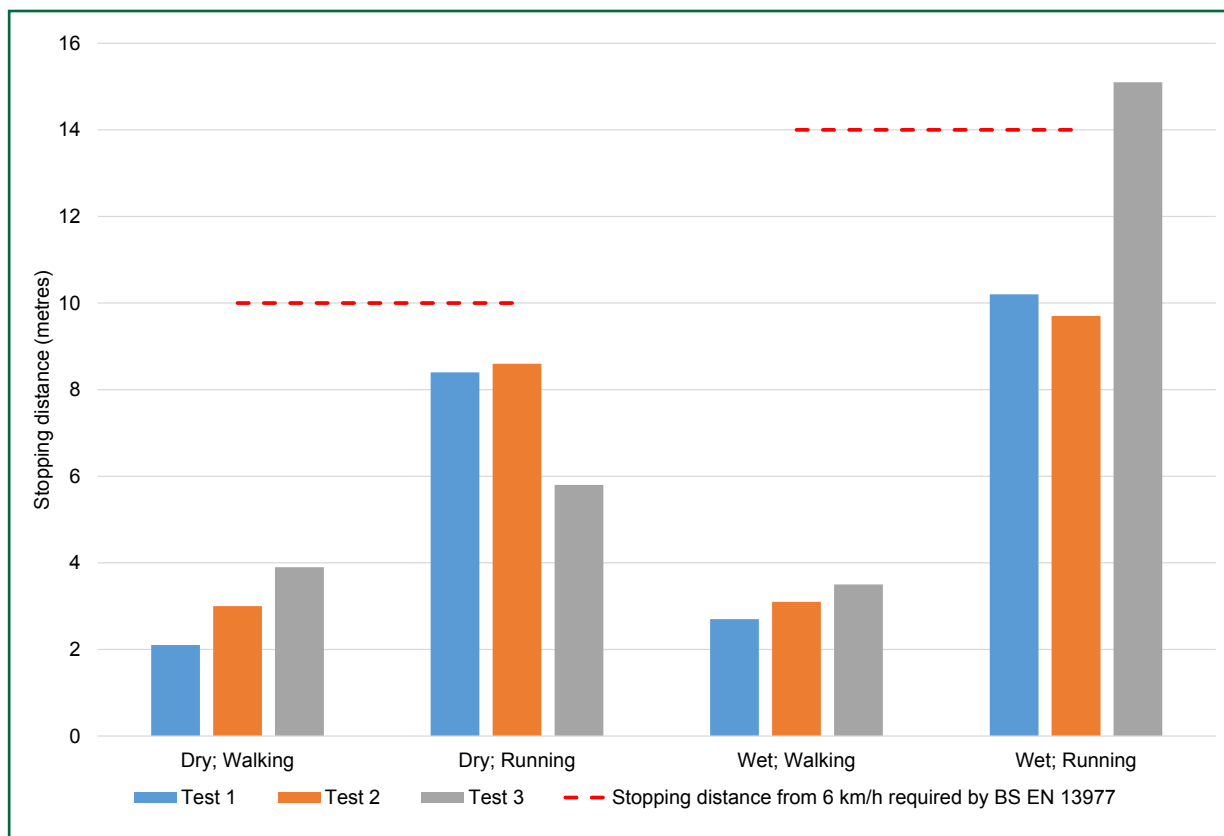
Figure 8: Ironmen stopping distance tests 18 April 2006

- 37 Neither Network Rail nor Permaquip has been able to provide the RAIB with a copy of the brake test results that supported the product acceptance certificate issued on 7 April 2006. However, records of testing carried out on 18 April 2006 do exist; these show that the ironman complied with the stopping distances mandated by BS EN 13977:2005 for wet and dry conditions, both 'walking' and 'running' (figure 8)<sup>4</sup>. The results also record that the average brake torque for the ironman being tested exceeded the minimum brake torque that was specified at the time (30 Nm, refer to paragraph 69) by 21%.

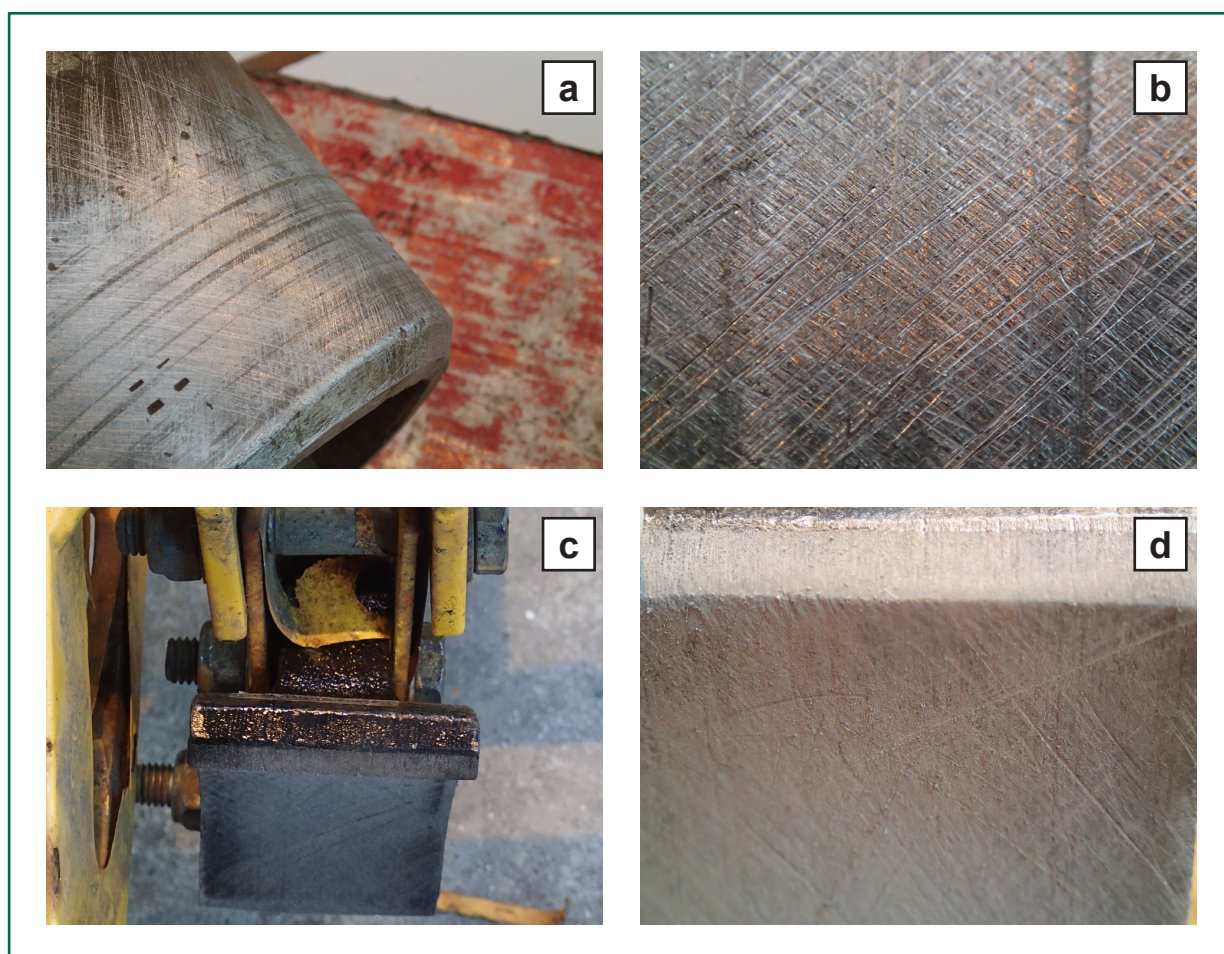
Figure 9: General view (a) and close-up (b) of wheel surface, and general view (c) and close-up (d) of brake pad surface, showing roughening with emery paper

- 74 Ironman No. E0005087 was tested on behalf of the RAIB with slack brake cables (so that the cables did not reduce the brake force, see appendix G, paragraph G5), new brake pads and the original brake springs, without shims. This found that it was practically impossible to achieve the required minimum average torque of 40 Nm. An average torque of 39.6 Nm was achieved only after both wheels and pads had been roughened with emery paper (figure 9). Such roughening is not a normal maintenance practice and would probably not be effective in maintaining the brake torque once the aluminium wheels have rolled a short distance along rails and once the pads have been used to stop an ironman a few times.

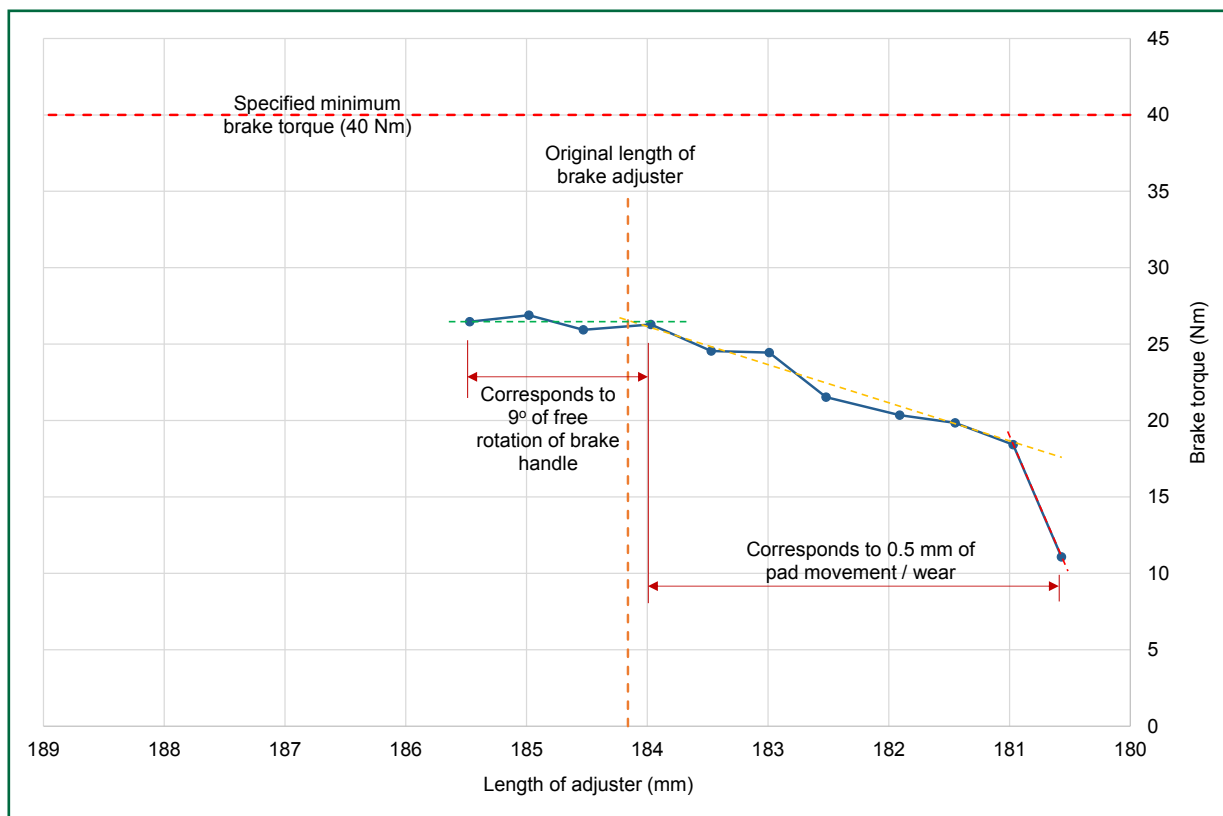
Figure 10: Brake torque measurements; ironman No. E0005087

- 79 The results for testing of the leading ironman (No. E0005087) are shown at figure 10. These show that there is a region of constant brake torque while there is still slack in the cables; this was 26 Nm without roughening of the wheels and pads (paragraph 74). This region is followed by a linear reduction in torque as the length of the adjuster is reduced further, culminating in an abrupt reduction when the pad is no longer held in contact with the wheel. The length of the adjuster, as found after the runaway, indicates that the brakes had previously been adjusted so that there was minimal slack present with new brake pads. This is consistent with witness evidence that Torrent Trackside's mobile fitter would normally turn the adjuster by hand to take the slack out of the brake cable before tightening the locknuts. A total loss of brake force occurred after a reduction in adjuster length that was equivalent to 0.5 mm of brake pad wear.

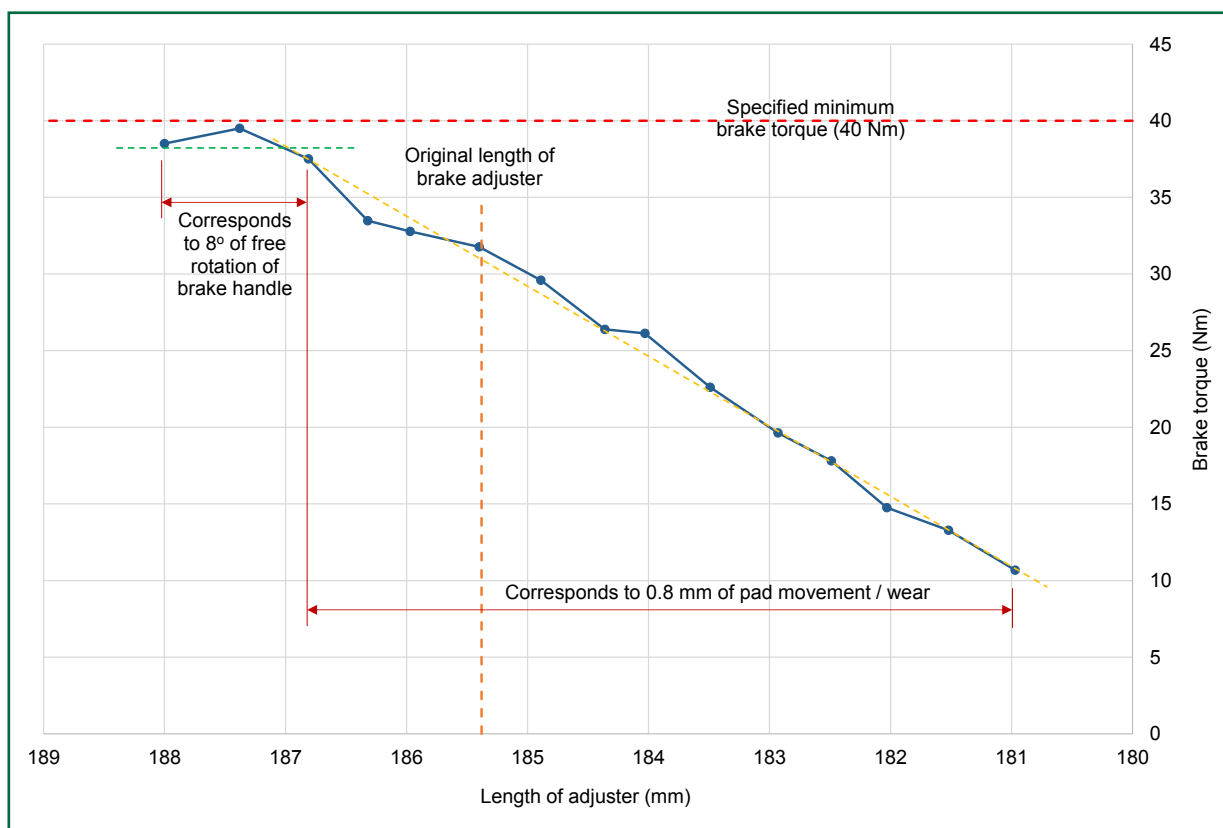
Figure 11: Brake torque measurements; ironman No. 202003429

- 80 The results for testing of the trailing ironman (No. 202003429) are shown at figure 11; this ironman was fitted with the later type of springs that had a spring rate 37% higher than those fitted to the leading ironman (paragraph 70). The results show a region of constant torque while the cables are slack; this is slightly lower than the specified minimum of 40 Nm. There is a linear reduction in torque as the adjuster is progressively tightened, up to the point that the measurements became unreliably small. No sudden loss of brake force was observed; this may have been because the bottom pulley of the vertical brake cable was progressively collapsing with increasing cable tension during the testing (figure 12). The average brake torque with new brake pads, and with the brake adjuster at the length at which it was found after the runaway, was approximately 32 Nm.

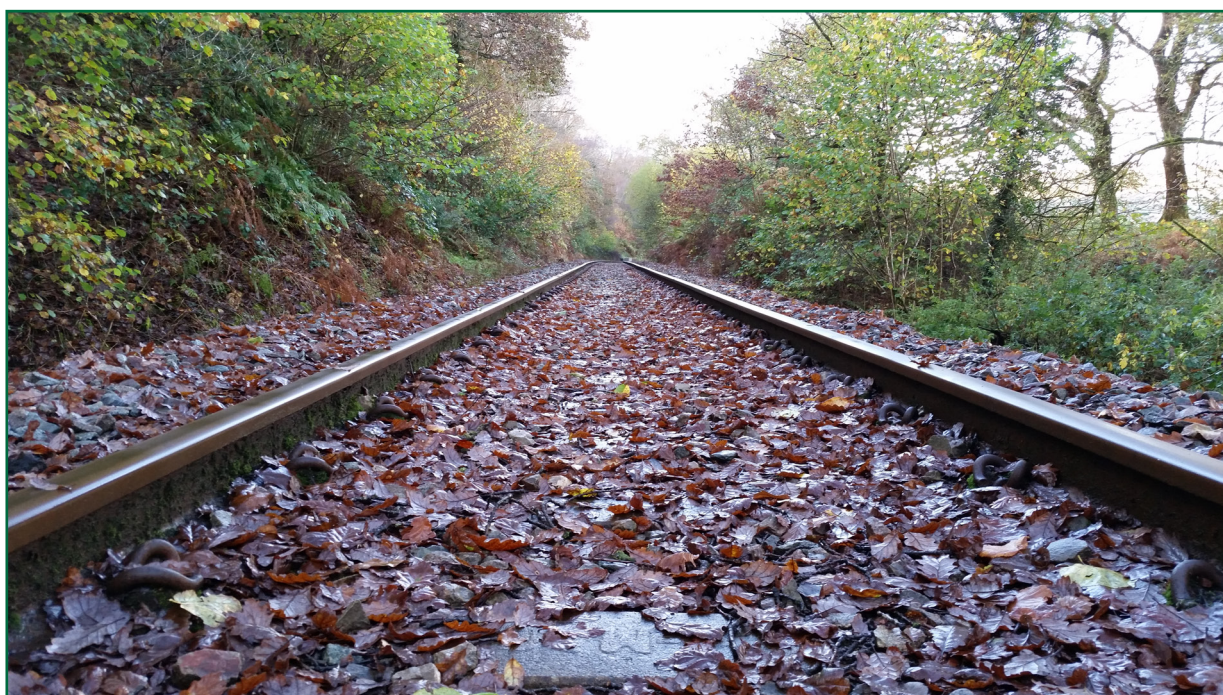
Figure 13: Garnant Branch line below GCG on 3 November 2014

- 92 As well as the reported heavy rain, the runaway occurred at a time of leaf fall (figure 13). Subsequent examination of the ironmen revealed the presence of leaf contamination on the brake pads (figure 14); it is possible that this may have reduced the friction between the pads and wheel treads. There was no evidence that leaf contamination had caused the wheels of the ironmen to lock up and slide along the rails, and witness evidence indicated this did not happen.

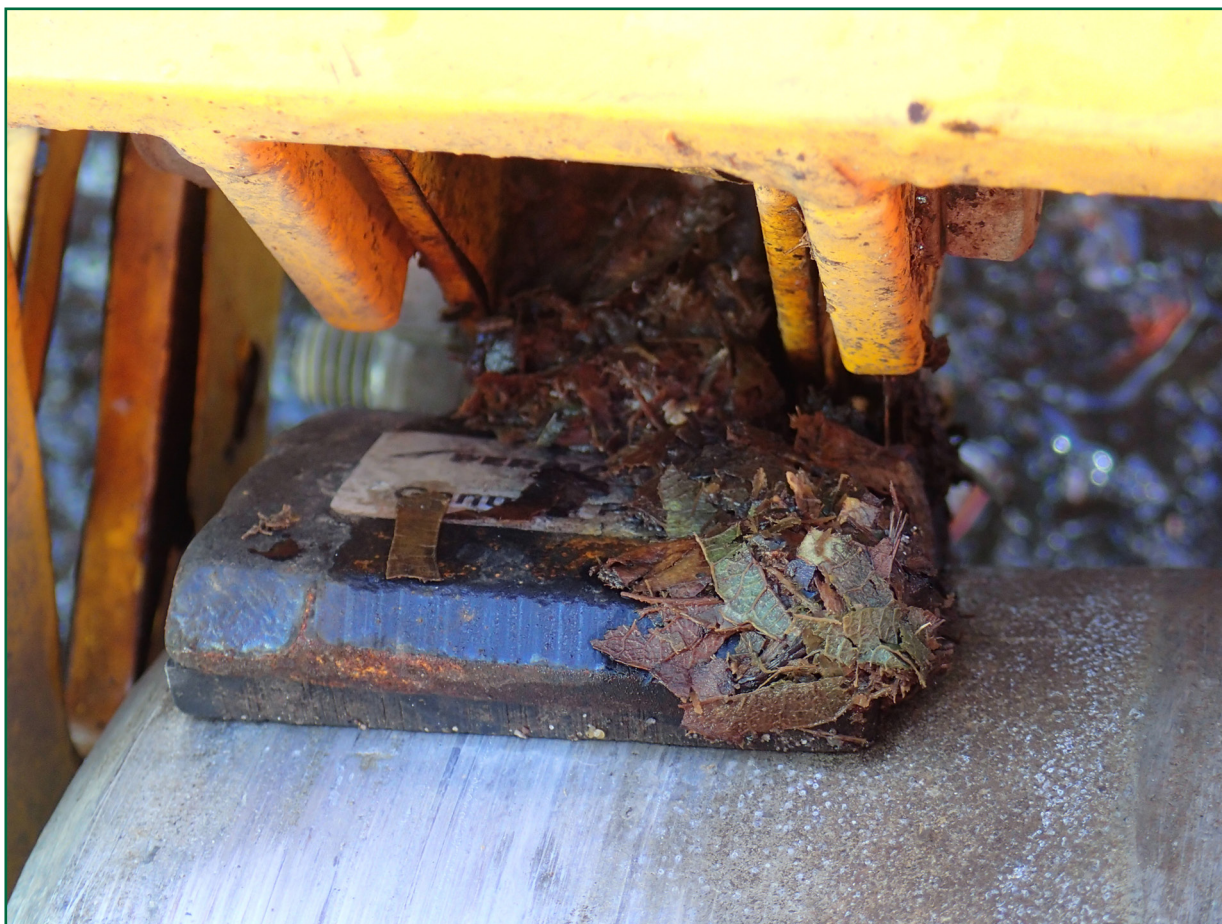
Figure 14: Leaf contamination of brake pad (ironman No. E0005087) on 3 November 2014

- v. The effectiveness of the brakes may have been reduced due to the presence of water and leaf contamination (paragraph 92, **Recommendation 3**).

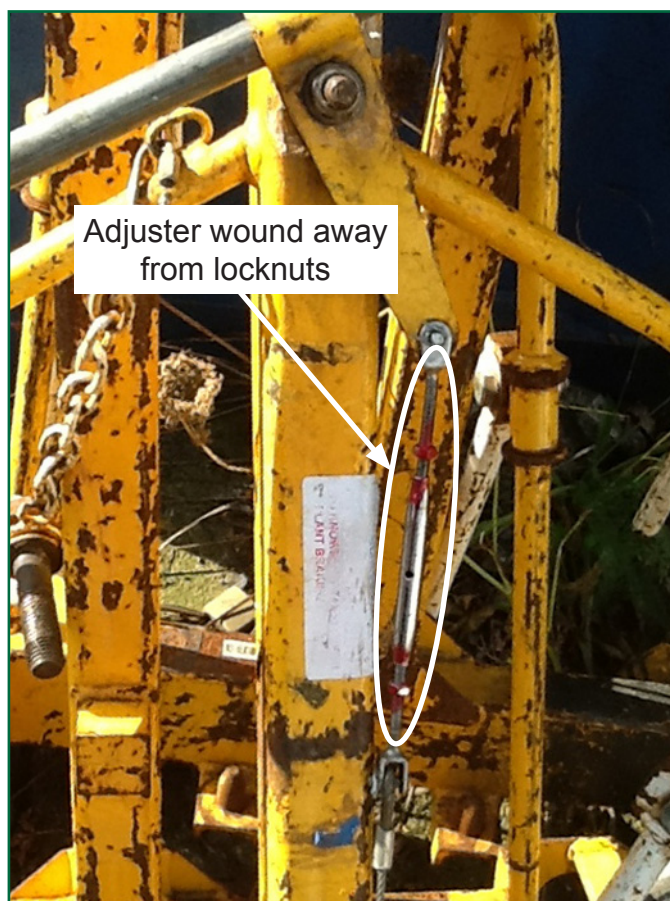
Figure 15: Evidence of interference with ironman brake adjustment (courtesy Torrent Trackside)

- 96 Torrent Trackside has reported a number of instances in which the adjustment of the brakes of Network Rail's manually propelled plant has been interfered with. These include slackening ironmen brake cables, to make it easier to depress the handle and release the brake (figure 15), and tying off brake handles with rope or cable ties.

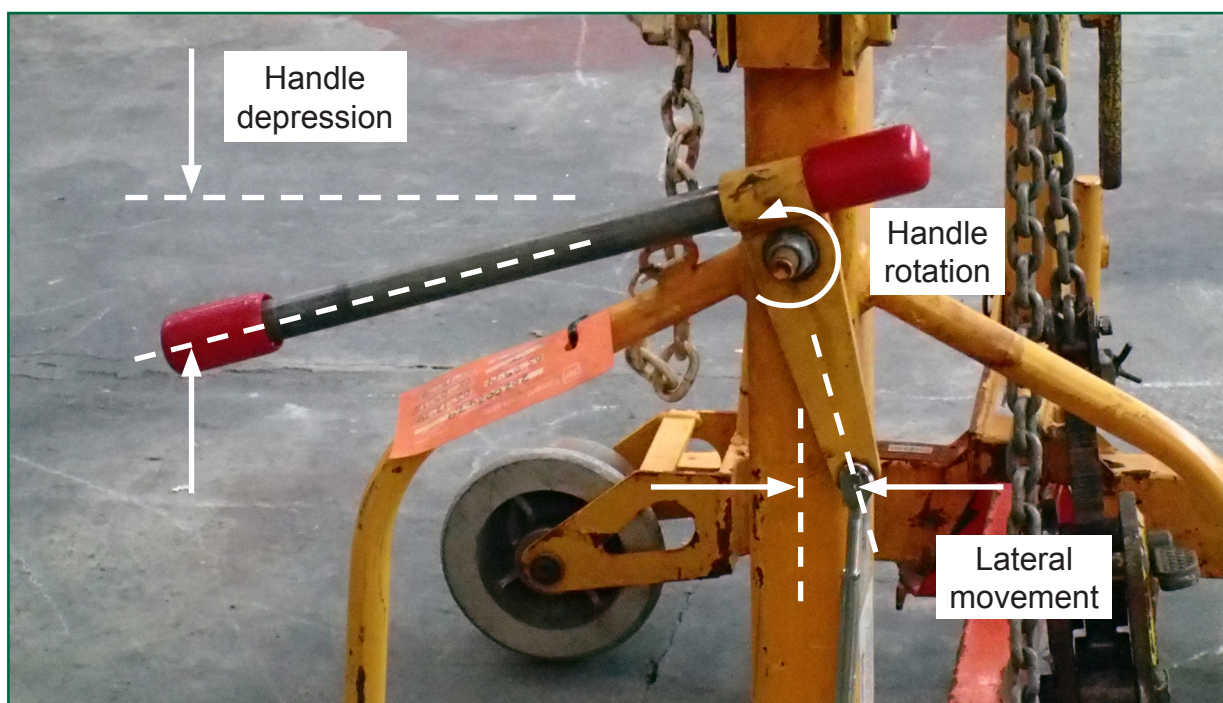
Figure G5: Measurement of slack in the brake cable

- G6 The maintenance section of Permaquip's user guide MAN/M/O/105 (appendix D) states that the brake cables should be slack when the brake handle is released and the brakes are engaged, although the extent of slack that is required is not defined. Permaquip advised the RAIB that it typically adjusts the cable slack to make one end of the brake handle approximately 40 to 50 mm lower than the other end when the handle is released and the brakes are applied; this is equivalent to a rotation of approximately 7 to 9° (figure G5 shows a rotation of 14°).

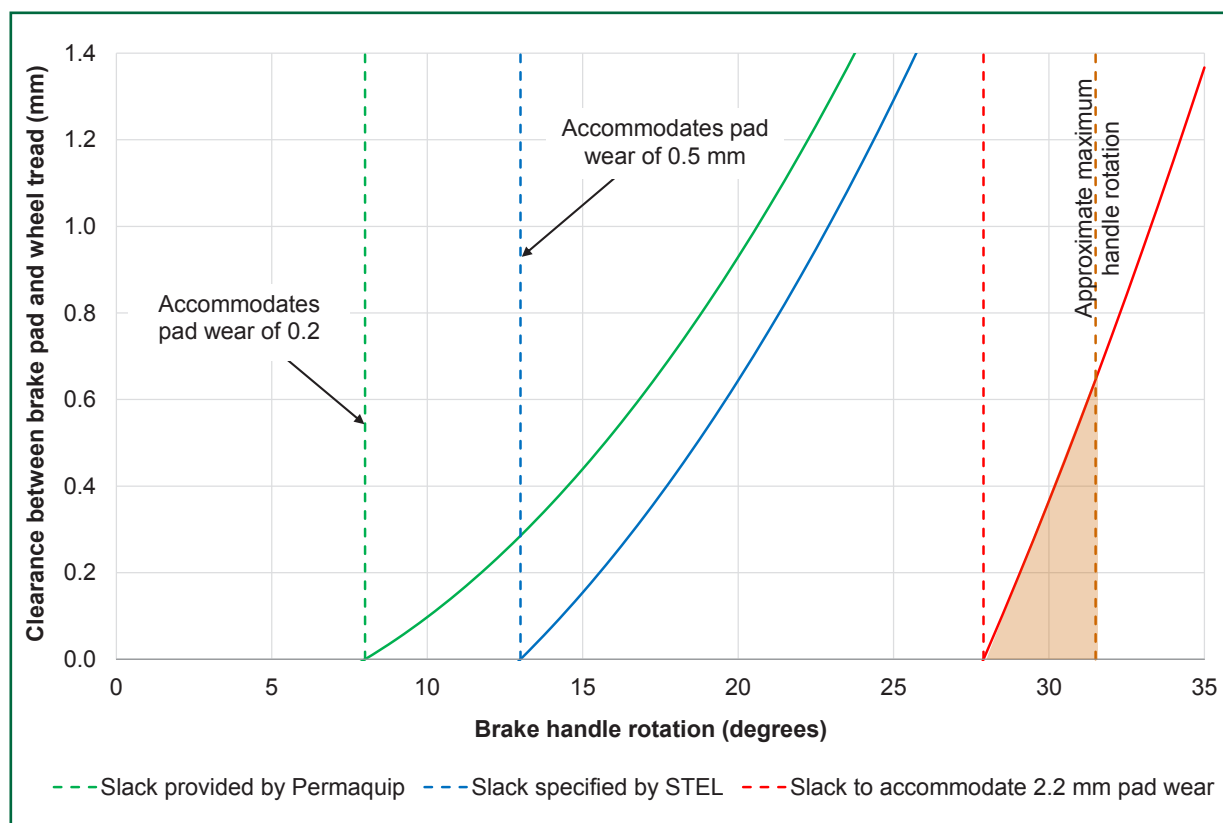
Figure G6: Relationship between brake handle rotation and pad position

- G8 The relationship between the rotation of the handle and the position of the brake pads is shown at figure G6. The amount of free rotation of the handle when it is released corresponds to the slack in the vertical brake cable. As the brake pads wear, the amount of slack reduces; this is equivalent to moving the X axis downwards.

G9 The slack normally provided by Permaquip on an ironman leaving the factory is sufficient to accommodate 0.2 mm of pad wear before the cable will remain in tension when the handle is released. The amount of slack specified in the STEL User and Maintenance Guide will accommodate approximately 0.5 mm of pad wear. However, the wear limit before brake pads should be changed during maintenance is 2.2 mm<sup>13</sup> (in practice, the brakes could be adjusted to compensate for wear in service at successive maintenance intervals before reaching this limit). If sufficient slack was provided to compensate for 2.2 mm of pad wear with new pads fitted, it might not be possible to release the brakes when the handle is depressed fully due to the tolerances and play in the various linkages of the braking system. The limited operating range with this amount of slack is represented by the shaded area in figure G6.
