Rail Accident Investigation Branch

Rail Accident Report

Derailment of a passenger train at Ealing Broadway 2 March 2016

Report 24/2016
December 2016

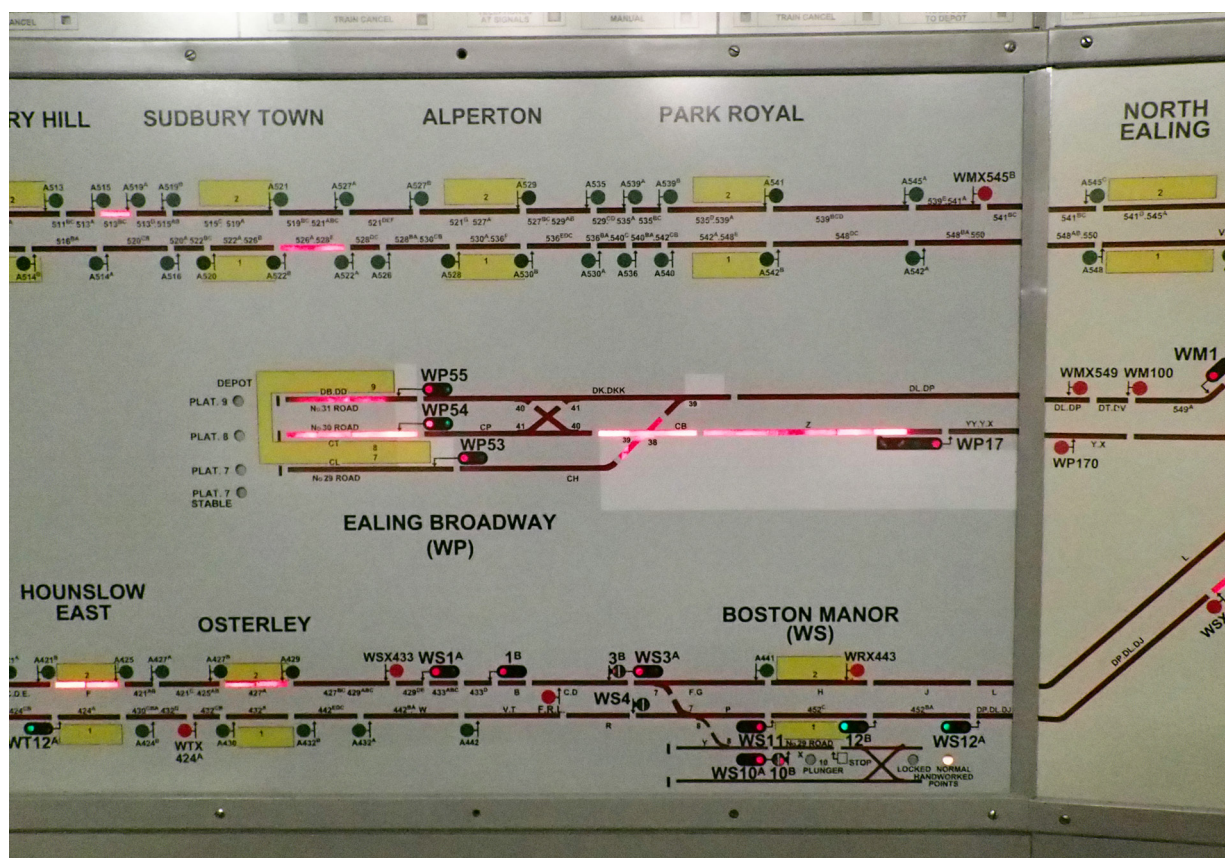
Figure 8: Signaller's overview panel in Earl's Court signal control centre

84 The overview panels in the Earl's Court control room do not show which position of the points is normal, and which reverse, and they do not indicate which position the points are actually in. Most railway signalling displays include information on normal/reverse position, and more modern displays allow the signaller to identify the position the points are lying. The former practice of LUL and its predecessors was not to include this information. However, the signalling of LUL's sub-surface railway, including the District line, is to be completely renewed in the near future, and this will include the provision of better information and displays for control room staff.

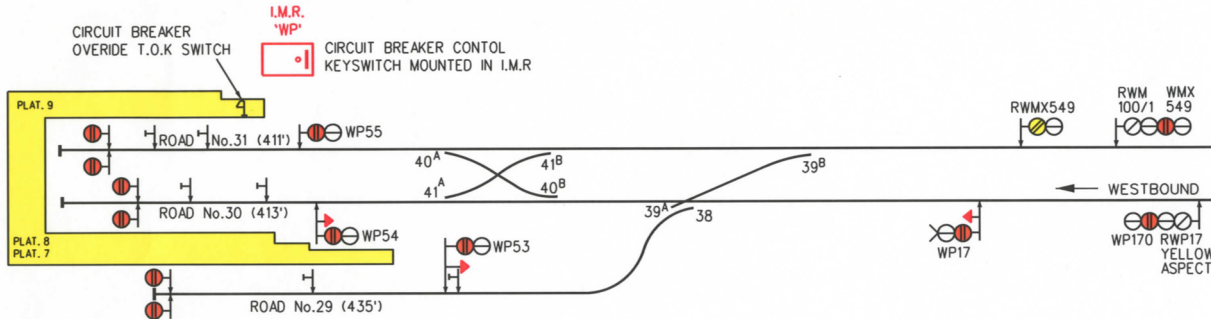
Figure 11: Version of the Traffic Controller's Diagram available to the District line service controllers

- 86 The District line service controllers had a later version of the diagram (figure 11) and *Tracknet* (figure 12) to inform their decision making (although LUL company standards state that the Tracknet system must not be used as the basis of safety critical decisions).
