# Rail Accident Report

**Self-detrainment of passengers onto lines that were still open to traffic and electrically live at Lewisham, south-east London  
2 March 2018**

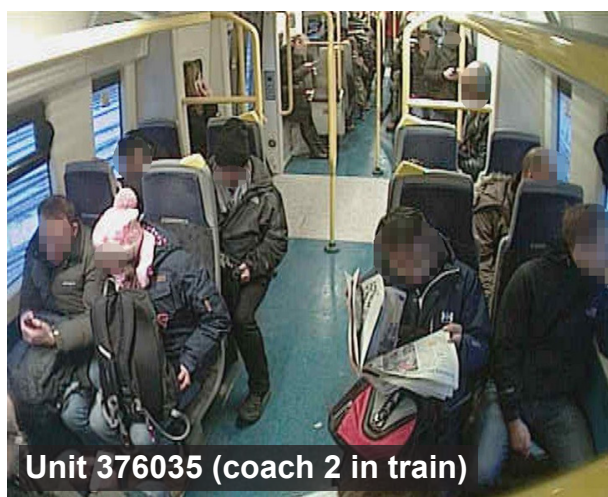
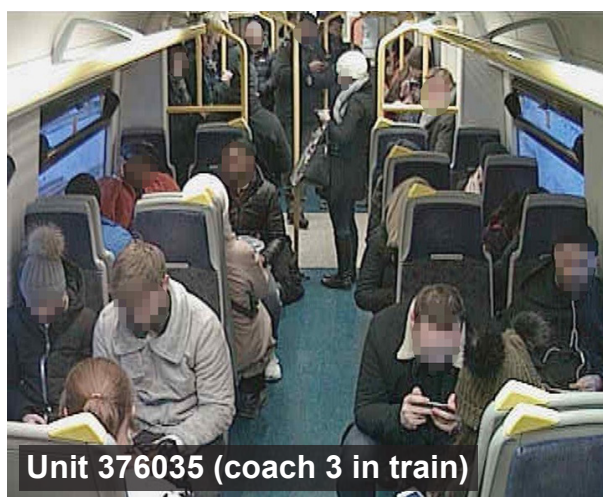
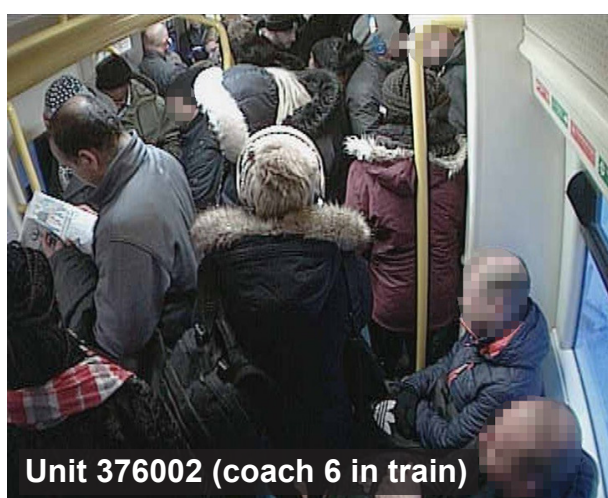
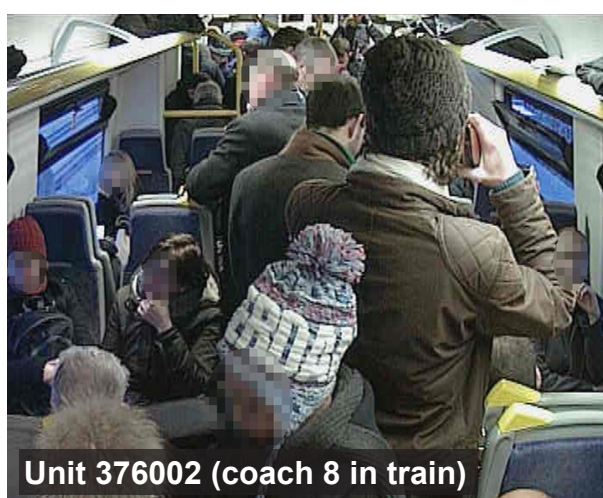
Figure 7: Images showing passenger occupation on leading and trailing units of train 2M50 (images courtesy of London and South East Railway Ltd)

- 100 Train 2M50 was held at L445 signal for 63 minutes before the first passenger detrained. During this time many passengers were standing in crowded conditions and were unable to judge how long they would remain trapped on board the train. In such circumstances it is understandable that some passengers became uncomfortable, frustrated or agitated.

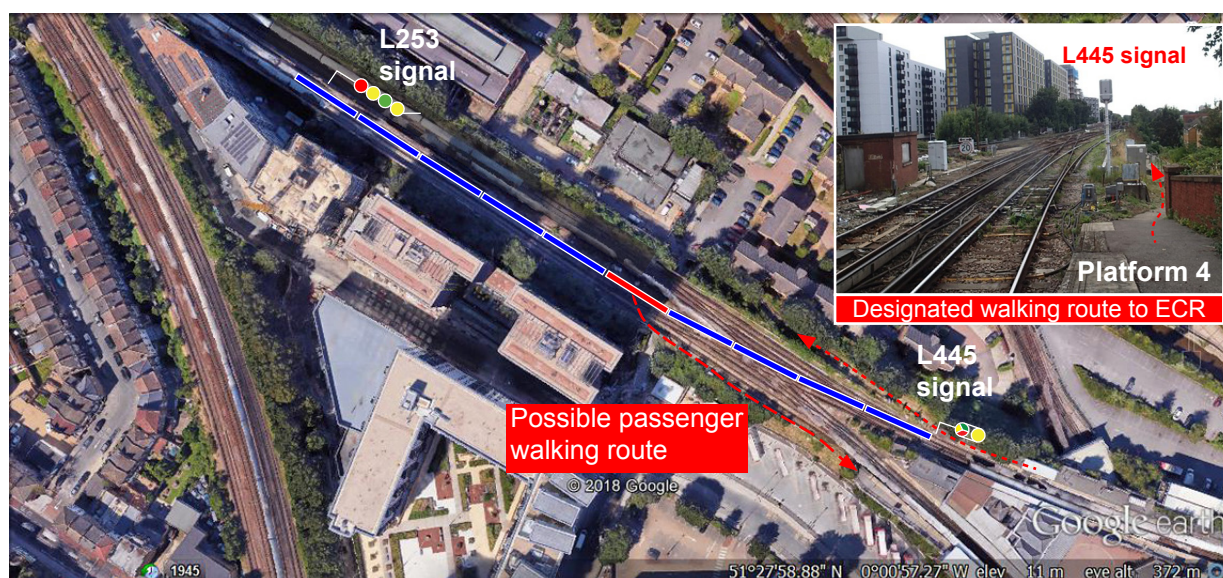
- 61 At 17:34:33 hrs the signalling data logger recorded that Signaller 1 set the route for train 2M50 to cross from the Down Kent Fast line onto the Down Tanners Hill line and proceed to Lewisham Junction. Train 2M50 arrived at the junction at 17:37 hrs and was held at L445 signal on the Down North Kent line waiting to enter platform 4. The 10 coaches of the train occupied the junction and extended onto the Down Lewisham line as far as L253 signal (figures 2 and 14).

Figure 14: Lewisham Junction showing the position of train 2M50 when held at L445 signal. It also shows the designated walking route to Lewisham electrical control room (paragraph 12), the coach (coloured red) that the first passenger got out of and a possible walking route to platform 1 (paragraph 141)

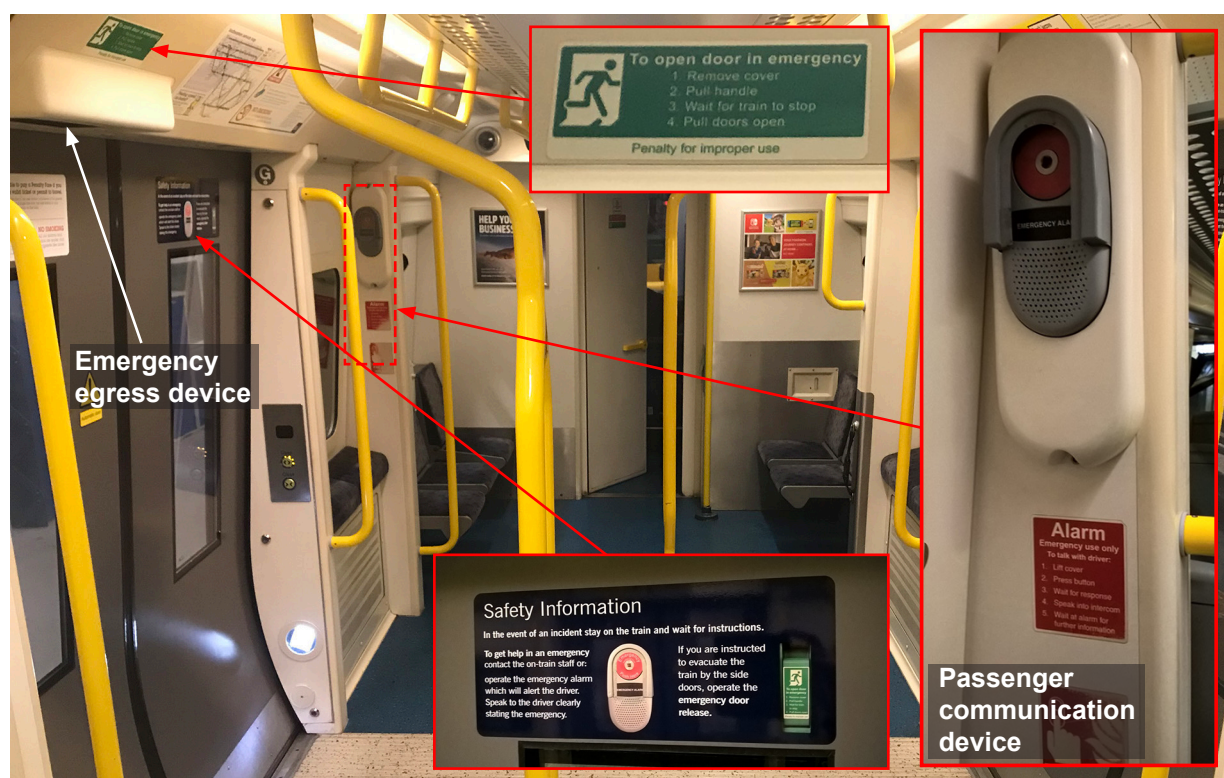
- 96 On-train CCTV recordings confirmed that the passenger that first got off train 2M50 decided to use an emergency egress device on the right-hand side of the fifth coach (paragraph 81). This was contrary to instructions on passenger safety information notices that Southeastern had fitted to the inside of the passenger doors, and to signs located immediately above each emergency egress device (figure 15). The initial detraining of passengers was also in spite of announcements made by the driver (paragraph 143).

Figure 15: Passenger vestibule on class 376 unit (images courtesy of London and South East Railway Ltd)

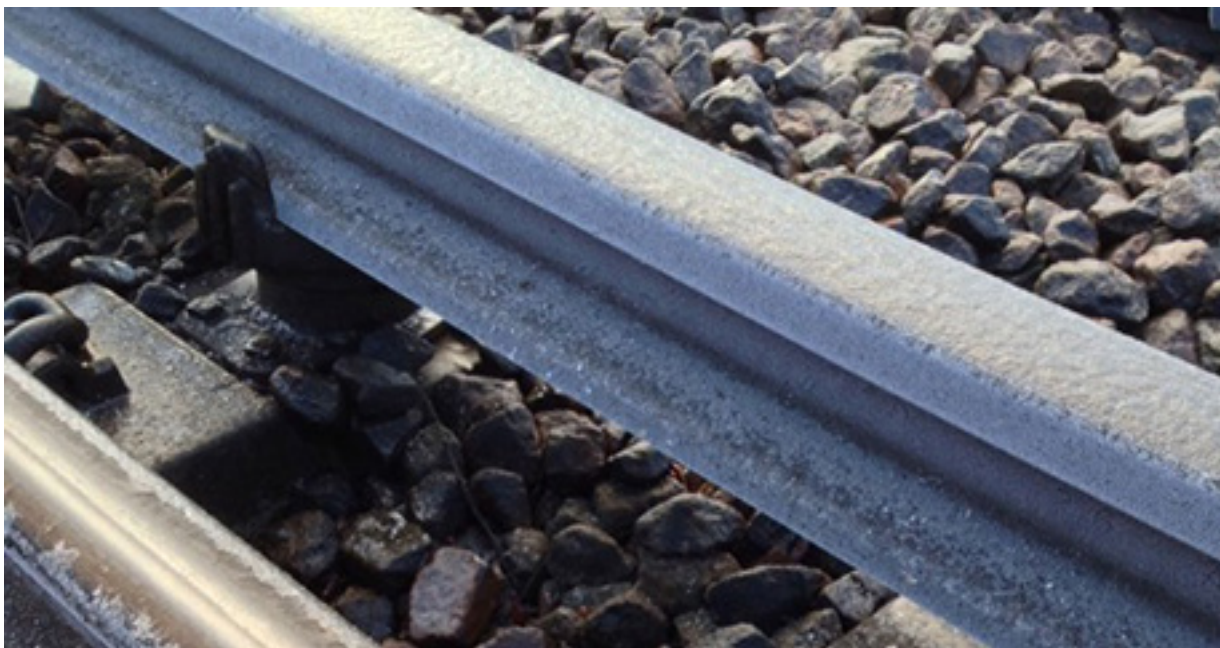
106 The class 465 and 466 units that formed train 2M48 rely on electrical contact between the top surface of the conductor rail and the train shoe gear (paragraph 21). Since ice is generally a poor conductor of electricity, its accumulation on the conductor rail can result in an insulating layer that can lead to trains having difficulty drawing traction current. Figure 16 illustrates typical ice and frost formation on a conductor rail.

107 The weather conditions in the Lewisham area prior to train 2M48 departing from platform 4 were consistent with the formation of ice and frost on the surface of the conductor rail. The factors that led to the ice formation were:

- the frost point of the air rising to the surface temperature of the conductor rail; and
- rain freezing on the surface of the conductor rail.

*Figure 16: Typical ice and frost formation on the surface of a conductor rail (image courtesy of Network Rail)*

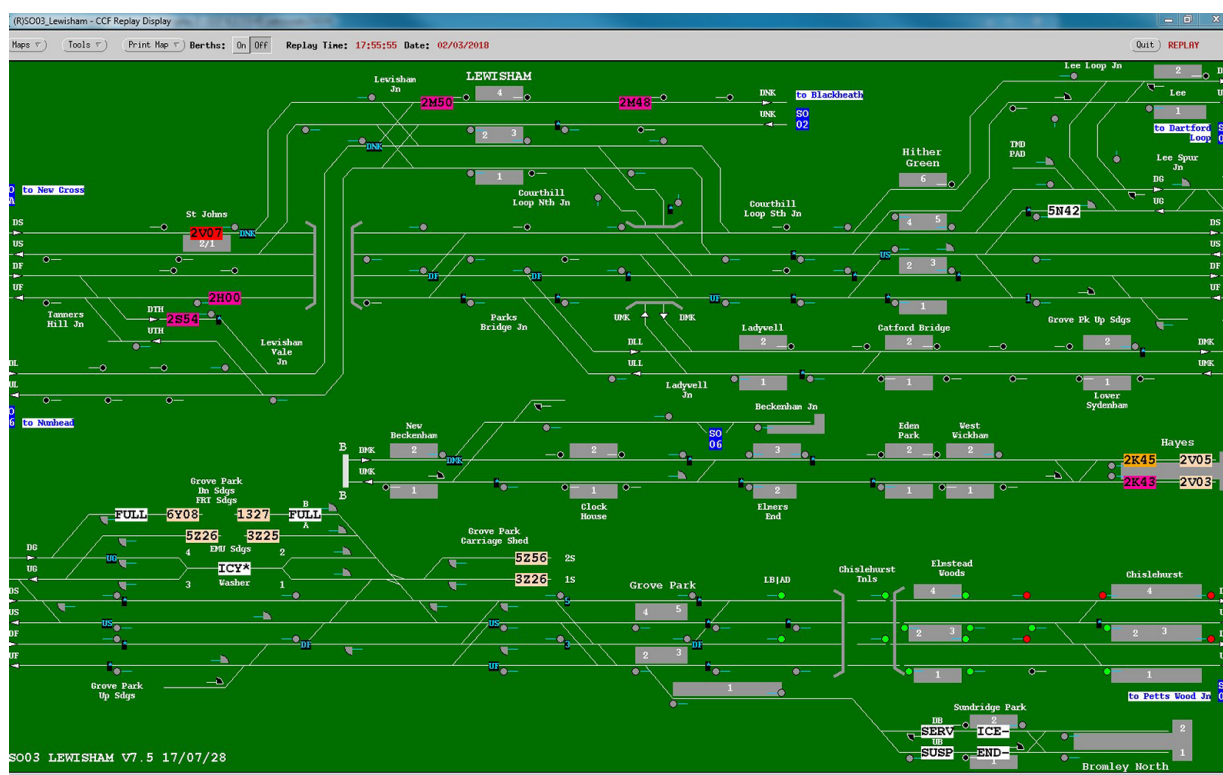
Figure 18: CCF screen image for Lewisham at 17:55 hrs on 2 March 2018. Note: this image was acquired using the playback facility in CCF (image courtesy of Network Rail)

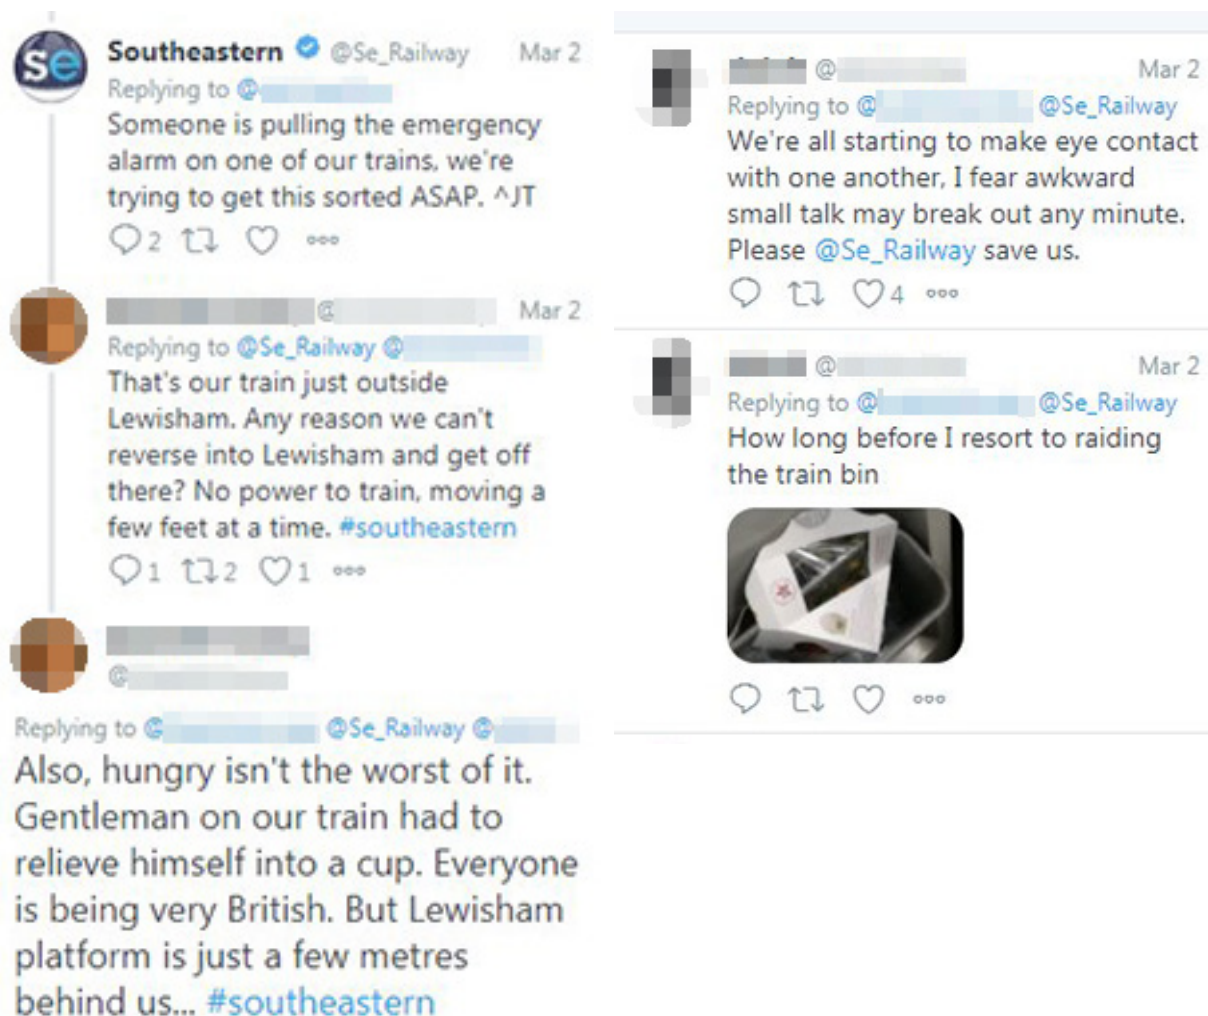
Figure 20: Typical tweets to Southeastern's Twitter account prior to 18:41 hrs

- 149 It would not necessarily be possible for passengers to know that an individual message related to the train they were on. However, the information being exchanged would probably have promoted a shared feeling of dissatisfaction and possibly thoughts of getting off the train. These, and other tweets sent over the course of the evening, may also have influenced others to leave stationary trains in the area.
