# Rail Accident Report

## **Collision at Plymouth station 3 April 2016**

Report 02/2017  
February 2017

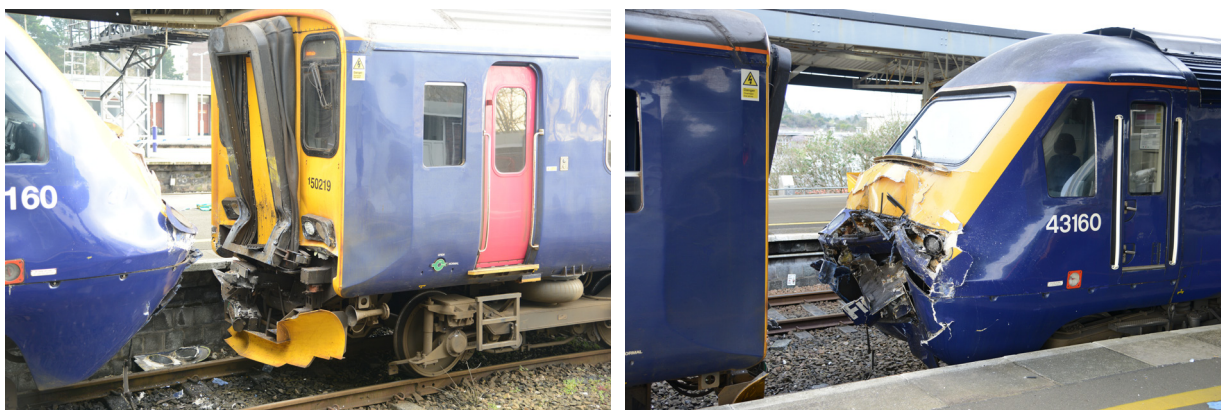
Figure 2: Damage to train 2E68 (left image) and train 1A91 (right image)

- 29 Many people who were standing up waiting to get off train 2E68 were thrown into each other, into the train's fixtures, and onto the floor. The collision resulted in injuries to 42 passengers and 4 members of staff on train 2E68, including one passenger who was seriously injured<sup>3</sup>. Two members of GWR staff on train 1A91 were also injured during the collision. Both trains were damaged.

- 104 Although both driving cabs were damaged, there was no significant damage to the main structural components of the carriages. This meant that passengers and staff were protected from injury caused by structural deformation of the carriages. The driver's desk of train 2E68 showed no signs of movement, and in the passenger compartments the fixtures and fittings remained largely secured, intact and undamaged. This meant that passengers and staff were not exposed to the risk of injury from train components dislodged during the accident.

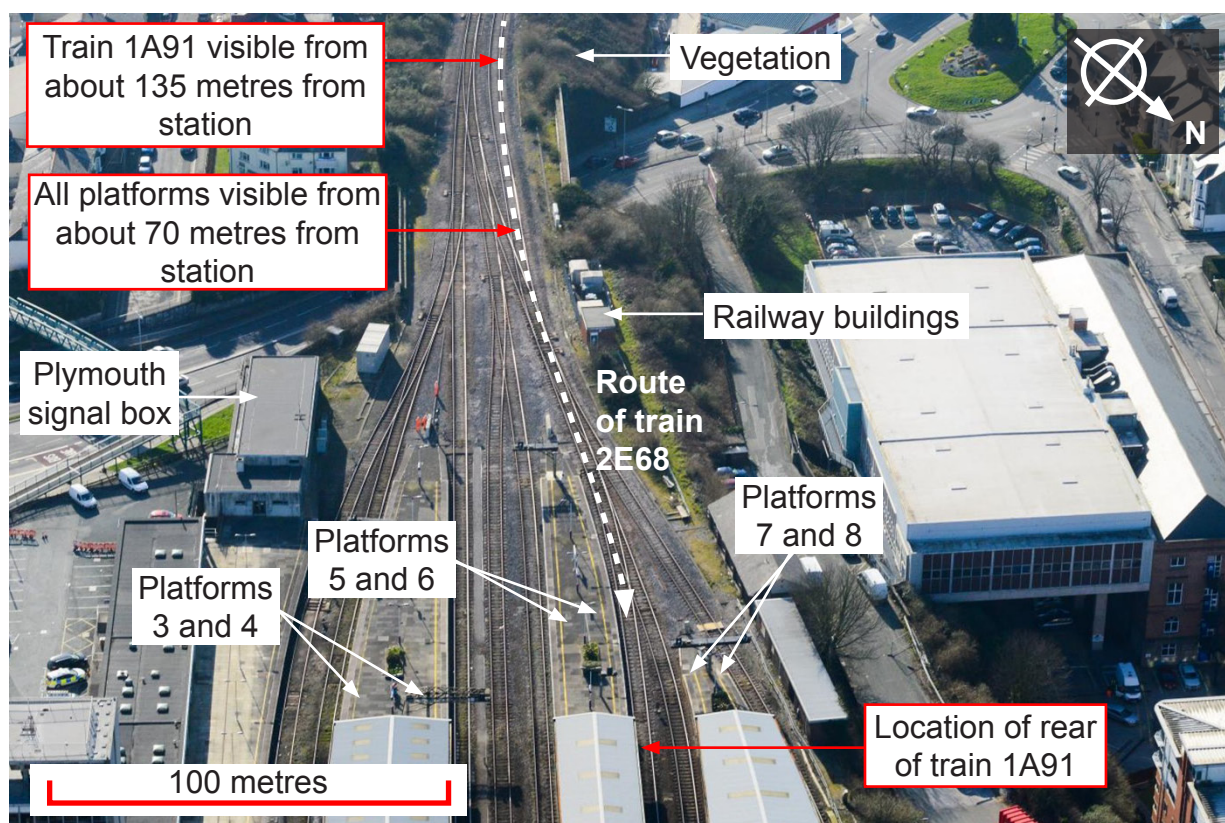
Figure 4: Features obscuring an approaching driver's view of platforms 6, 7 and 8 (image courtesy of Network Rail)

- 70 The presence of track curvature, vegetation and railway buildings (figures 3, 4 and 12) meant that the driver of 2E68 could not see platforms 7 and 8, and so could not establish the location of platform 6 by counting across from platform 8, until about 13 seconds (125 metres) before the collision. Counting at this stage would have revealed that train 1A91 was in platform 6 and would have given the driver sufficient time to stop his train safely. He did not count platforms at this stage because he had concluded that there was insufficient room for his train to share the platform occupied by train 1A91, and so had discounted the possibility of his train being routed into this platform. Although the driver of train 2E68 was competent to drive the route to Plymouth, he was still gaining practical experience driving it. It is possible that a more experienced driver would have recognised that train 1A91 was occupying platform 6 in time to prevent a collision (paragraphs 66 and 67).

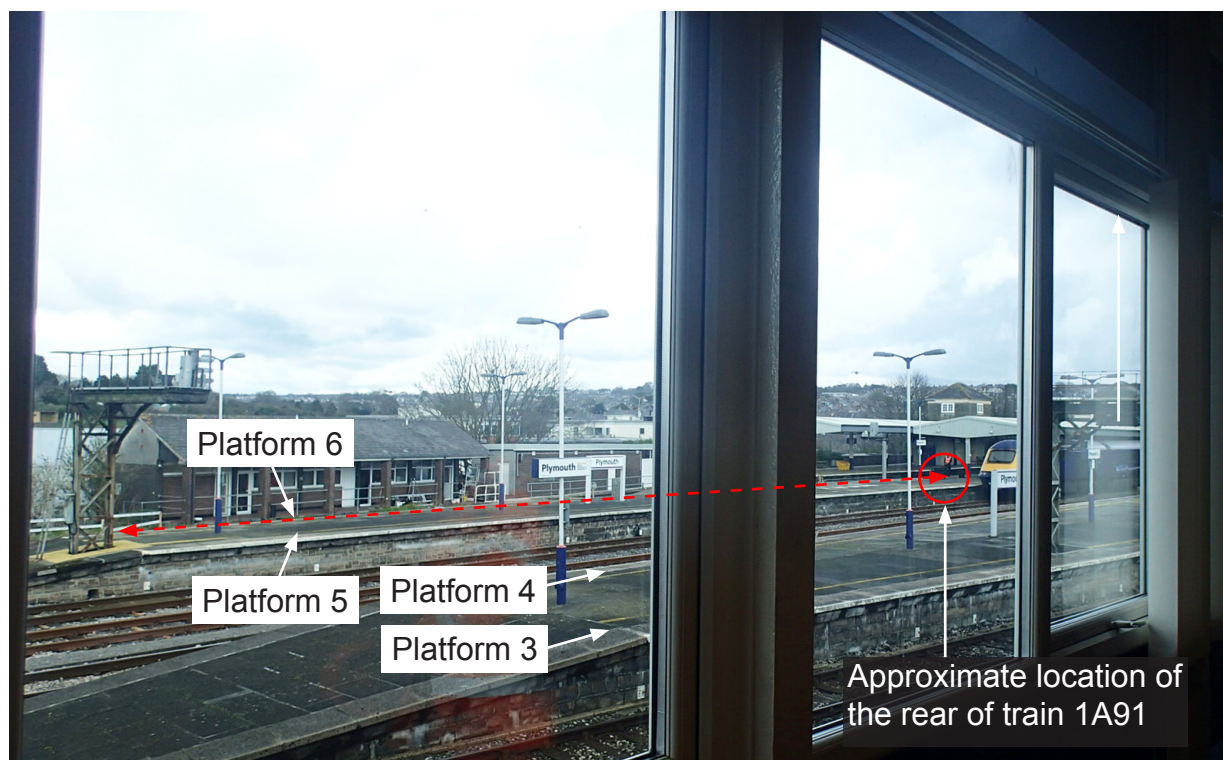
- 45 When considering whether he could put train 2E68 into platform 6, the signaller looked through the signal box window and judged that there was enough room for train 2E68, which he knew to be four vehicles long, to fit between the rear of train 1A91 and the end of the platform (figure 9). This would require a permissive movement by train 2E68 (paragraph 32).

Figure 9: View of platform 6 through the signal box window

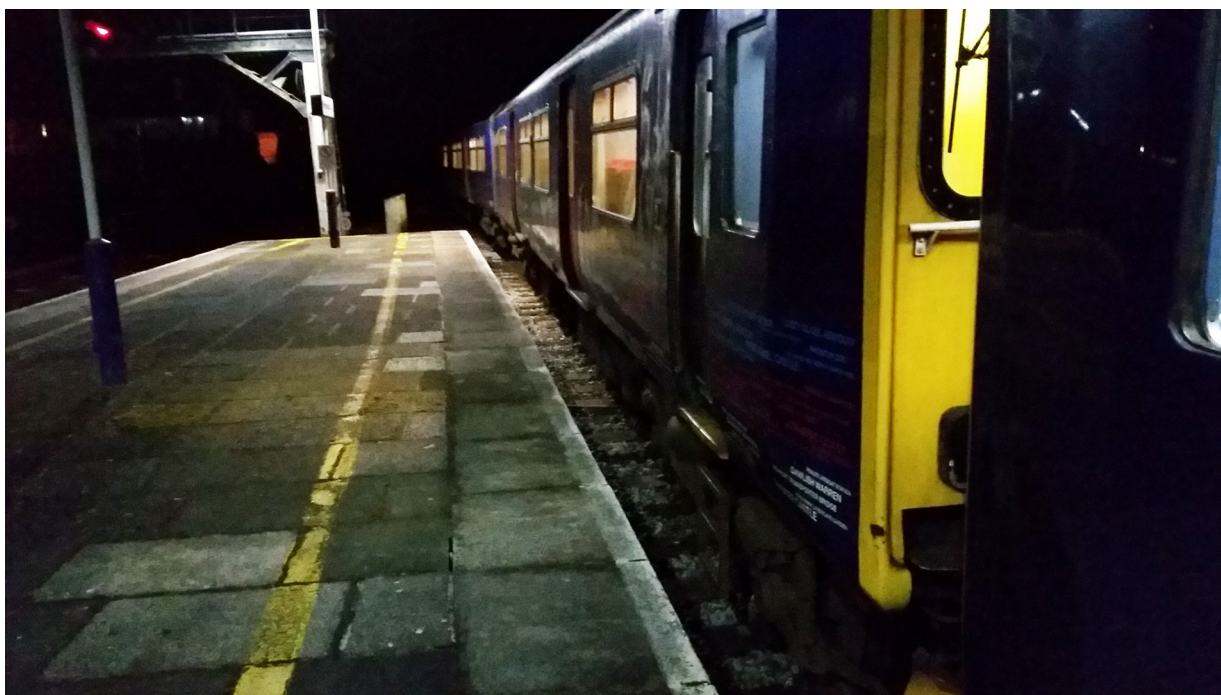
- 49 The actual length of platform available to accommodate train 2E68 was about 61 metres, around 20 metres less than needed. GWR considered that part of this 61 metres was unsuitable for boarding and alighting passengers (paragraph 53).

Figure 10: Gap between the third vehicle of train 2E68 and the platform edge

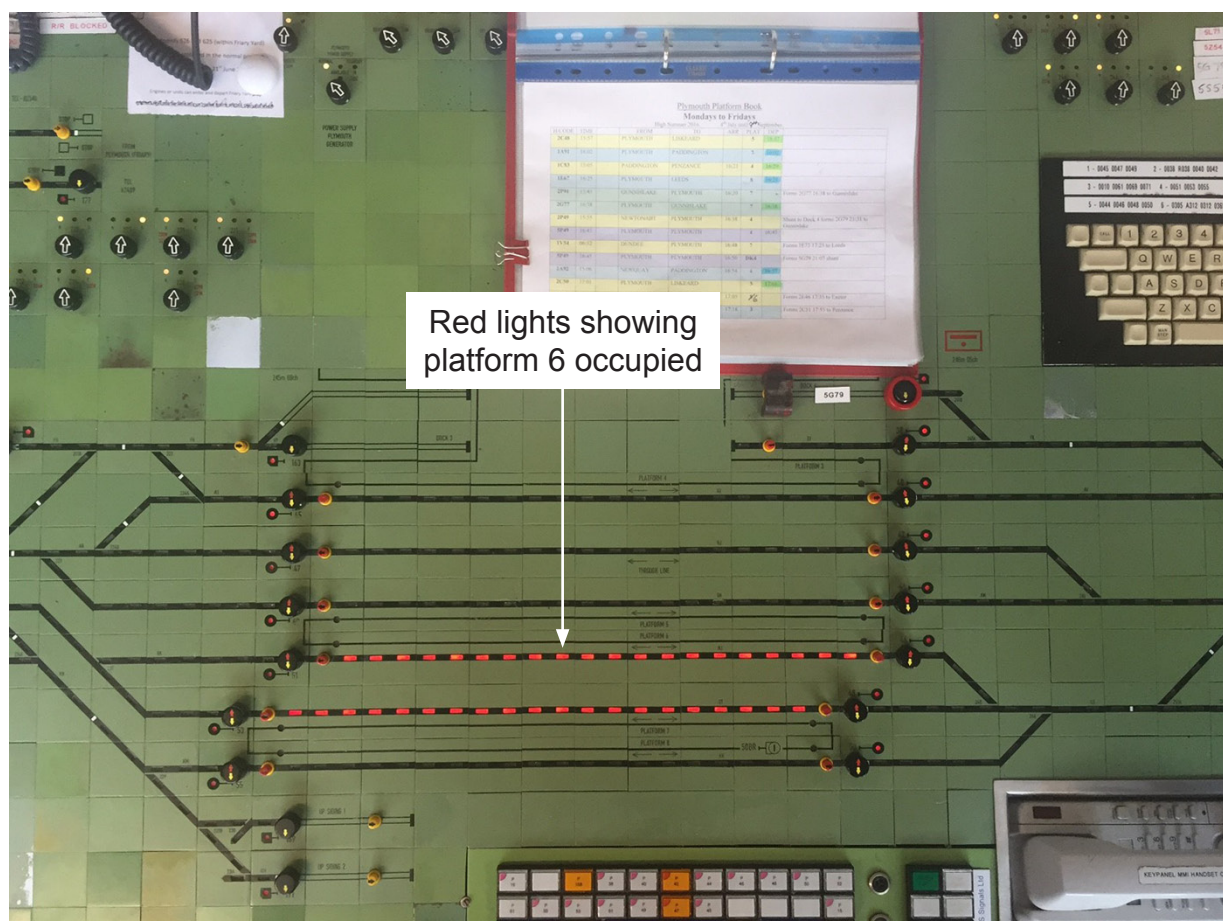
- 52 Network Rail had not formally provided the signallers at Plymouth with information about the combinations of trains that could be safely accommodated in each platform. However, the signallers had produced their own document, based on information from the Western Route Sectional Appendix that showed the length of each platform and the length of typical trains that use the station. This document showed that platform 6 had a useable length of 260 metres, and that the combined length of trains 1A91 and 2E68 was 301 metres. Use of this document was not mandated and it was little used by the Plymouth signallers. On the day of the accident the signaller had not referred to the document because he had relied on his visualisation of the length of train 2E68, and his judgement of the available length of platform 6 (paragraph 45).

Figure 11: The signaller's panel display at Plymouth signal box

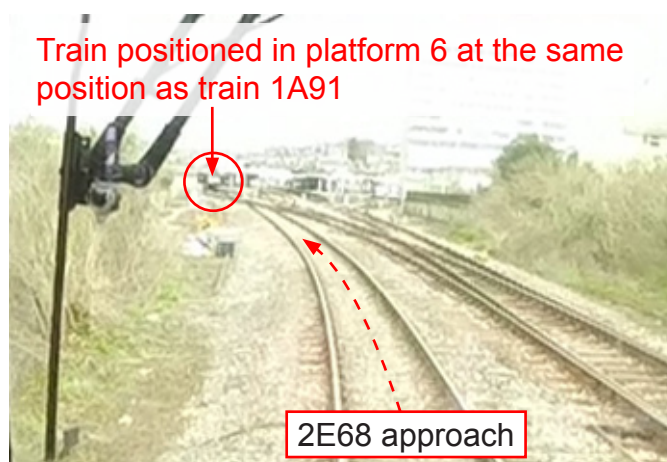
- 66 The driver further stated that as his train rounded the curve on the approach to Plymouth station, he saw train 1A91 in a platform ahead. He immediately thought that his train would not be going into the same platform because train 1A91 looked as though it was occupying nearly the whole length of platform and there was no room for his train to fit behind it. At this time platforms 7 and 8 were not visible to the driver because of track curvature and the position of nearby railway buildings (figure 12). This meant that he did not realise that train 1A91 was actually standing in platform 6, the same platform that his train was to use.

Figure 12: Platforms 3, 4, 5 and 6 become visible from about 135 metres from the station (image courtesy of GWR)

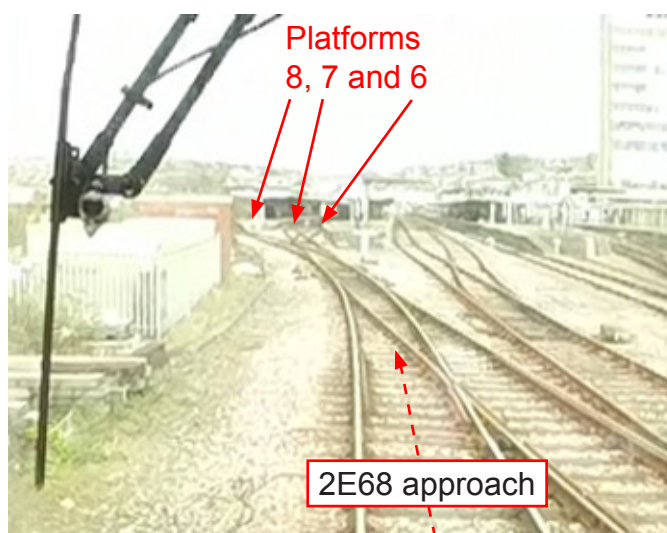
- 67 Train 2E68 continued towards Plymouth station with the driver's attention divided between looking forward, looking at the train's speedometer in the driving cab, and adjusting the power settings as the train negotiated the inclined and curved approach. When platforms 8 and 7 came into view to the left of train 1A91, the driver of train 2E68 continued to discount the possibility that his train was proceeding towards the same platform that train 1A91 was occupying because he firmly believed he was proceeding into one of the platforms to the left of train 1A91. His view along these platforms was partly obscured by train 1A91 and station buildings and so he could not see that there were no trains standing further along these platforms (paragraph 64, figure 13) where he would have expected a shorter train to be.

Figure 13: All platforms visible from about 70 metres from the station (image courtesy of GWR)

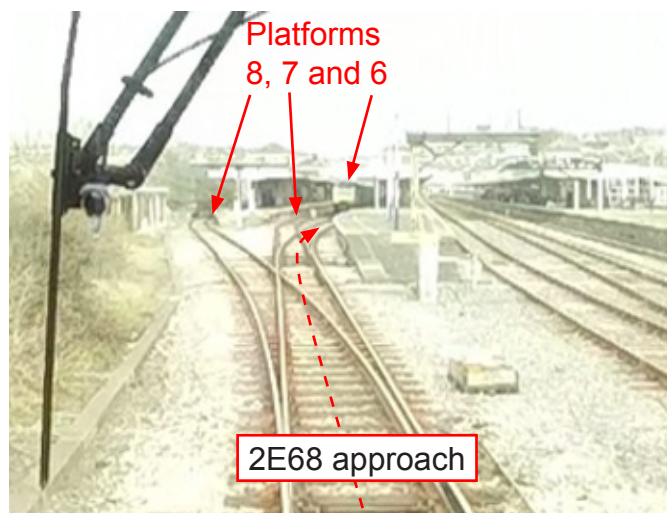
- 68 About 10 seconds (91 metres) before the collision, train 2E68 approached the points giving access to platform 8 (figures 6 and 14). The driver stated he looked at the points and saw that they were set for the straight ahead route, and continued to believe that his train was not going into the platform occupied by train 1A91.

Figure 14: Approaching the points giving access to platform 8 about 91 metres from where train 1A91 was standing in platform 6 (image courtesy of GWR)

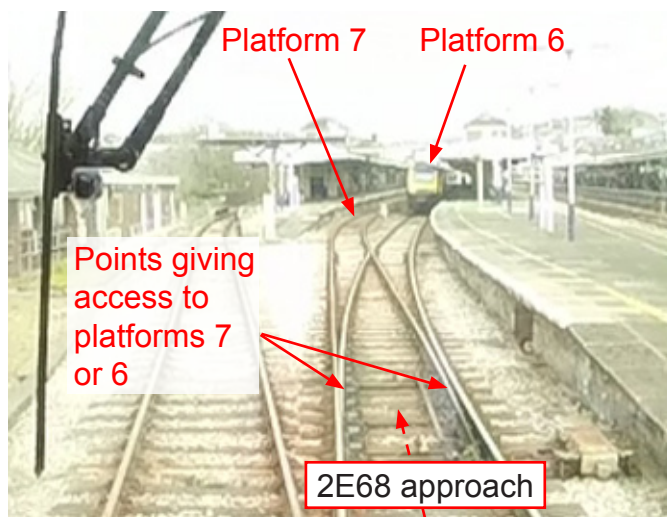
- 69 About 7 seconds (62 metres) before the collision, the train approached the start of platform 6 and the driver shut off power in preparation to stop in the station. At about the same time the driver looked at the final set of points which are located at the start of platform 6. This set of points permits a straight ahead movement into platform 7, or a route to the right into platform 6 (figure 15). On the final approach to this set of points the driver saw they were set towards train 1A91. The driver stated that, in disbelief, he counted the platforms across from 8 to 6, and on realising train 1A91 was in platform 6, he made an emergency brake application. The OTDR shows that the emergency brake was applied about 4 seconds (31 metres) before the collision.

Figure 15: The points giving access to platforms 7 or 6 located near the start of platform 6 (image courtesy of GWR)

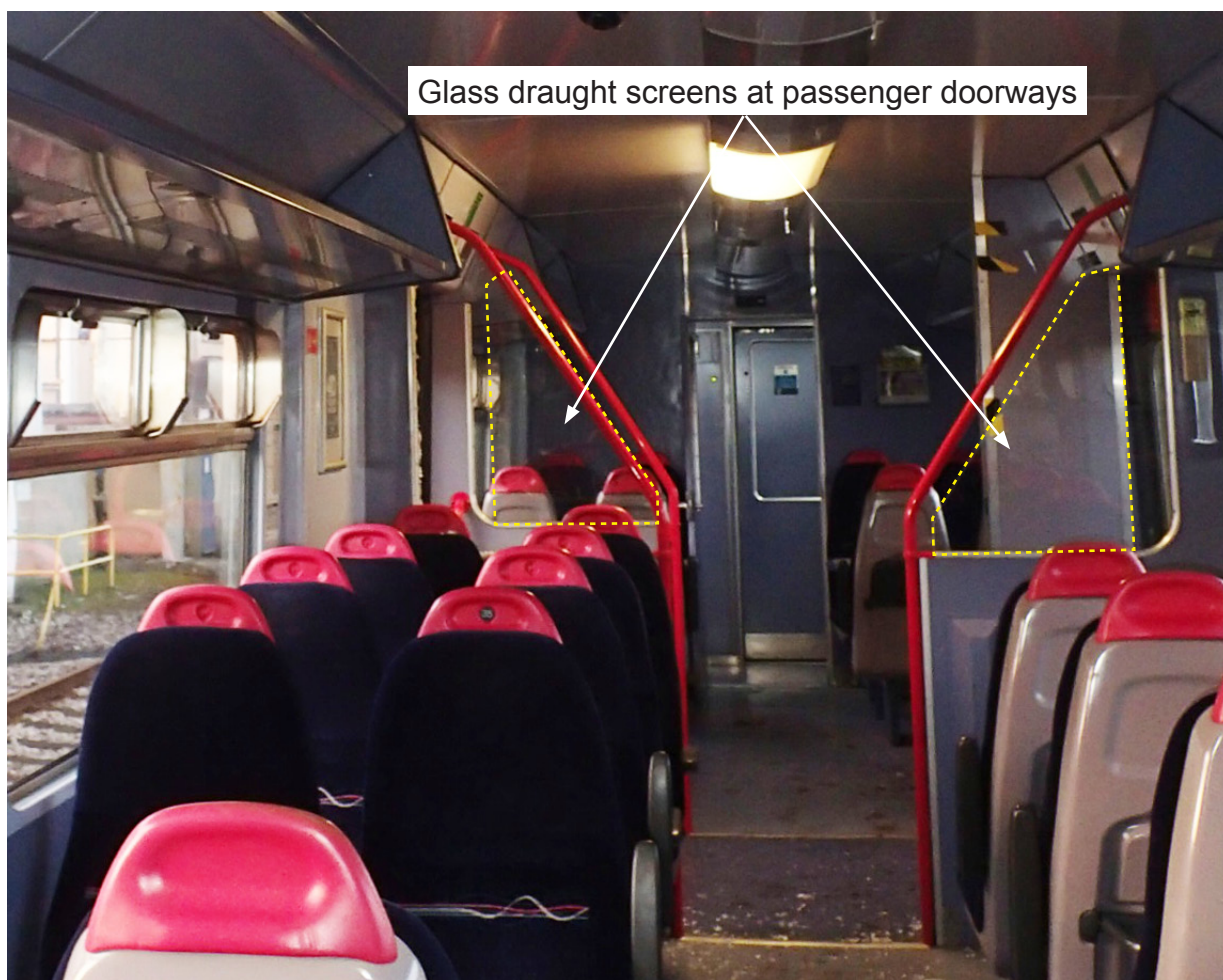
- 103 Some passengers were injured when they made contact with the glass draught screens (figure 16). One passenger was injured when the draught screen broke because their head struck it. Other passengers were injured when they struck their heads against the screens, but the screens did not break. The draught screens on train 2E68 were made of toughened glass as their installation predates the requirement in the current Railway Group standard<sup>7</sup> to fit laminated glass. This accident does not provide sufficient evidence to justify a recommendation for retro-fitting laminated glass to class 150 trains.

Figure 16: Glass draught screens

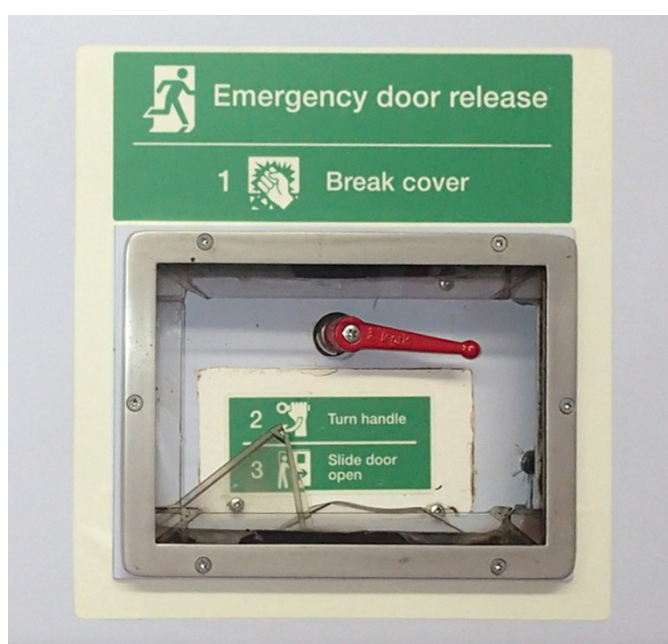
- 107 **One passenger and a member of GWR staff were injured when they broke the protective covers in order to operate the emergency door release handles. Other passengers said they were afraid to break the covers in case they injured themselves.**
- 108 An emergency door release device is provided adjacent to each passenger doorway on trains where the door locks are operated remotely by train crew. Operating this device allows the adjacent train door to be opened in an emergency situation. On class 150 trains the emergency release device is operated by a lever which cannot be used until a protective cover is broken. The cover is intended to prevent misuse of the lever. The sign next to each emergency door release lever says 'break cover' and shows an image of a closed fist (figure 17).

Figure 17: Emergency door release

- 109 One passenger and one member of GWR staff reported cutting themselves when breaking the covers while attempting to open the doors to enable evacuation of the train following the accident. Some passengers told RAIB they were afraid to break the covers because they thought the cover was glass and would cause them injury. Figure 17 shows that, even though they are not made of glass, the hard plastic cover can leave sharp edges when broken.
