Rail Accident Report

Freight train derailment at Angerstein Junction, 3 June 2015

Report 10/2016
June 2016

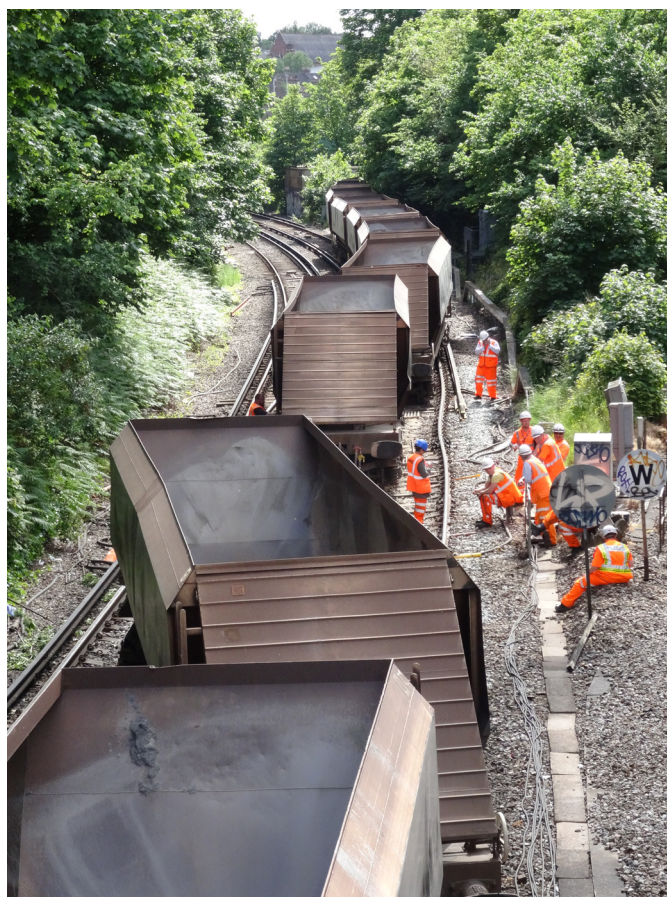
- 5 At about 12:10 hrs on Wednesday 3 June 2015, three wagons of an empty freight train derailed as the train was leaving sidings to run onto the North Kent lines at Angerstein Junction, near Charlton in south east London (figure 1). The train came to a stand with the three wagons partly obstructing the opposite line, which was open to traffic (figure 2). No-one was injured in the accident, but there was significant damage to the railway infrastructure.

Figure 2: Derailed portion of the train (courtesy of Network Rail)

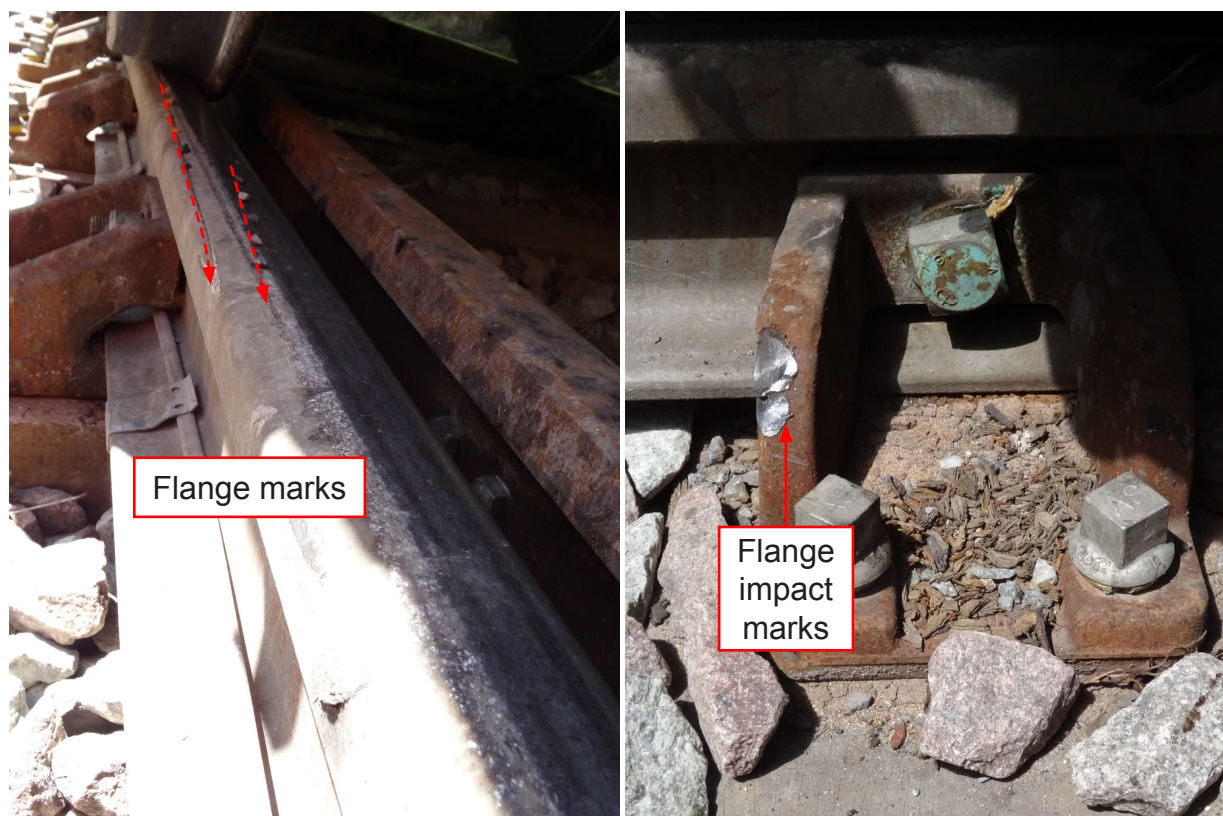
- 38 There was insufficient load on the front right-hand wheel of the leading bogie on wagon BHQ 17121 to counteract the lateral forces at the wheel-rail interface, and thus to prevent the flange climbing over the rail head in the vicinity of trap points 851A.
- 39 The marks on the rails at the point of derailment indicate that two wheel flanges climbed onto the head of the outer rail before derailing to the outside of the curve. This is supported by two sets of impact marks to the chairs supporting the outer rail (figure 7).

Figure 7: Derailment marks on the rail head and on the subsequent chairs

- 40 The RAIB considers that it was the right-hand leading wheel on the leading bogie of the eleventh wagon (BHQ 17121) that derailed first. RAIB experience of flange climb derailments and derailment theory³ indicates that the leading wheel on a bogie is much more likely to climb the outer rail on a curve than the trailing wheel, because the *angle of attack* between the wheel flange and the rail will be larger and because it is likely to run closer to the outer rail. Gotcha wheel weight data from before the derailment showed that the leading wheel on this wagon was also significantly lighter than it should have been (paragraph 46). The wheels on both the 10th and 12th wagons had close to the normal load, making them less susceptible to derailment. It is likely that the trailing wheelset on the same bogie was the second to derail, with its flange climb assisted by the increased angle of attack due to the leading wheelset being turned towards the outside of the curve after it derailed.

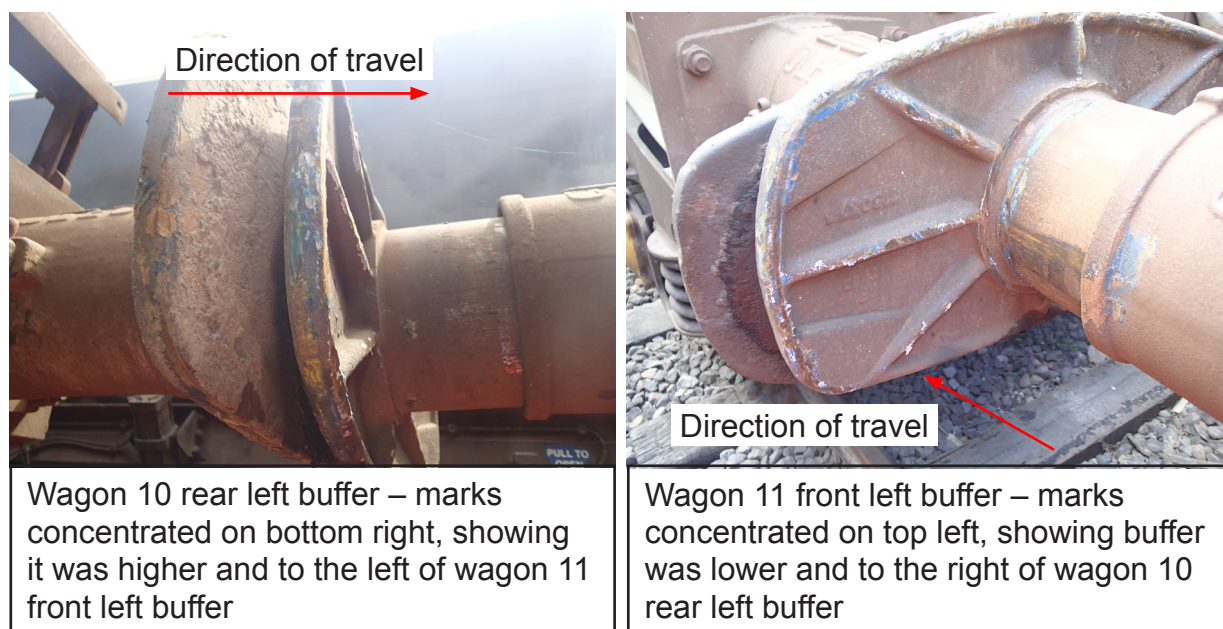
- 41 The marks on the *buffers* of the 10th and 11th wagons (figure 8) are consistent with this derailment sequence, because they indicate that the front bogie of the 11th wagon derailed to the right-hand side of the train and dropped off the rails while the 10th wagon was still on the rails. This is evidenced by the buffer face marks being concentrated on the top left-hand corner of the front left buffer of the 11th wagon and on the bottom right corner of the rear left buffer on the 10th wagon.

Figure 8: Buffer marks (shown after wagons had been rerailed)

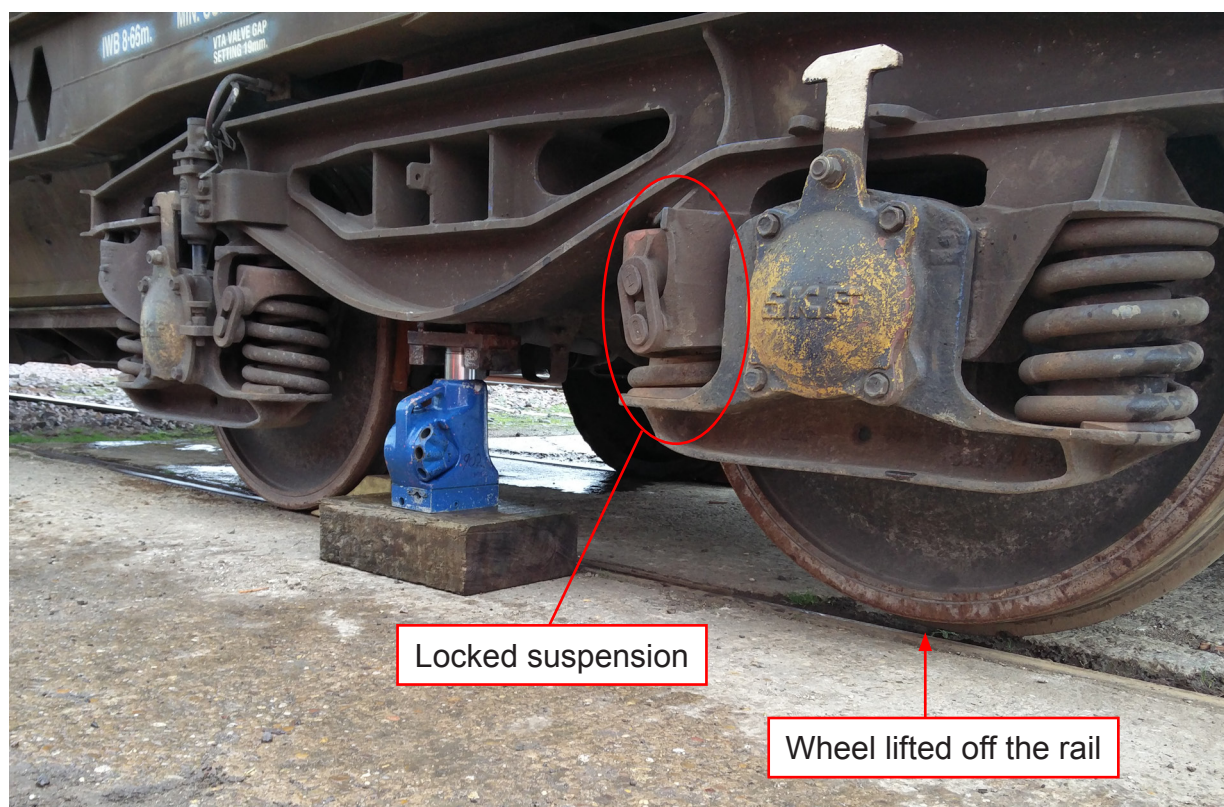
- 51 RAIB analysis of the Gotcha wheel weight data (paragraph 61) suggested that the suspension on the front bogie of wagon BHQ 17121 was not operating correctly. The RAIB observed, during testing of the wagon (paragraph 48), that the suspension on the front right wheel of wagon BHQ 17121 was locked, and not moving vertically. The effect of the locked suspension was demonstrated by jacking up the right side of the bogie (figure 9), and observing the front right wheel lifting off the rail while the other three wheels were still carrying load. Further wheel unloading testing of wagon BHQ 17121 provided evidence that the rest of the wagon's suspension was operating correctly.

Figure 9: Effect of locked suspension when bogie side is jacked up

- 52 The effect of the locked suspension on the front right wheel was to prevent it from retaining its share of the load as the wagon load was reduced and the other suspension springs lengthened (figure 10). A consequence of this was that the diagonally opposite rear left wheel also became lighter than should have been the case, as its suspension springs extended further to keep the front right wheel, whose springs were not extending, on the rail. The front left and rear right wheels then carried a greater load than would have been the case if the suspension had been fully working, as they took up the remaining load (table 1).

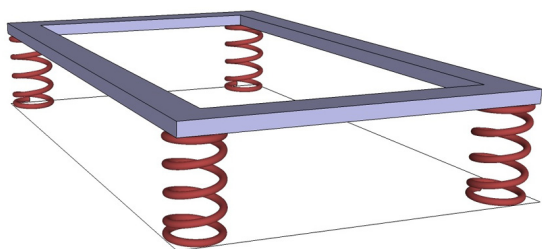
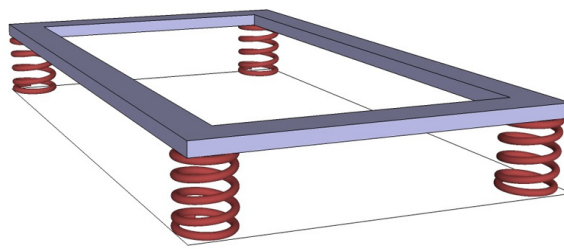
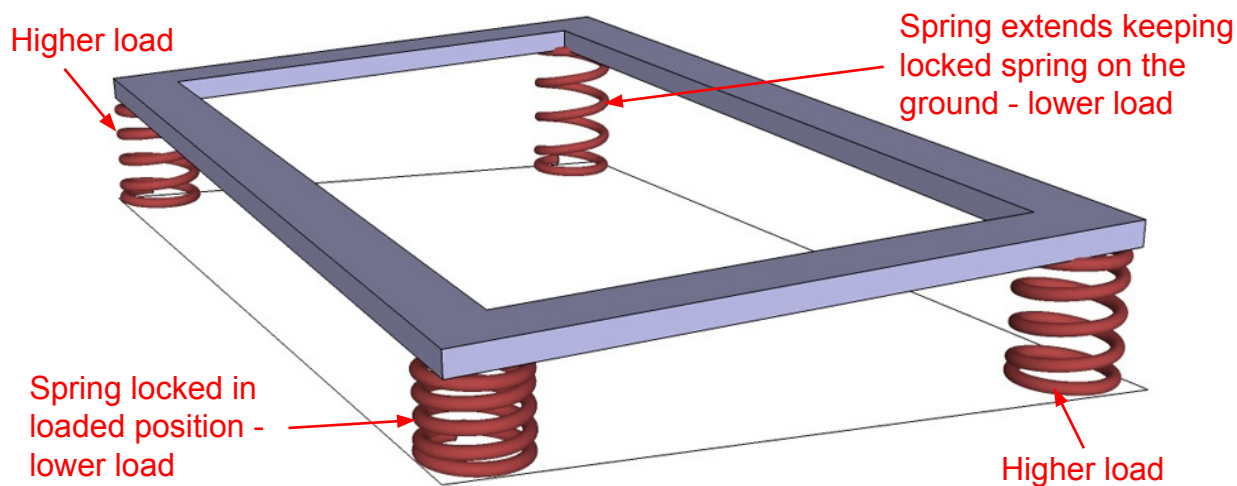
Figure 10: Representation of the effect of locked suspension on wheel loads

Tare condition prior to derailment, with front right spring locked in compressed condition

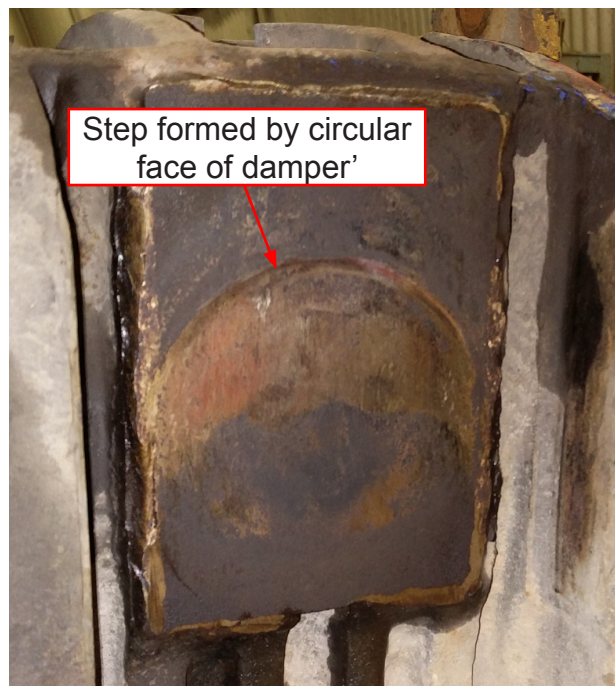
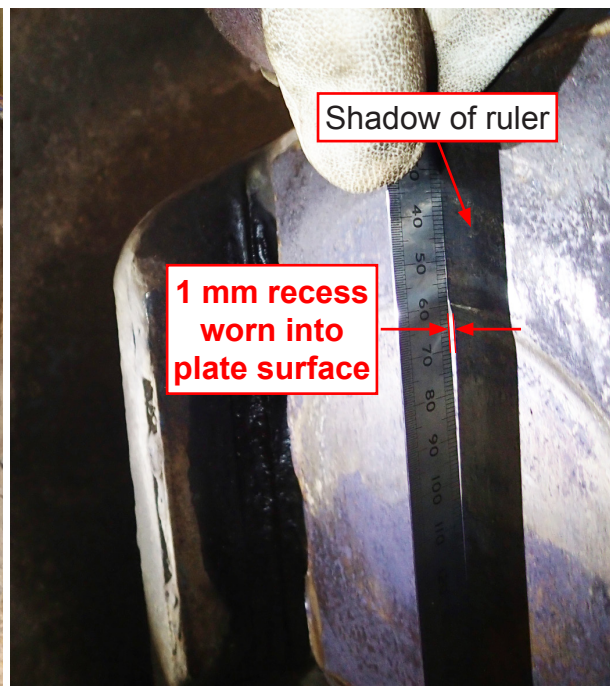
- 53 The RAIB observed the stripping down of the leading bogie of wagon BHQ 17121 to identify the cause of the locked suspension. The longitudinal wear plate (paragraph 36) on the front right-hand wheel's axle box had become worn such that there was a step change in profile of approximately 1 mm just above the position where the damper contacted it when the suspension was in the laden condition. The wear pattern and recess are shown in figure 11. The relatively unworn wear face of the damper is shown in figure 12.

- 54 This change in profile meant that the damper entered a recess that was approximately 1 mm deep when the wagon was laden, and was then unable to slide out of the recess onto the less worn surface that it would normally contact when the wagon was unloaded.

Figure 11: Worn axle box longitudinal wear plate

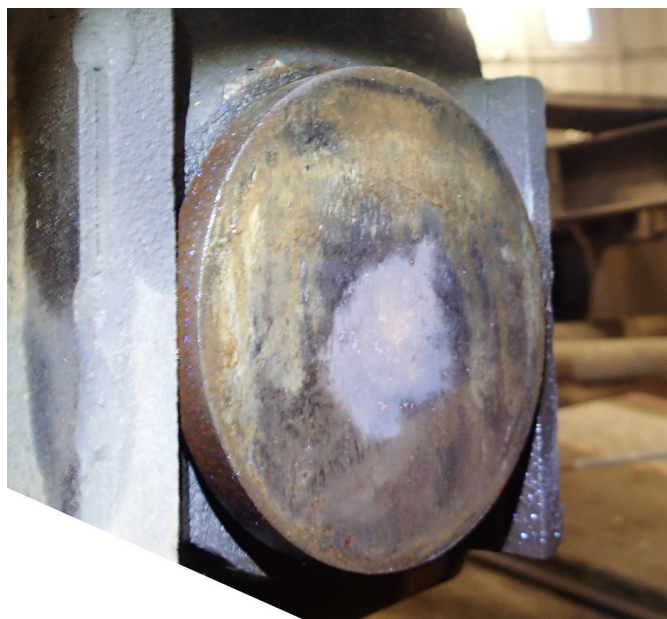
Figure 12: Damper wear face

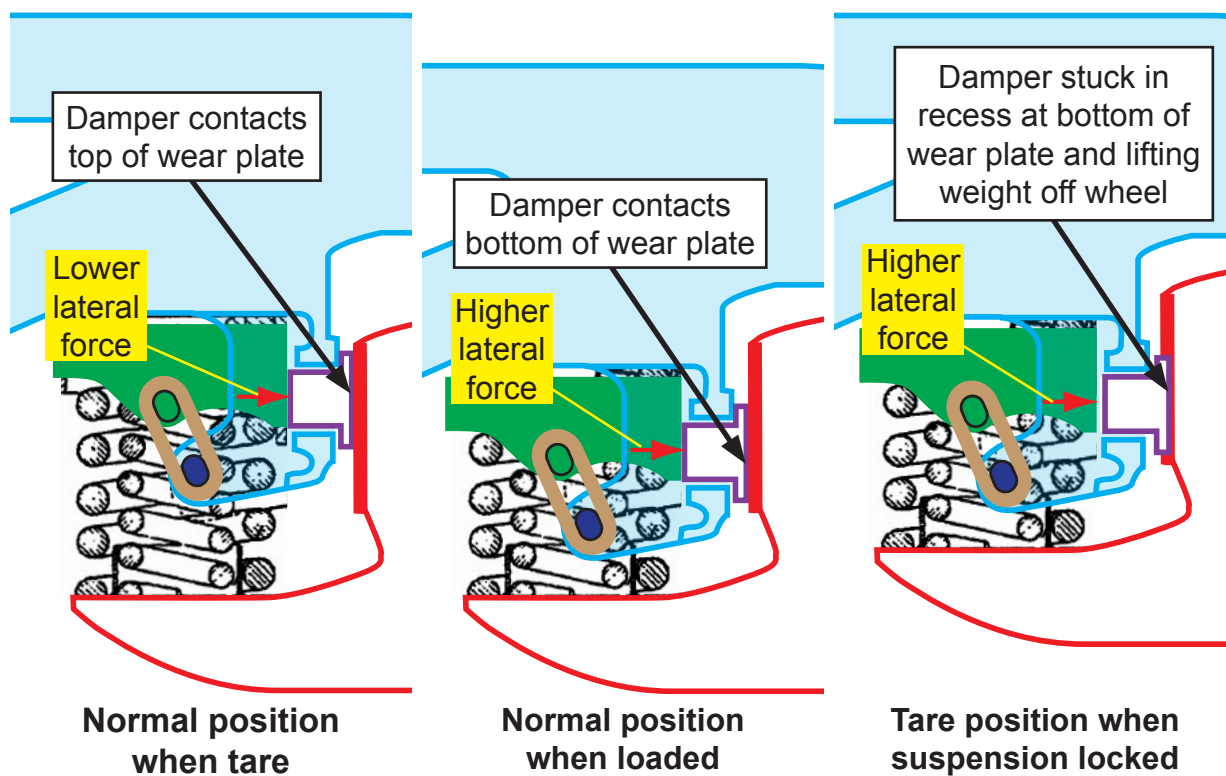
Figure 13: Suspension locking mechanism

- 55 Because the wagon normally operates either empty or heavily laden, the damper normally contacts the wear plate in one of two positions (figure 13). When the wagon is empty, the damper contacts the wear plate at the top, with a relatively low contact force. When laden, it contacts it nearer the bottom, with a larger force (paragraph 36). This means that the bottom of the wear plate is likely to be subject to more wear than the top, thus promoting the observed wear profile. Figure 13 shows the mechanism by which the change in wear plate profile, combined with the suspension and damper forces, prevented the suspension from moving to the correct unladen position.

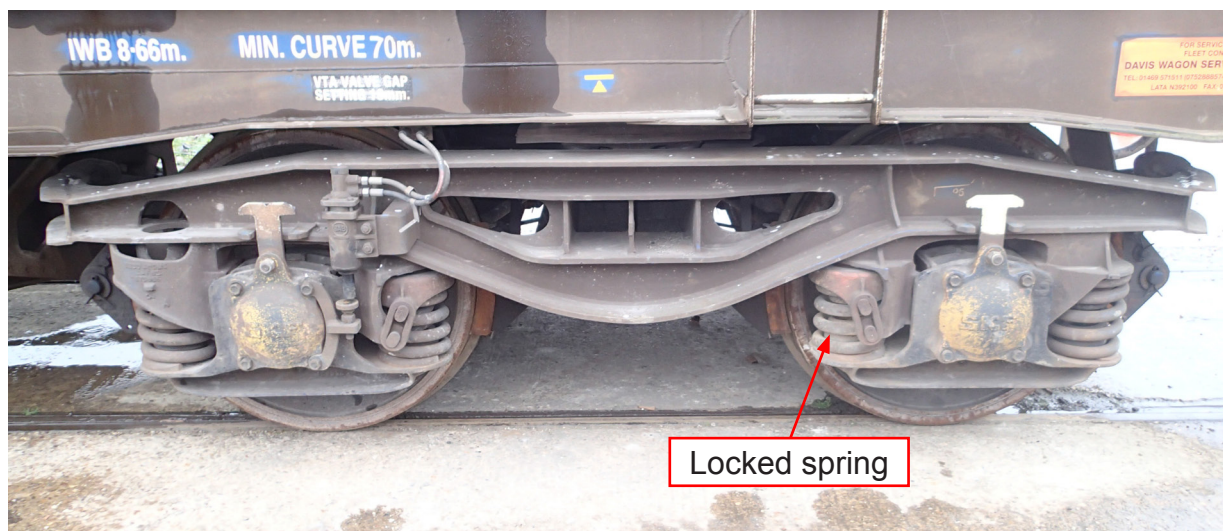
- 74 Figure 14 shows the right-hand side of the leading bogie, with the wheel with the locked suspension on the right. Visually it is not obvious that the springs in the leading wheel are locked in the compressed position, as they do not appear to be significantly different in position from those on the trailing wheel. This demonstrates that it is probable that the locked suspension would not be identified by the visual inspections included in PPM and VIBT. The locking could be identified by measurement of, or observing the position of, appropriate components in the suspension, but this was not a specified part of PPM or VIBT.

Figure 14: Wagon BHQ 17121 leading bogie – wheel with locked suspension on the right

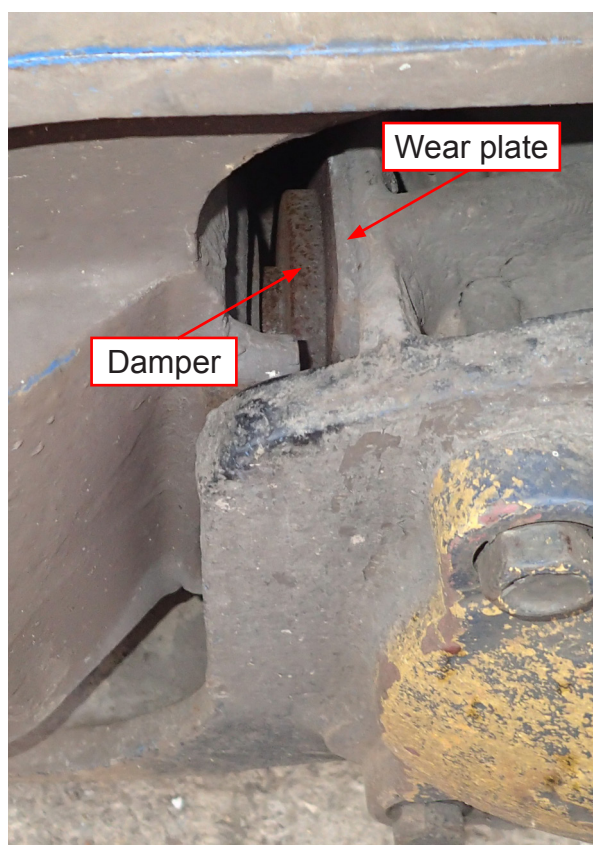
- 76 During PPM and VIBT, this check is undertaken with the suspension fully assembled, and so it is not possible to see all of the surface of the wear plates, particularly the part being hidden by the damper. Figure 15 shows that only the top edge of the wear plate is visible when viewed from above, while the view from below is even more restricted. This makes it impossible to check for wear over the part of the wear plate that is being contacted by the damper, and hence the part that is being worn. Inspection of this area would require the suspension to be dismantled, which is not specified as part of the PPM/VIBT. The difficulty in seeing most parts of the wear plate surface means that the plate thickness can only be measured at the top edge, where the wear is not present, unless the suspension is dismantled.

Figure 15: Visibility of the wear plate with the suspension fully assembled

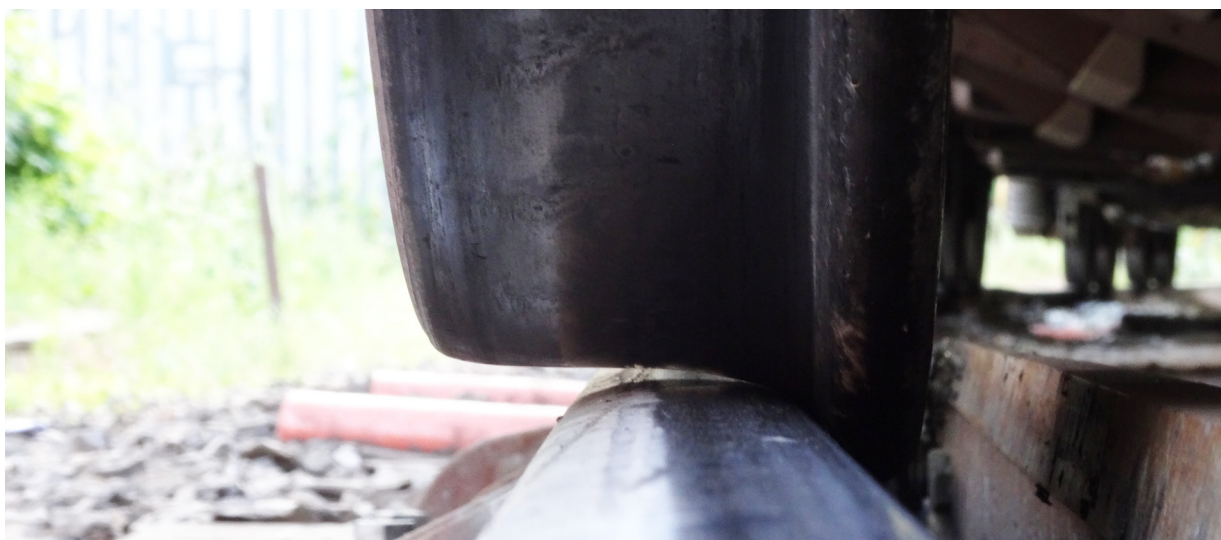
Figure 16: Wheel with working suspension starting to flange climb at the point of derailment

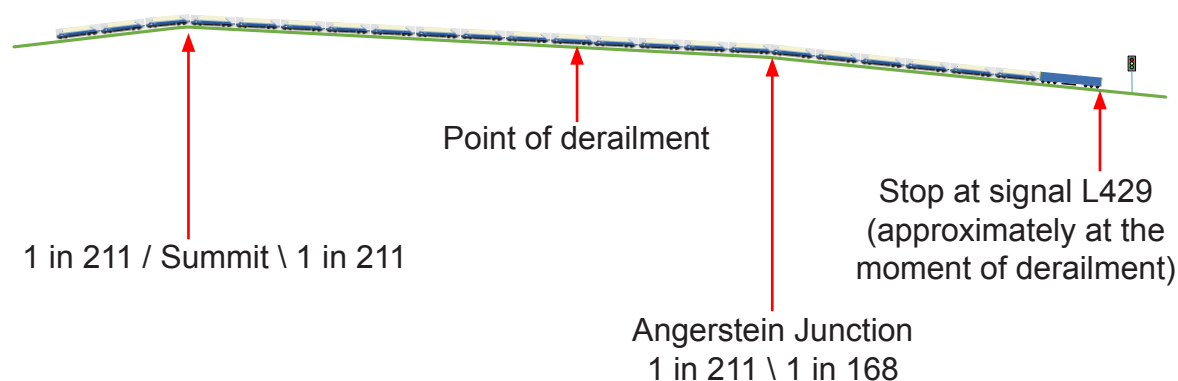
- 83 The train was braking gently on a left-hand curve with the front 19 wagons on a downhill gradient (figure 17), at the time of derailment, and this could have affected the lateral forces between the wheels and the outer rail. This was a normal operational condition for any train that was required to stop at signal L429.

Figure 17: Gradient profile relative to the train position at derailment

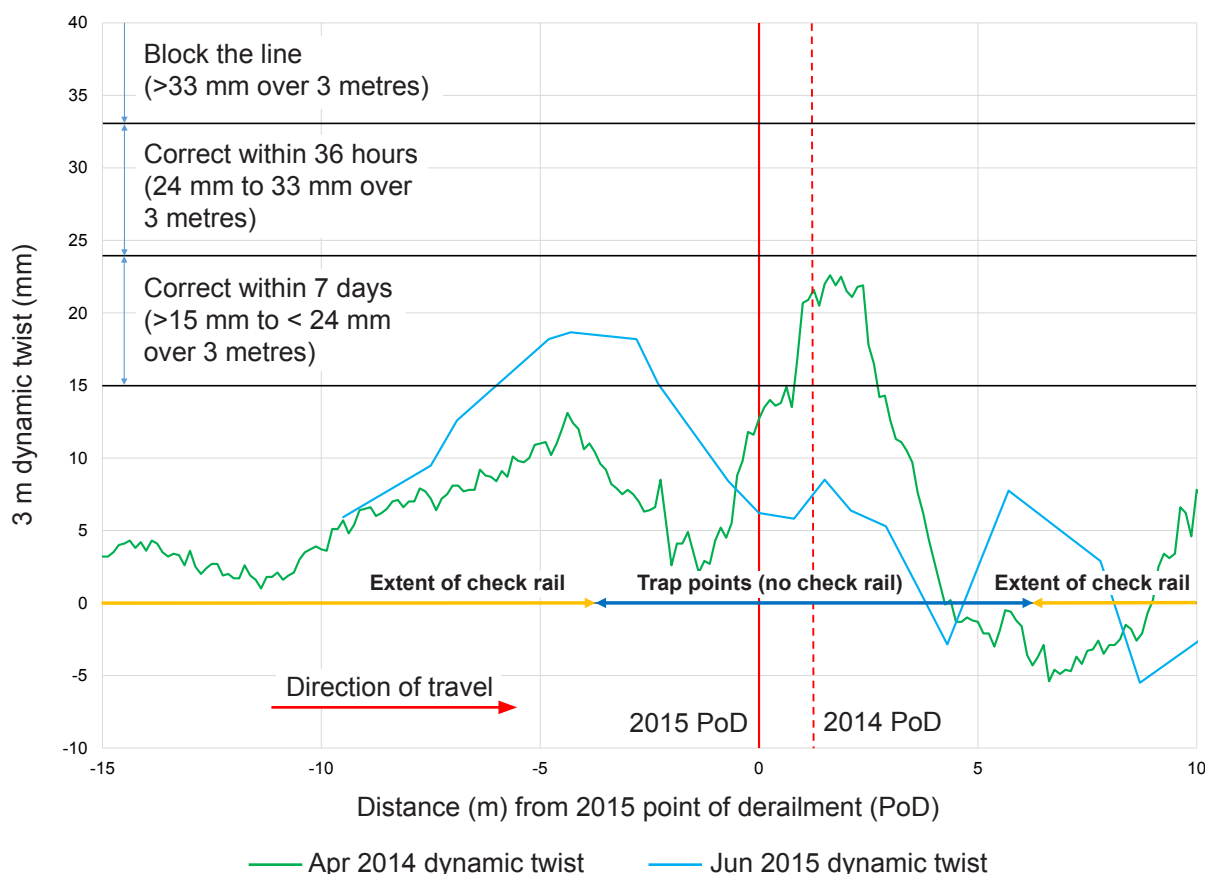
- 89 The 3 metre dynamic twist at the point of derailment was well within these limits, measuring 6 mm, or an average gradient of 1 in 500. This was much less than the 22 mm that was present at the point of derailment on 2 April 2014.

Figure 18: Track twist in the vicinity of the derailment location

- 90 However, the June 2015 survey found twist reaching a maximum of 18 mm on the approach to the point of derailment. This exceeded the first maintenance action limit of 15 mm for a distance of approximately 4 metres until 2.5 metres before the point of derailment. The first 3 metres of track that exceeded the first maintenance intervention limit was within the section of line that had a check rail, and so had additional derailment risk mitigation when compared to the last metre. There were no marks on the rail head to indicate that the derailed wheel had climbed onto the rail head in the 4 metre length that exceeded the first maintenance intervention limit.
