Rail Accident Report

Two signal passed at danger incidents, at Reading Westbury Line Junction, 28 March 2015, and Ruscombe Junction, 3 November 2015

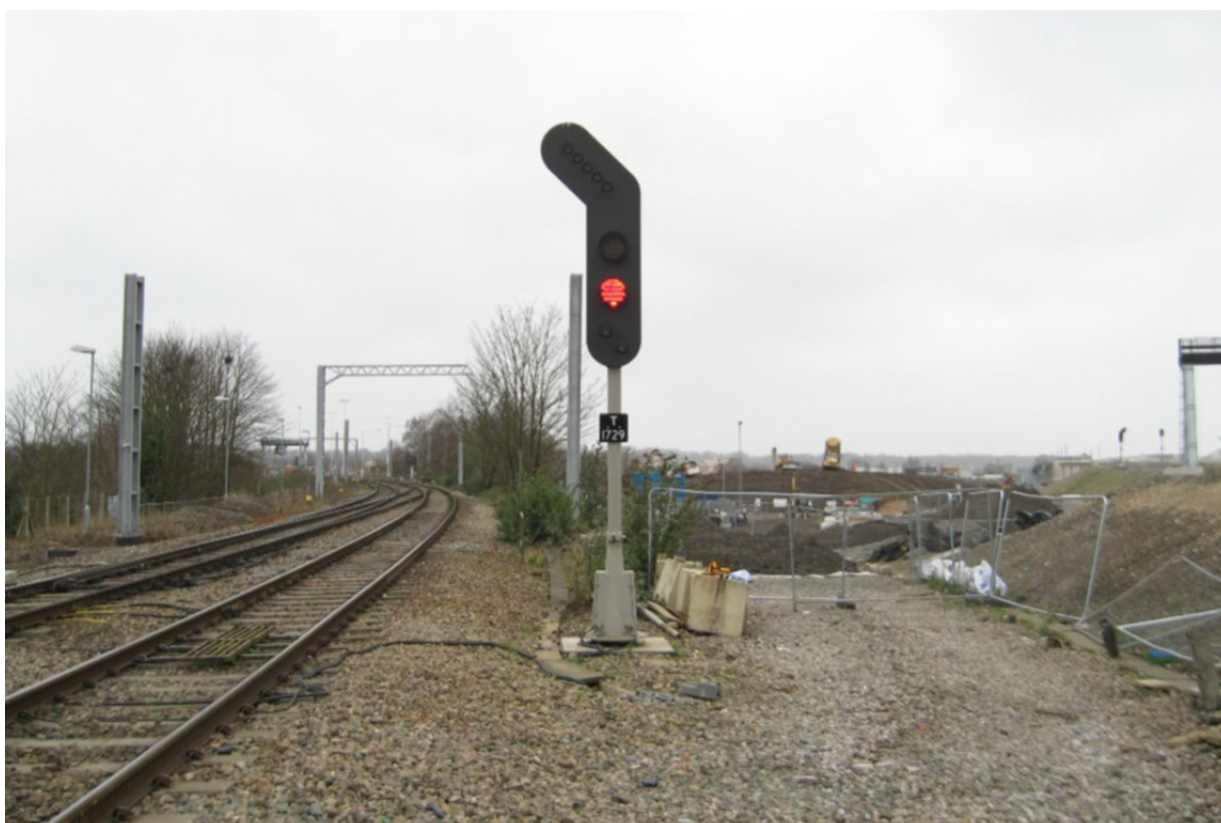
Figure 2: Signal T1729 at Reading Westbury Line Junction (image courtesy of DB Cargo (UK) Ltd)

- 7 T1729 is a four-aspect LED signal located on the right-hand side of the *bidirectional* Up Westbury line at 36 miles 29 *chains*, approaching Reading Westbury Line Junction to the west of Reading station (figure 2). For the path that train 7C29 took on 28 March 2015, this signal is preceded by two similar four-aspect signals. Permissible speed at this location is 40 mph (64 km/h).
- 8 On the morning of 28 March 2015, signal T1729 was being held at danger because the parallel signal (T1727) was showing a proceed aspect to allow for the passage of passenger train 2K32 (figure 3).

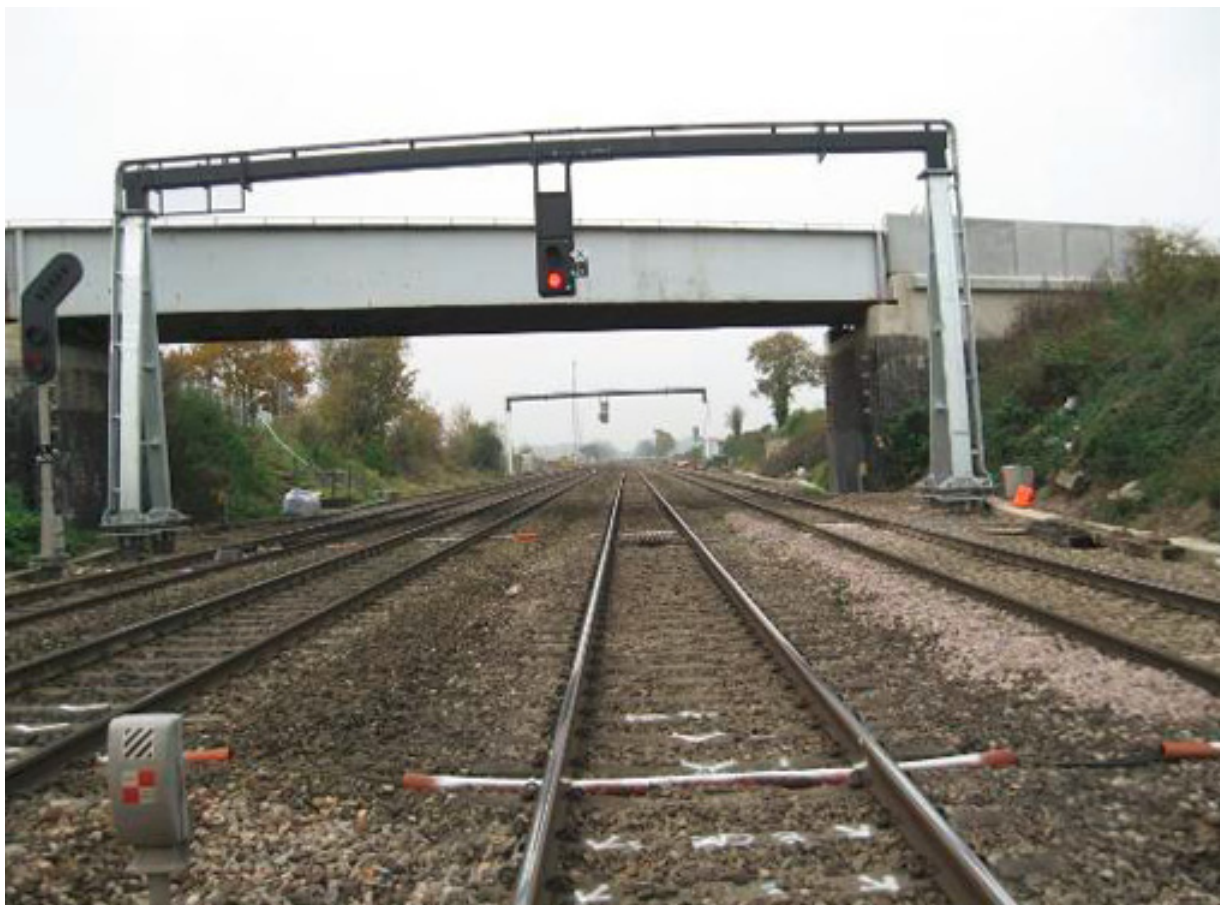
Figure 4: Signal T1627 at Ruscombe Junction (image courtesy of DB Cargo (UK) Ltd)

- 9 T1627 is a gantry-mounted four-aspect LED signal protecting Ruscombe Junction on the Down Relief line at 29 miles 16 chains, to the east of Twyford station (figure 4). Its preceding signals are T1623 (four-aspect) and T1611 (three-aspect), meaning that when T1627 is at danger the two signals on the approach to it show green and single yellow respectively. Permissible speed at this location is 60 mph (97 km/h) for freight trains and 90 mph (145 km/h) for passenger trains, although the maximum permitted speed for the train concerned was 45 mph (72 km/h) (see paragraph 15).

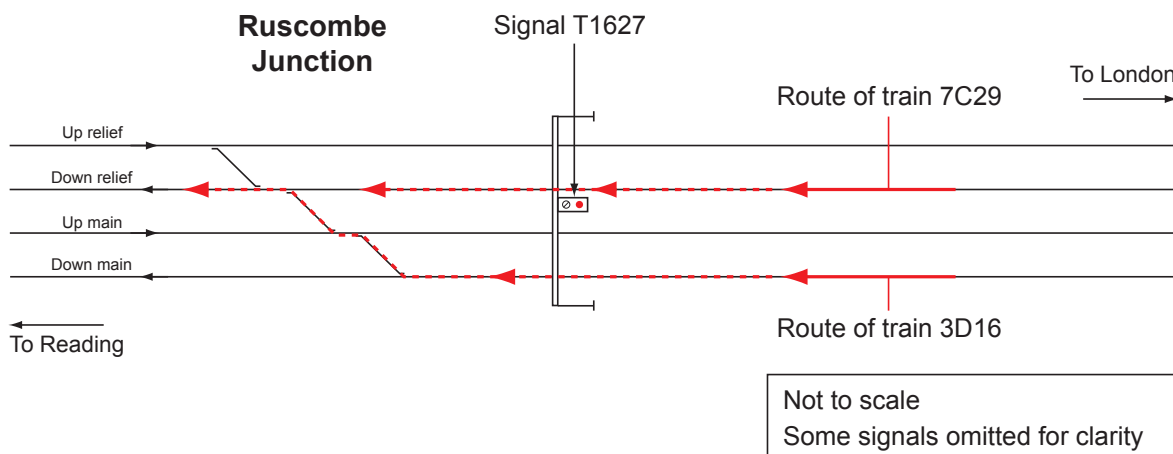
Figure 5: Simplified track layout showing the location of signal T1627

- 10 When the incident occurred on 3 November 2015, signal T1627 was showing a red aspect, protecting a route which had been set for train 3D16, an empty high speed passenger train (HST), to cross from the Down Main to the Down Relief line at Ruscombe Junction (figure 5).

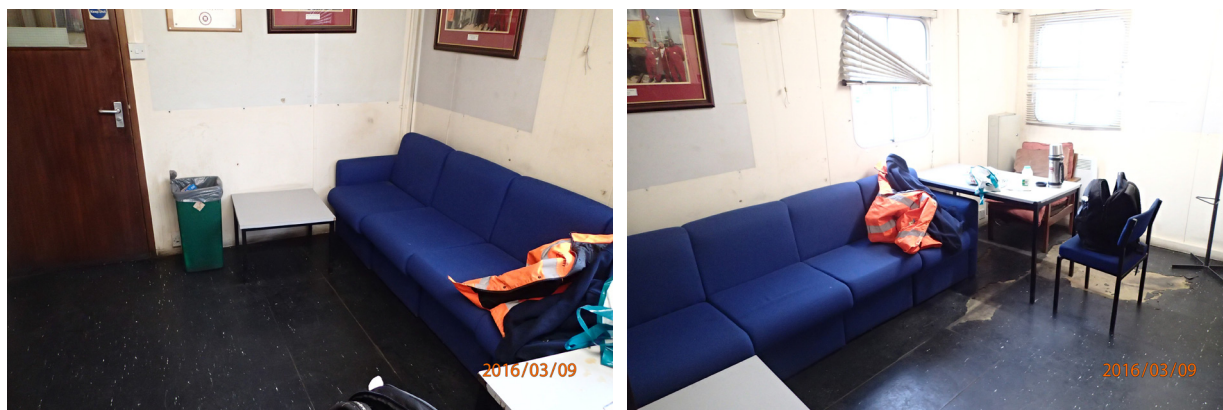
Figure 6: The rest facility at Acton train crew depot

- 72 Evidence gathered during the current investigation found widespread dissatisfaction with the standard of the drivers' facilities at Acton train crew depot relative to equivalent facilities at other depots. The RAIB's inspection confirmed that the designated rest facility at Acton was not conducive to napping because of the amount of noise, its location (being on a through route between other rooms), and the unsuitability of the furniture for napping (see figure 6).

- 123 Although DB's current position largely meets the requirements of these recommendations, RAIB notes that the facilities provided for napping at Acton depot were not fit for purpose (paragraph 68).
