# Rail Accident Report

## **Overspeed at Queen's Park, London 5 January 2016**

Report 19/2016  
October 2016

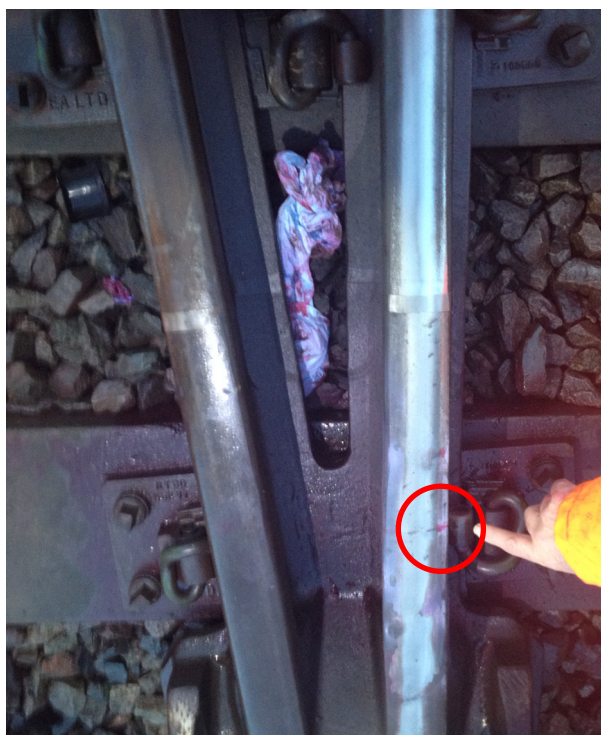
Figure 4: Defect at 2322B points

- 29 In the early hours of 5 January 2016, a Network Rail permanent way team, inspecting the *plain line* in the Queen's Park area, noticed a crack in the crossing of 2322B points. This was reported to Network Rail control at 03:10 hrs. The track maintenance staff arranged for a *dye penetrant inspection* to be carried out and for an emergency speed restriction to be applied in accordance with Network Rail standards. They also appointed a watchman who was required to monitor the crossing's condition until the fault was repaired.

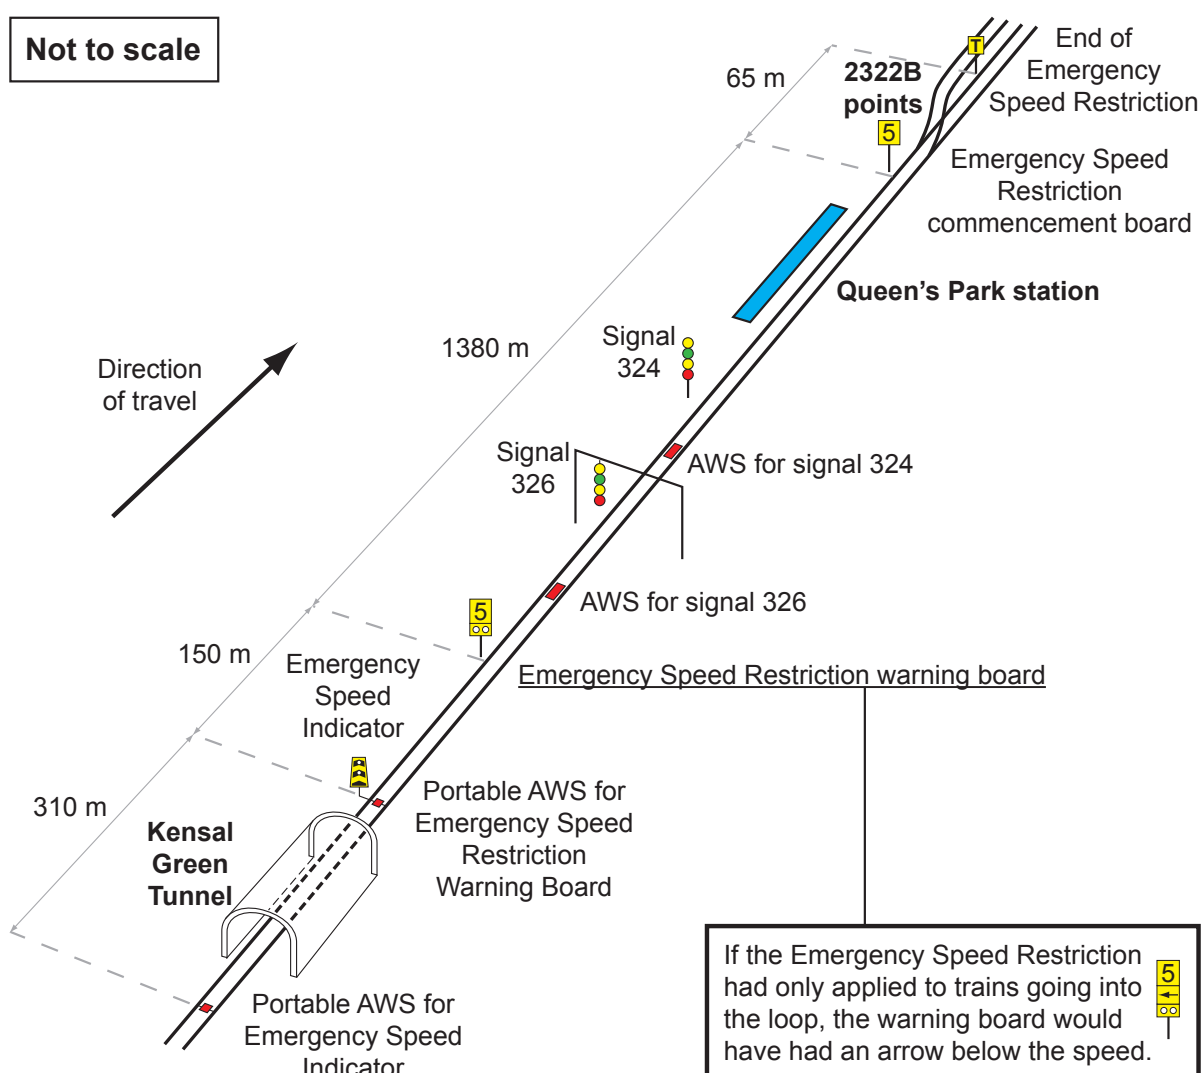
Figure 8: Layout of signs at Queen's Park

- 54 The lineside signage did not correct the driver's misunderstanding as he was already convinced that the emergency speed restriction did not apply to his train. The driver recalled being able to see the emergency warning indicator before reaching the AWS magnet at the entrance to Kensal Green tunnel and that this indicator remained visible until his train passed it. He does not recall seeing any of the other emergency speed restriction signs.
