Rail Accident Report

**Fatal accident at Alice Holt footpath crossing,
Hampshire
5 October 2016**

Report 14/2017
October 2017

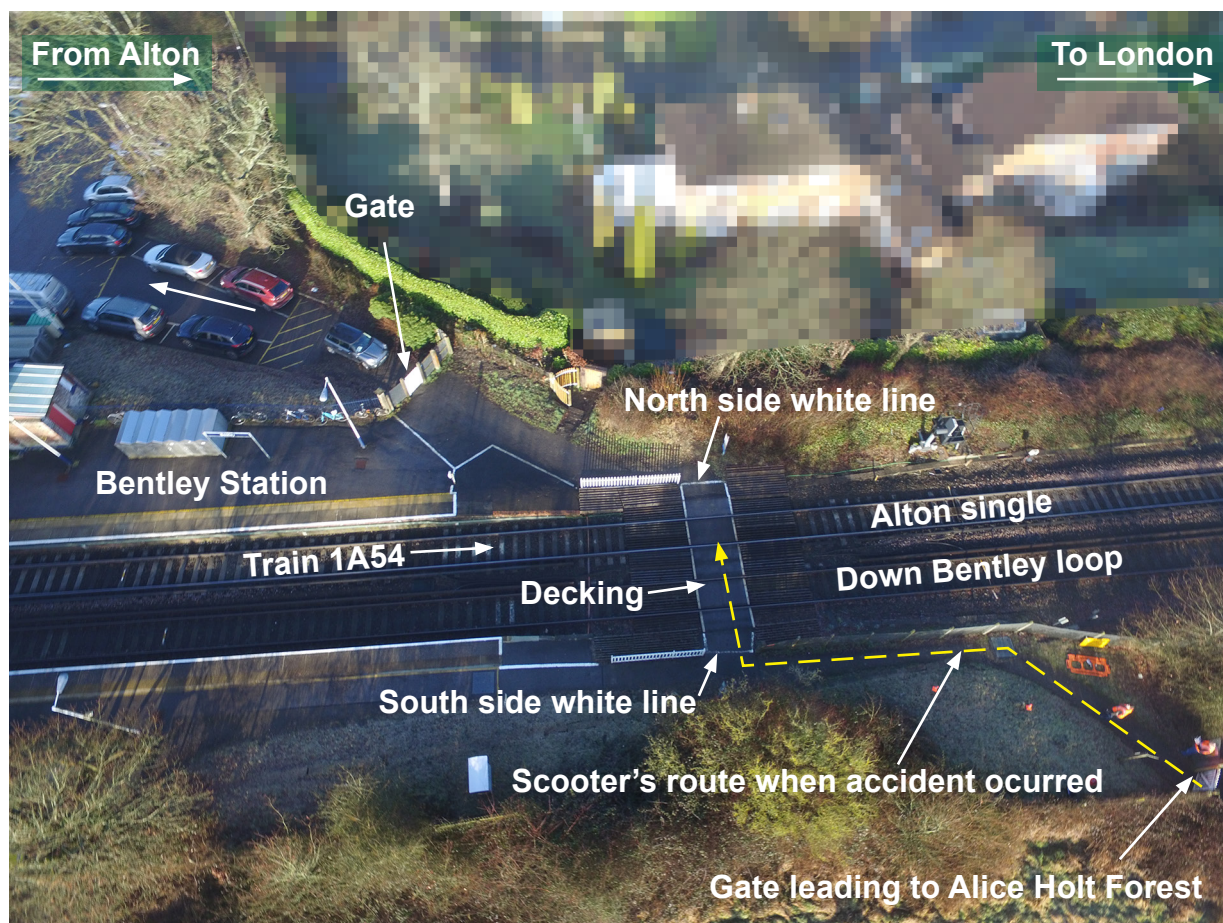
Figure 3: Layout of Alice Holt footpath crossing

- 11 The railway at this location runs approximately east to west. Self-closing wooden wicket gates at the railway boundary provide access to tarmac footpaths leading to a level timber *crossing deck*. The paths run parallel to the railway line as they approach the crossing decking which is 8.7 metres long, 2.4 metres wide and runs perpendicular to the rails (figure 3). Lineside signs (*whistle boards*) located 305 metres on the Alton side of the crossing and 415 metres on the London side of the crossing instruct train drivers to sound their train's warning horn.

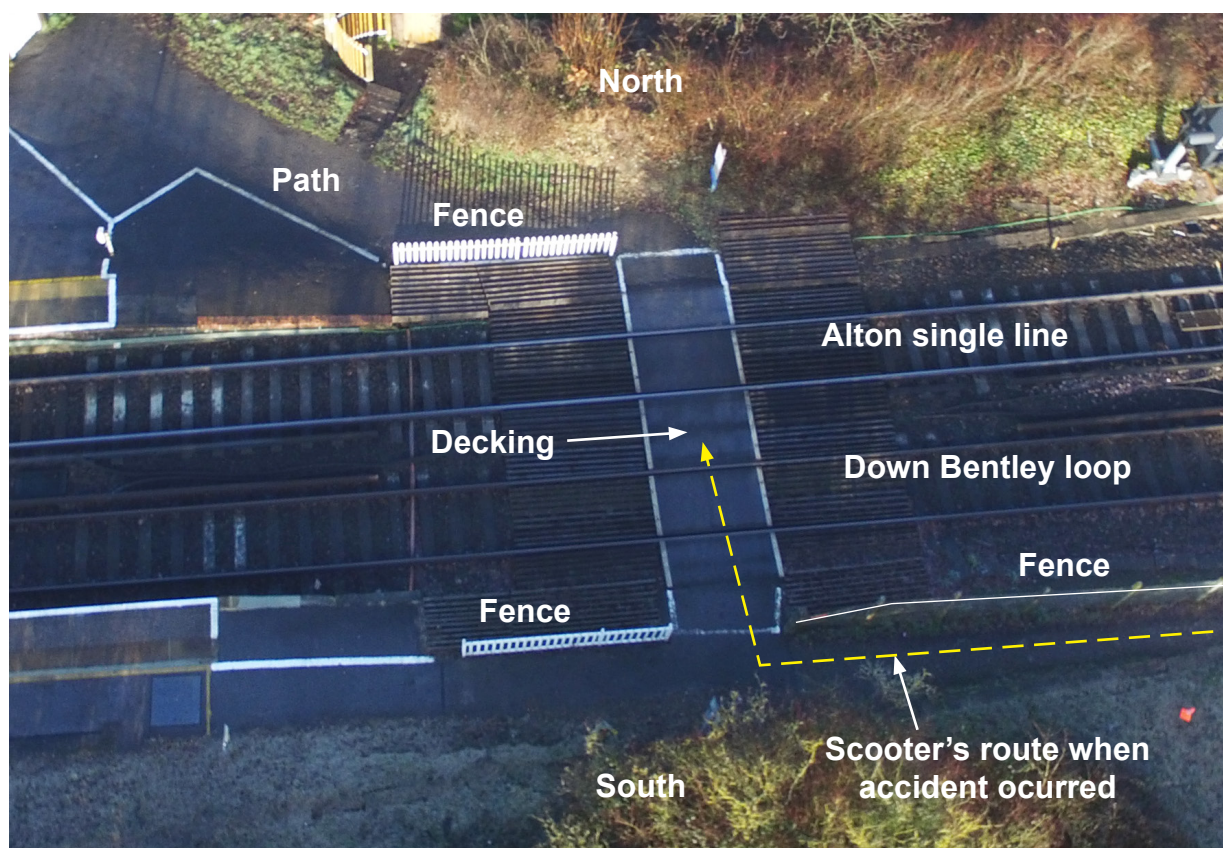
Figure 4: Arrangement of fences, white lines and decking at Alice Holt footpath crossing

- 12 Fencing separates the footpath from the adjacent railway on the southern side of the railway, with a gap at the end of the crossing. A fence separates the footpath from the adjacent railway on the Alton side of the northern end of the crossing (there is no path in the other direction at the northern end). White lines on the ground, around 2 metres from the nearest rails, mark the ends of the decking (figure 4). A sign near each end of the crossing instructs users to 'Stop Look Listen' and 'Beware of trains' (figure 5). The white lines are at the position described as the decision point within Network Rail and Office of Rail and Road (ORR) level crossing documentation. Level crossing management processes assume users look and listen for trains, and decide whether to cross the line while at the decision point. The practical limitations of a mobility scooter user's position are discussed in paragraphs 68 to 70.

- 95 Network Rail has lowered all three fences at Alice Holt level crossing and has widened the path on approach to the south side of the crossing. Resurfacing of the crossing is included as a recommendation in the November 2016 risk assessment of the crossing.

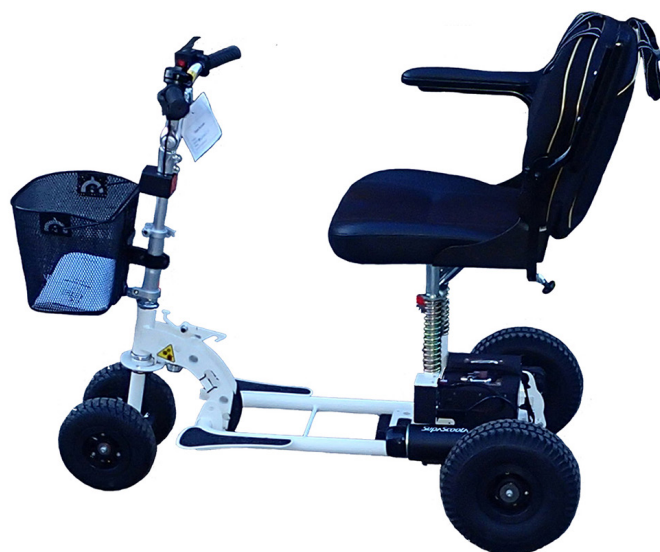
Figure 6: A mobility scooter of the type, but not the colour, involved in the accident

- 15 The mobility scooter involved in the accident was around six months old at the time of the accident. It was a SupaScoota Sport XL with twin 180 Watt motors (figure 6) and was fitted with lithium batteries which, according to the manufacturer's data, gave the scooter a range of around 11 miles (18 km).
- 16 The scooter was fitted with a device to limit its maximum speed to 4 mph (1.8 m/s) in order to comply with UK regulations for 'class 2 invalid carriages'. This class of mobility carriage should not be used on public roads except to cross them or where there is no pavement³. The scooter manufacturer's data for other markets indicates that, without the speed limiting device, the maximum speed of this model of scooter would be 5.6 mph (2.5 m/s).

- 17 This model of scooter is also fitted with a device limiting cornering speed in order to reduce the likelihood of the scooter overturning. This slowed the scooter in proportion to how far the handlebars were turned.
- 18 *Forward facing closed circuit television (FFCCTV)* from train 1A54 shows that, in the moments before the accident, the scooter was travelling at approximately its maximum speed (paragraph 30). The station CCTV shows the scooter turning normally when using the crossing about 38 minutes before the accident (paragraph 26). There is therefore no evidence of any scooter defect relevant to the accident.

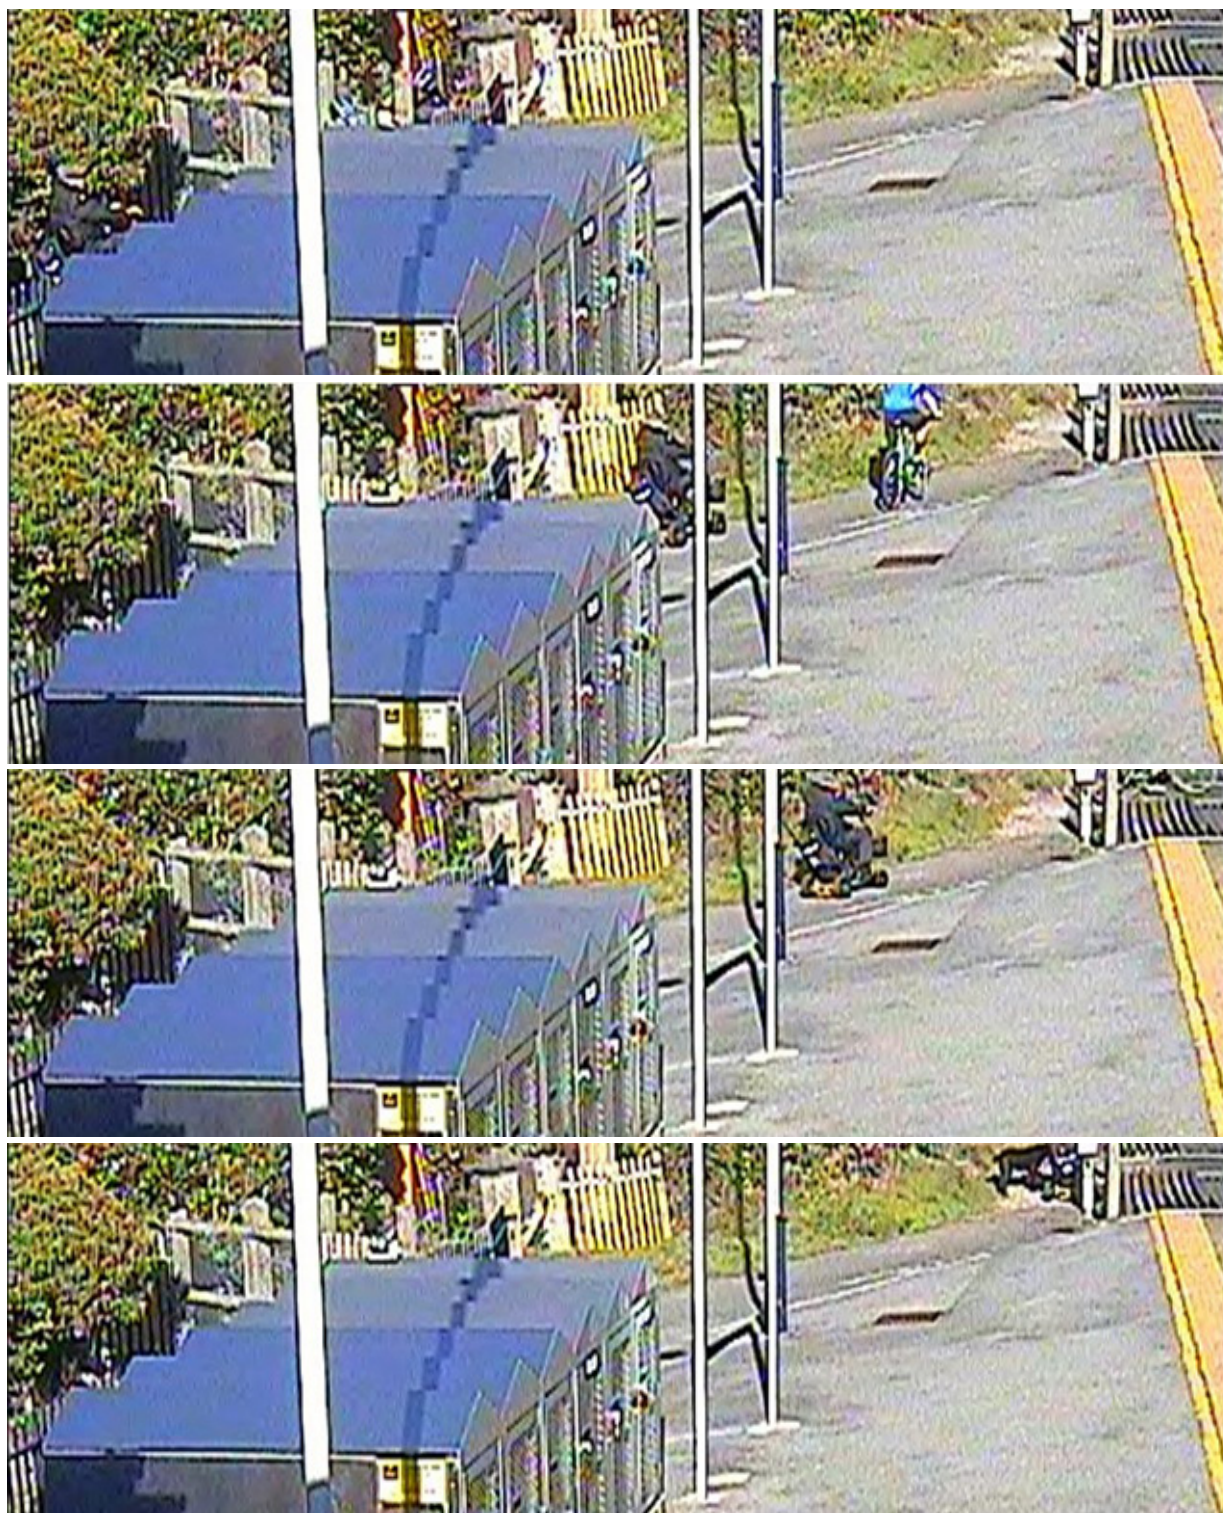
Figure 7: The mobility scooter user crossing from the north side, 38 minutes before the accident

- 26 Station CCTV recordings show that, on the outward journey, the mobility scooter user travelled through the station car park and along the path leading to the north side of the crossing around 38 minutes before the accident (figure 7). Just before reaching the north side of the crossing, the user stopped for 6 seconds, with his dog at his side. The scooter then moved forward and turned slowly onto the crossing before accelerating towards the southern side of the crossing and out of the CCTV coverage. The framing of the CCTV image is such that the user's head cannot be seen, so the RAIB is unable to tell which directions he looked before moving forward. The CCTV shows that the user's dog started to move forward at the same time as the mobility scooter but, because the dog moved faster, it crossed the railway ahead of the scooter.

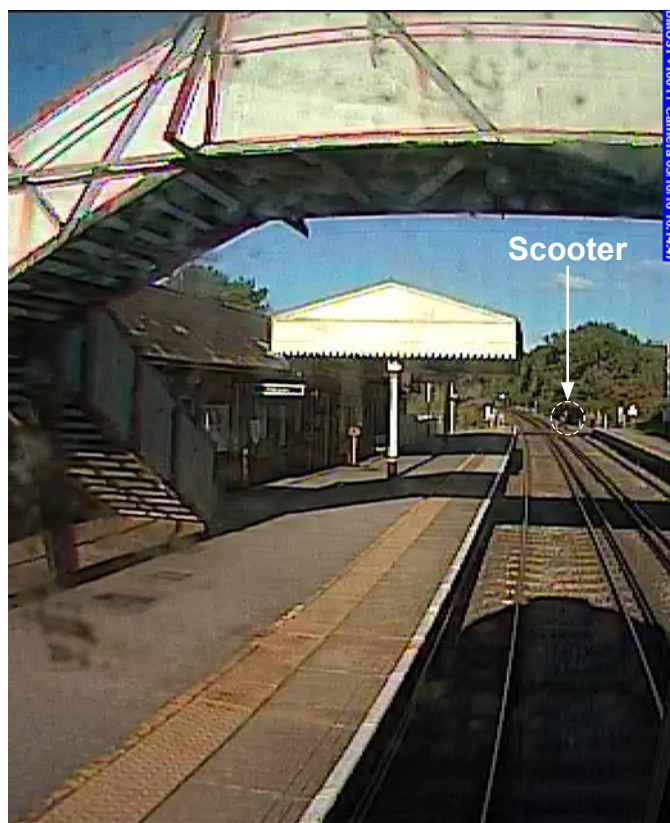
Figure 8: View from the train's forward facing CCTV at the moment brakes were applied, when the scooter was about to complete crossing the Down Bentley Loop

- 30 The train driver sounded the train horn at the whistle board (paragraph 11), around ten seconds before reaching the crossing, while travelling at close to 70 mph (113 km/h)⁴. The train's FFCCTV shows that the scooter was not visible to the train driver until about four seconds before the impact. Upon seeing the mobility scooter crossing the line, the driver applied the train's full service brake, followed by sounding the train's horn and applying the emergency brake just before impact. From the initial brake application until the train came to rest 327 metres past the crossing, its average deceleration rate was 14%g, compared to the 12%g minimum specified for emergency brakes on this type of train⁵.

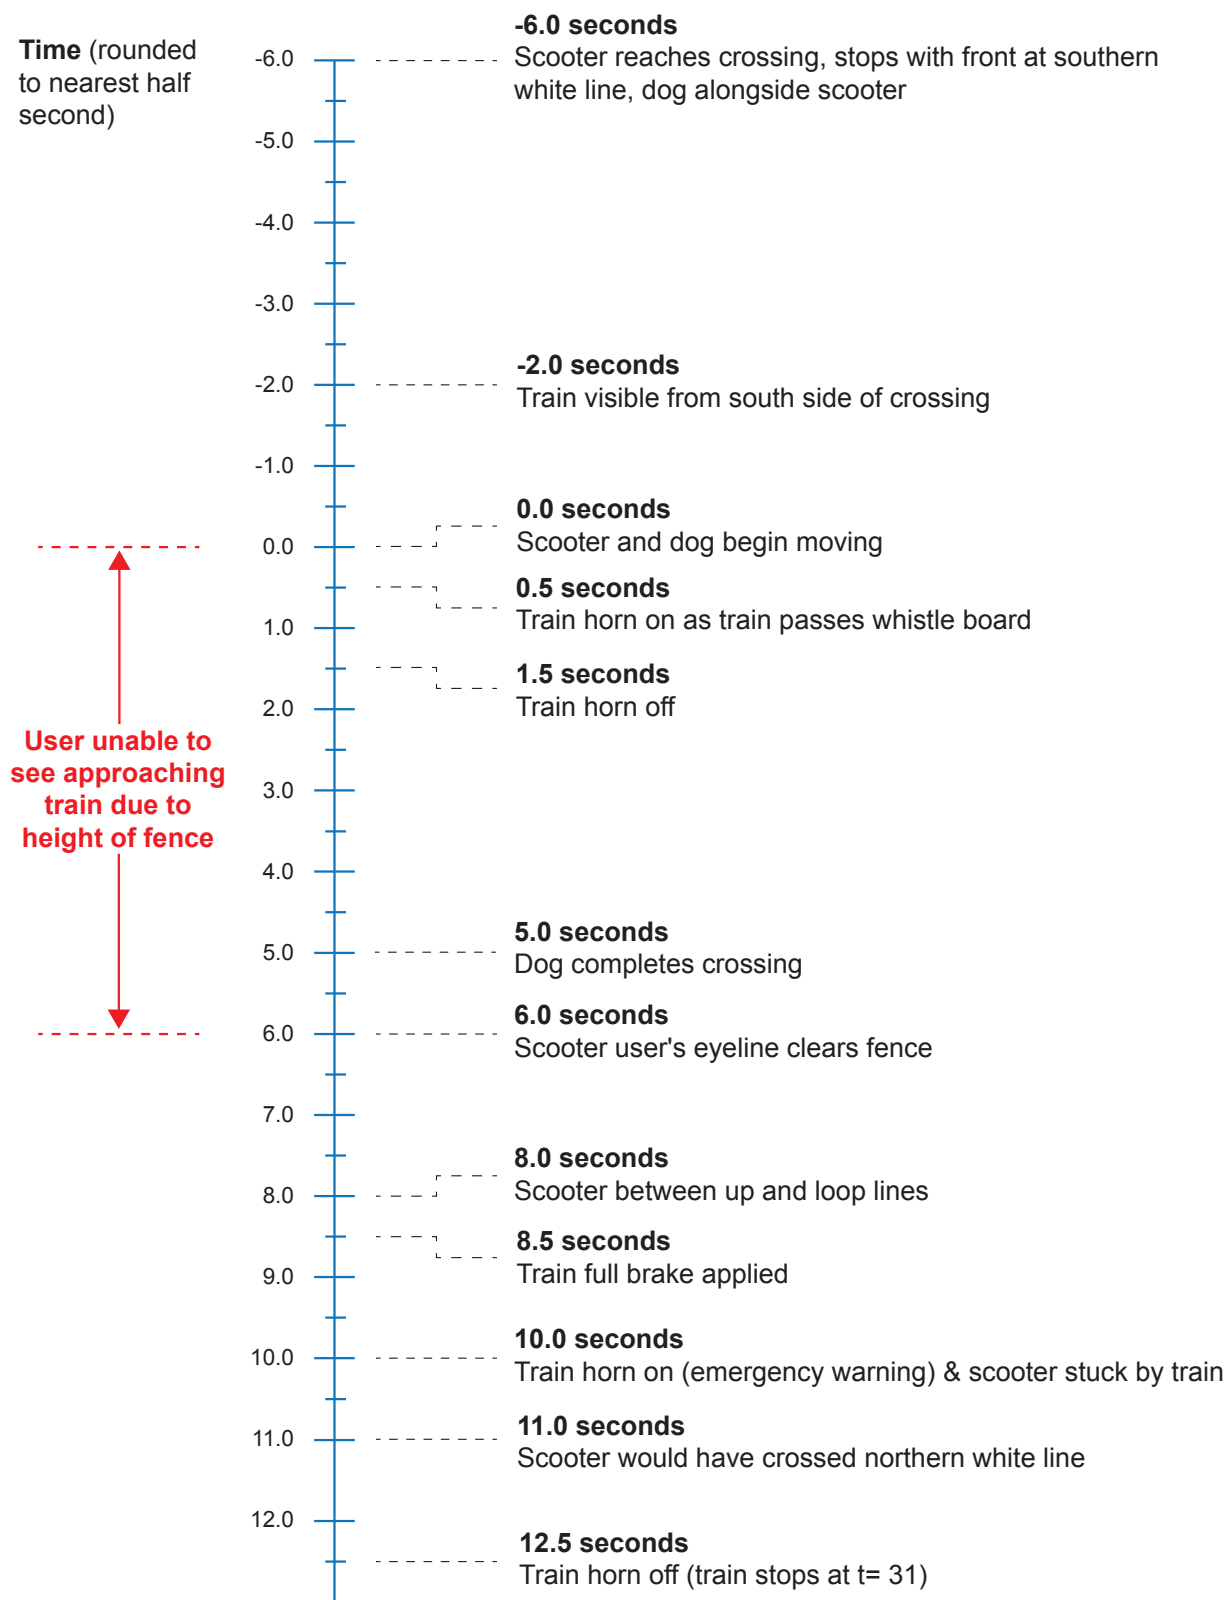
Figure 9: A timeline of the accident, derived from the available CCTV recordings

- 50 The scooter then moved off (designated $t = 0$ seconds in this description and figure 12) and began to turn towards the decking. The user then could not see trains approaching from Alton because the view from his scooter was obscured by the fence separating the path from the railway. When visiting the site after the accident, the RAIB noted that the fence height was sufficient to obstruct the view of a mobility scooter user. An adult of average height could see over it.

- 51 The limitation on scooter speed during turning meant that the fence then prevented the user seeing trains approaching from Alton for about 6 seconds until, at $t = 6$ seconds, his head passed through the gap. It is uncertain whether he looked towards Alton at, or shortly after, this point (figure 11). It is possible he did not do so because he was concentrating on controlling his scooter and/or he was looking for trains approaching from the opposite direction.

- 52 The scooter then accelerated to its maximum speed of 4 mph (1.8 m/sec) as it continued over the crossing. About 3.5 seconds later ($t = 9.5$ seconds) the train collided with the rear of the scooter.

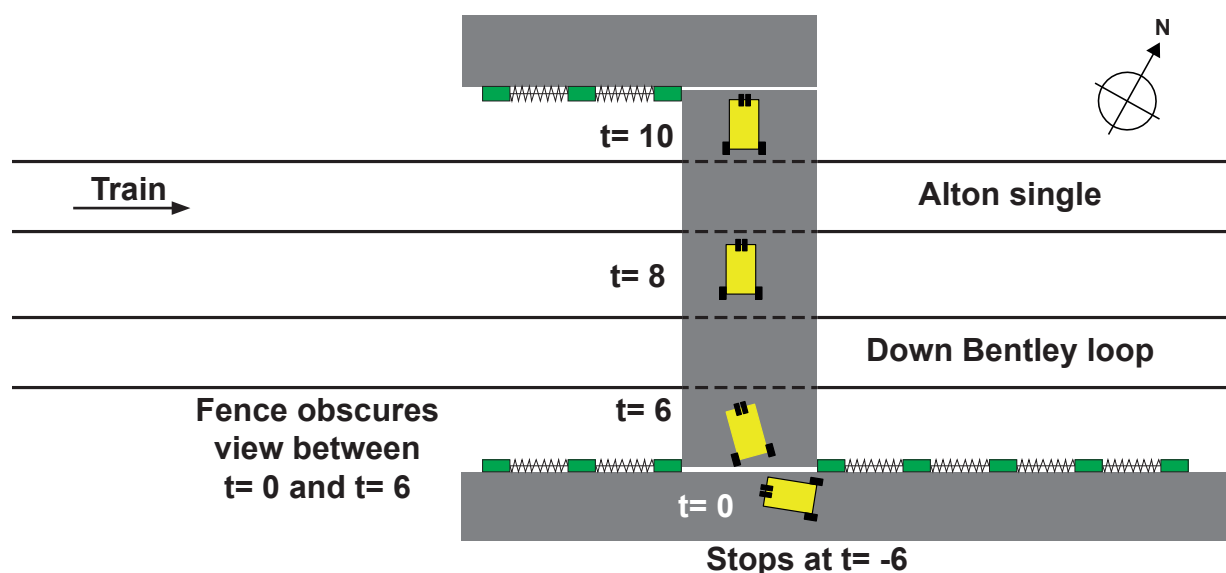
Figure 12: positions of the mobility scooter at key times during the crossing

- 55 The user was probably unaware that it was unsafe to cross when the front of the scooter was at the white line.**
- 56 It is probable that the user made his initial decision to start to cross when the front of the scooter was at the white line. The train would have passed the sighting point approximately two seconds before the scooter started moving.

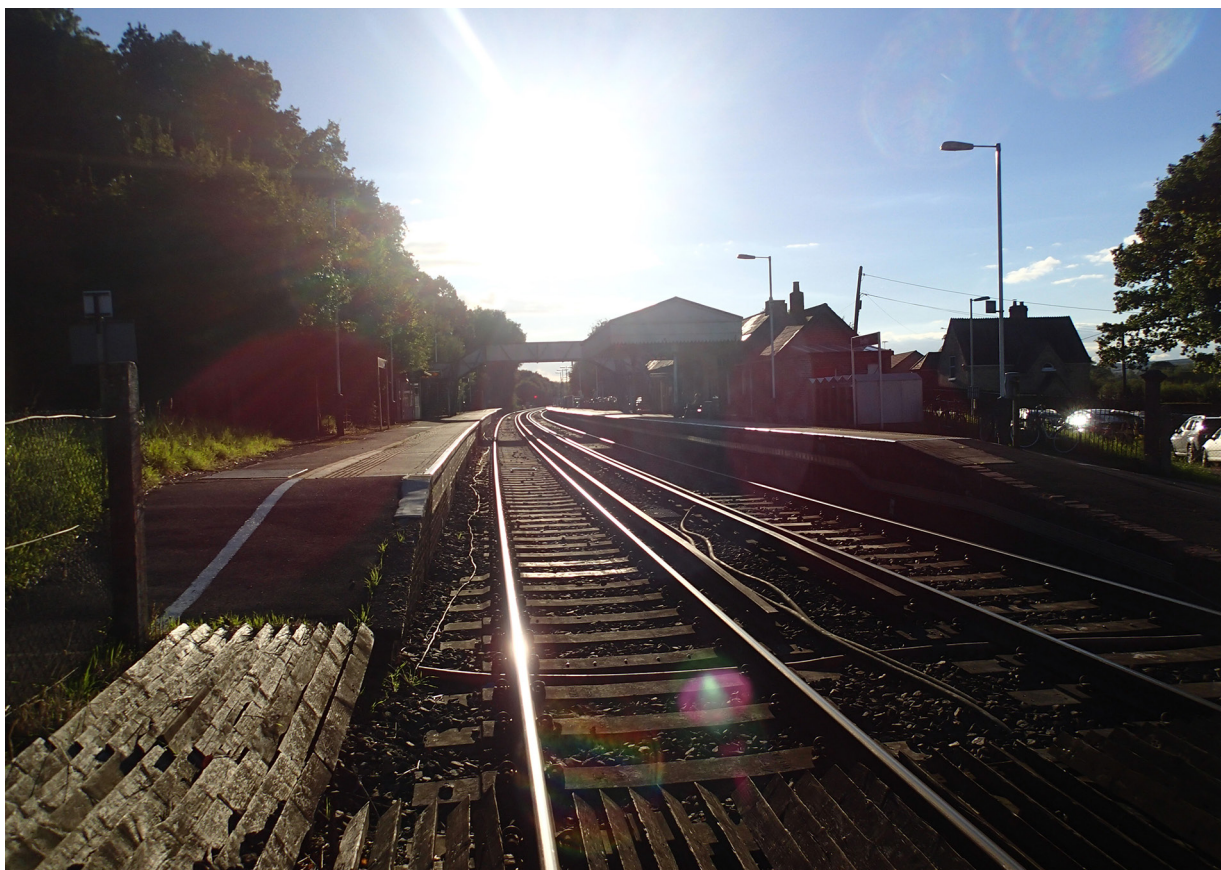
Figure 13: view from the southern end of the crossing decking, taken at the same time of day as the accident, showing the effect of sun glare

- 42 The last risk assessment at Alice Holt before the accident is dated 1 September 2015 and was carried out as a consequence of a near miss incident. Previous risk assessments had been carried out in December 2007, January 2011 (relating to a site inspection in December 2010) and June 2013.
- 43 The September 2015 risk assessment calculated a traverse time of 7.57 seconds¹⁰ for Alice Holt crossing and found that the warning time exceeded the traverse time for users crossing in both directions and trains travelling in both directions (table 1). This conclusion relied on users crossing from the north hearing train horns being sounded at a whistle board and made no allowance for vulnerable users. Sun glare was among the risks identified at this crossing.

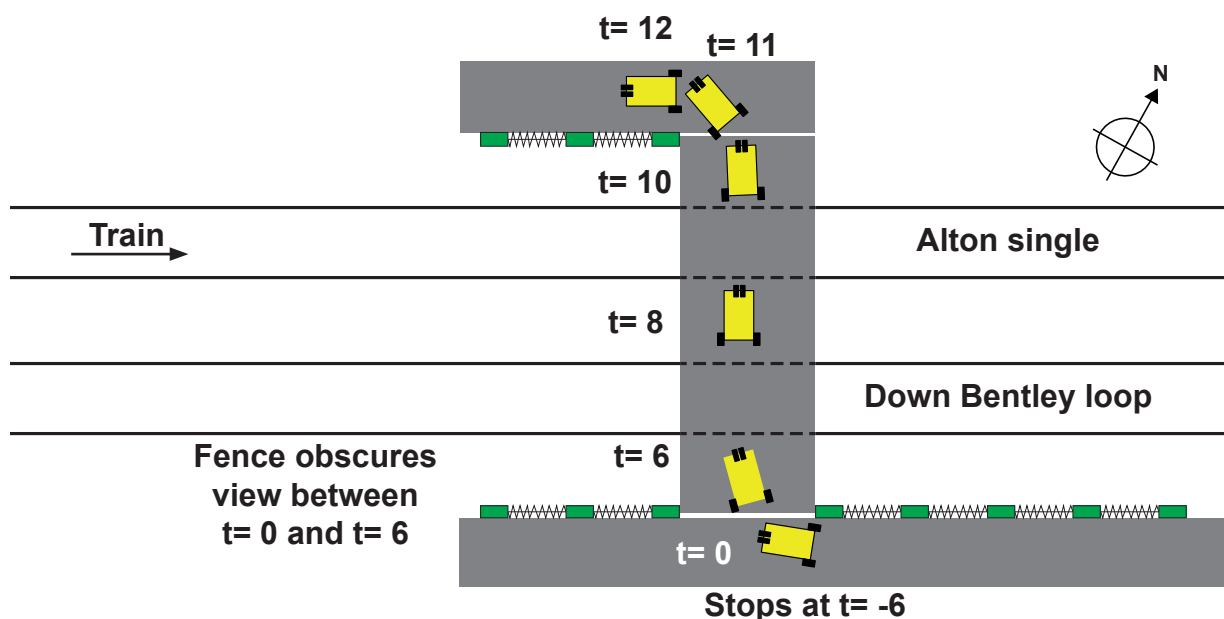
Figure 14: the scooter's trajectory at Alice Holt footpath crossing, had the accident not occurred

75 The September 2015 risk assessment did not make provision for the additional 50% traverse time applicable to vulnerable users (paragraph 80). It calculated the standard traverse time as 7.57 seconds, close to the 7.25 seconds calculated by the RAIB after the accident. Adding the 50% allowance would have given a traverse time of 11.35 seconds. This is less than the 12.9 seconds warning time available to users looking towards Alton from the south side of the crossing (the accident situation). As a result, consideration of vulnerable users crossing only from the south side of the railway would not have resulted in a change in crossing arrangements.

- 76 However, consideration of vulnerable users crossing from the north side could have resulted in changes to arrangements at the crossing. The traverse time of 11.35 seconds required for vulnerable users is longer than the 9.7 seconds warning time available to users at the north side of the crossing (table 1). If changes had been made to accommodate vulnerable users on the north side of the crossing, it is possible that these would have altered the circumstances of the accident.
