# Rail Accident Report

**Near miss with a group of track workers at  
Egmanton level crossing, Nottinghamshire  
5 October 2017**

Report 11/2018  
August 2018

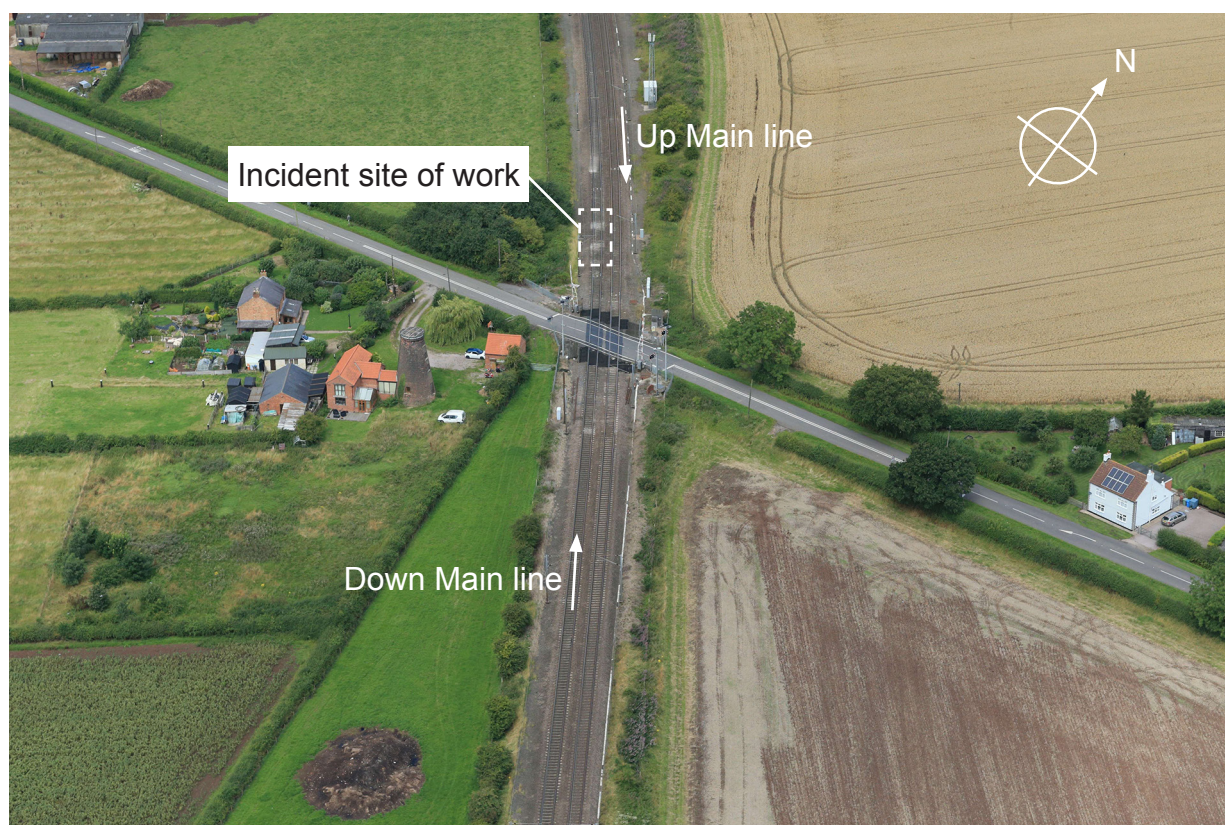
- 8 The incident occurred around 30 metres north-west of Egmonton level crossing (figure 2) which is located on the East Coast Main Line (ECML) at 130 miles 29 chains from London Kings Cross. The location is between Newark North Gate station to the south, and Retford station to the north.

Figure 2: The track layout and the incident site of work near Egmonton level crossing (image courtesy of Network Rail)

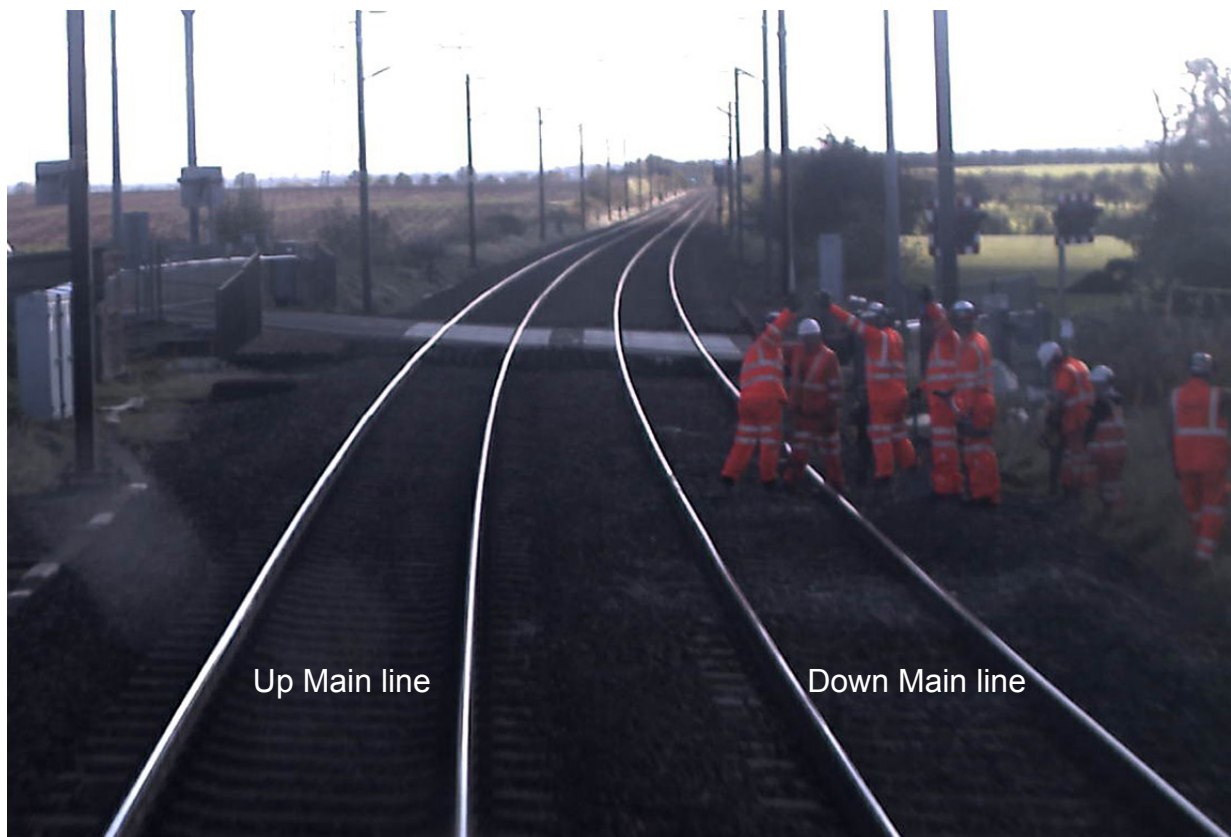
- 46 Around 20 seconds after the passage of this train, train 1E06 passed the group on the up line. The CCTV image from the front of train 1E06 shows that the group had recommenced work as soon as train 1S11 had passed (figure 4). At this time the TOWS warning tone would have continued to sound as both trains were present in the section.

Figure 4: Forward facing CCTV image from train 1E06 approaching the group on the Up Main line, captured 20 seconds after train 1S11 had passed them on the Down Main line (image courtesy of Virgin Trains East Coast)

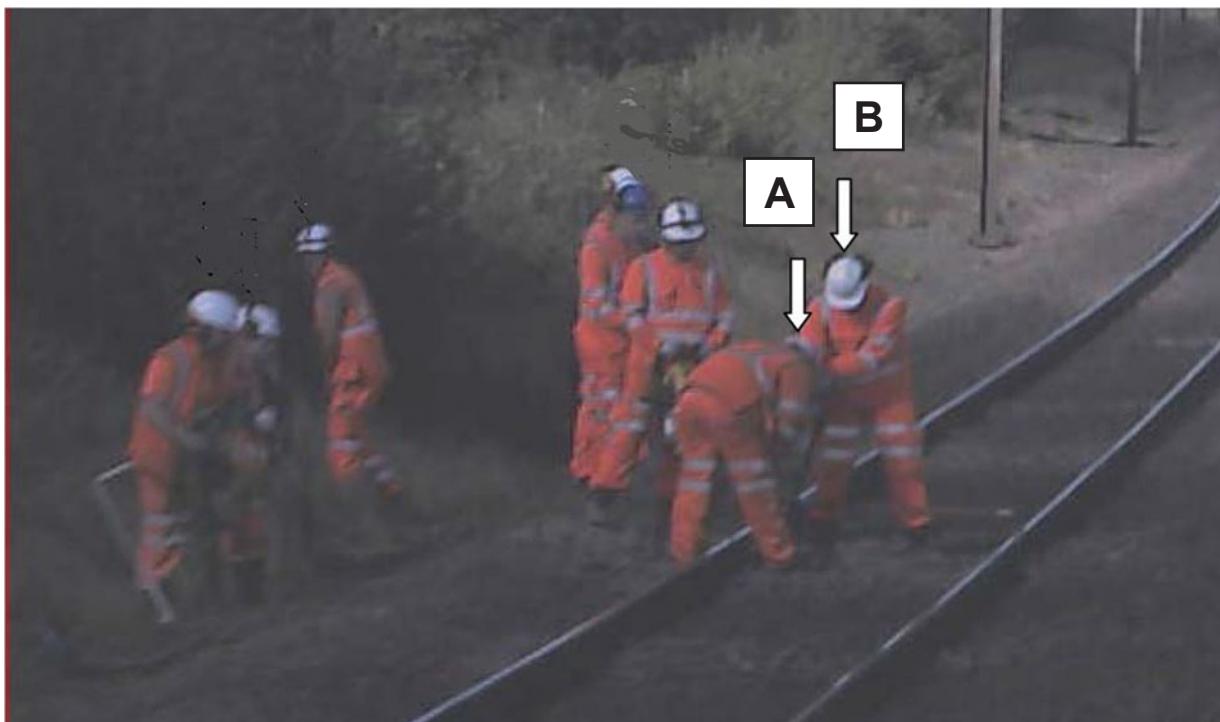
- 47 Train 1E06 was also fitted with a rear facing CCTV camera (figure 5). The RAIB has determined that the person marked 'A' in the image, is the PiC who is bending over to read a cross level gauge with his back to trains approaching in the down direction. The person marked 'B' is operating a track jack, and is the track worker whom the PiC appointed as the site lookout at the first site of work and who performed the lookout role later on at the second site of work (paragraph 41).

Figure 5: Rear facing CCTV image from train 1E06 passing the group on the Up Main line, showing the positions of the PiC ('A'), and the lookout ('B') (image courtesy of Virgin Trains East Coast)

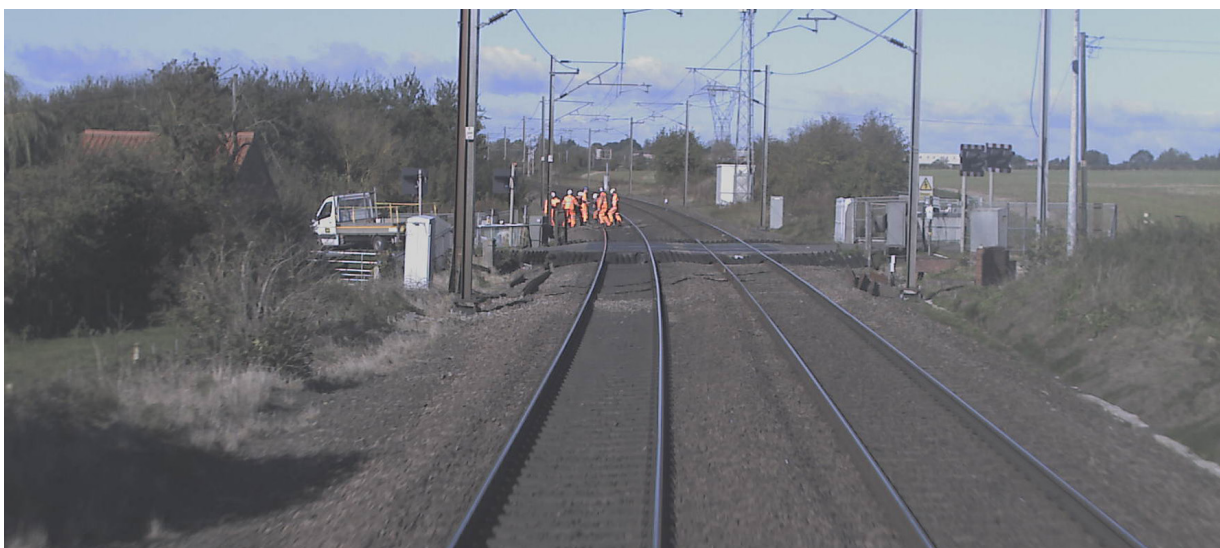
- 48 At around 11:22 hrs the work was nearly complete and TOWS began sounding the warning tone as train 1D09, the incident train, was approaching in the down direction (figure 6).

Figure 6: Forward facing CCTV image from train 1D09 showing three workers on the track as it approached the group on the Down Main line approximately 2 seconds before reaching the site of work (image courtesy of Virgin Trains East Coast)

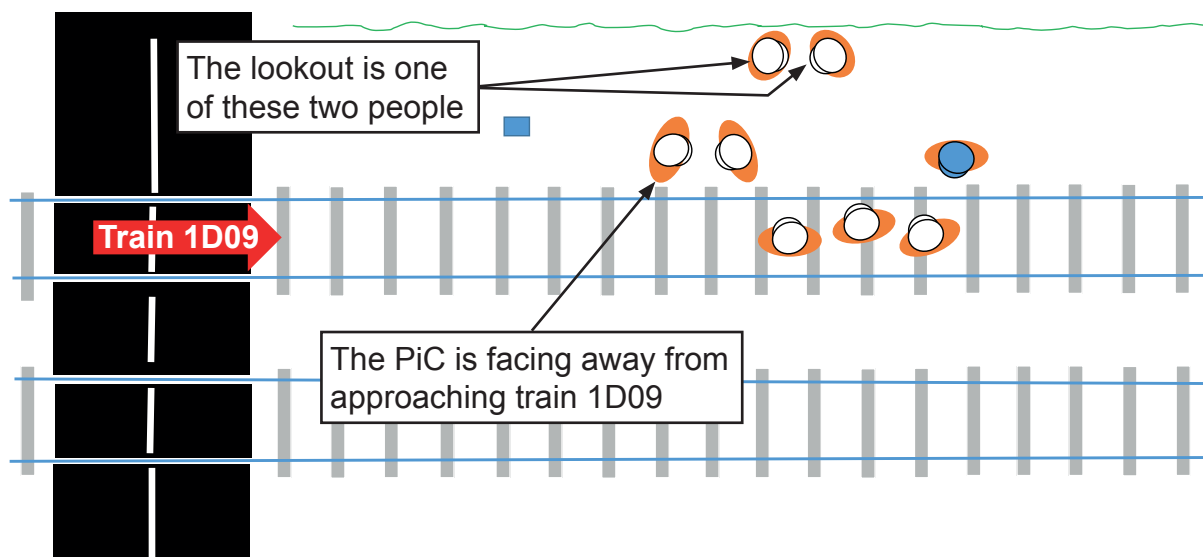
- 49 The approximate positions of the members of the group, and their actions immediately prior to the arrival of train 1D09, are based on witness evidence and forward facing CCTV images from this train (figure 7).

Figure 7: The approximate positions of the track workers immediately prior to the arrival of train 1D09

- 50 The PiC, who was standing close to the track with his back to the approaching train, told the RAIB that he was waiting for a down train to pass so that he could check that the track levelling work was satisfactory. Although accounts vary, it is likely that he was talking with one of the VHRL team who was facing the approaching train.

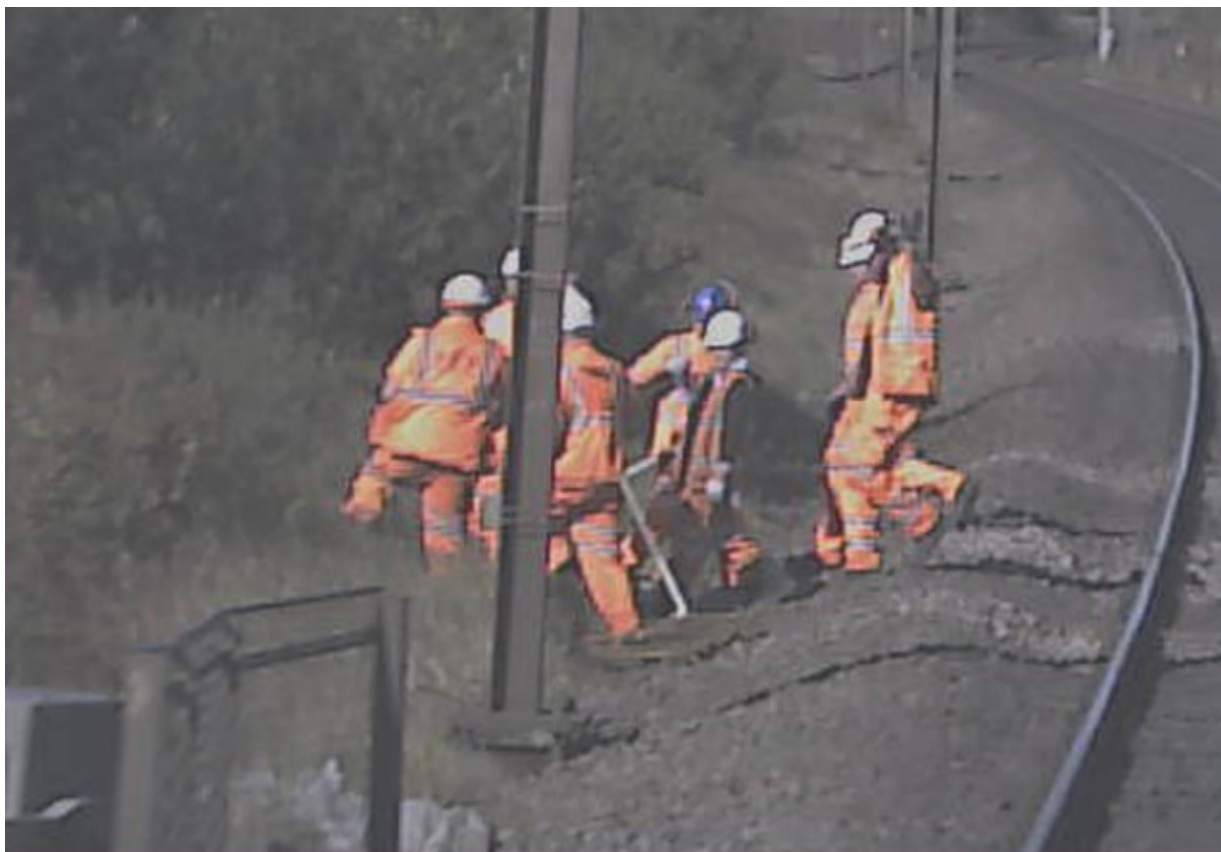
- 51 Four of the group had been on the track, clearing loose ballast from the top of the sleepers. One of them, who had been using a shovel, had moved clear leaving three on the track. The train's CCTV camera images indicate that around 5 seconds before the train arrived, one of them was crouching down, probably removing loose ballast with his hand. The track worker who was talking to the PiC and facing the approaching train shouted to the others when he saw it. This was around three seconds before the train arrived. The CCTV images show that the three workers on the track were clear of the track around one second before the train reached the site (figure 8).

- 52 Most of the group reported that they did not hear the train horn until a few seconds before the train reached the site of work. The driver told the RAIB that he sounded the horn twice on the approach, once when he first saw the group and then a continuous sounding of a series of short blasts from around nine seconds before reaching them. This is supported by evidence from the train's on-train data recorder (OTDR). The driver reported that after applying the emergency brake he closed his eyes as the train passed the site of work, expecting an impact.

- 53 It is likely that the track workers did not hear the horn earlier as, although the mechanised element of the work was complete, TOWS was sounding its warning, and some were still wearing ear defenders.

Figure 8: Forward facing CCTV image from train 1D09 showing the track workers moving clear of the train approximately one second before it passes them at 125 mph (201 km/h) (image courtesy of Virgin Trains East Coast)
