Rail Accident Report

Dangerous train door incident at Bank station on the Docklands Light Railway 6 February 2017

Report 12/2017
September 2017

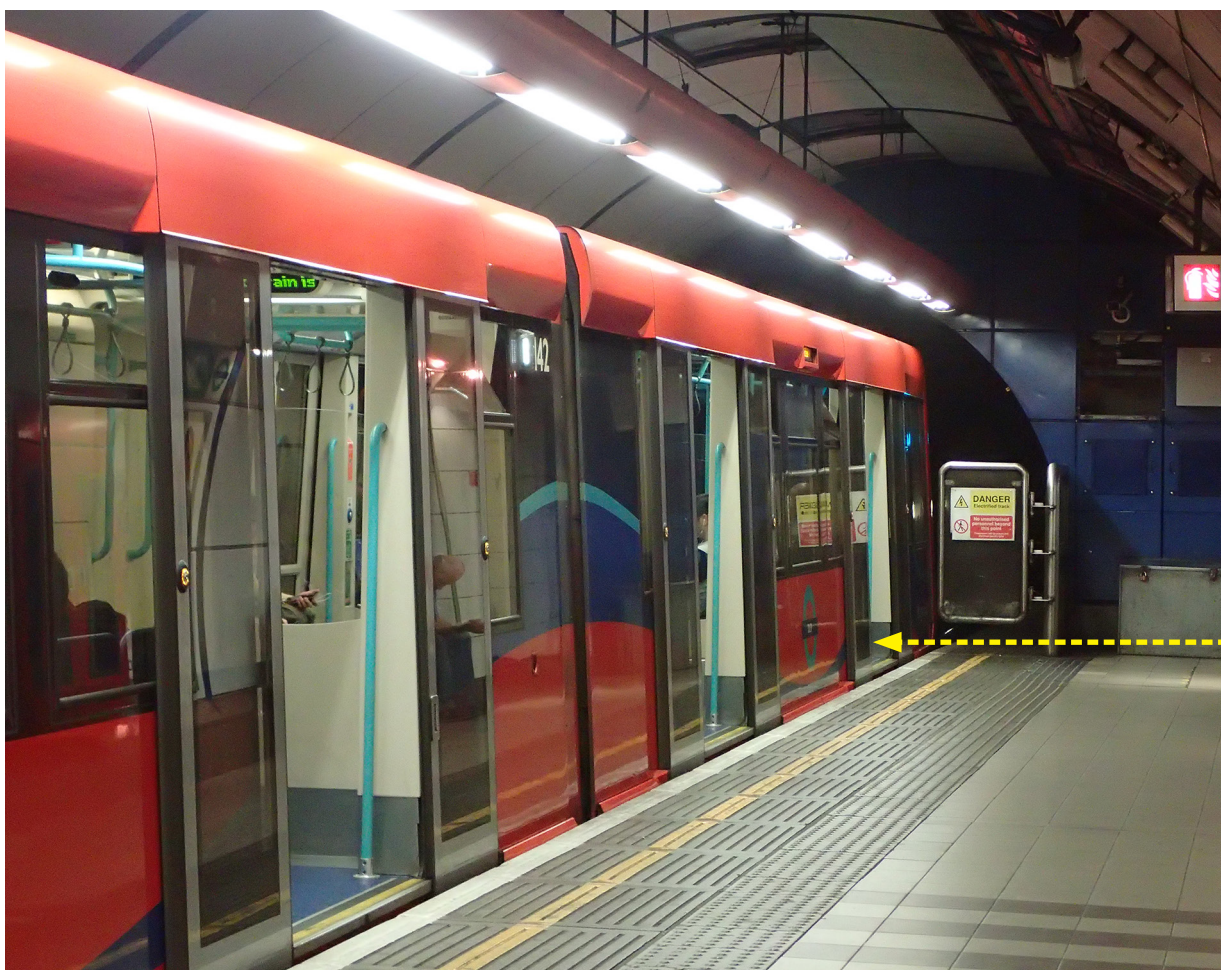
Figure 4: The area of platform 9 at Bank station where the incident took place – view looking east. Arrow indicates path of the passenger.

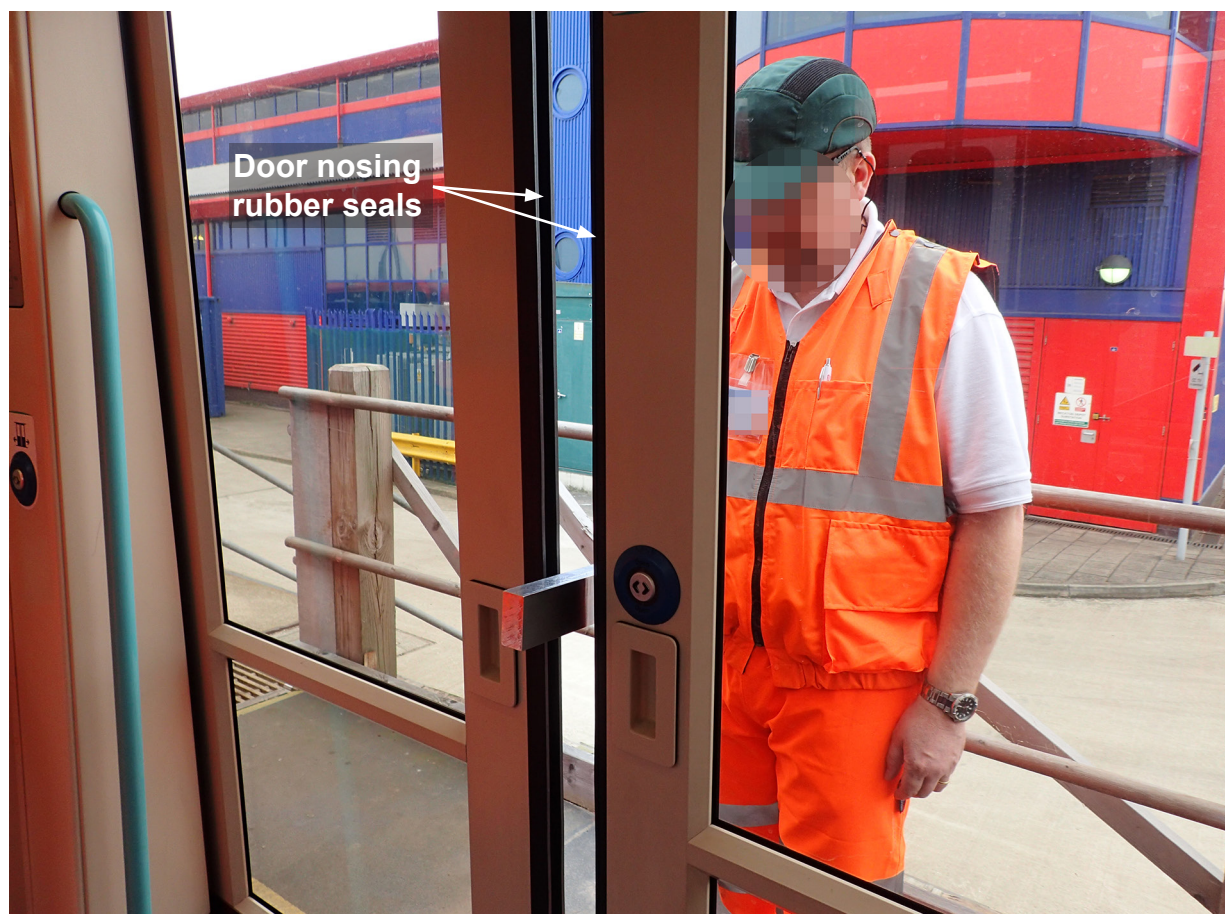
Figure 8: Testing of the door system

- 46 Testing carried out by the RAIB (figure 8) demonstrated that the door system was able to detect a rigid object significantly smaller than the 30 mm x 60 mm standard test block. Provided that the object was rigid, the door system was able to detect objects as small as 1 mm wide (such as a steel ruler).

- 47 However, the RAIB found that objects which were thin and flexible, such as a coat drawstring or fabric, were deflected around the door *nosing rubbers* (paragraph 64) and were not detected by the door system.

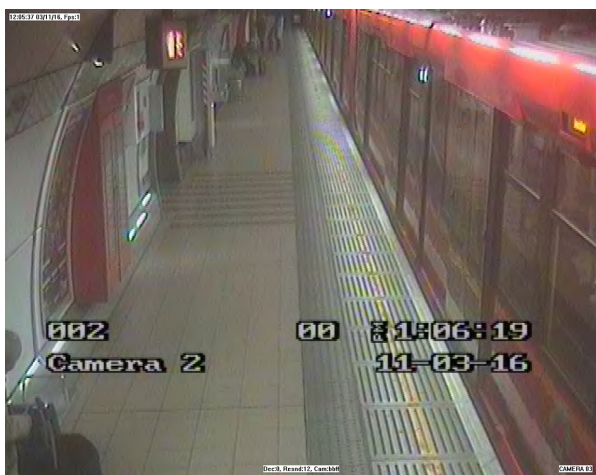
- 54 To allow observation of the platform and doors of a three-car train at platform 9 at Bank station, two CCTV monitor screens are provided for the use of PSAs located at the EDP. The monitors are located at the entrance to the tunnel at the eastern end of the station. One screen shows an image of the eastern end of the platform and the train. The second screen shows a similar image from the western end of the platform.
- 55 The camera showing the image from the eastern end was incorrectly angled. The effect of this defect was that the image shown on the CCTV monitor did not show the leading door (figure 9). As a result, this door and the adjacent platform area could not be observed by a PSA when located at the EDP.

Figure 9: Platform CCTV image at the time of the incident (image courtesy of Keolis Amey Docklands)

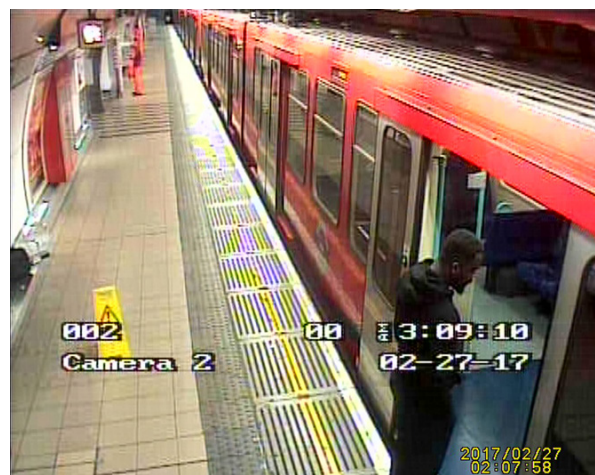
Figure 10: Platform CCTV view after camera adjustment following the incident (image courtesy of Keolis Amey Docklands)

- 56 The RAIB has been unable to establish what caused the camera to be incorrectly angled or when it became so. Following the incident, the camera was angled to show the leading door (figure 10). The management of the CCTV system defect at platform 9 is discussed further at paragraph 68.

- a) examine the integrity of its processes for detecting and rectifying defects in platform observation equipment used by PSAs such as mirrors, monitors and CCTV systems. The review should include consideration of:
 - training and reminders given to staff on the timely reporting of defects;
 - how defects which can impact upon the safe operation of the system, are identified, recorded and addressed in a timely manner;
 - risk mitigation measures in the period between detection and correction for safety-critical defects; and
 - monitoring processes to verify the effective correction of reported defects.
- b) implement a documented procedure to address the shortcomings identified in its existing processes.

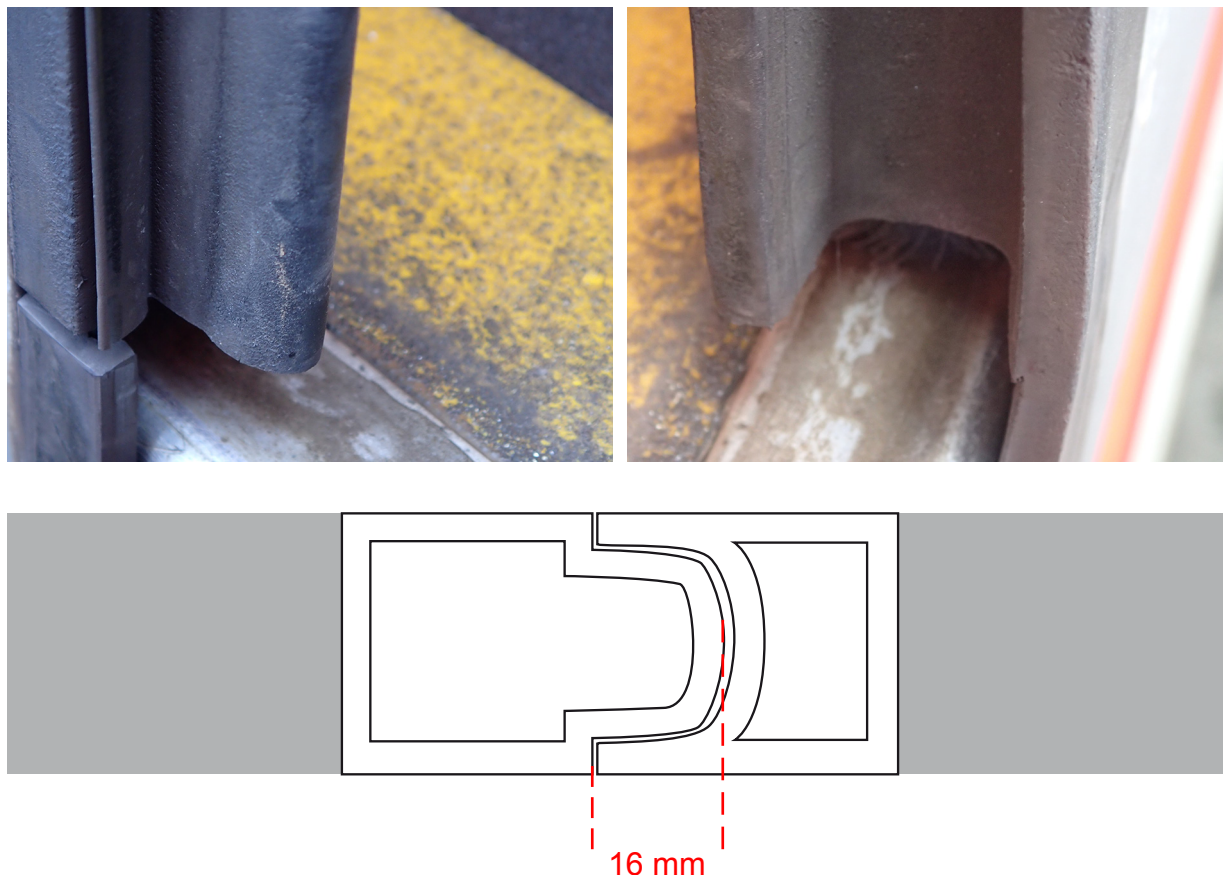
Figure 11: Nosing rubber element used on DLR cars

- 64 The doors on DLR cars have seals called ‘nosing rubbers’, along the vertical edges of the door leaves (figure 8). One door leaf seal has a convex cross-section. This engages with a concave cross-section (figure 11) on the opposing door leaf. The seals reduce draughts, water ingress and noise.

- 65 The nosing rubbers are able to compress around small objects when the doors close, but are intended to have sufficient flexibility, when combined with a *pushback mechanism*, to allow trapped objects to be withdrawn. The shape, flexibility and friction characteristics of the nosing rubbers affects the ease with which trapped objects can be pulled from the doors. The interlocking between the two halves of the nosing rubbers on the DLR cars is around 16 mm. It is greater than that on LUL vehicles² (figure 12), which is around 3 mm. Although the RAIB has not carried out any comparative tests, it is evident that the more convoluted the path that a flexible object, such as a piece of trapped clothing, has to take to be extracted the greater the extraction forces are likely to be, for a given type of nosing rubber design.

- 66 The RAIB also carried out testing using a piece of clothing trapped in the doors of DLR cars and found that forces in excess of 200 N were required to withdraw a fabric test piece. By comparison, the maximum force criteria used by LUL in its tests using a fabric test piece is 90 N.

- 1 *The intent of this recommendation is to reduce the risk of trap and drag incidents on current Docklands Light Railway rolling stock, caused by clothing and other thin, flexible objects becoming trapped in the closing doors.*
