Rail Accident Report

Track worker struck by a train at Stoats Nest Junction, near Purley 6 November 2018

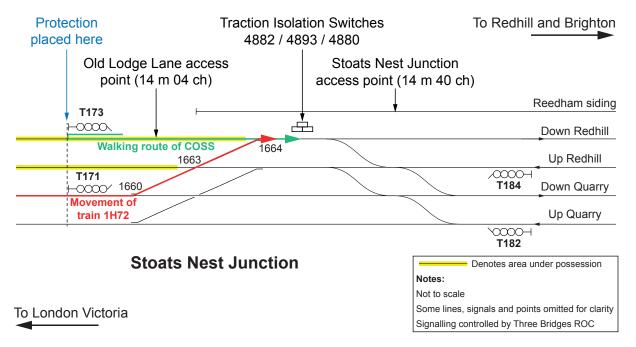
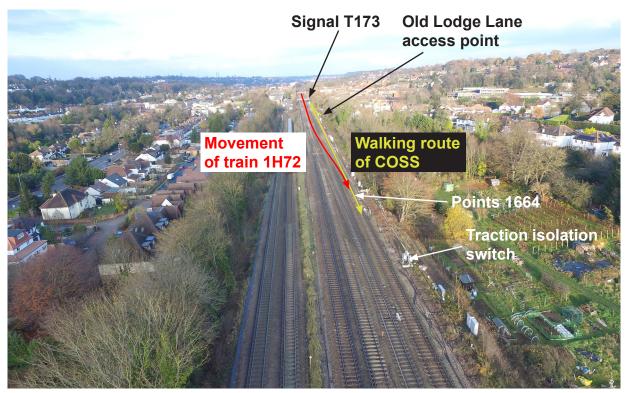
Figure 10: Diagram showing the walking route taken by the COSS and path of train 1H72 prior to the accident

46 Between 00:24:39 hrs and 00:25:09 hrs, signalling data shows that another northbound train passed through the area on the up fast line. Based upon the times derived from the reconstruction, the RAIB believes the COSS, who had not returned to his vehicle, had now passed the pedestrian access point on Old Lodge Lane and was walking south on the down slow line towards points 1664 (figures 10 and 11).

- 73 Although a safe, reasonably even walking route, clear of the track was available between Old Lodge Lane and Reedham sidings, the COSS did not use it. As train 1H72 approached and crossed over from the down fast to the Redhill line, the COSS was outside the limits of protection and was still walking in the four-foot of the down slow line (figures 10 to 12). From his training and experience it is likely that the COSS would have understood that walking in the four-foot was not recommended or safe in these circumstances, and he was probably doing so out of habit.

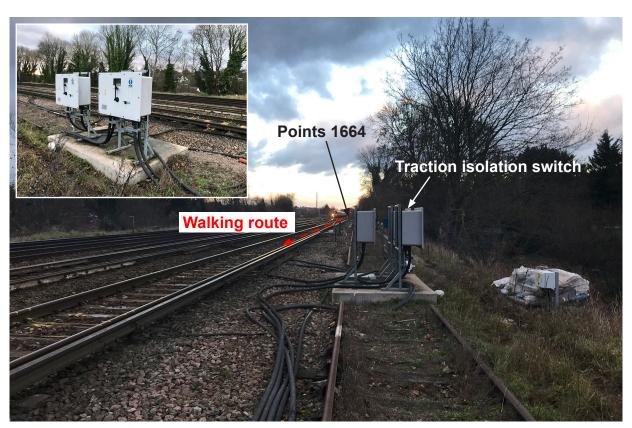
Figure 12: Image showing the location of the traction isolation switch equipment (inset image) in the cess running parallel to the down Redhill (slow) line

- 81 It is probable that the COSS was distracted by going to look at the traction isolation switch equipment to the south of Stoats Nest Junction.
- Witnesses stated that the COSS was keen to educate himself. He had applied for his COSS competence in 2017, but had initially failed to achieve the required standard, because he had not achieved the required level of underpinning knowledge and confidence to perform as a COSS. He reapplied for the course and successfully achieved the required standard in January 2018. The COSS completed the mentoring scheme which is required as part of the process to achieve the competence of COSS, but most of his work was to act as possession support. Prior to the accident he had gained very little experience of acting as a COSS managing the safety of a work gang on the railway.

- When he arrived at 1664 points (probably to check the identification number plate attached to the bearer/sleeper see paragraph 64), the COSS, who was wearing a head torch, would have been able to see that at the side of the line a short distance beyond those points there were hook switch and traction isolation switch cabinets (figures 11 to 13). The RAIB believes that the COSS may have then become distracted by this equipment. With his attention focused on the equipment, he continued walking towards the switch cabinets, probably to look more closely and educate himself in preparation for taking this training.

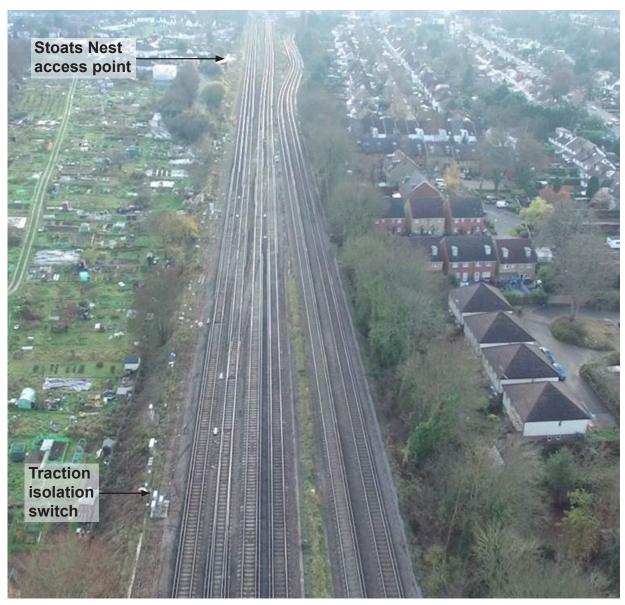
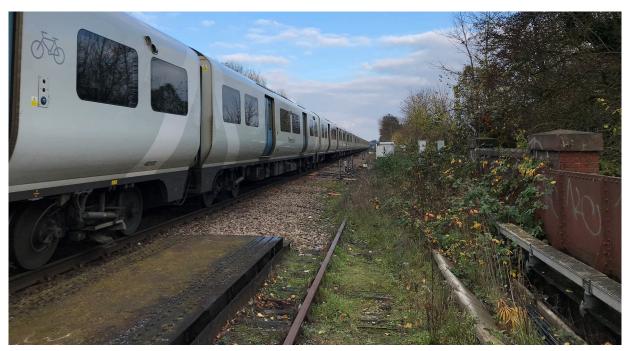
Figure 13: Image showing the location of the traction isolation equipment and Stoats Nest Road access point

- e. The COSS was walking towards Stoats Nest Road access point to take a personal needs break. There were no welfare facilities at Stoats Nest Road access point so it would not appear to be a more likely personal needs break location than somewhere nearer the possession limit (figures 13 and 14).
