# Rail Accident Report

**Container detachments at Scout Green,  
Cumbria, 7 March 2015 and near Deeping St  
Nicholas, Lincolnshire, 31 March 2015**

# **Container detachments at Scout Green, Cumbria, 7 March 2015 and near Deeping St Nicholas, Lincolnshire, 31 March 2015**

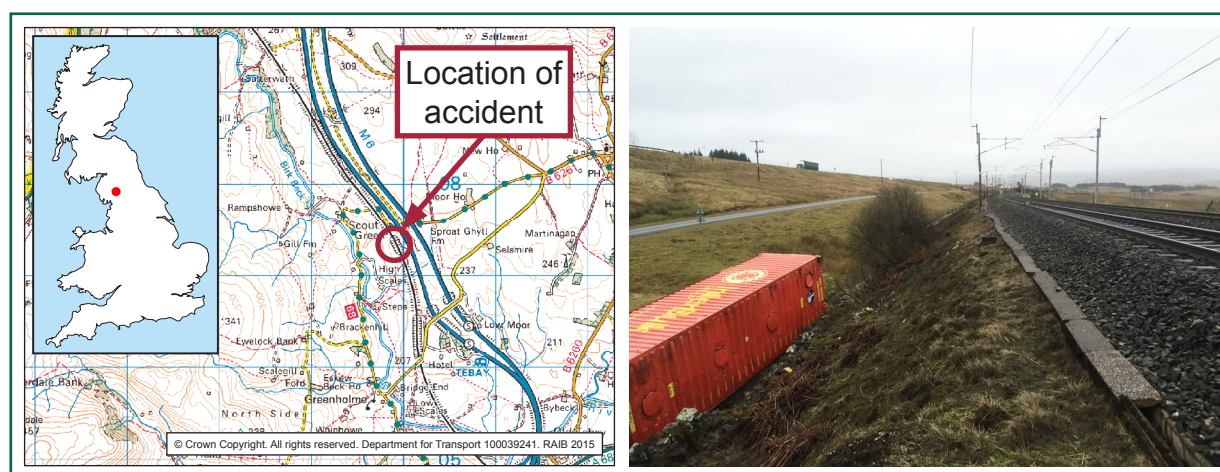
- 4 At around 02:20 hrs on 7 March 2015, an empty 30 ft container was blown from freight train 4S83<sup>1</sup>, the 23:54 hrs Freightliner service from Basford Hall to Coatbridge, while it was travelling on the down<sup>2</sup> main line of the West Coast Main line at Scout Green, Cumbria (figure 1). The container toppled over the adjacent up<sup>3</sup> main line and came to rest at the bottom of the embankment on the east side of the railway (figure 1). There was no damage to the train or to the infrastructure but some trees on the embankment and a boundary wall at the foot of the embankment were knocked over. There were no passing trains at the time of the detachment although the Glasgow Central to London Euston sleeper service had passed the site of the incident on the adjacent line about four minutes earlier.

- 5 Train 4S83 comprised 26 container carrying vehicles hauled by a pair of class 86 locomotives and was travelling at around 75 mph (121 km/h). The detached container was being carried on an FEA-B type wagon, number 640017, which was the 20th vehicle in the train. The container was one of two empty 30 ft containers carried on the wagon and was located at the leading end (in the direction of travel).

Figure 1: Extract from Ordnance Survey map showing location of incident and photograph of the detached container at Scout Green (Image courtesy of Network Rail)

- 6 The train driver was unaware of what had happened and the train continued to Coatbridge, arriving at 04:47 hrs. At 06:55 hrs a member of the public reported the detached container to Network Rail and subsequent enquiries established which train it had come from.
- 7 Around the time of the container detachment, the wind speed, measured approximately six kilometres away at Shap weather station, was gusting to around 62 mph (100 km/h). The wind was from the south-west, blowing almost perpendicular to the line of the railway.

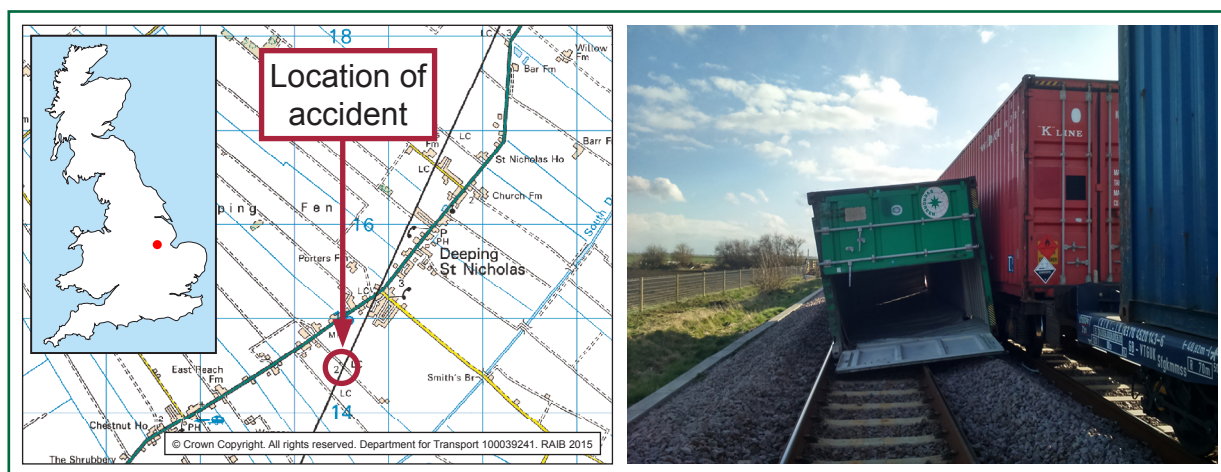
- 8 On 31 March 2015, at around 15:22 hrs, an empty 40 ft container was blown from freight train 4Z33, the 11:21 hrs GB Railfreight service from Felixstowe South to Doncaster Railport. The detachment occurred while the train was travelling at approximately 38 mph (61 km/h) on the down main line, near the village of Deeping St Nicholas, Lincolnshire (figure 2).

- 9 The container fell against the side of the wagon and was dragged a short distance before coming to rest on the adjacent track (figure 2). The train continued for approximately 250 metres until it was brought to a stand by the train's brakes. The brakes were applied automatically when the container struck the handbrake handwheels of several wagons and damaged a brake safety mechanism.

Figure 2: Extract from Ordnance Survey map showing location of incident and photograph of the detached container near Deeping St Nicholas (Image courtesy of Network Rail)

- 11 The detached container caused significant damage to the infrastructure, including a trackside telecommunications cabinet, a level crossing surface, sleepers, rail fixings, and signalling equipment. Thirteen vehicles also suffered damage, mainly to handbrake handwheels. There were no trains passing at the time of the incident although another freight train operated by GB Railfreight carrying containers had passed on the adjacent line about five minutes earlier.

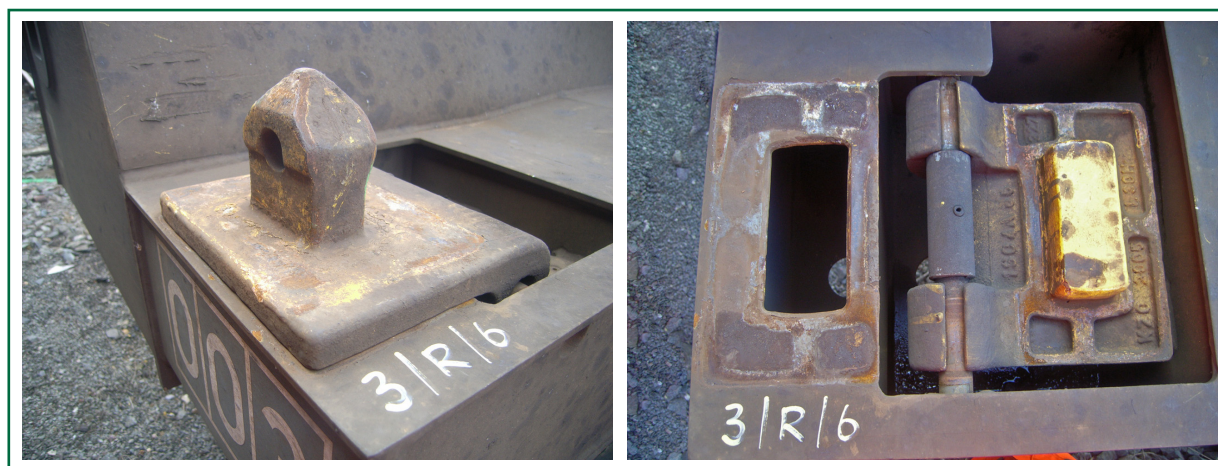
- 15 The FEA-B and FEA-S wagon types can carry various combinations of 20, 30, and 40 ft containers or a single 45 ft container. They are provided with ten pairs of spigots which can be deployed as required to carry, for example, three 20 ft containers or one 20 ft container and one 40 ft container. The containers carried on FEA-B and FEA-S wagons have corner castings which locate on the spigots. The spigots are designed with inboard hinges so that they can be rotated manually and stowed in recesses in the wagon bed when not in use (figure 4).

Figure 4: Fold-down spigot with inboard hinge, as fitted to FEA-B and FEA-S wagons, deployed (left), stowed (right)

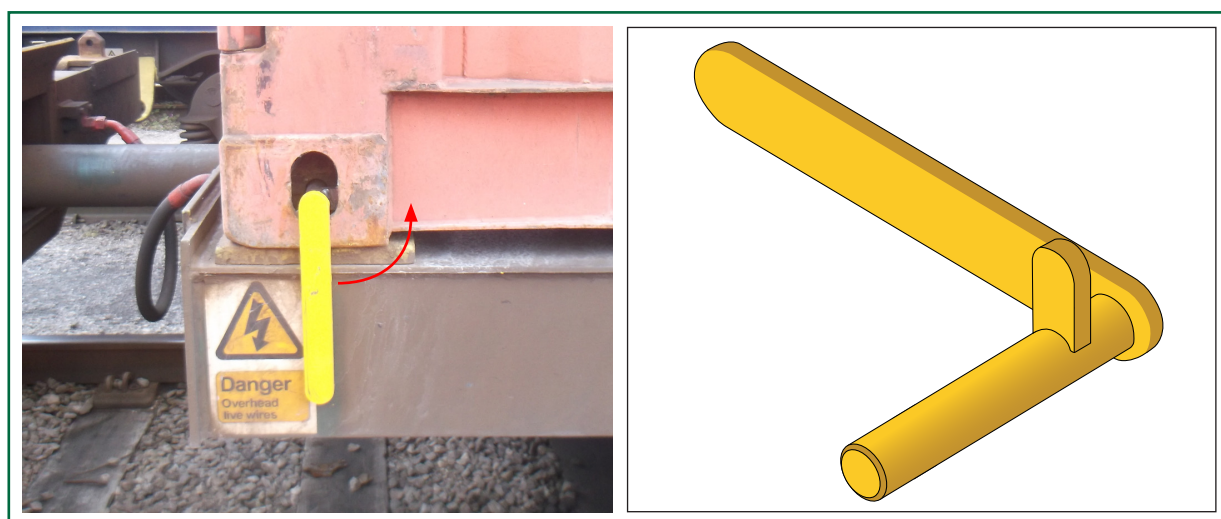
Figure 7: Pin used to secure the container corner casting to the spigot head (images courtesy of Freightliner)

- 25 Freightliner reported that it began using spigot locking pins (figure 7) in June 2008 to secure empty containers to the spigots of FEA-B wagons (and also on its FEA-E wagons, which have the same design of inward hinging spigots) when wind speeds of over 55 mph (89 km/h) were forecast, removing the need to restrict the train speed to 60 mph (97 km/h) in high wind conditions.

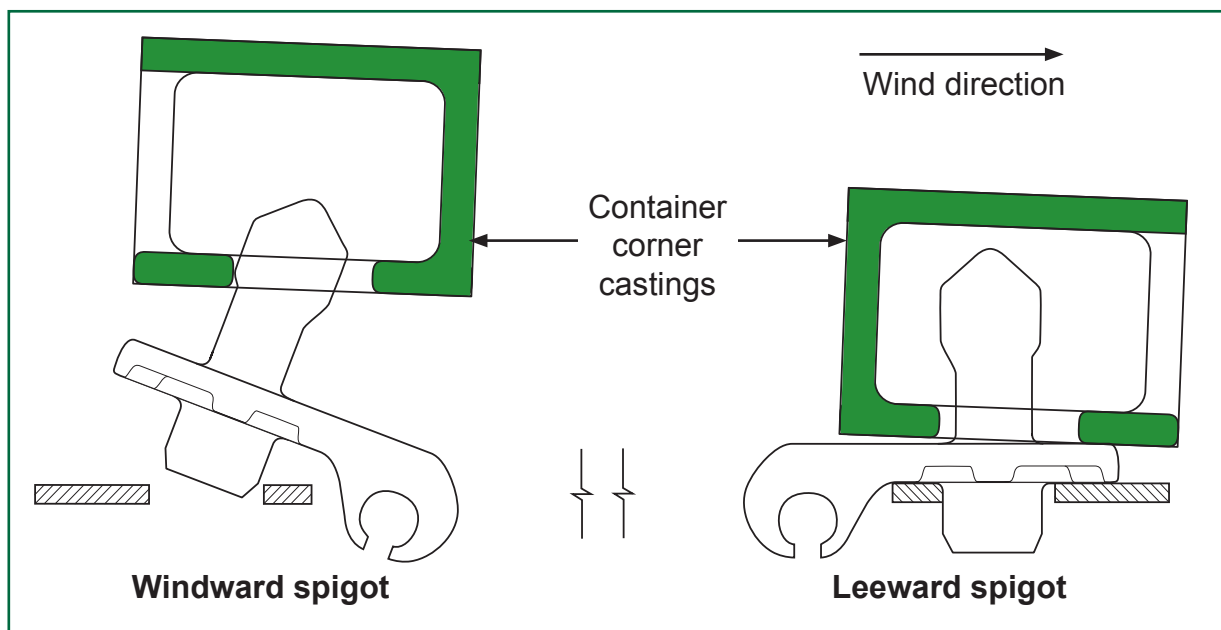
- 27 In May 2009 the RAIB published its investigation report into the container detachments at Hardendale and Cheddington ([RAIB report 12/2009](#)). The investigation found that spigots with inboard hinges do not comply with UIC 571-4 because the spigot is free to tilt inwards towards the centre of the vehicle by more than the permitted two degrees of rotation (paragraph 19). Once a container starts to lift on the windward side and engages with the neck of the spigot, the spigot rotates on its inboard hinge with the container and cannot prevent the container from overturning (figure 8).

Figure 8: Mechanism of container detachment on spigots mounted on inboard hinges (not to scale)

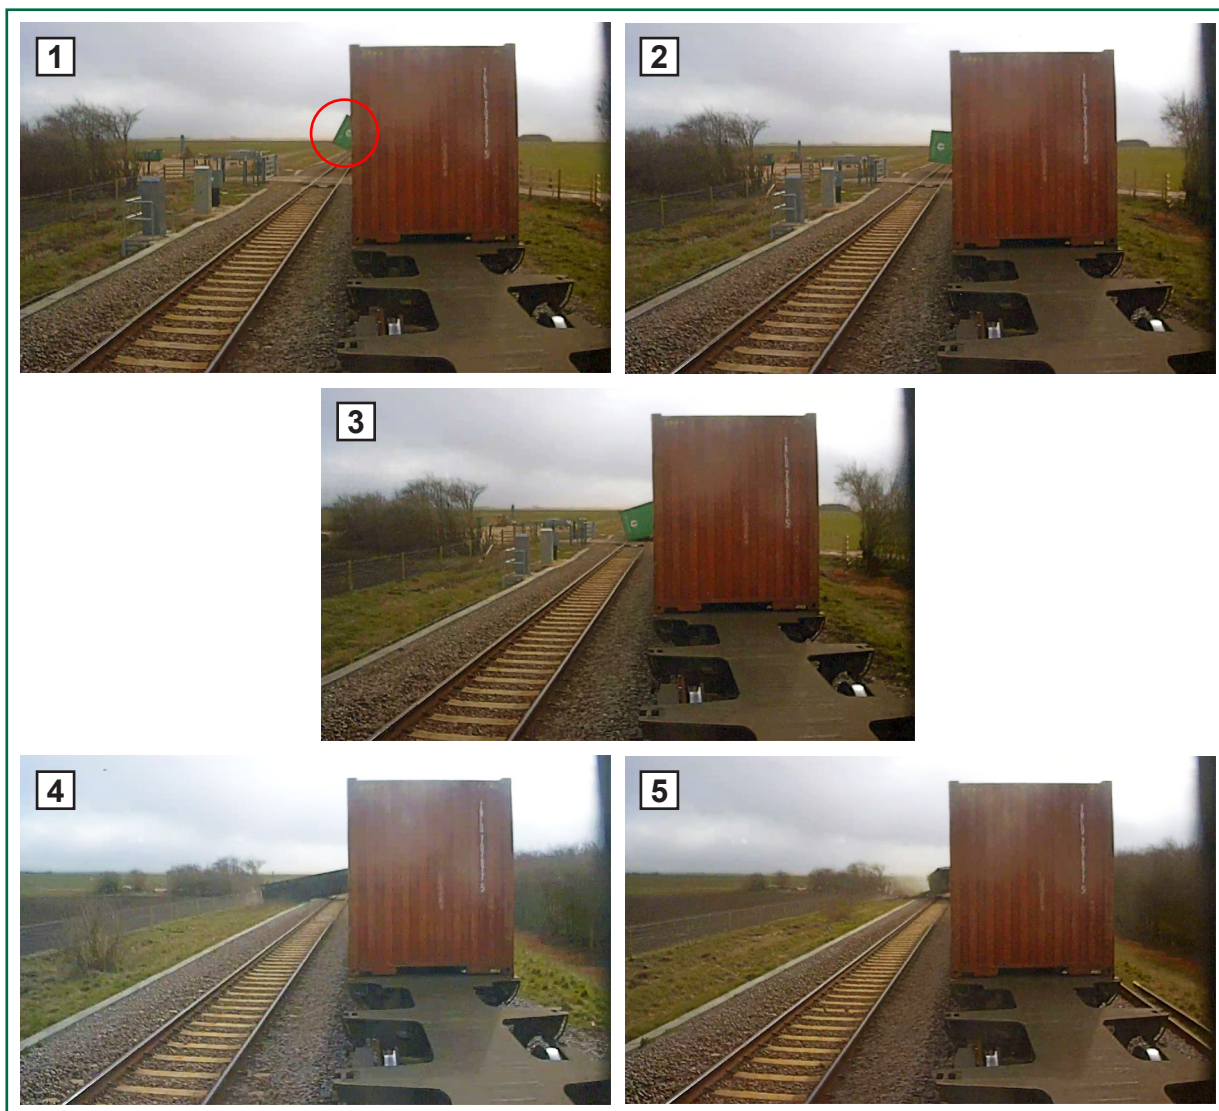
- 57 The locomotive hauling train 4Z33 was fitted with forward and rear facing closed circuit television (CCTV) cameras. These recorded an apparent deterioration in weather conditions around the time of the detachment; the sky darkened and strong gusts of wind blew debris across the track from adjacent fields. Images from the rear facing camera captured the third container in the train overturning about its leeward spigots and falling from the wagon (figure 9). It was struck by a wagon outrigger and swung across the adjacent track before being pulled into line and dragged by the train for about 60 metres.

- 58 Taking the worst case wind gust speed of 67.8 mph (109 km/h) measured near the site of the container detachment, and a train speed of 38 mph (61 km/h) the RAIB has calculated the resultant wind speed to be 78 mph (125 km/h) at a wind angle of around 61 degrees (paragraph 22). These figures indicate that a container overturning could theoretically occur, but there is no record of any containers previously detaching in these conditions. It is possible that the wind gust speed was higher at the railway than that measured at the wind farm. It is also possible that the gap in the line of containers immediately in front of the container that detached may have had some bearing on the aerodynamics around the container (there were similar gaps preceding the first containers to detach at Hardendale, Cheddington, and at Scout Green).

Figure 9: Series of images recorded by the rear facing camera on the locomotive of train 4Z33 to show the container detachment (images courtesy of GB Railfreight)

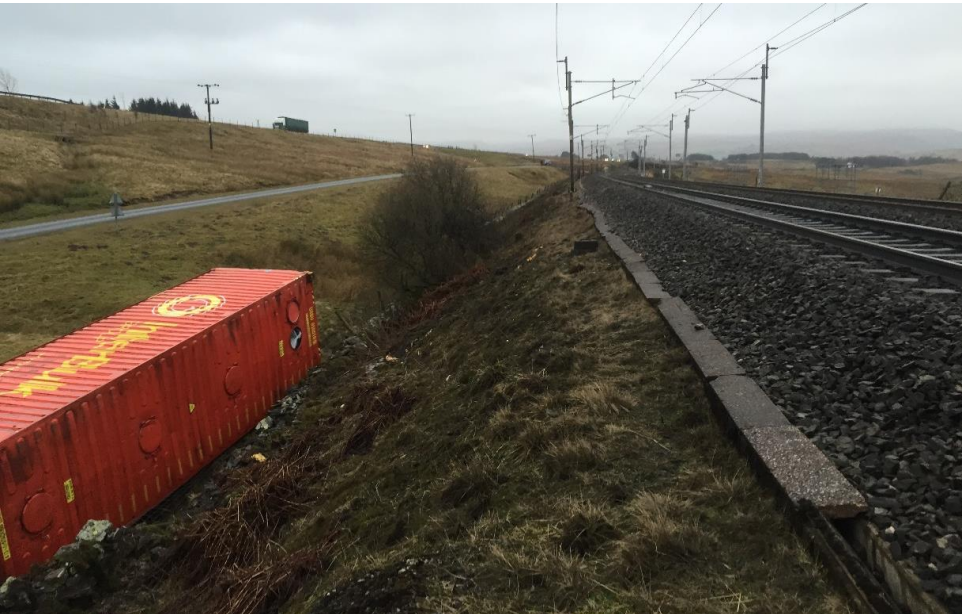
1. INCIDENT DESCRIPTION			
LEAD / INSPECTOR		CONTACT TEL. NO.	
INCIDENT REPORT NO	0744	DATE OF INCIDENT	7 March 2015
INCIDENT NAME	Scout Green		
TYPE OF INCIDENT	Container blown off freight train		
INCIDENT DESCRIPTION	<p>At around 02:20 hrs on 7 March 2015, an empty 30 ft container was blown off an FEA(B) wagon, that formed part of train 4S83 operated by Freightliner. The train was travelling at around 75 mph (120 km/h) on the Down Main line in the vicinity of Scout Green, Cumbria, around 2.5 miles south of Shap Summit. The container passed over the adjacent Up Main line and came to rest at the bottom of the Up side embankment. There was no damage to train 4S83, any other train, the overhead line equipment or the track. Trees on the embankment and a boundary wall at its foot were knocked over.</p> <p>The incident took place at a time of high cross-winds. Although it did not result in injuries, the potential for more serious consequences is evident.</p>

<p>[Image courtesy of Network Rail (looking south)]</p>
