Rail Accident Report

**Signal passed at danger on approach to
Wootton Bassett Junction, Wiltshire
7 March 2015**

Signal passed at danger on approach to Wootton Bassett Junction, Wiltshire, 7 March 2015

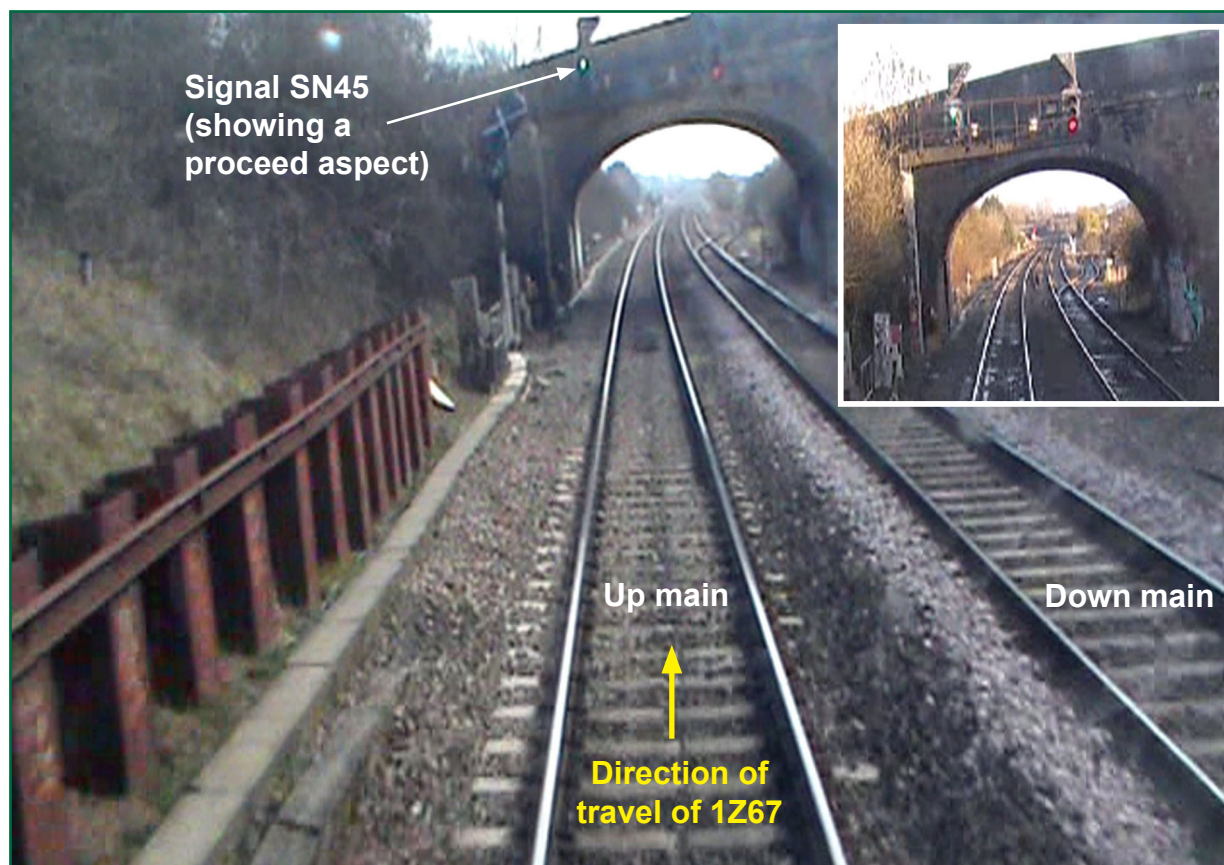
Figure 3: A video image of signal SN45 taken shortly after the incident. Inset figure shows an HD video image of the signal head taken in 2012 (images courtesy of Network Rail).

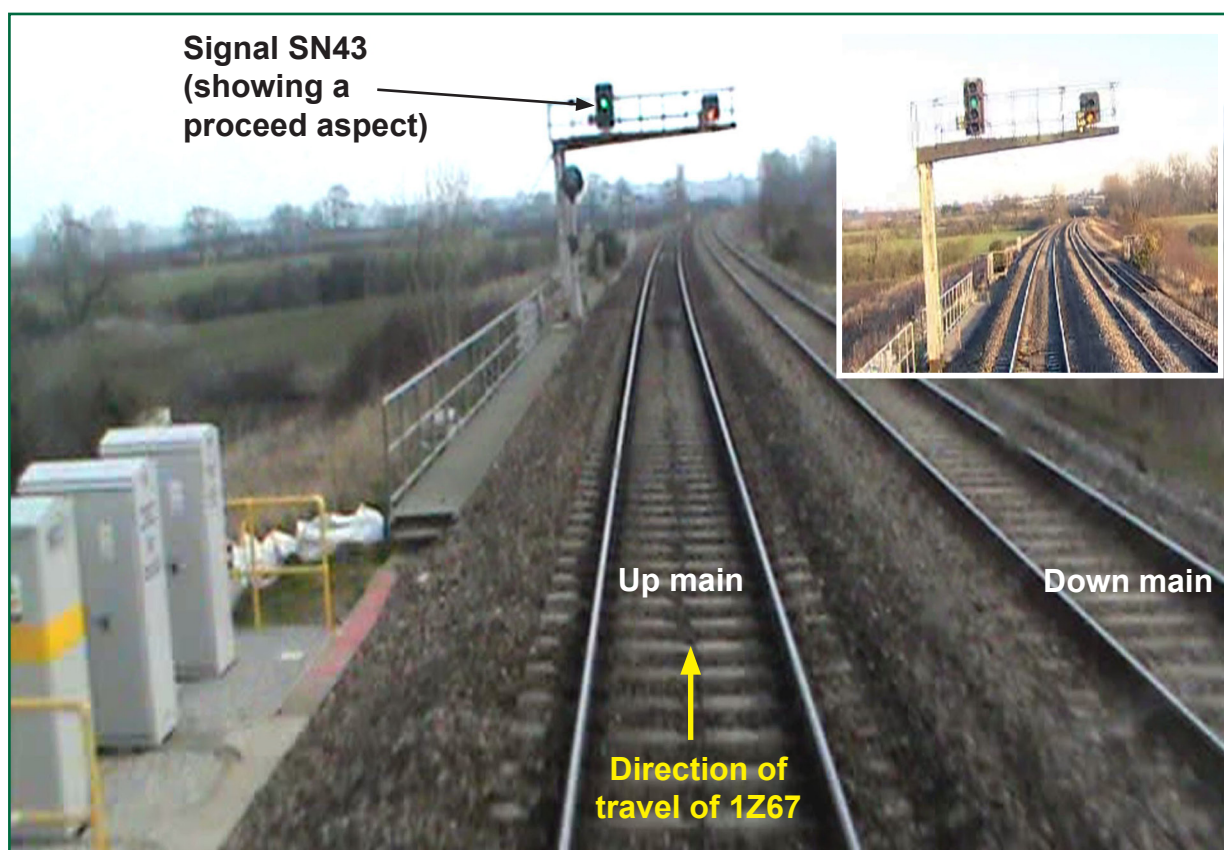
Figure 4: A video image of signal SN43 taken shortly after the incident. Inset figure shows an HD video image of the signal head taken in 2012 (images courtesy of Network Rail).

- 92 Network Rail undertook wrong-side failure testing of signal SN43 following the SPAD. No fault was found with the signal as a result of this testing. Signalling system monitoring equipment recorded that, as train 1Z67 passed, signal UM85 had been displaying a green proceed aspect, signal SN43 had been displaying a single yellow caution aspect and that signal SN45 had been displaying a red danger aspect.

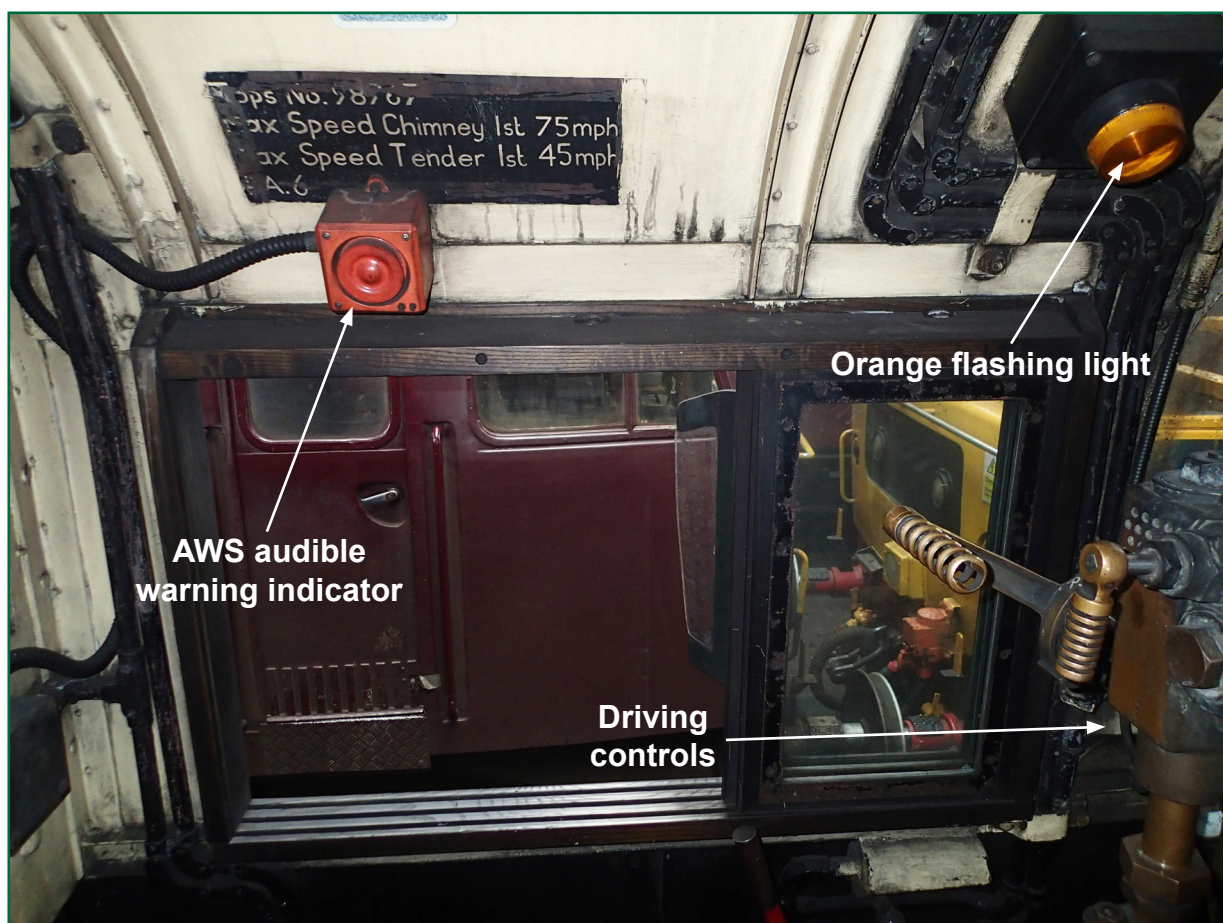
- 15 At the time of the incident, the AWS audible warning indicator on Tangmere was positioned on the inside of the cab roof, just above the *driving position* (which is on the left-hand side of this locomotive) and towards the rear of the driver's side window. The orange flashing light was also positioned on the inside of the cab roof, slightly higher than the audible warning indicator and to the front of the driver's side window (figures 8 and 9). The AWS visual indicator (commonly called the 'sunflower') is mounted in front of the driving position just above the main driving controls, with the TPWS display panel positioned directly above it (figure 9).

Figure 8: The position of the AWS audible warning indicator unit and flashing light on 7 March 2015
