Rail Accident Report

Occupied wheelchair contacting a passing train at Twyford station 7 April 2016

Report 01/2017
January 2017

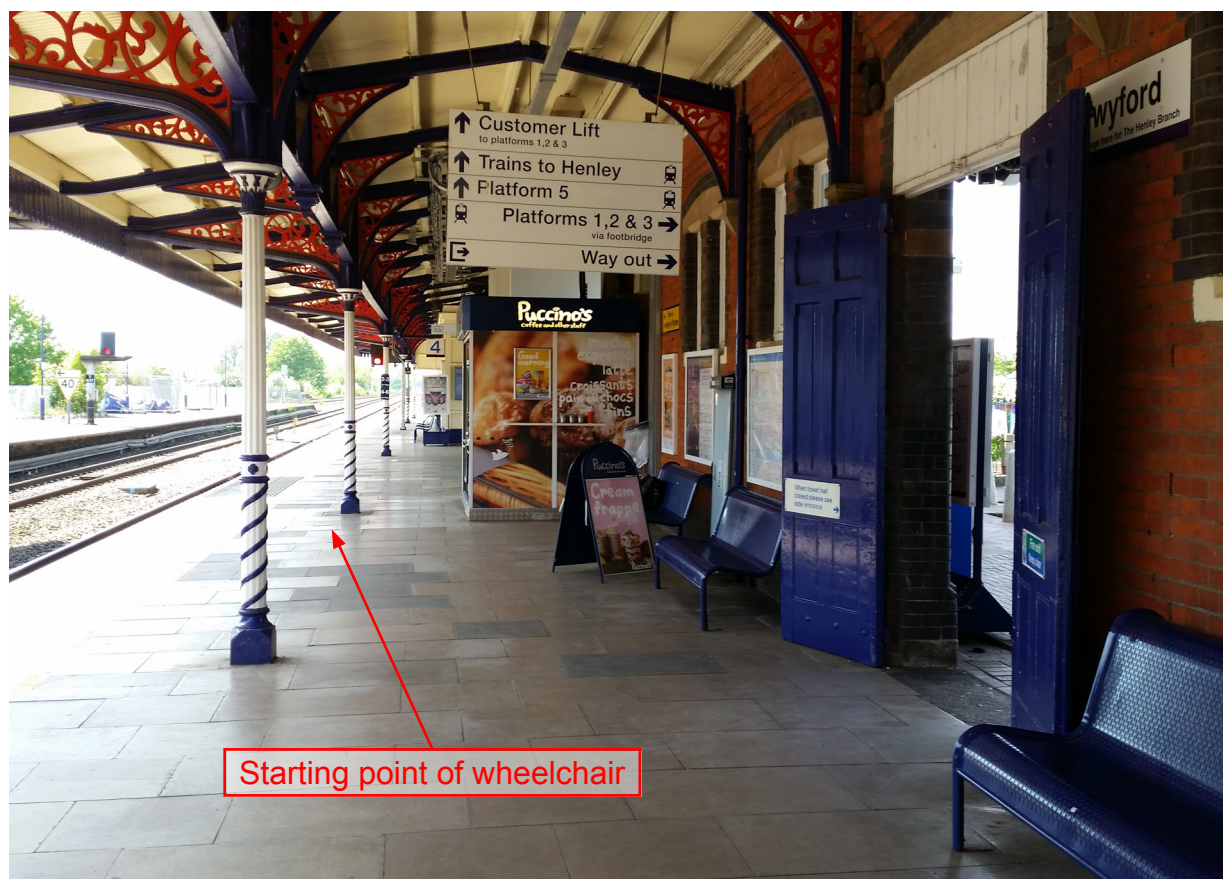
Figure 2: Platform 4 at Twyford station, looking towards Reading

- 7 The surface of platform 4 is laid with paving slabs (figure 2) and slopes towards the track at an angle of approximately one degree (1 in 57 or 1.7%)³. The platform is level in the direction parallel to the railway. A *tactile strip* is provided approximately 1 metre from the platform edge.

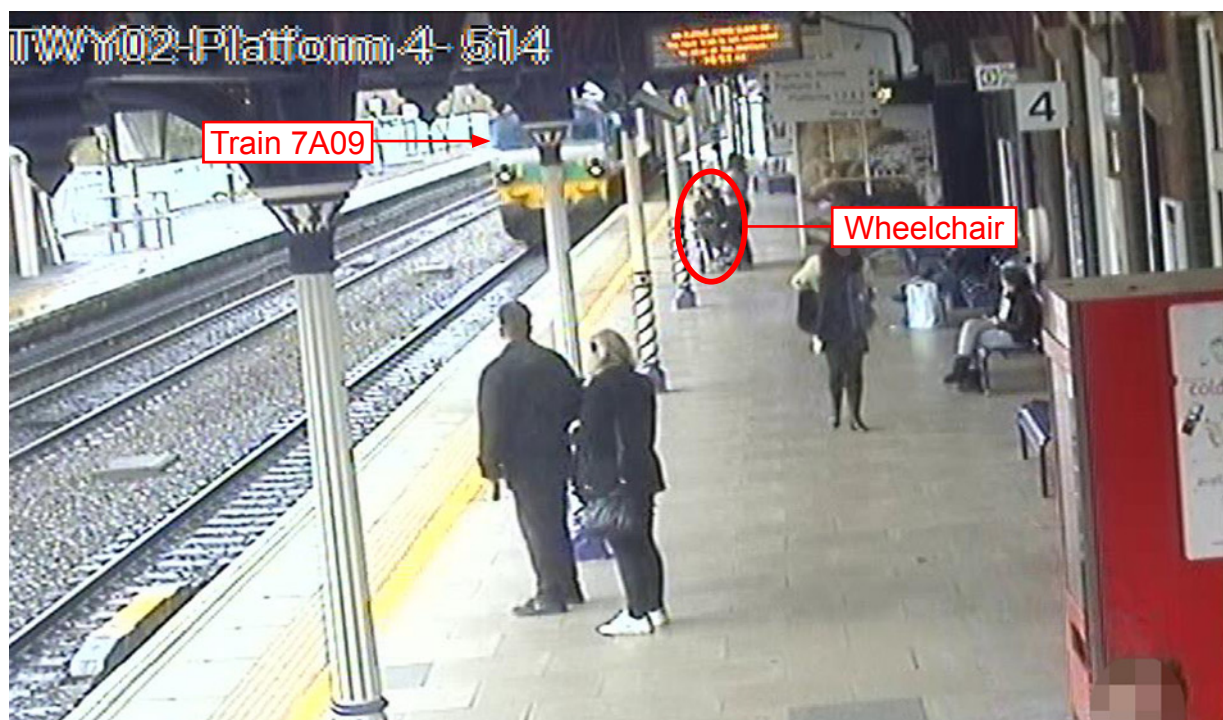
Figure 7: CCTV image showing the locomotive of train 7A09 passing the wheelchair (courtesy of GWR)

- 21 At 10:51:50 hrs, the locomotive of train 7A09 passed the wheelchair (figure 7). After approximately 13 seconds, the wheelchair began to move slowly, turning to the right and towards the train (figure 8). The initial movement occurred as the transition between the box wagons (wagons 1 to 16) and hopper wagons (wagons 17 to 44) passed the wheelchair.

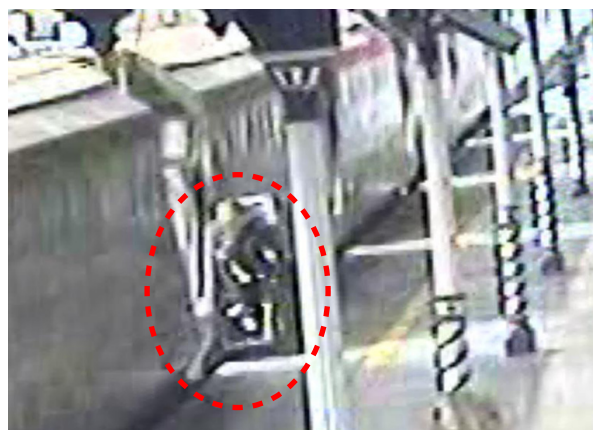
Figure 9: CCTV image showing the wheelchair in contact with the 29th wagon of train 7A09 (courtesy of GWR)

- 22 After a further six seconds, the wheelchair's front right foot plate collided with the 27th wagon on the train. This caused the wheelchair to rotate such that it was moving parallel to the train. The wheelchair then struck the 29th wagon, rubbing along the side of that wagon (figure 9) before contacting the leading edge of the hopper on the 30th wagon. This third and final contact caused the wheelchair to be propelled away from the train and along the platform, where it came to rest. Figure 10 illustrates the general path taken by the wheelchair.

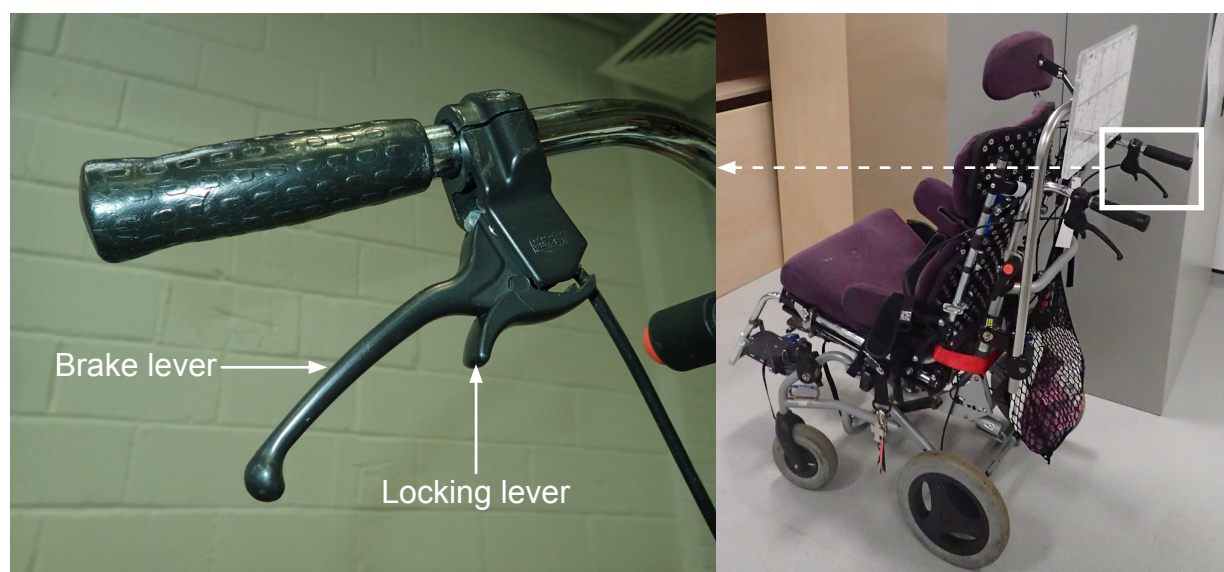
Figure 11: The wheelchair involved in the accident

- 30 The wheelchair involved was manufactured by Otto Bock Healthcare during 2010 and was the 'Discovery' model (figure 11). This design of wheelchair can only be propelled and braked by a carer; it cannot be operated by the user. The combined weight of the wheelchair and the girl at the time of the accident was approximately 90 kg.
- 31 The wheelchair is fitted with drum brakes operated by the carer using levers, one on each handle. There is one drum brake on each rear wheel controlled using a cable from the corresponding handle. The brakes operate independently of each other. A cam mechanism, operated by the cable (figure 12), causes brake pads to press outwards onto an annular inner surface within the wheel hub to apply the brake.

- 32 Each brake lever has a separate smaller lever (figure 11) which allows the carer to lock the brakes into one of three steps, until released.
- 33 As part of its product acceptance process, this type of wheelchair was tested by the manufacturer in accordance with EN12183:1999 'Manually propelled wheelchairs – Requirements and test methods' and ISO7176 part 3 'Wheelchairs – Determination of the effectiveness of brakes' to check the adequacy of the brakes. A wheelchair was loaded with a test dummy and placed on an inclined surface. The total mass of chair and dummy was 131 kg. The brakes were applied with a maximum pull force on the handles of 72 Newtons (N). This force corresponds to step 2 on the brakes of the Discovery wheelchair design. The inclination on the surface is then increased until either the wheelchair starts to roll or it starts to slide. The greater the angle of inclination achieved, the stronger the brake. The minimum acceptable inclination is 7 degrees. The test report for the Discovery wheelchair design, dated August 2004, showed that it achieved a 10.7 degree inclination, equating to a brake force of 239 N.

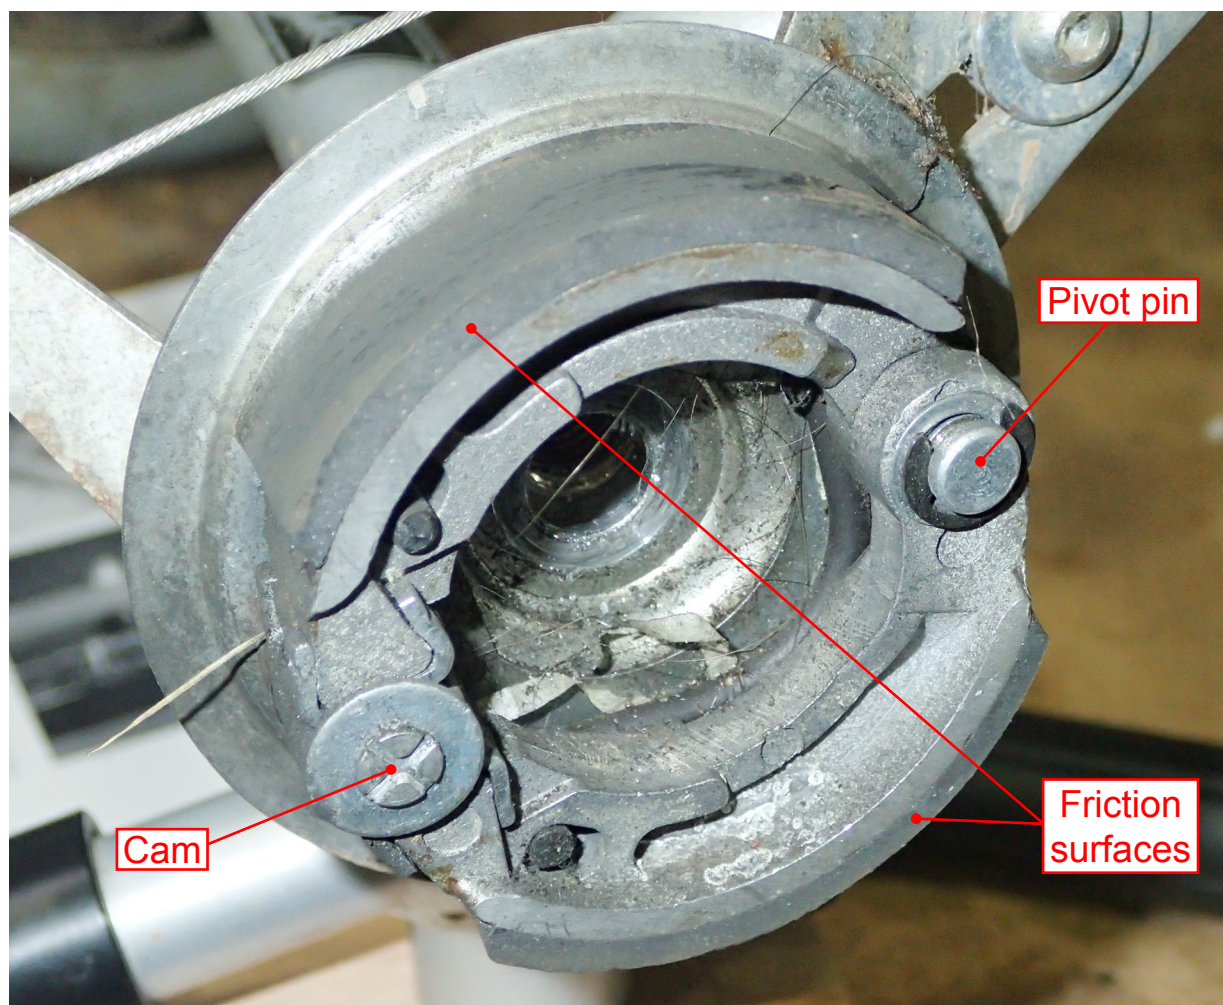
Figure 12: The wheelchair brake mechanism

- 50 The RAIB arranged for Otto Bock Healthcare to examine the wheelchair. It noted that there was more wear on the left hand brake than the right. The effect of this wear would be that the right side brakes would have been more effective. Otto Bock Healthcare has advised the RAIB that the usual reason for a reduction in the effectiveness of the brakes on this type of wheelchair is stretch in the operating cables. It cannot be confirmed if the cables fitted to the wheelchair at the time of the accident had been subject to stretching since the original length of the cables fitted to the wheelchair is unknown⁹.

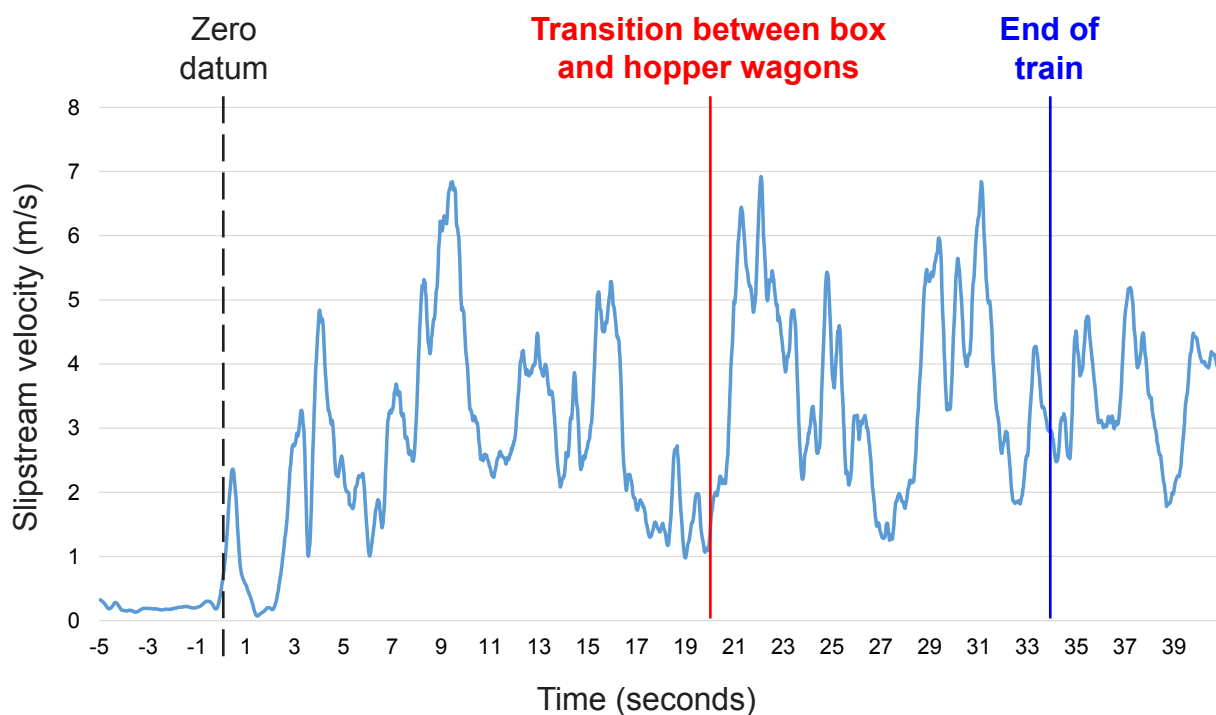
Figure 14: Typical measured slipstream velocity against time graph for the passage of a single train similar to 7A09. Data is taken from the passage of train 7A91 through Twyford station at 02:05 hrs on 9 August 2016.

- 43 Measurements for the trains of a similar configuration to train 7A09 were analysed. Figure 14 shows the slipstream velocities measured by an anemometer when such a train passed through platform 2. It should be noted that there was significant variability in the anemometer measurements between trains and also between anemometers during the passage of a single train.

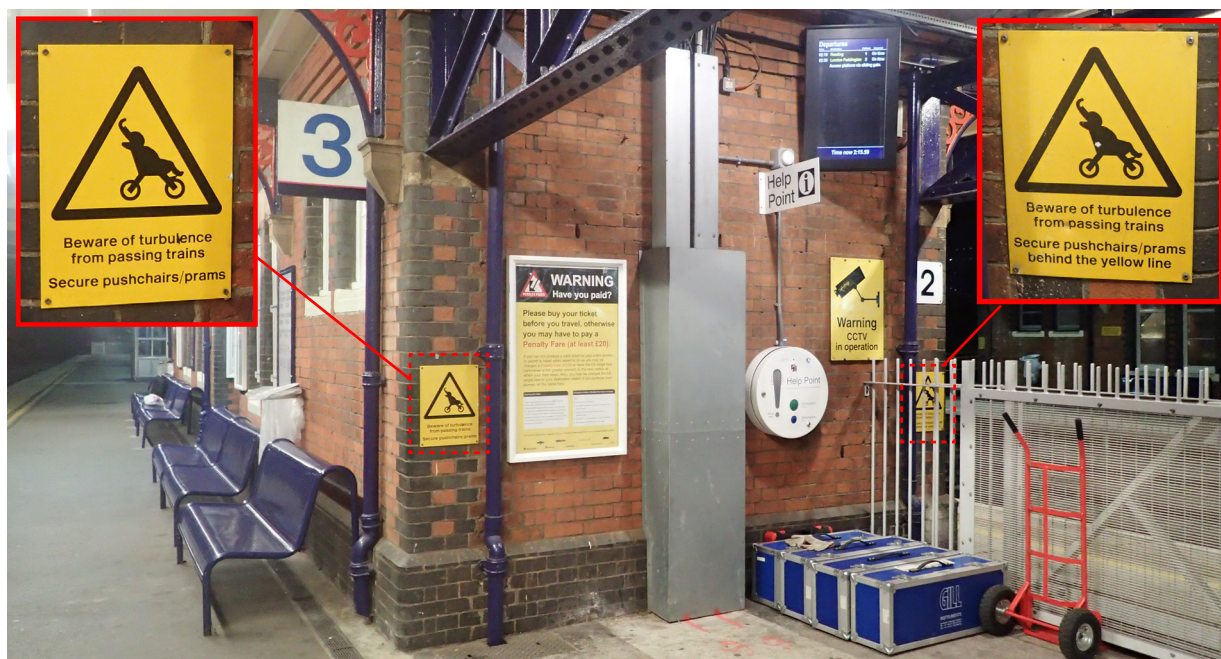
Figure 15: Warning signs on platforms 2 and 3

- 55 Yellow lines are painted on all the platforms at Twyford. Those on platform 4 are 1.2 metres from the edge of the platform. The wheelchair and the mother were well behind the yellow line (paragraph 20). These yellow lines are painted adjacent to the tactile strip near platform edges and serve to warn passengers that they are close to the platform edge. At platforms where passenger trains are permitted to pass through at greater than 100 mph (161 km/h) or freight trains at greater than 60mph (97 km/h), the yellow line must be located at 1.5 metres from the platform edge. The purpose of this is to reduce the exposure of station users to the effects of train slipstreams.
