Rail Accident Report

**Trains passed over washed out track at Baildon,
West Yorkshire
7 June 2016**

Report 03/2017
February 2017

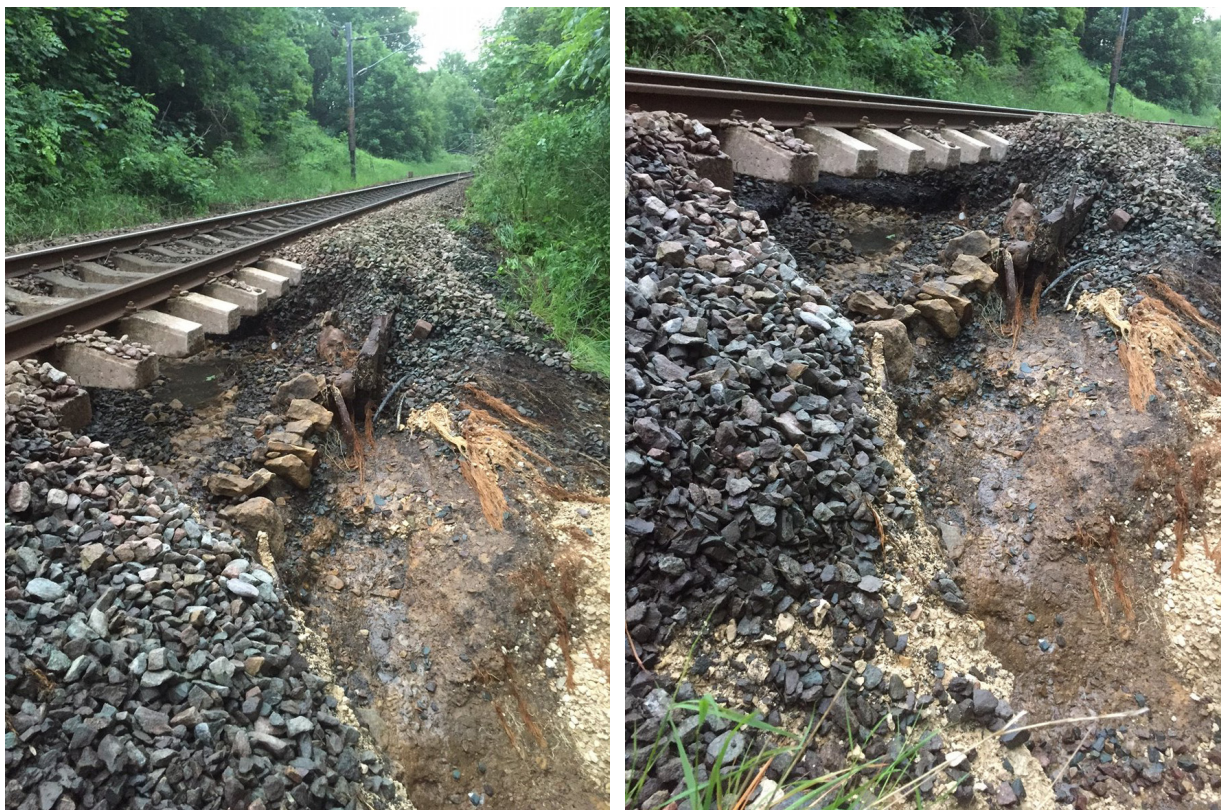
- 5 A member of Network Rail staff inspected the area that had been reported as flooded and concluded that it was safe to reopen the line. The washed out track, which was at a location 280 yards (250 metres) south of the inspected area, was not identified and the line was reopened. Another two passenger trains then passed over the washed out track. The driver of the second of these trains saw the damage as he approached it, applied the train's brakes and then reported that he had passed over it. The train was not derailed and nobody was injured, but the driver was badly shaken. The line was repaired and reopened to trains on 9 June 2016.

Figure 2: The washed out track and the embankment

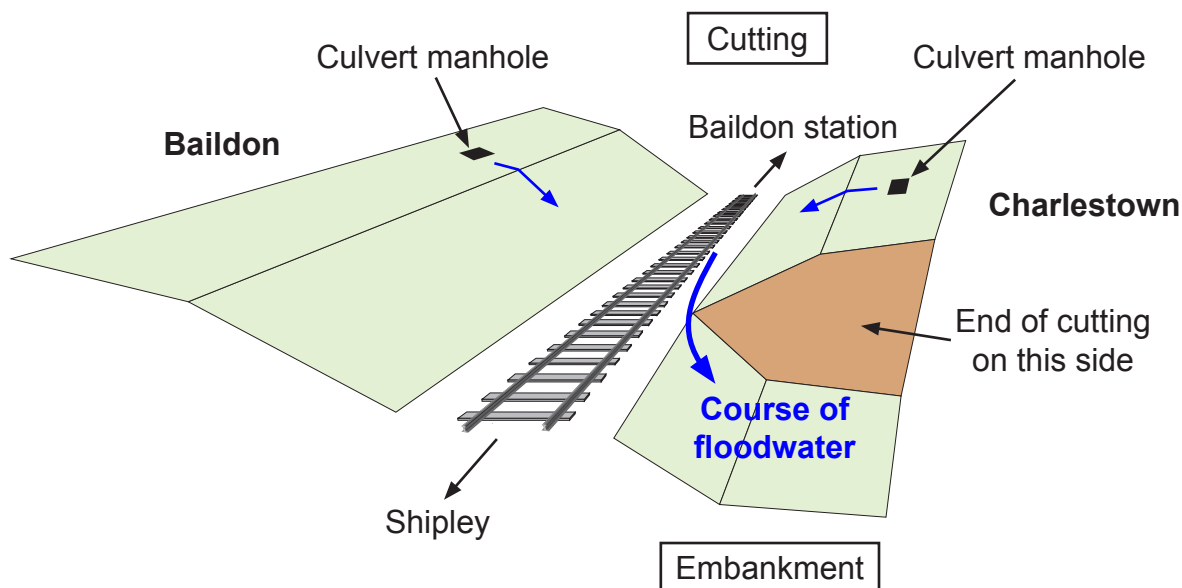
- 13 The section of affected track was constructed from rails mounted on concrete sleepers. These were supported by ballast on top of clay soil. This particular section is where a shallow cutting (running from Baildon station approximately 600 metres towards Shipley) ends and a single sided embankment begins (figure 4). The gradient of the line in the area of the washout was approximately 1 in 100 sloping down towards Shipley.
- 14 The signalling system on the single line is *track circuit block* with entry and exit signals at Dockfield Junction near Shipley and Esholt Junction near Guiseley. This is visible on the signaller's workstation as a single section 3.5 miles (5.6 km) long.

Figure 4: The cutting and the single sided embankment

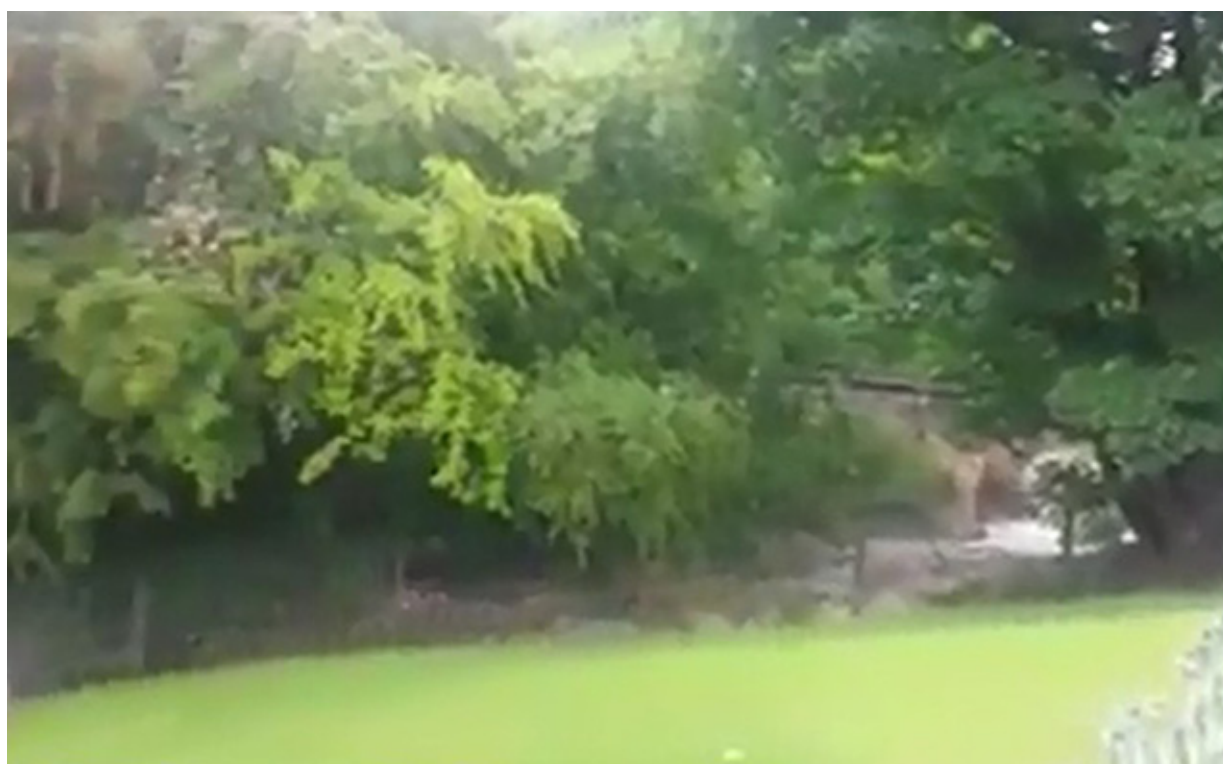
- 23 Between 16:00 and 16:30 hrs, several members of the public who lived close to the railway, about 600 metres south-west of Baildon railway station (in an area known as Charlestown), were observing flood water flowing down a railway embankment. It had been raining there between approximately 15:30 and 16:00 hrs, but at the time they were watching the flood water, and for the rest of the day, it remained dry. One of them captured video footage of the flood water on his mobile phone (figure 5).

Figure 5: Still image of the flood water and the washed out embankment taken from the video recorded by a member of the public

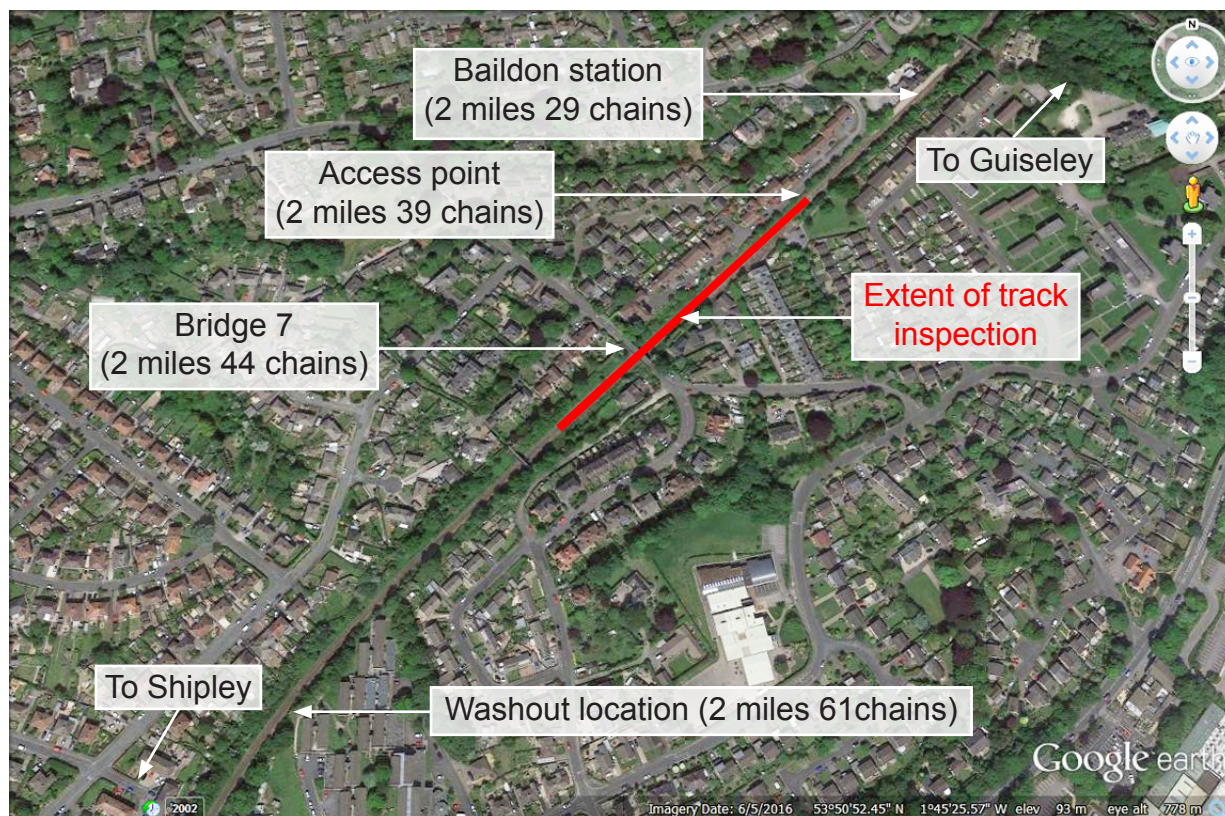
- 33 By 17:20 hrs the local track technician was on the track close to bridge 7 having accessed it via the access point near Baildon station. He reported to controller 2 that there was some water on the track but it was slow moving and below rail level. At 17:28 hrs, having walked 60 to 80 metres along the track beyond bridge 7 in a south-westerly direction (figure 6), he reported to controller 2 and the signaller that there was some water in both cesses and some in the *four foot*. He also reported that there was no sign of ballast disturbance and it was safe to reopen to trains at the maximum permissible speed of the line.

Figure 6: The location of the track that was inspected for flooding by the track technician²

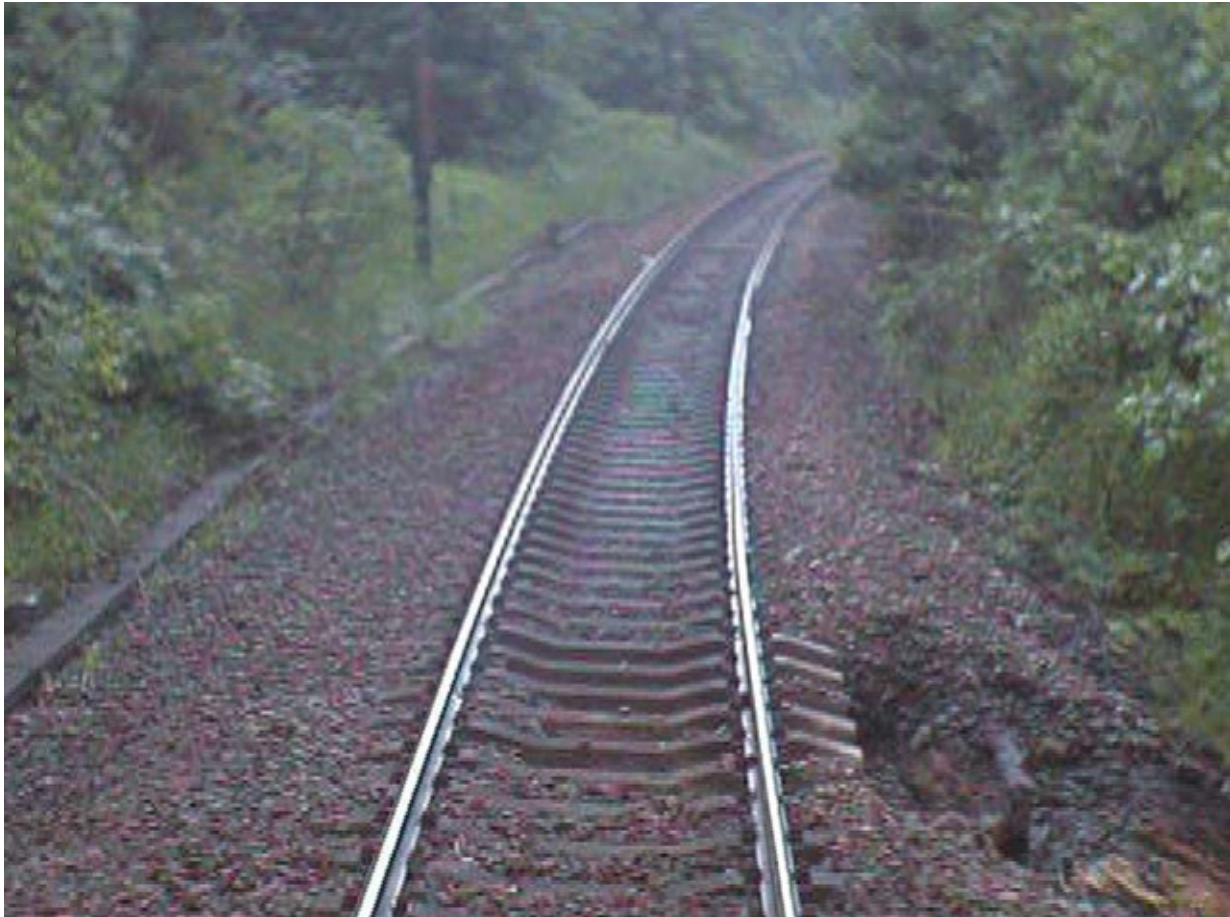
- 34 At 17:30 hrs the signaller reopened the line to traffic. The next train over the single line was train 2D72 which passed over the section of damaged track at 17:45 hrs. This train was travelling from Shipley towards Baildon in a north-easterly direction. Images taken from the forward facing closed-circuit television (FFCCTV) on this train clearly show that ballast was missing from the right-hand side of the track in the direction of travel (figure 7). However, the driver, who had been made aware of the previous flooding report by the signaller, did not see the washed out track. This was probably because, relative to the FFCCTV camera, he was further back and to the left-hand side of the cab. There was a structural pillar in the centre of the cab windscreen and foliage in front of the washed out section on the approach to the site along a right-hand curve, making visibility of the embankment difficult for drivers of trains travelling in the down direction³. Also the driver has stated that as he came around the curve he was concentrating on his approach to Baildon station which was his next station stop.

Figure 7: Still image of the track damage taken from the forward facing CCTV footage from train 2D72 (image courtesy of Northern Rail)

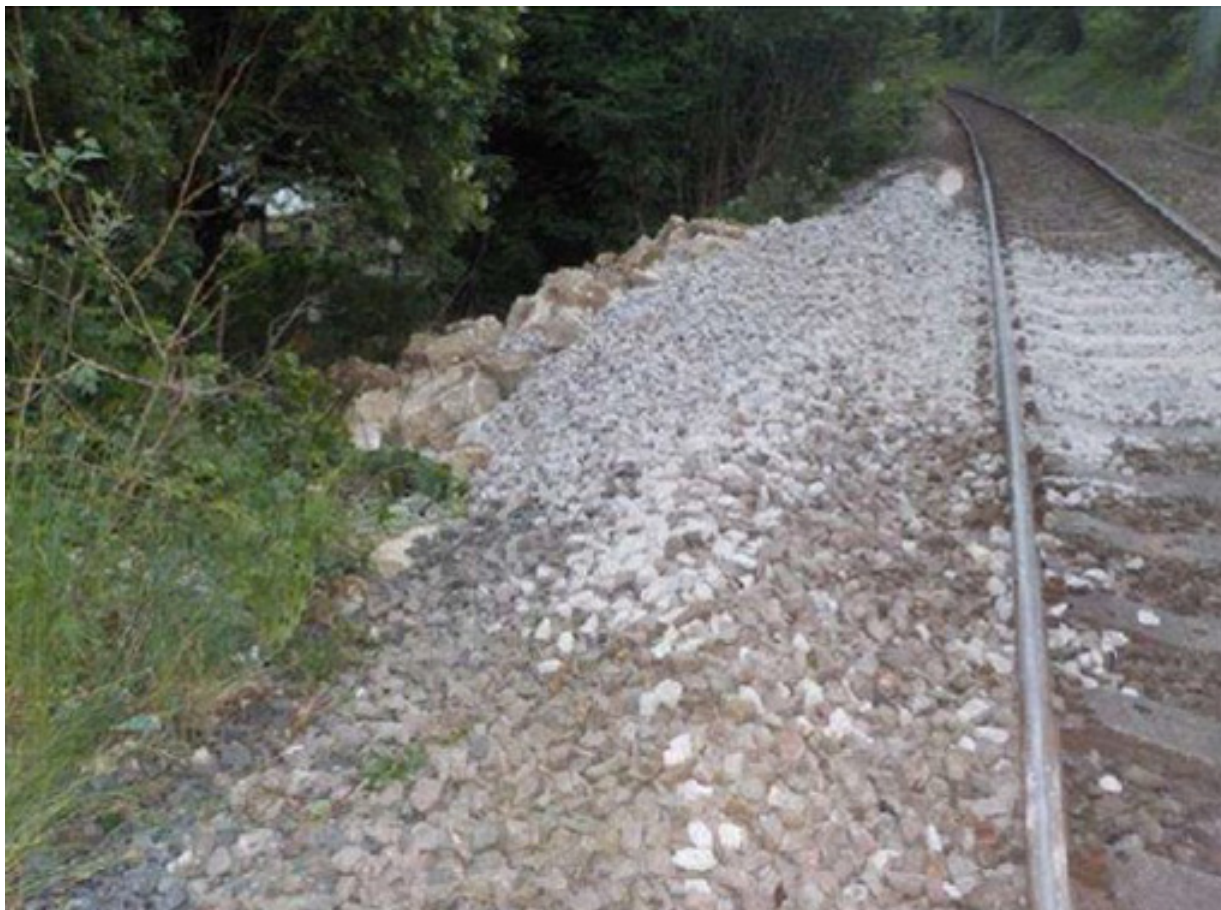
Figure 9: The rebuilt embankment following its repair

- 41 Following repairs to the embankment, the line was reopened to trains with a 20 mph (32 km/h) speed restriction at 23:45 hrs the following day. This included adding large boulders, weighing approximately 1 tonne each, to re-establish the embankment (figure 9). This section of track was opened at its maximum permissible speed at 07:07 hrs on 12 June 2016.

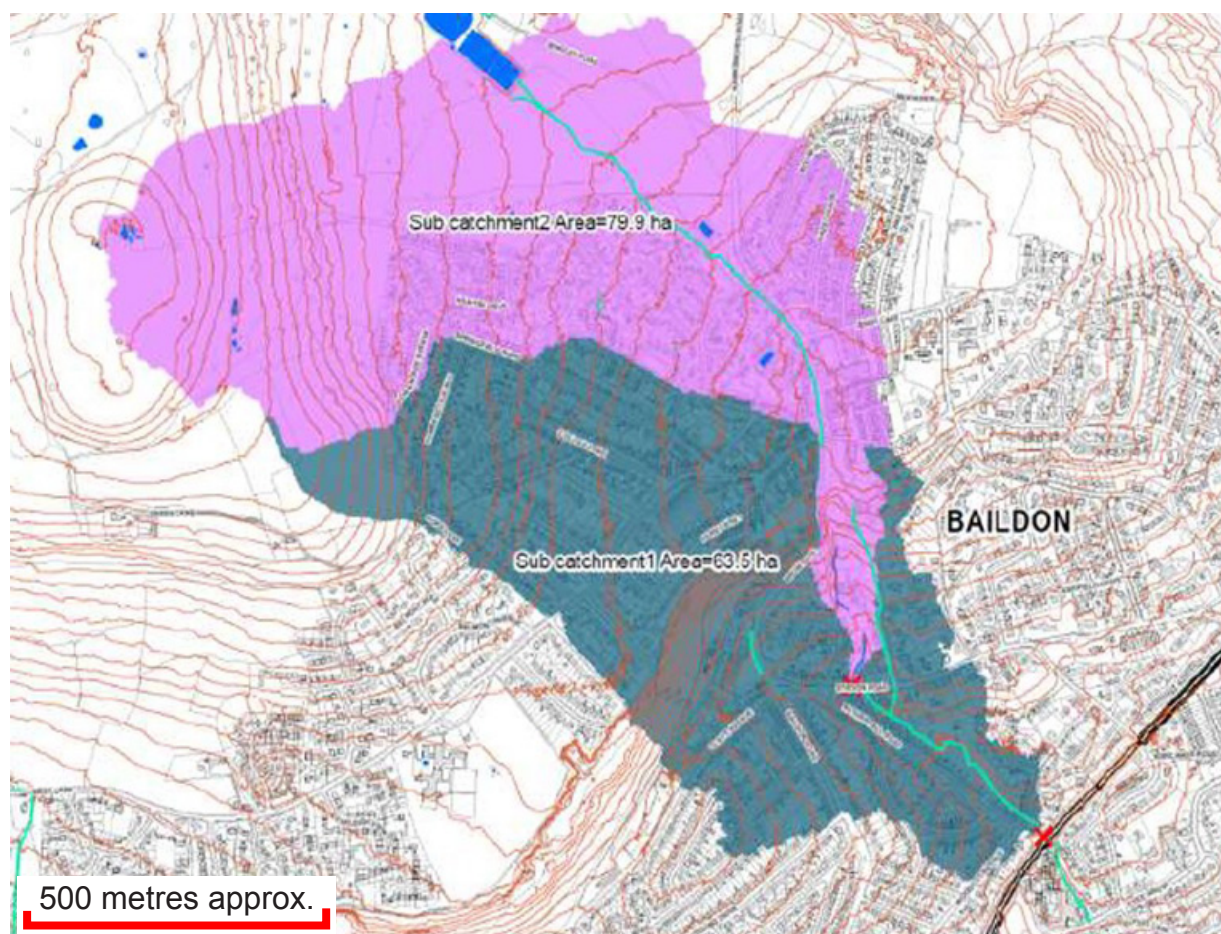
- 48 Figure 10 shows the Baildon rainfall catchment areas. A natural watercourse, known as the Barnsley Beck, is shown in blue. It runs from a former reservoir to the north-west of Baildon, under the town and to the south-east where it crosses under the railway line through a culvert known to the railway as structure GUE2/5. The difference in height between the land on the north-western edges of the catchment area and the culvert is around 180 metres.

Figure 10: The Baildon rainfall catchment areas (courtesy of Bradford Metropolitan District Council)

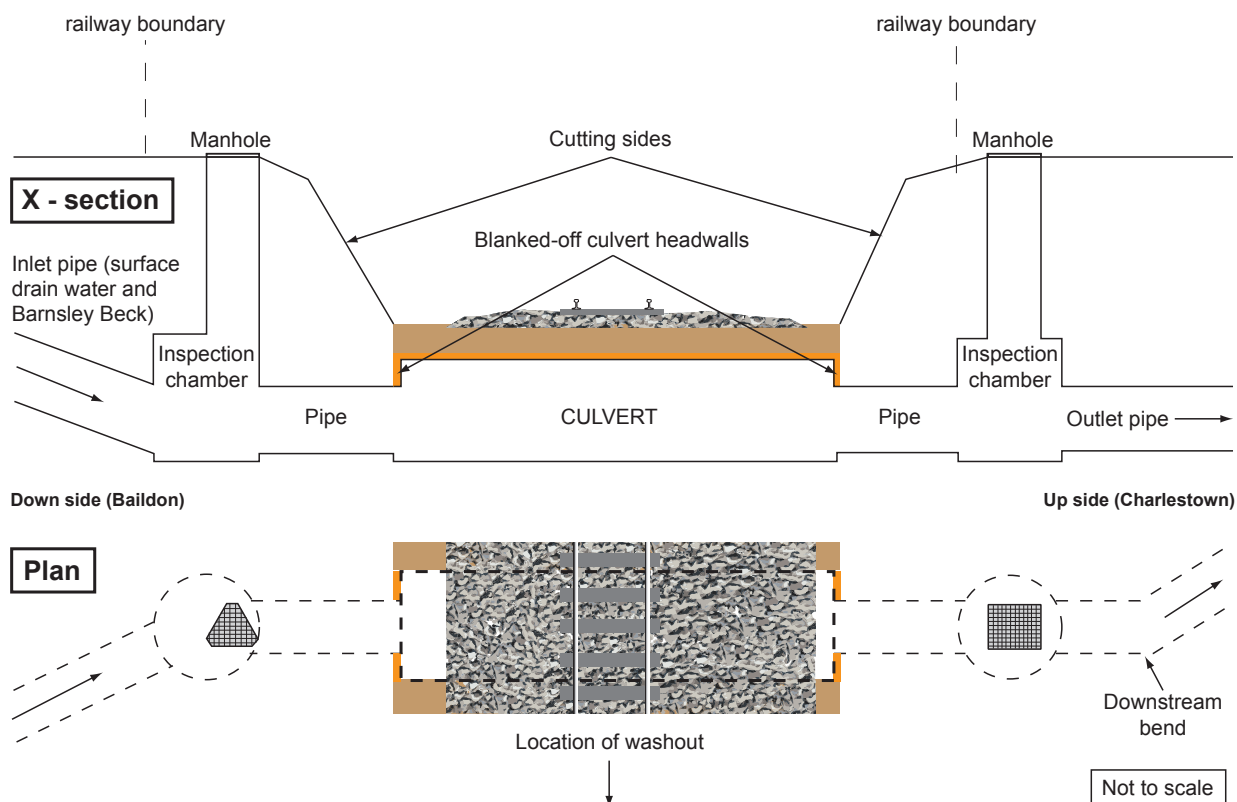
- 50 In 1966 an agreement was made between the British Railways Board and the then Baildon Urban District Council to connect drain pipes to the culvert. Inspection chambers were added at both ends of the culvert and then connected to it at its *headwalls* (figure 11). Records indicate that both the inlet and outlet, to and from the chambers, consist of circular concrete pipes with internal diameters of 36 inches (915 mm). The bore of these pipes reduced the overall cross sectional area of the drainage system, which affects the quantity of water that can be carried, to approximately one-third of that of the original culvert. It is also known that there is a change in direction of the downstream outlet which would tend to further restrict the flow.

Figure 11: The culvert and its connections to the drainage system

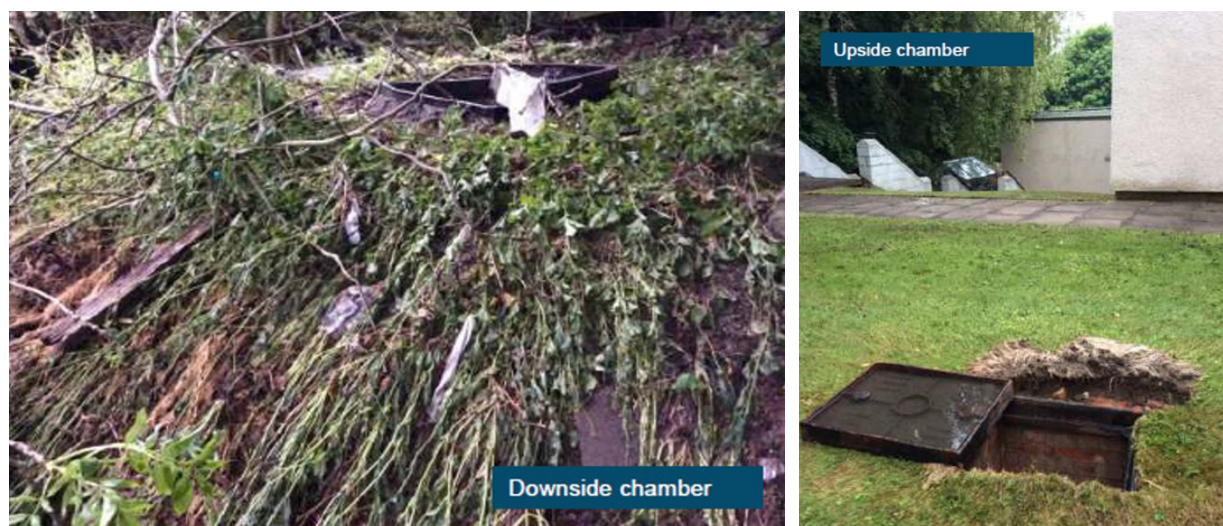
- 52 The track flooding in this incident was caused by water overflowing from the inspection chambers either side of the railway at each end of the culvert. This is supported by the evidence of the lifted manhole covers (figure 12). The water then flowed down the sides of the cutting and onto the track. This occurred because the drain system was unable to cope with the quantity of water that entered it during this flash flooding event.

Figure 12: The lifted manhole covers of the drain's inspection chambers

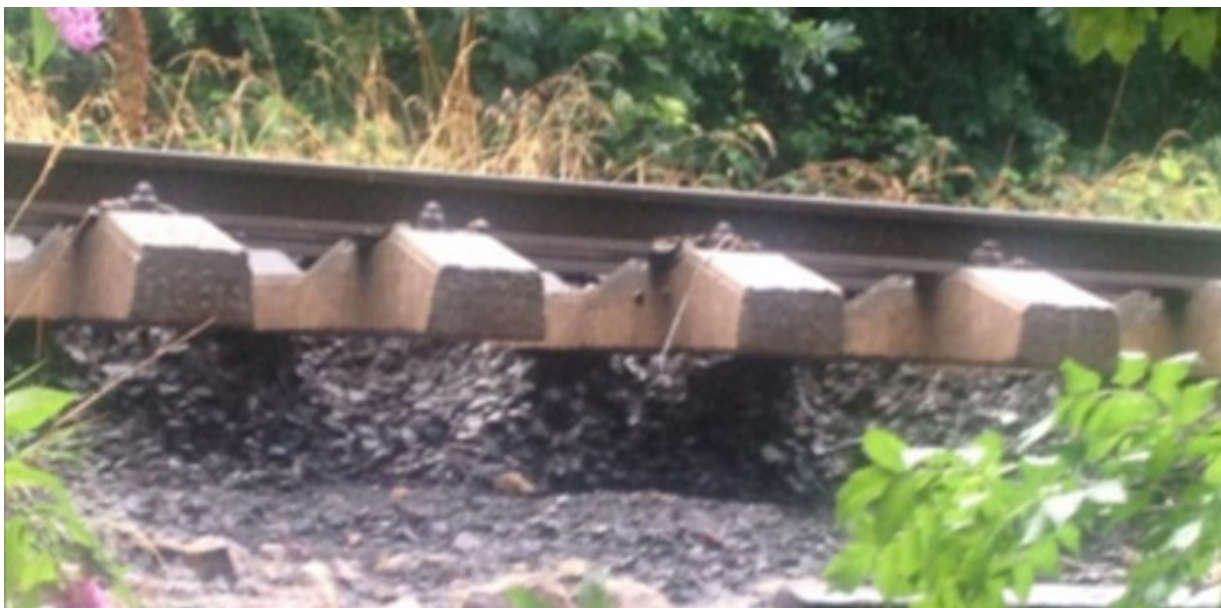
Staff involved

Figure 13: The unsupported track section following the washout in 2012
