Rail Accident Report

Explosion inside an underframe equipment case at Guildford 7 July 2017

Report 05/2018
March 2018

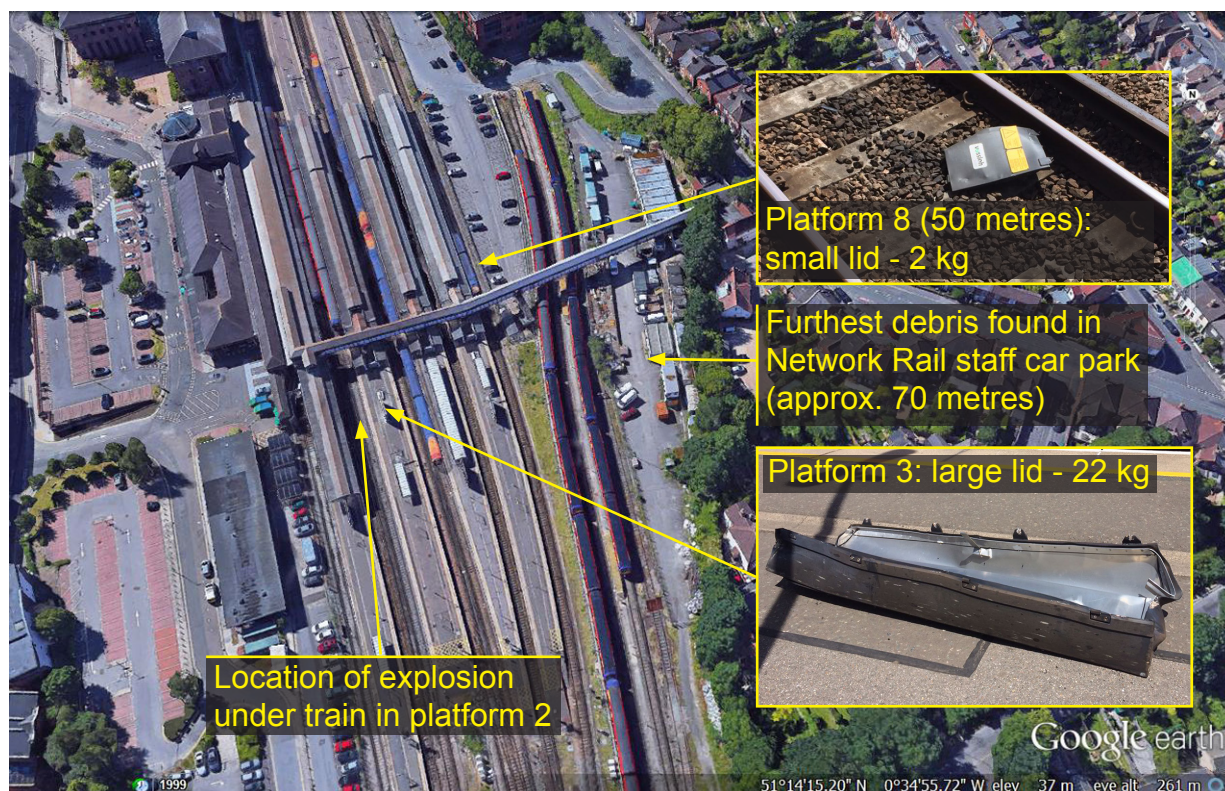
- 27 A large piece of debris, weighing 22 kg, was found on the neighbouring platform 3 (figure 3), where damage had been caused by the debris to a station seat. Smaller pieces of debris were found adjacent to platform 8 (approximately 50 metres away) and in a Network Rail staff car park (70 metres away).

Figure 3: Locations of debris found after the explosion

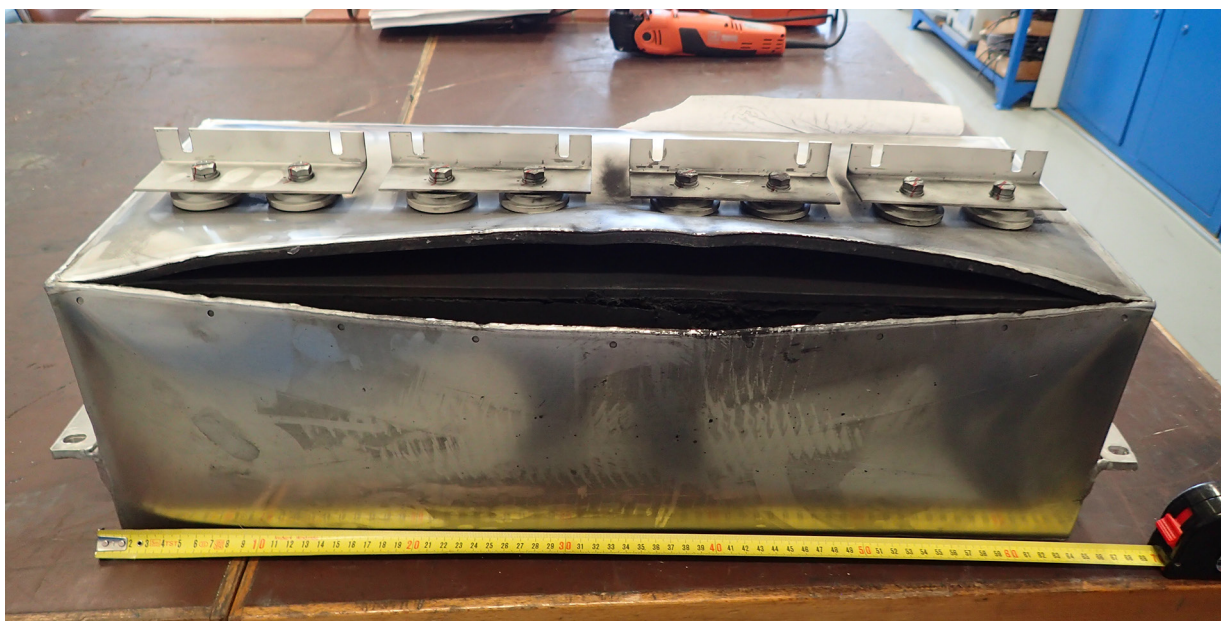
- 60 The capacitor involved in the accident at Guildford was dismantled and examined at Electronicon's factory in Germany, witnessed by Kiepe and RAIB. The examination (figures 8 and 9) showed that a short winding had failed in a manner which was similar to the failures covered by Electronicon's November 2016 report.

Figure 8: The damaged capacitor removed from coach 62826 prior to examination at Electronicon's facilities in Germany

- 69 The capacitor case was manufactured from aluminium. Electronicon has advised RAIB that the internal pressure at which the case would be expected to rupture is approximately 7 bar. Once the case ruptured (figure 8), the flammable gases produced by the pyrolysis of the polypropylene film passed directly into the traction equipment case.

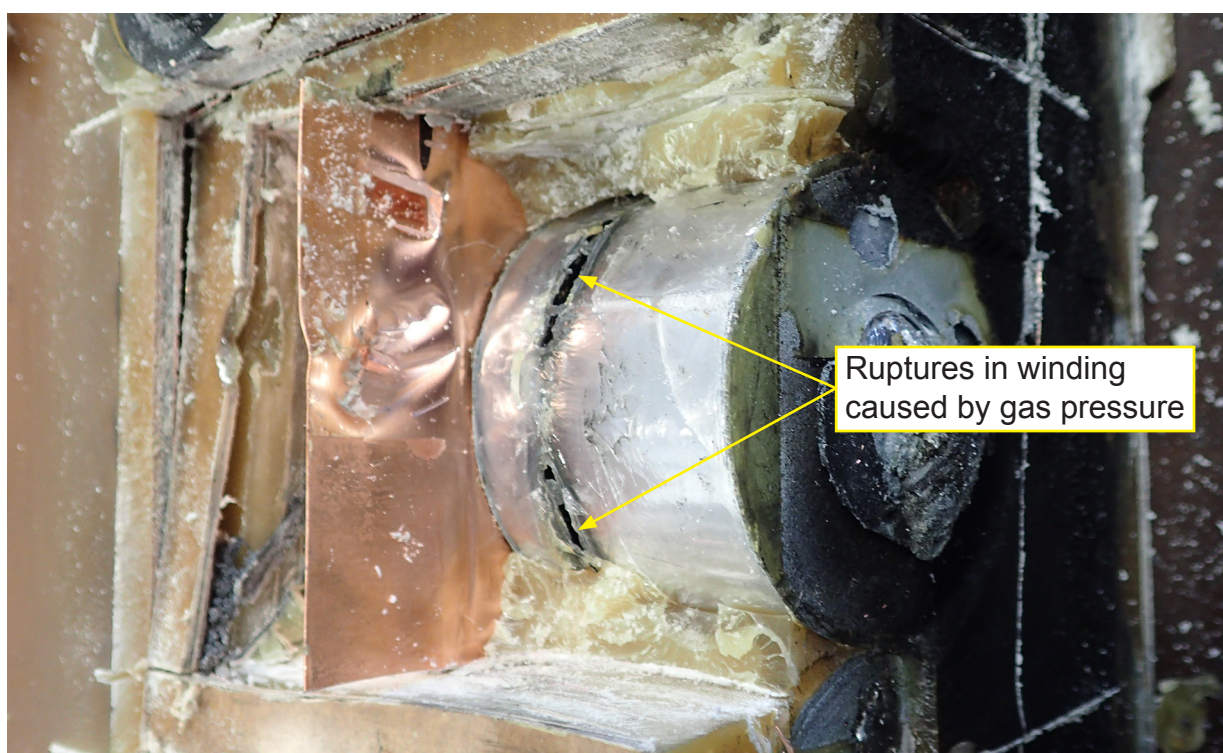
Figure 9: The failed short winding, with resin cut away to expose the ruptures at the point of gas escape indicated

- 79 The production cycle which commenced on 14 November 2014 terminated at 04:50 hrs on 15 November 2014, when the winding machine was re-set to commence manufacture of a different type of winding. The Electronicon investigation did not identify that windings manufactured early on 15 November 2014 were a continuation of the batch commenced on 14 November, and hence were also at risk of manufacturing defect.

- 80 The winding which led to the capacitor failure at Guildford was part of the batch completed at 04:50 hrs on 15 November 2014. These windings were incorporated into a capacitor which was fitted to unit 5901 when it was modified in March 2017 (paragraph 21). Had the risk from the windings manufactured on 15 November 2014 been recognised in the November 2016 investigation by Electronicon, it is unlikely that any capacitors containing these windings would have been used on any of the class 455 units.

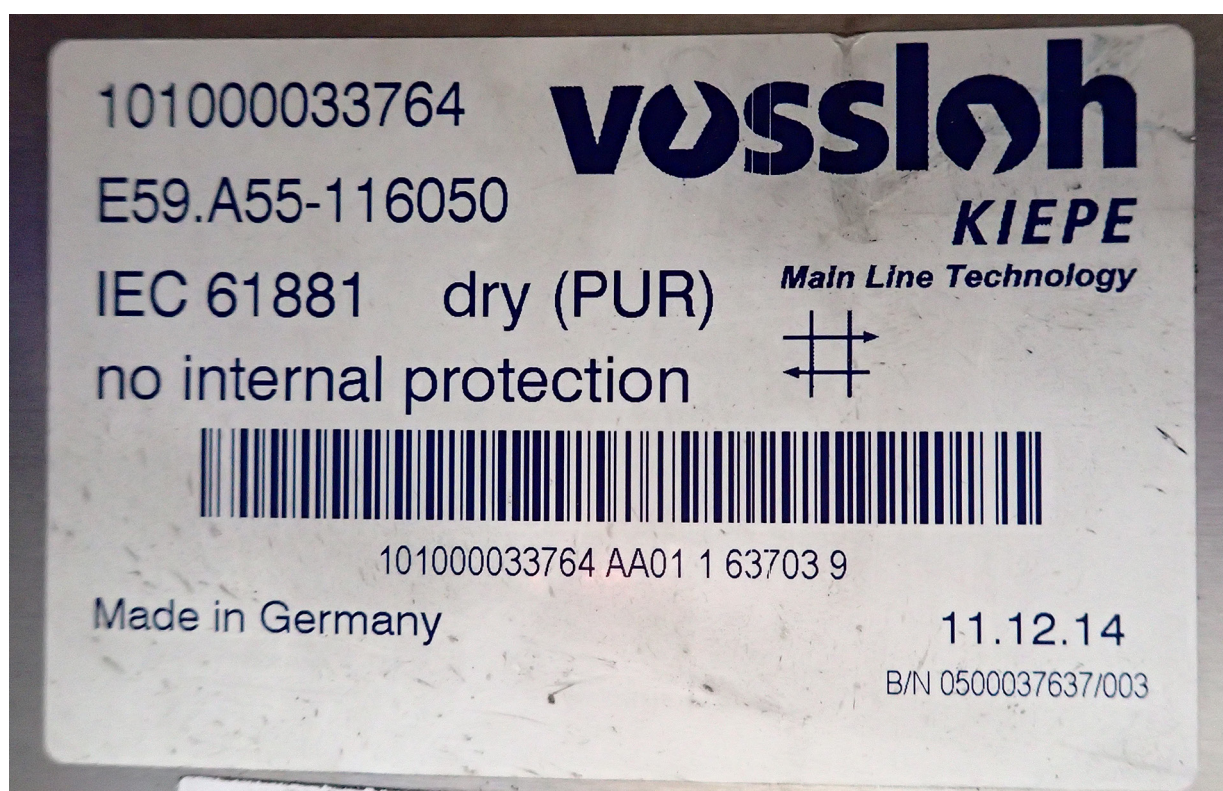
- 89 Electronicon has confirmed to the RAIB that the capacitors it supplies conform to EN 61881-1 (paragraph 62) and are classified as unprotected capacitors⁸. The unprotected status of the capacitors is also stated by the application documentation for the capacitors, and by identification labels on the capacitors (figure 10).

Figure 10: Identification label applied to a capacitor, showing manufacture against EN 61881-1 and confirming that the capacitor has no internal protection

- 90 EN 61881-1, section 9.14 states: 'For power electronics capacitors, the user has to ensure by qualified installation that no danger appears due to a failing capacitor. The requirement applies in particular to unprotected capacitors.'
