Rail Accident Report

**Fatal accident involving a train passenger near
Balham
7 August 2016**

Report 09/2017
May 2017

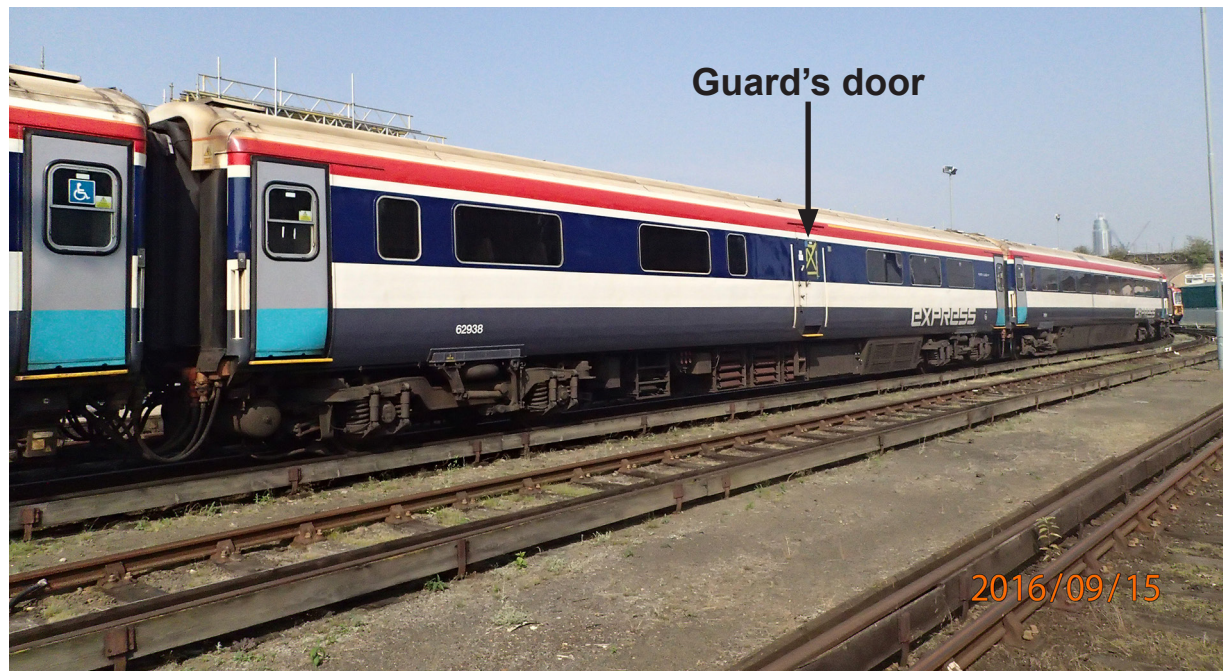
- 14 There are power-operated external doors at each end of every carriage for passengers to use when boarding and alighting the train. In addition, there are manually-operated external doors at the centre of the middle carriage intended for use only by the guard during train dispatch at stations (figure 4). One of these doors is in the guard's compartment, while the other is opposite the compartment in the connecting corridor. When not in use, these doors are locked with a carriage key.

Figure 4: Middle carriage of a Class 442 unit showing guard's door (NB: the yellow tape on this door reflects a post-accident modification intended to discourage passenger use of the droplight window; see paragraph 111).

- 111 After the accident, GTR implemented an interim measure of marking the corridor droplight window with yellow hazard tape, in order to deter its use by passengers (figure 11). The company then consulted with its health and safety representatives and, after agreeing that there was no requirement for guards to lean out of the window for train dispatch purposes, fitted window bars to its remaining Class 442 units (figure 12). This was completed by mid-December 2016.

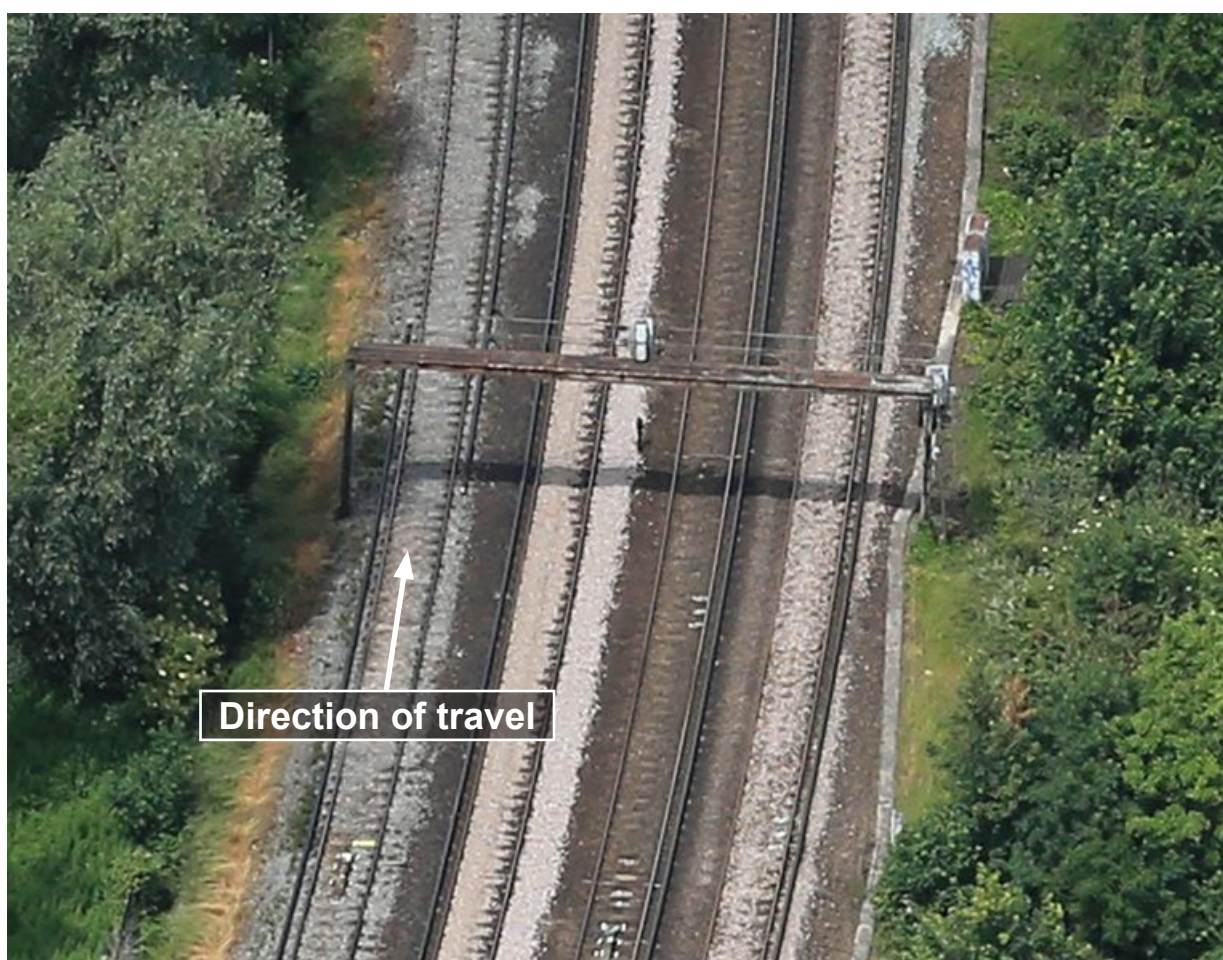
- 16 The signal gantry is a *portal* structure spanning all four tracks of the railway (figure 5). It carries signals VC641 and VC643, which are for trains running in the down direction. The column on the up (west) side stands on the crest of a low embankment which is about 4 metres high and rises at an angle of approximately 30 degrees.
- 17 Evidence indicates that the gantry was installed in 1952, but no records relating to its design or installation are available.

Figure 5: Overhead view of the signal gantry (courtesy of Network Rail)

- 37 Witness marks were found on the gantry for VC641 and VC643 signals, consistent with the nature of the accident. The RAIB's analysis of these marks suggested that the passenger's head overlapped the gantry by just over 60 mm.

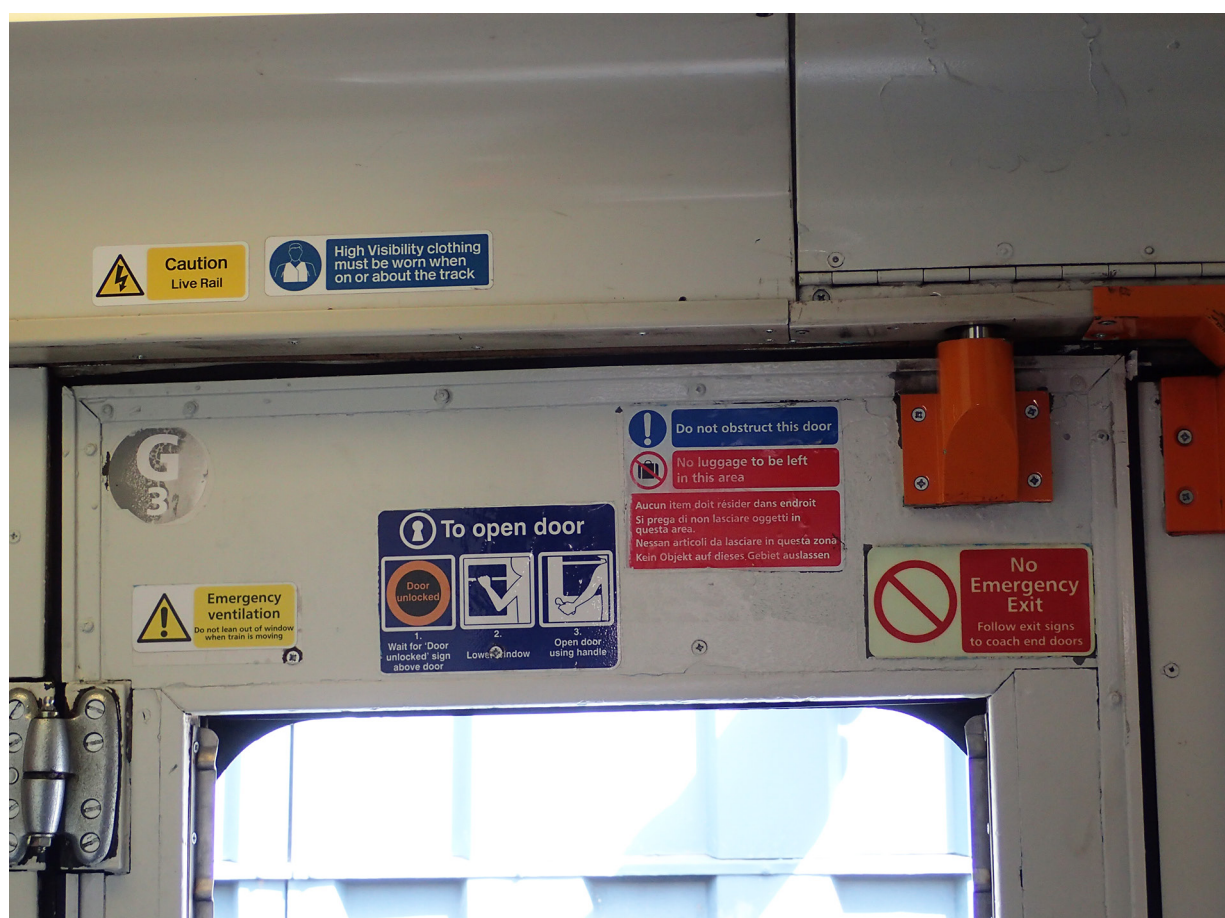
- 49 There is a yellow warning sticker on the door above the window stating, 'Emergency ventilation. Do not lean out of window when train is moving' (figure 6). The RAIB observed that the warning about leaning out of the window was secondary to the wording about emergency ventilation; moreover, this sticker exists in a cluttered environment of other warning and information signs. One of these signs, which is more prominent than the warning sticker, provides instructions on opening the door (including lowering the window to access the exterior door handle), despite the fact that this door is not intended for passenger use. Although there is a notice on the outside of the carriage that this door is 'not for passenger use', there is no such notice on the inside. It is not possible to say whether the lack of conspicuity of the warning notice was a factor in the accident at Balham, although the passenger was an experienced railway employee (paragraph 20), who was accustomed to trains with windows of this type.

Figure 6: Warning signage above the window

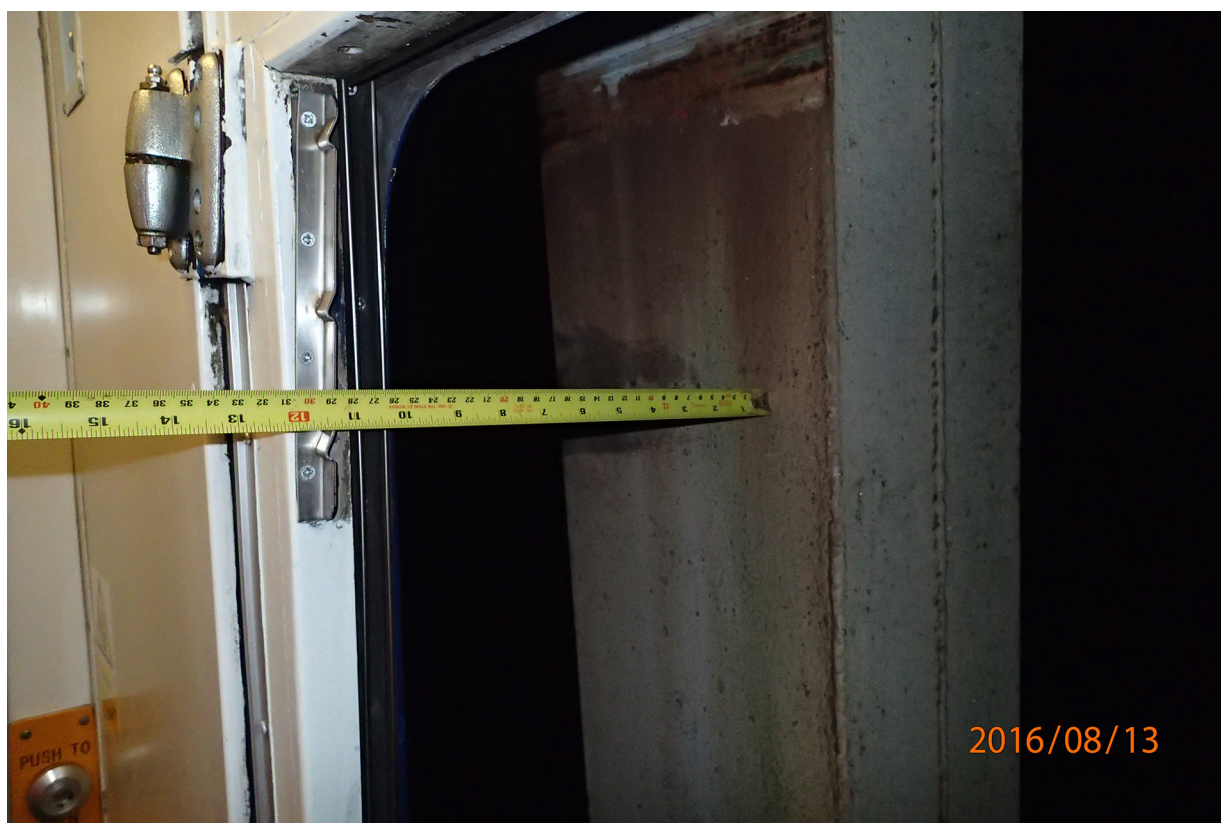
- 59 Prior to the accident on 7 August 2016, the most recent survey of the gantry by the structure gauging train was on 15 May 2015. Taking into account the full swept envelope of a Class 442 unit, this survey found that the smallest dynamic clearance from the window (measured at the top of the window) was 68 mm, while the static clearance was 209 mm. After the accident, the RAIB measured the static clearance at the impact point (which was about one-third of the way down the window) to be 260 mm (figure 7). Given the differences in measurement points and statistical variation in gauging surveys, these values are broadly consistent with each other.

Figure 7: Static clearance to the gantry from the droplight window

- 68 The RAIB's site inspection found that the gantry column on the up side of the track leans inwards (towards the track) by two degrees. This results in a further reduction in clearance of about 105 mm at the top of the window.

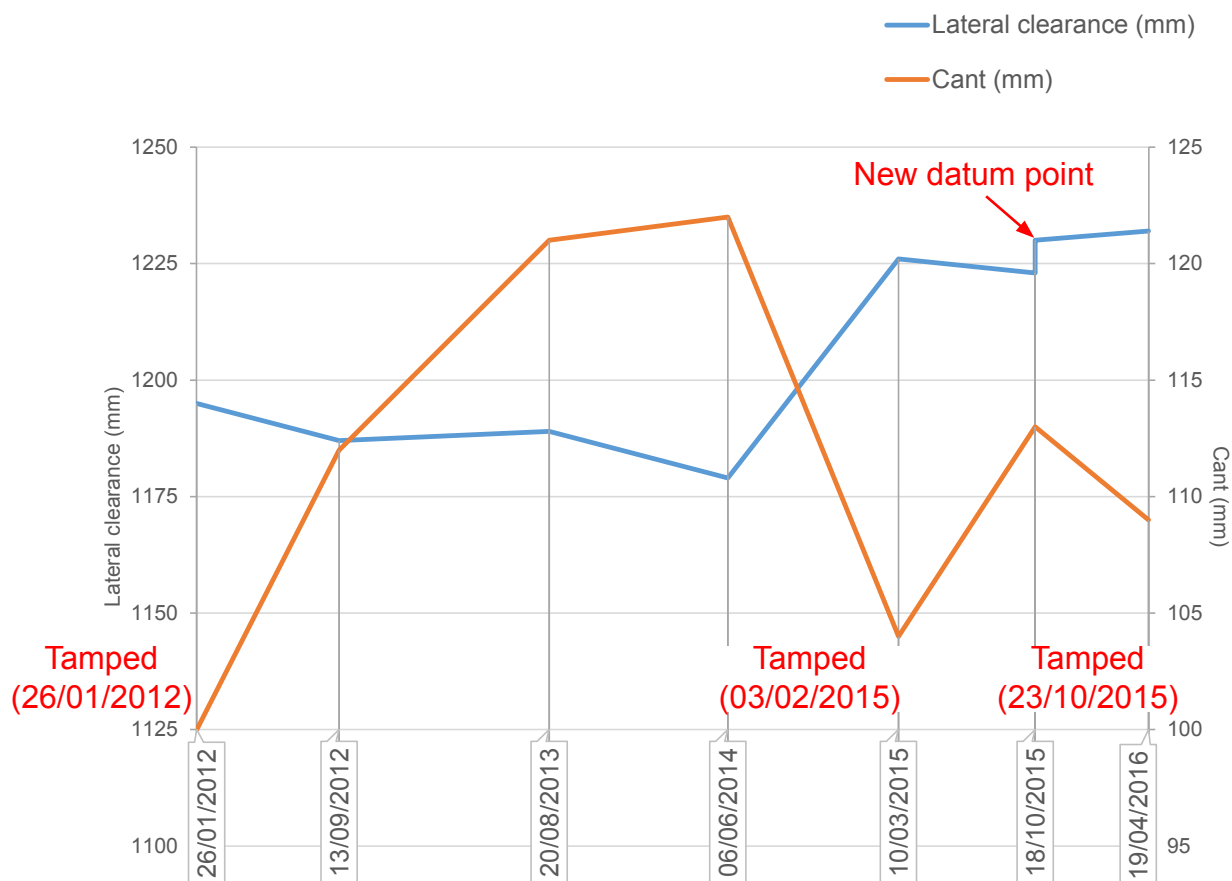
- 62 The most recent manual monitoring before the accident took place on 19 April 2016 and measured the lateral distance between the base of the gantry and the nearest rail at 1232 mm. This is the largest recorded clearance in measurements dating back to 26 January 2012 (although the datum point has changed in that time, so the measurements are not directly comparable), but it is still less than the minimum recommended in Network Rail's standard for new signalling installations (paragraph 58).

- 65 As well as lateral distance, the manual measurements also record track *cant*. These data show that, as well as the changes in lateral distance described above (paragraphs 62 and 63), track cant at this location also increases over time¹⁵ (figure 8). The minimum value of cant, recorded on 26 January 2012 following the tamping work, was 100 mm; the maximum value (on 6 June 2014) was 122 mm, which was followed by tamping work (paragraph 63). The tamping work aimed to restore cant to a target value of 105 mm.

Figure 8: Graph of the lateral clearance and cant measurements since 2012

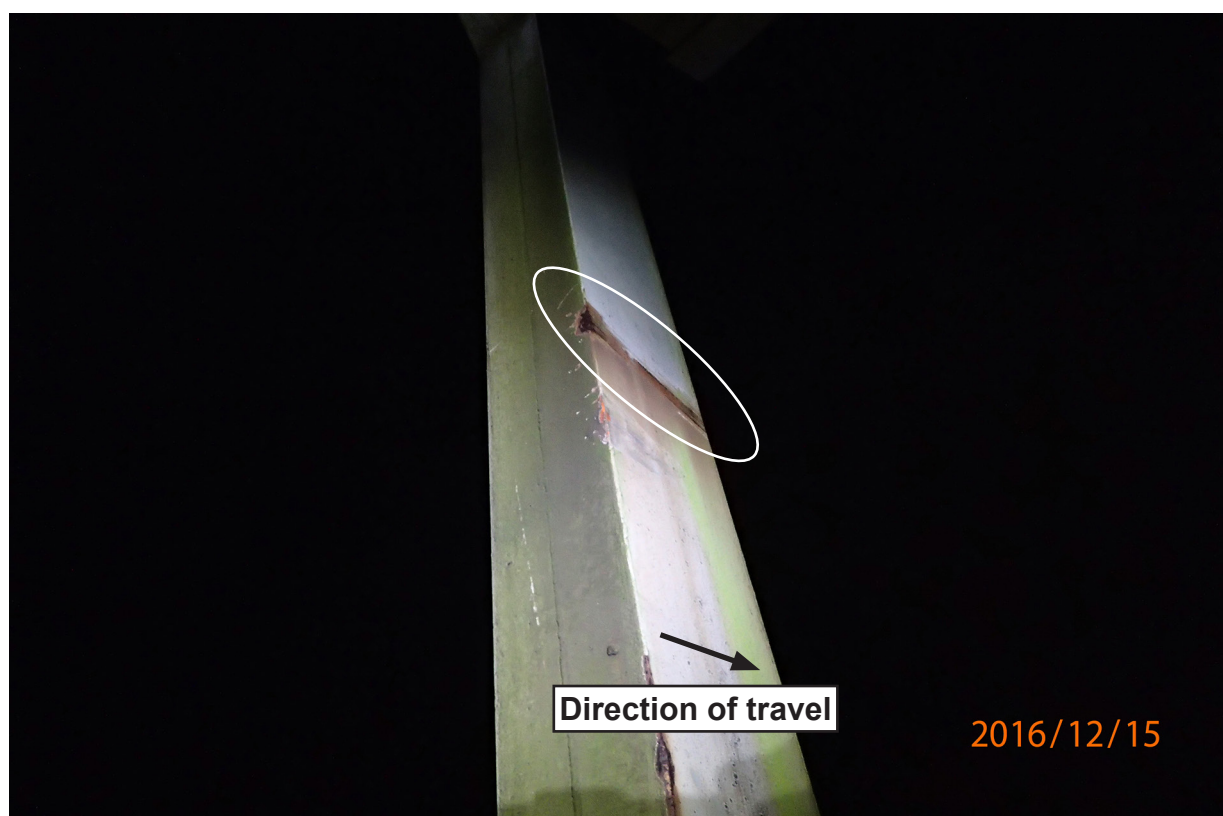
- 71 Network Rail stated that its risk management at this gantry was partly based on the assertion that there had been no vehicle impacts with the structure, despite surveys indicating negative clearance values for several years (paragraph 60). However, the RAIB observed witness marks on the structure indicative of a previous impact with the column (figure 9). Photographic records from Network Rail's structure examinations suggest that this impact occurred between April 2011 and April 2013, a period during which the surveyed clearance to the gantry was at its smallest and when track maintenance work took place to restore the clearance (paragraphs 60 and 63). However, there is no record of a vehicle striking the gantry, and so the RAIB cannot be certain about what caused the marks.

Figure 9: Witness marks (highlighted) on the gantry indicative of an earlier vehicle impact

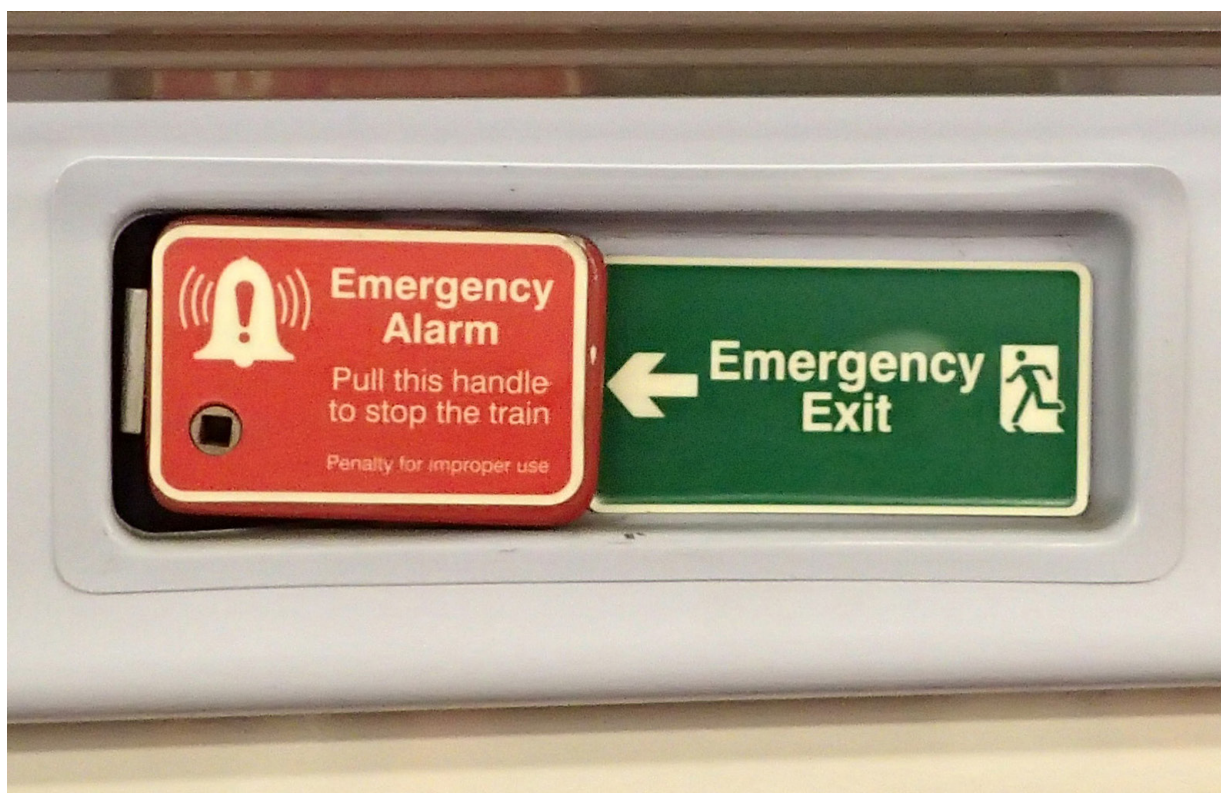
Figure 10: Emergency alarm on the Class 442 unit

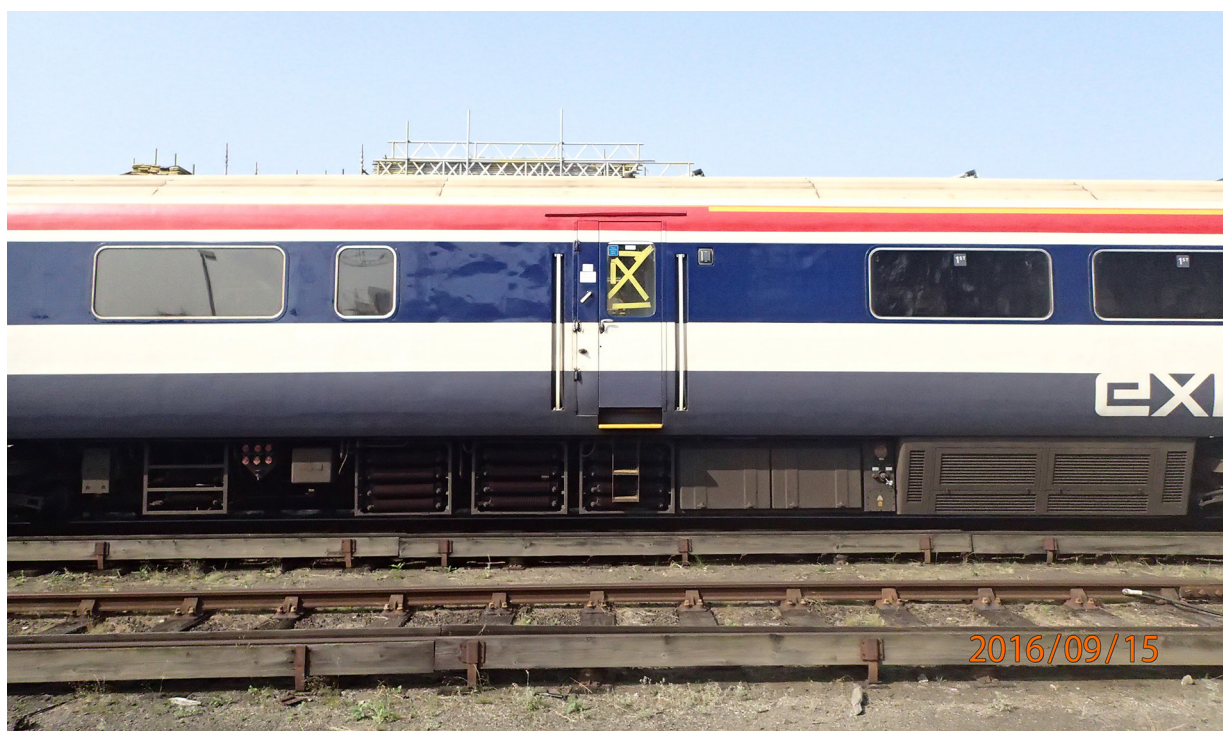
Figure 11: Class 442 unit with hazard tape applied to guard's droplight window

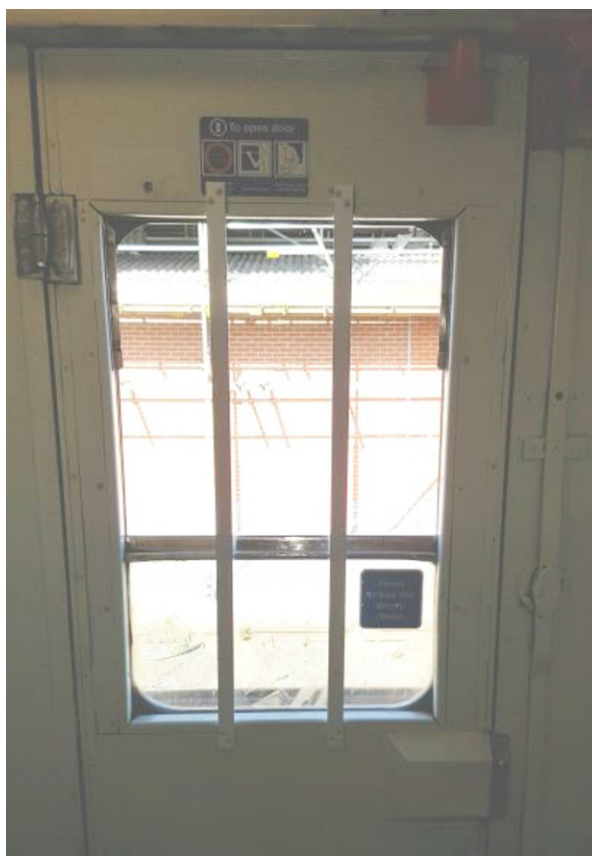
Figure 12: Class 442 corridor droplight window with bars fitted (image courtesy of ORR)
