Rail Accident Report

Train dispatch accident at Elstree & Borehamwood station 7 September 2018

Report 03/2019
May 2019

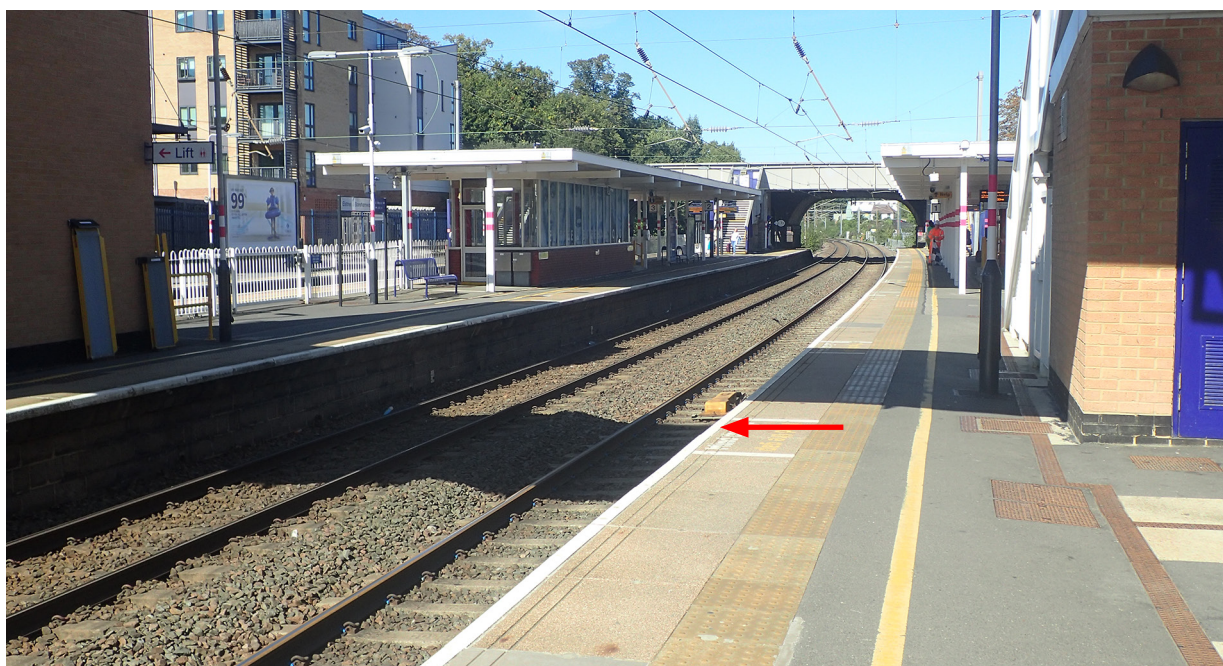
Figure 3: View looking north along platform 1 showing the location of the accident (red arrow)

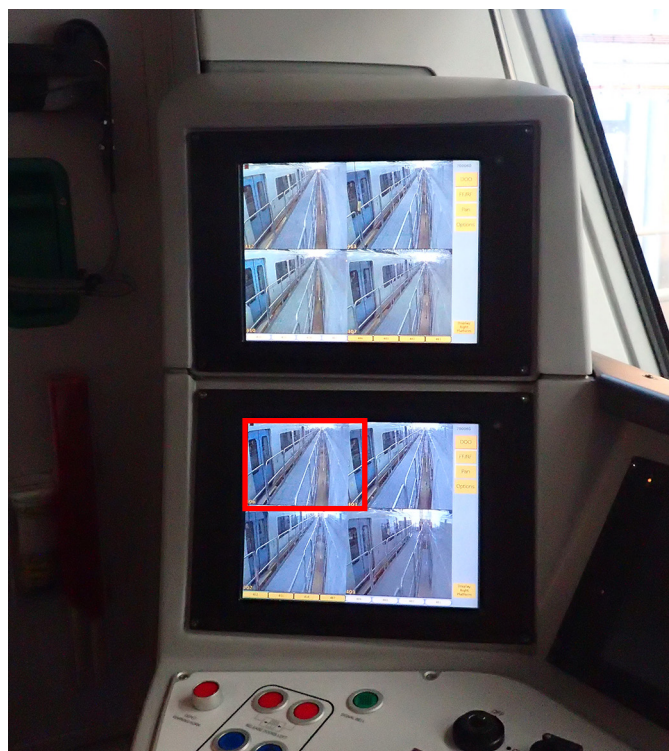
Figure 7: The screens displaying images from the externally mounted CCTV cameras. The red box shows the position of the image showing the fifth coach (involved in the accident). Images shown are not at Elstree and Borehamwood station.

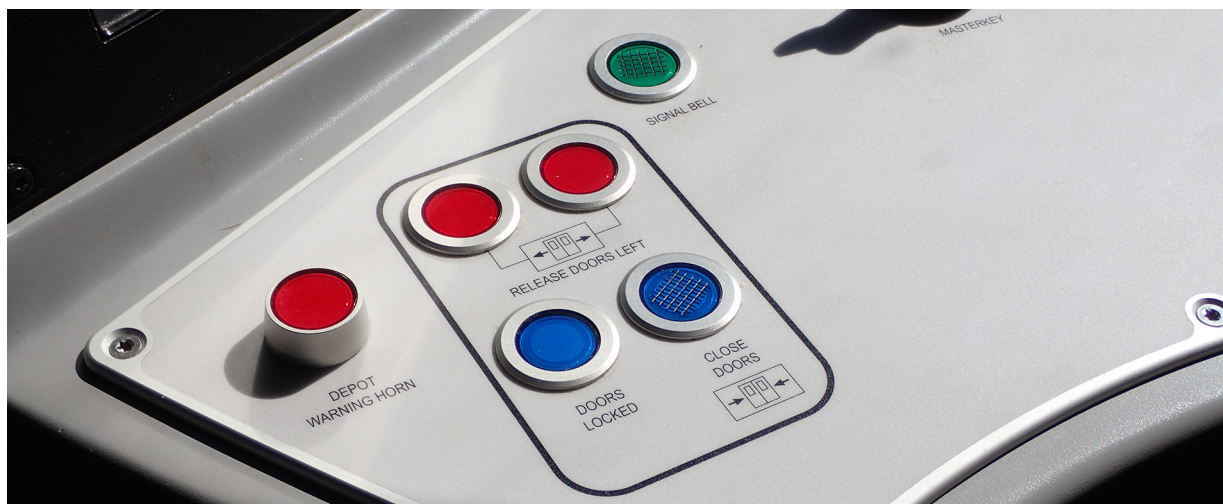
- 41 Door controls are provided in the driver's cab (figure 8). They are duplicated on each side of the cab, and control the doors on the respective side of the train. Two buttons¹², marked 'release doors', must be pressed simultaneously to allow the doors to be opened¹³. Doors are closed using a single push button. A 'doors locked' indication is provided to advise the driver when the doors are locked and the 'traction interlock' has been achieved. The traction interlock system detects when the doors are closed and locked and prevents the driver applying power to move the train unless both conditions have been met.

Figure 8: The door controls provided on the cab desk of the class 700 train

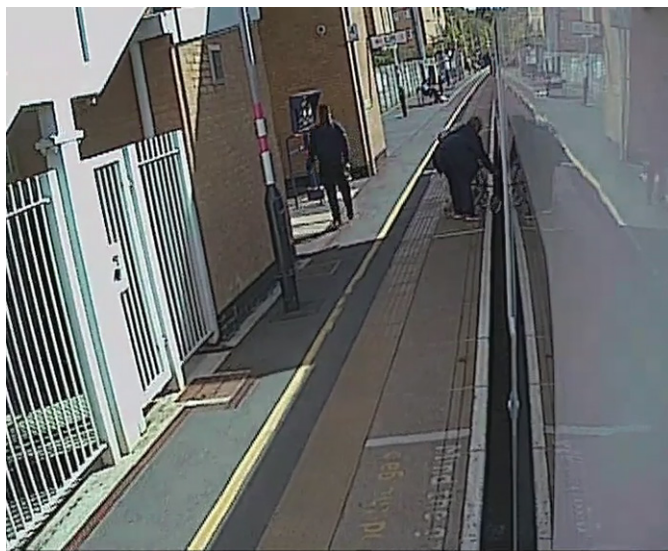
- 48 **The train driver was unaware of the passenger and her dog when he closed the doors and dispatched the train.**
- 49 Testing of the CCTV system carried out after the accident by Siemens (paragraph 36) indicated that it was working as expected. Siemens reported to the RAIB that there is no known system failure mode which could have provided false or misleading images to the driver. The RAIB's inspection of the recorded CCTV images found that the passenger was clearly visible, standing in close proximity to the train (figure 9).

Figure 9: The image of the passenger standing by the train as shown to the driver on the train's CCTV system. The image shown to the driver measured 104 mm horizontally by 87 mm vertically.

- 50 The driver stated that he recalled looking at the CCTV screens in the cab prior to applying power and departing Elstree and Borehamwood station, but he had no recollection of seeing the passenger or her dog in the monitors.
- 51 The investigation identified a number of factors, some or all of which may have played a part in the driver not seeing the passenger:
- a) the short time taken to check the platform-train interface during the dispatch process (paragraph 52);
 - b) reliance on the door interlock system (paragraph 57);
 - c) distraction (paragraph 60);
 - d) fatigue (paragraph 62); and
 - e) levels of human reliability in carrying out this task (paragraph 64).

- 1 *The intent of this recommendation is to reduce the risk of a passenger trap and drag accident by enhancing driver management processes to include checks that drivers spend sufficient time observing the platform-train interface during the train dispatch process.*
