# Rail Accident Report

## **Derailment at Knaresborough 7 November 2015**

Report 16/2016  
August 2016

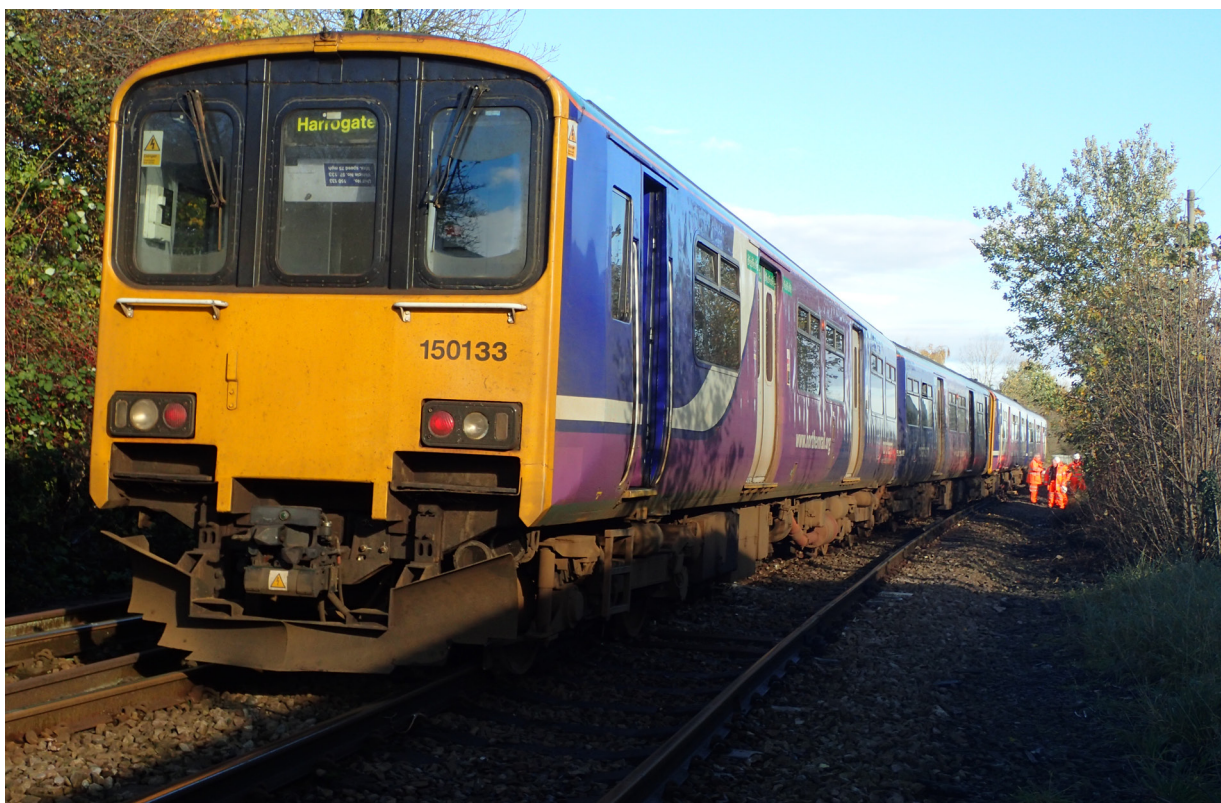
Figure 2: Train 2C07 at the site of derailment

- 4 The first five bogies derailed and damage was sustained by both the train and track. None of the train crew or five passengers on board were injured. The line was re-opened at 12:58 hrs on Sunday 8 November 2015.

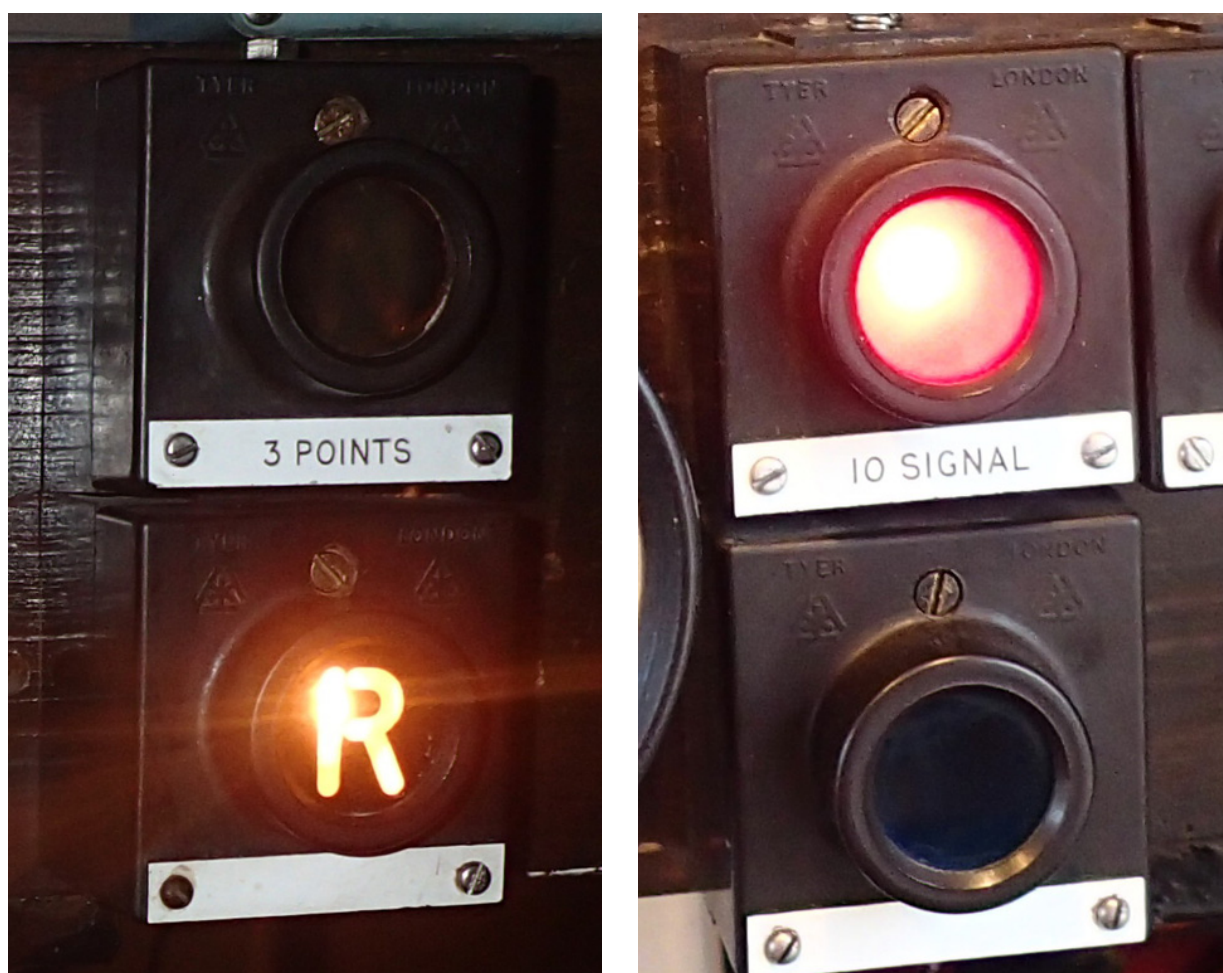
Figure 7: Points position indication<sup>3</sup> and signal aspect indication

- 72 The signaller (MOM) did not check the indication on points 3. Had he checked the indication, he would have discovered that neither the normal nor reverse lamp for points 3 was illuminated, indicating that the points were not correctly set. Signal K10 did not clear because of a points failure, and for no other reason.

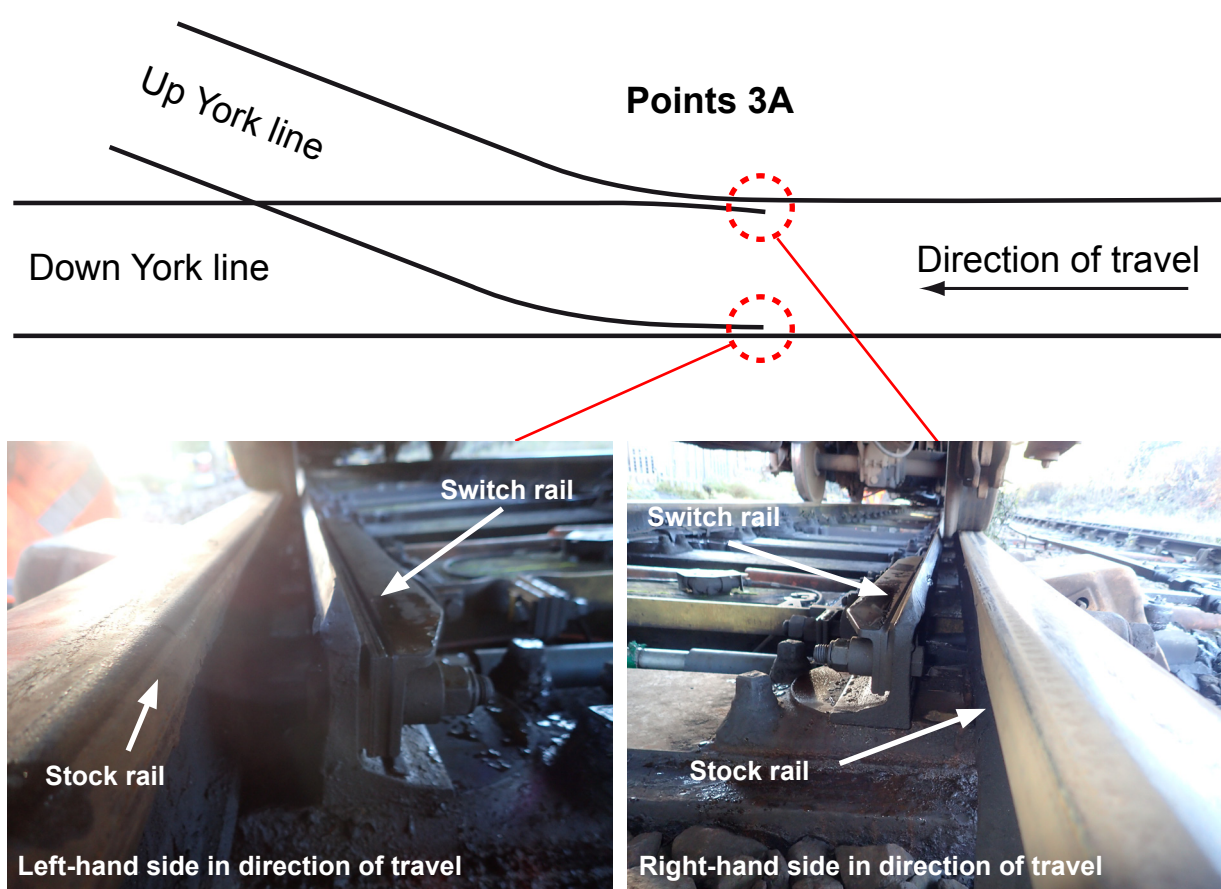
Figure 8: Toes of points 3A after the derailment

- 49 Train 2C07 derailed on points 3A on the approach to Knaresborough station because the signaller (MOM) authorised the train to proceed towards the points when they were not set in either normal or reverse.
- 50 There was no *data-logger* at the signal box to confirm the state of the points at the time of the derailment. The lack of tell-tale derailing wheel marks on the switch rails after the derailment, indicated that the derailed wheels had passed between the switch and *stock rails* on both the left and right-hand sides (figure 8). This shows that the points were not set in either the normal or reverse position at the time (ie neither switch rail was fully in contact with the adjacent stock rail).

- 51 Points 3 are interlocked with signal K10. The fact that points 3A were not set in either normal or reverse would explain why signal K10 remained at danger when the signaller (MOM) tried to clear the signal for a second time<sup>8</sup> (paragraph 42). When tested after the accident the interlocking and indicator worked correctly.

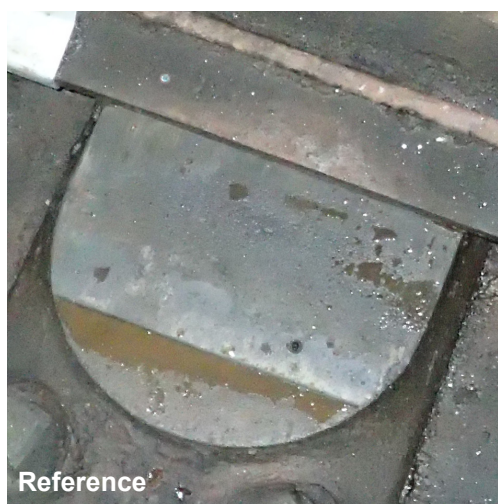
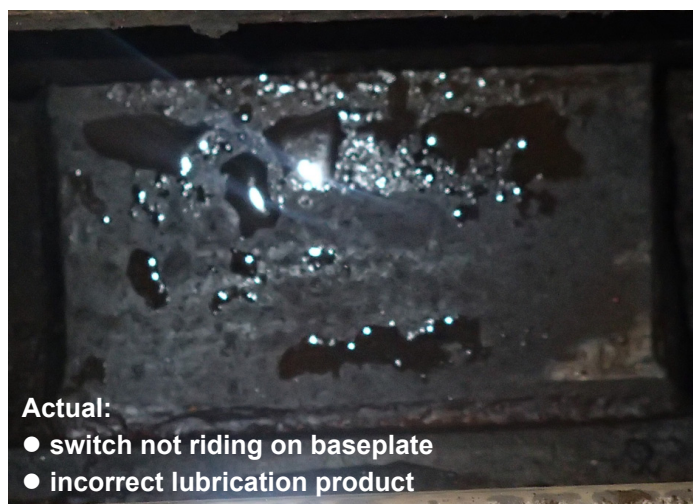
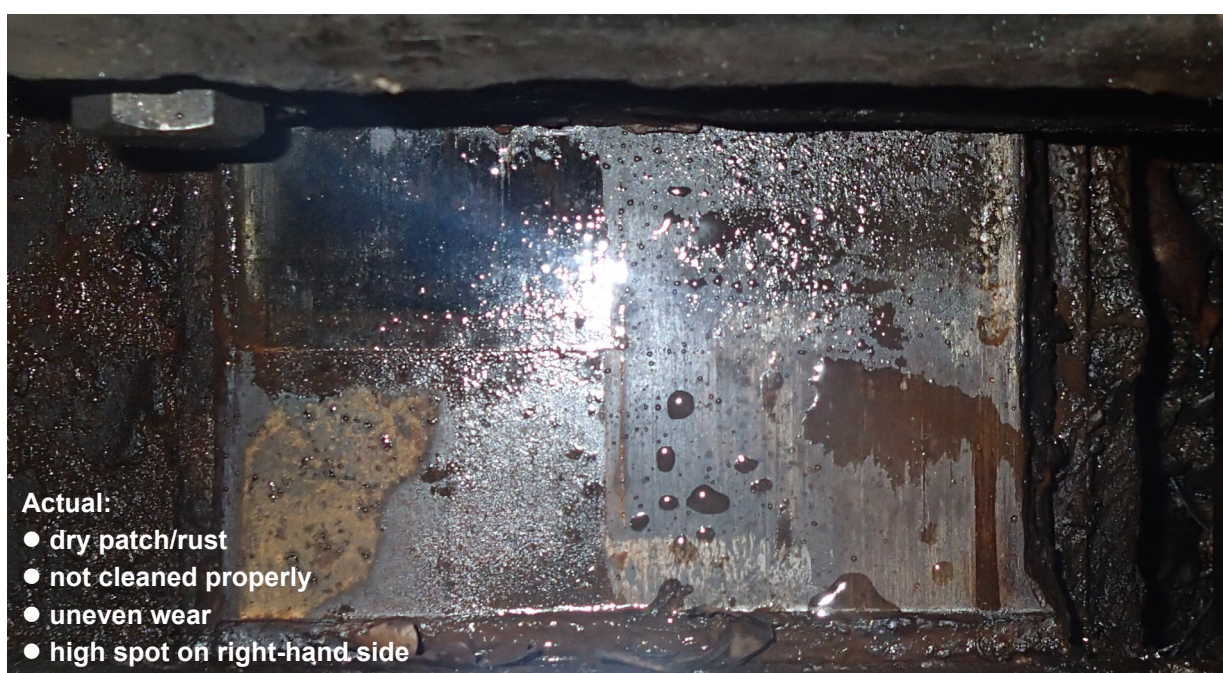
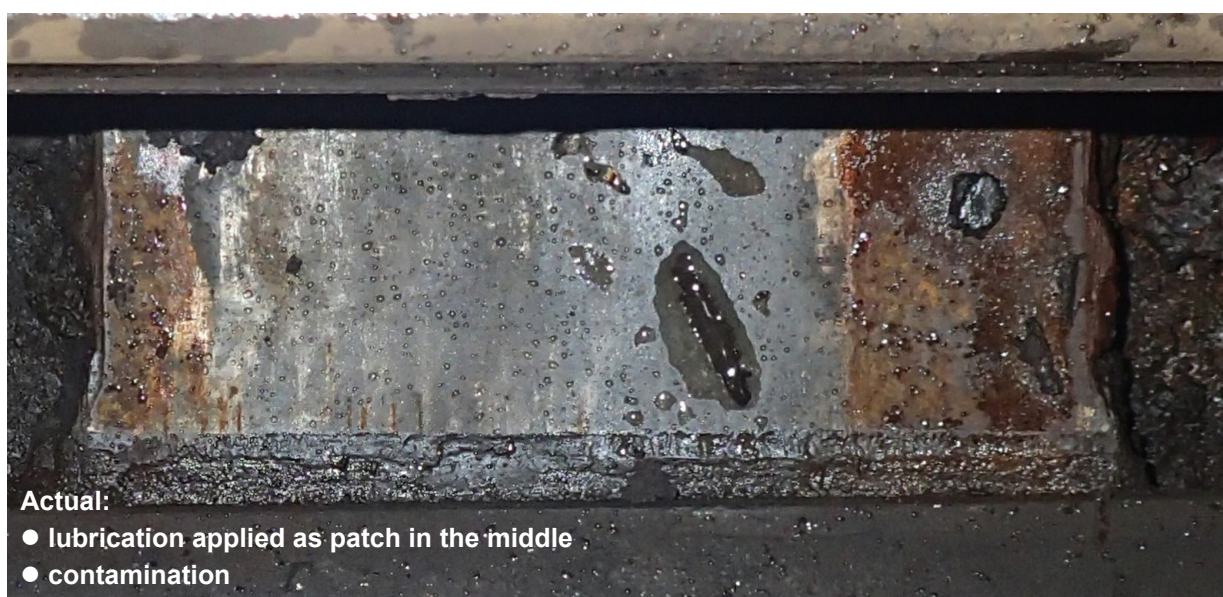
Figure 9 – Switch rail to baseplate interfaces (representative examples)

- 58 Following the derailment and after the train had been re-railed and moved away from the site of the accident, points 3A were subjected to a visual examination by the RAIB and functional testing by Network Rail. This testing revealed no mechanical or electrical fault, and did not reveal the presence of any obstruction which would have explained why the points stopped in an intermediate position. The RAIB considered that the most likely cause of the failure was high friction at the baseplate to switch rail interfaces. The RAIB examined the baseplate to switch rail interfaces on site and found evidence of debris, rust, uneven contacts and the use of incorrect lubricant which could all lead to high friction (figure 9). The RAIB shared this evidence with Network Rail who agreed that it was indicative of high friction.

- 63 The photographic evidence captured by the RAIB of the baseplates showed that close to the toe of points 3A, the switch rails were not riding correctly on the baseplates on both sides. This suggested that the bearers (sleepers) had been incorrectly installed at an angle and were causing high spots on the baseplates.
- 64 An examination of the full length of the points showed uneven contact between the baseplates and switch rails on more than 50% of the baseplates. An uneven contact between the baseplates and the switch rail meant that the lubrication product was not uniformly smeared over the baseplates when the points were thrown from one position to the next, possibly leading to high friction.

- 106 The maintenance team in charge of the track at Knaresborough is planning to replace the bearers under points 3A in 2017/2018 with a possibility of bringing it forward to 2016/2017.
