Rail Accident Report

Runaway of a road-rail vehicle at Bradford Interchange 8 June 2018

Report 01/2019
March 2019

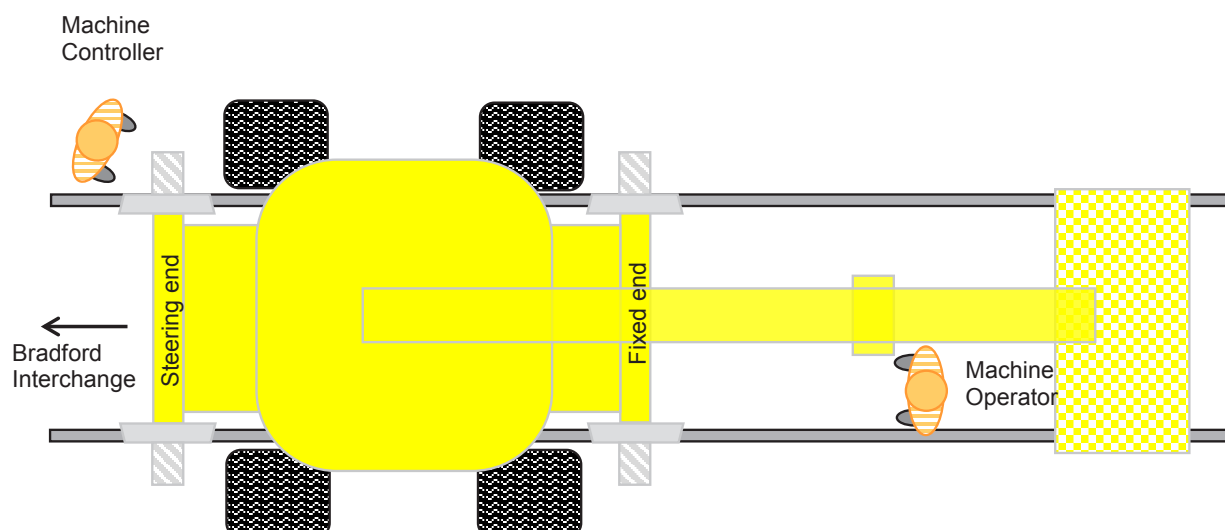
Figure 10: Position of machine operator and machine controller at time of runaway

- 25 He then proceeded to align the steering end of the machine guided by the machine controller. Once the steering end was aligned, he started to deploy the rail wheels at that end. He again stopped once the rail wheels had engaged with the rails and the road wheels at the steering end were off the ground. At that point, none of the road wheels were in contact with either the ground or the rail wheel hubs. His intention was to complete the deployment of the fixed end axle and then the steering end axle.

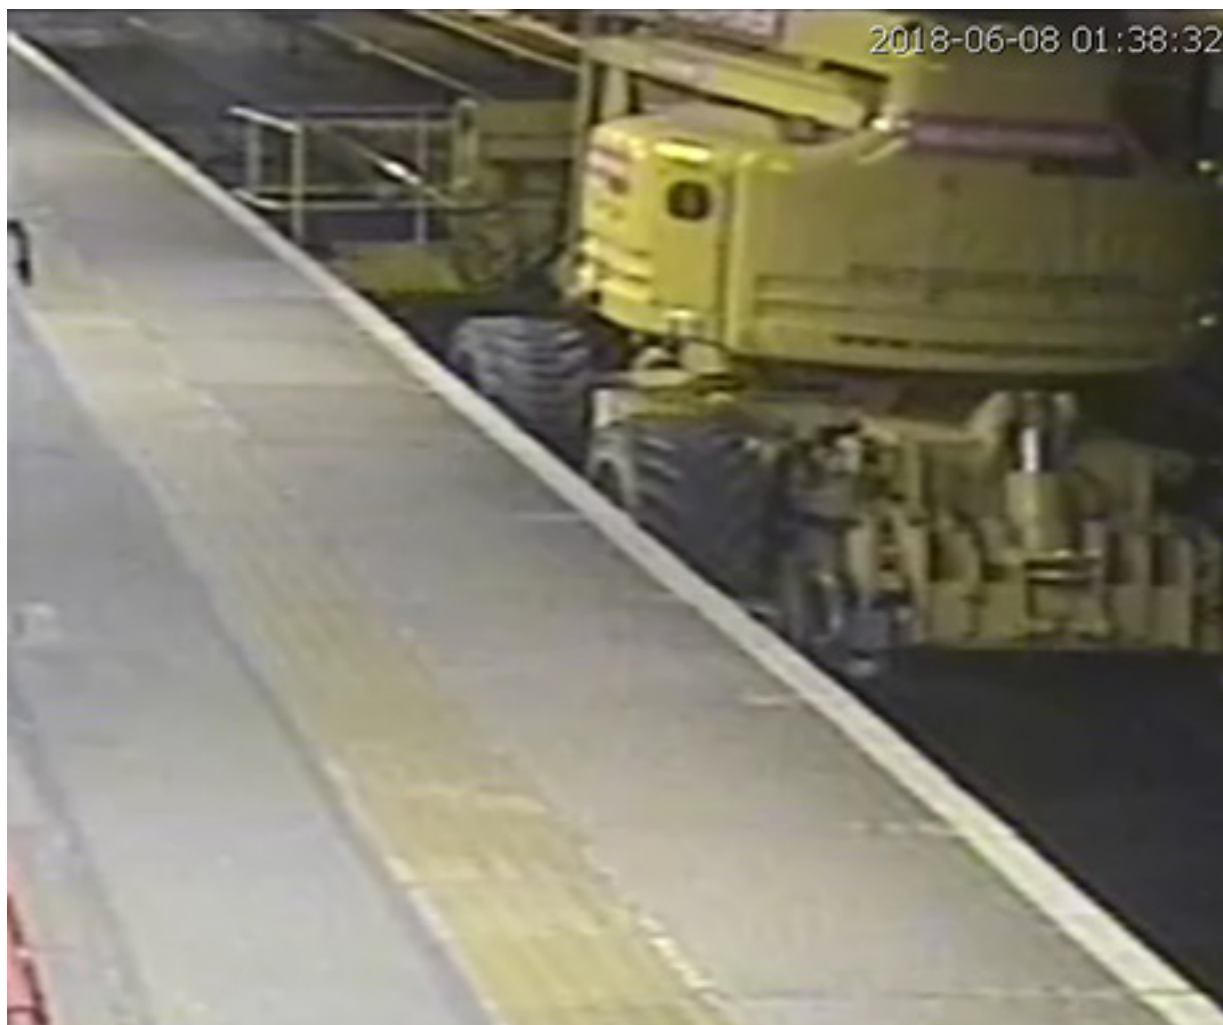
Figure 11: Incident MEWP at platform 1 immediately after the incident (courtesy Northern Rail)

- 29 Staff on the platform heard the commotion and quickly realised that there was a member of staff on the track alongside platform 1 in the path of the approaching machine. They warned him and helped him onto the platform approximately 5 to 8 seconds before the machine reached them. As the gradient levelled out and due to the action of the machine operator who pushed the basket against the platform, the machine came to a stop approximately 40 metres from the buffer stops located at the end of platform 1. The time was then 01:38 hrs (figure 11).

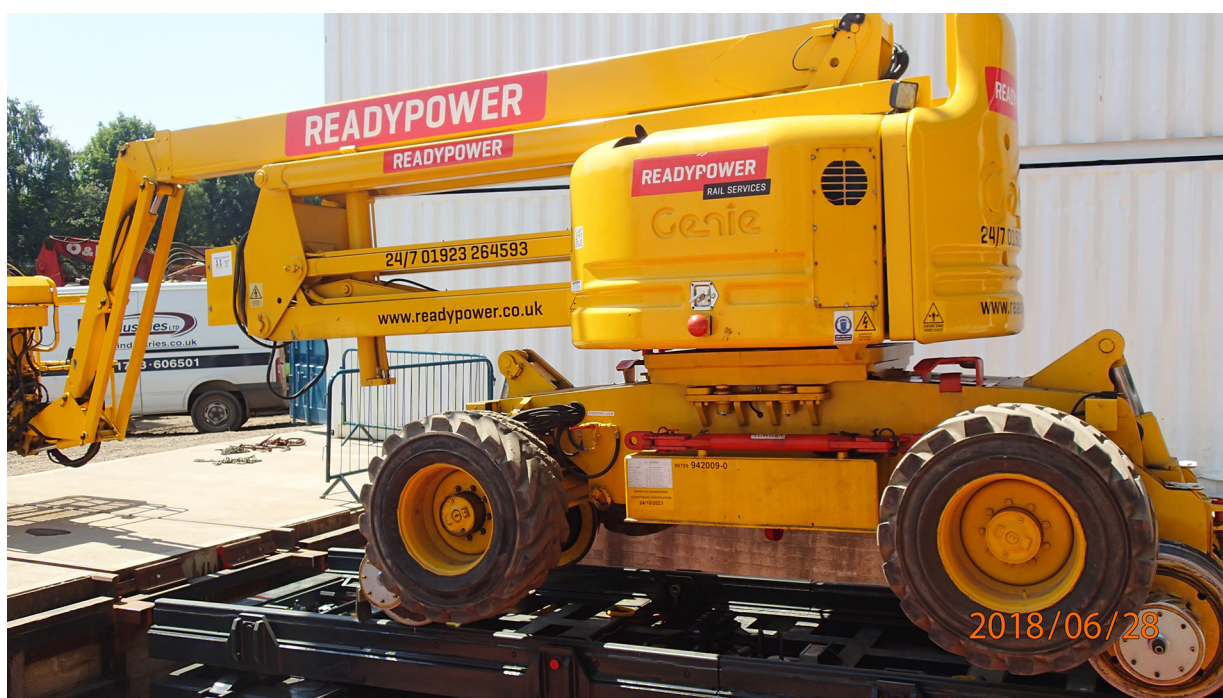
Figure 12: Incident MEWP during testing

Incident condition: Rail wheels partially deployed (Road wheels not in contact with ground or rail wheel hubs)		
Test	Angle	Gradient
1	0.9°	1 in 64*
2	1.1°	1 in 52*
3	0.9°	1 in 64*
* Test stopped because the machine started moving

Incident condition: Rail wheels fully deployed (Road wheels in full contact with rail wheel hubs)		
Test	Angle	Gradient
1	2.3°	1 in 25**
2	2.7°	1 in 21**
** Test stopped before any machine movement

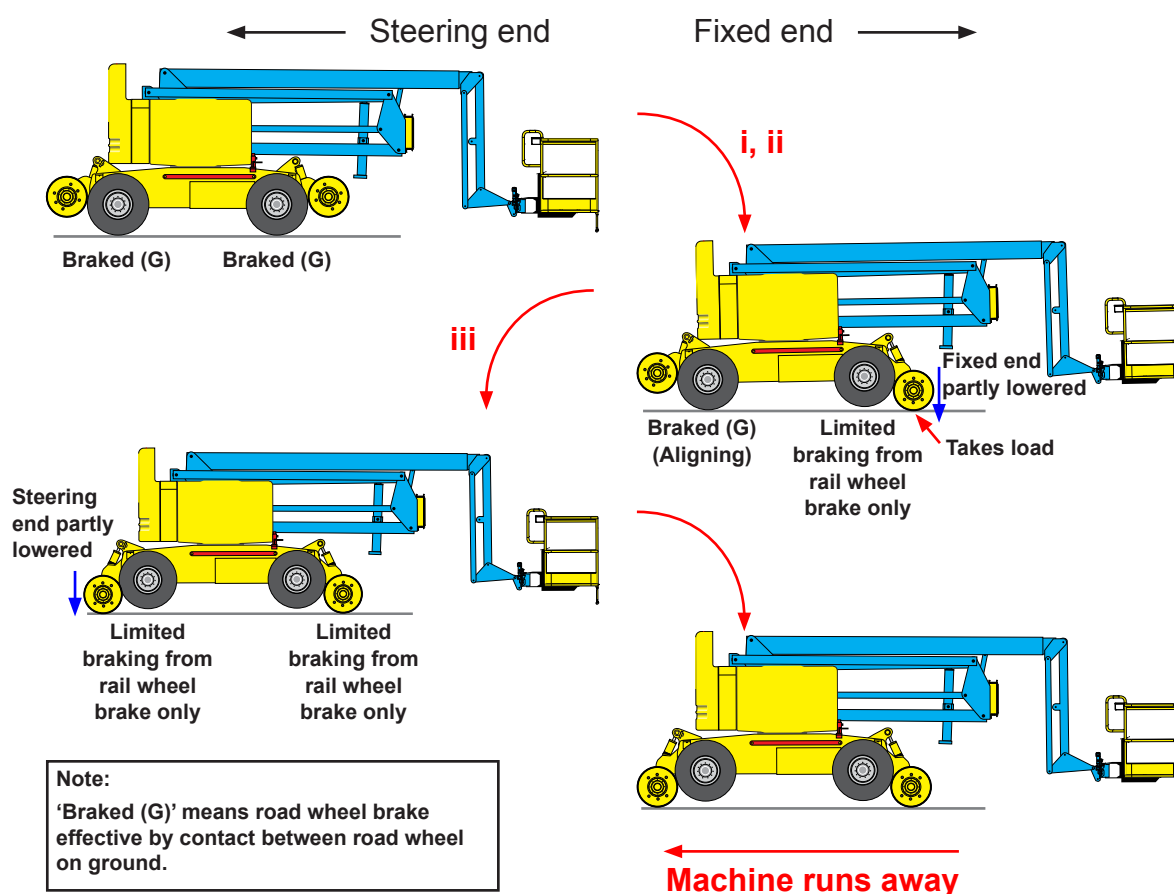
Figure 13: On-tracking sequence on the night

- 49 The machine operator involved in the incident at Bradford Interchange had been trained in September 2016 on a Genie Z60. He demonstrated during his assessments that he understood the importance of following the on- and off-tracking procedure. He confirmed post-incident that he knew how to deploy a machine following the on- and off-tracking procedure (figure 14). He also stated that he deployed the rail wheels on the night in the same way as he had been routinely deploying the rail wheels on other machines. He was aware that the MEWP was fitted with a DRWB system which should have prevented a runaway situation and he stated that this may have affected his perception of the risk.

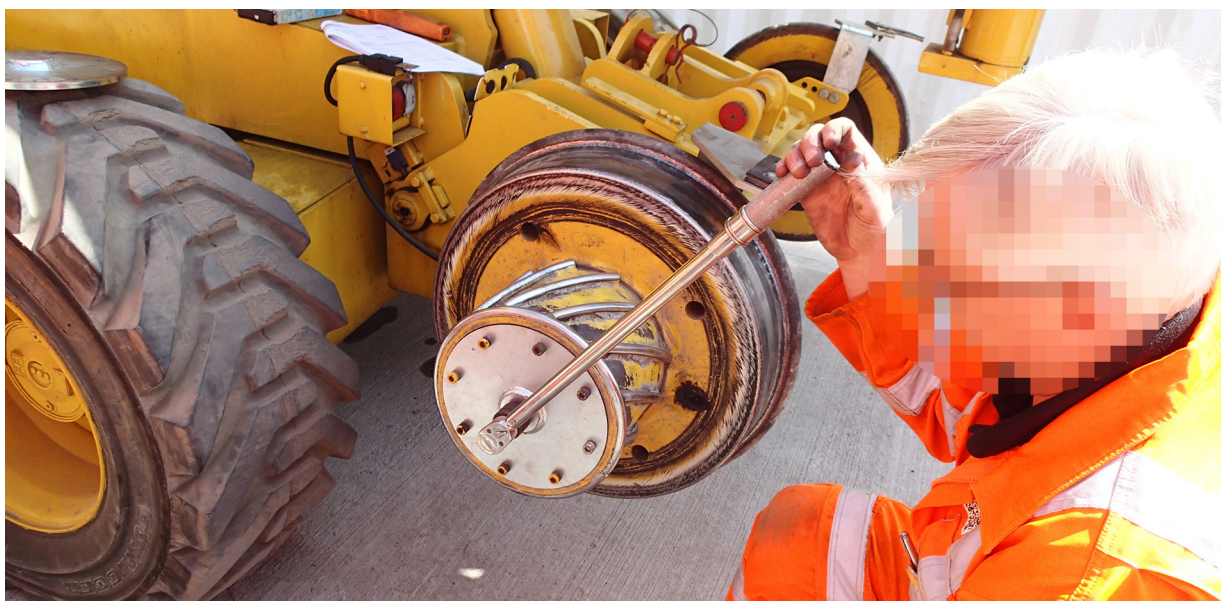
Figure 15: Torque testing of DRWB system

65 According to Hargreaves maintenance instruction AJH077⁹ issue 7, each rail wheel braking torque should have been a minimum of 950 Nm. The results of the torque tests show that the DRWB system was providing significantly less than the required torque. When converted to a brake force, the total resisting torque equates to a brake force of 220 kgf. The gradient at the RRAP (1 in 46) created a 380 kgf downhill force on the 17.5 tonne MEWP, which exceeded the brake force of 220 kgf. These tests further confirm (beyond the tests reported in paragraphs 38 and 39) that the MEWP rail wheel braking system was unable to provide enough brake force to prevent movement on a 1 in 46 gradient.

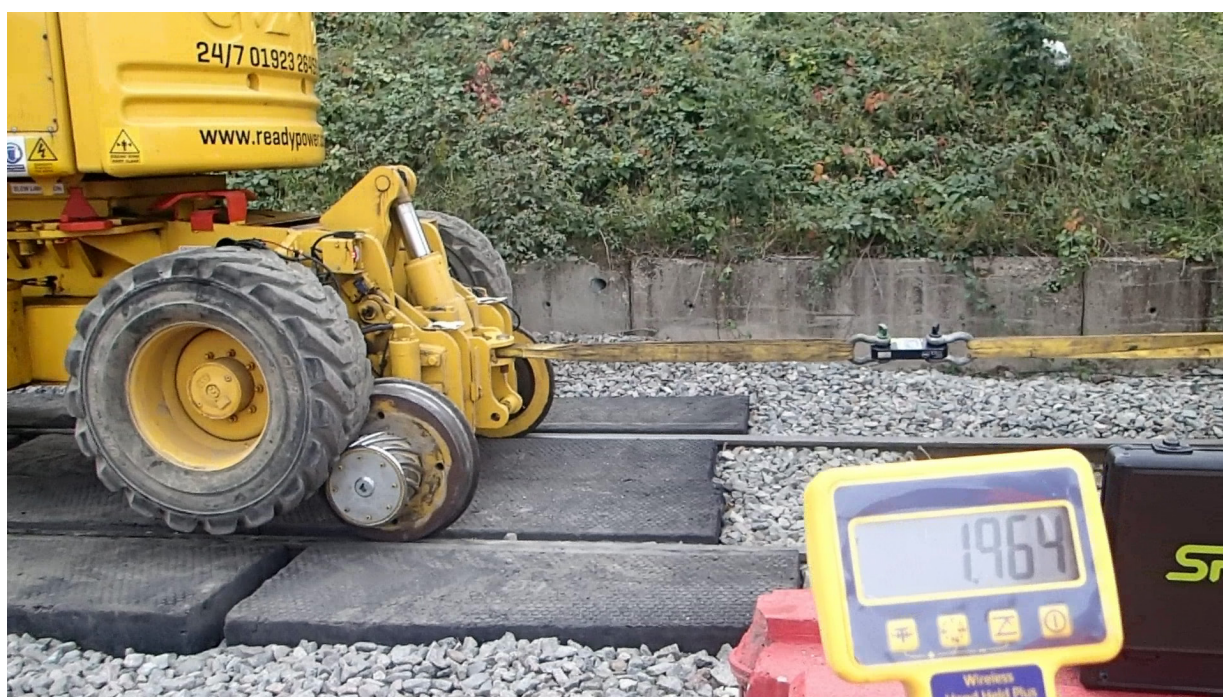
Figure 16: Pull-test when road wheels acting only (DRWB callipers removed)

Condition	Pull-force
As found #1	1750 kgf to 1950 kgf
As found #2	1850 kgf to 2000 kgf

- 92 Post-incident pull-tests on the incident MEWP showed that the road wheel brakes on their own provided somewhere between 1,750 and 2,000 kgf of brake force (table 4). A DRWB system which provided only 220 kgf of additional brake force (paragraph 65), would combine with the braking through the road wheels and achieve the target of 2,000 kgf. Therefore, a successful pull-test on the machine with fully deployed rail wheels may fail to reveal sub-standard performance of the DRWB system.

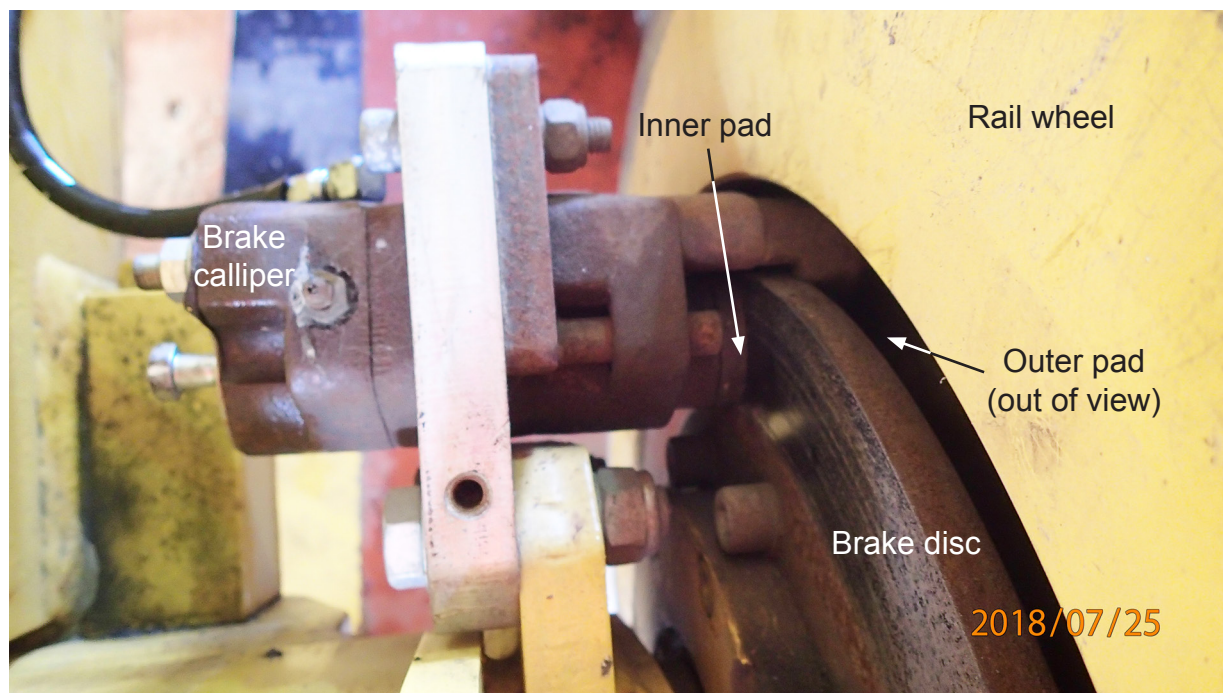
Figure 17: Hargreaves DRWB arrangement

- 68 Figure 17 shows the DRWB system fitted to the incident MEWP and figure 18 shows a cross-section of the calliper. The Hargreaves design uses a single acting calliper installed on a floating mount to accommodate a fixed brake disc. This design is replicated at every wheel. The clamping load (applying the brake) is provided by a spring made of Belleville washers¹⁰ in compression. In order to release the brakes, hydraulic pressure is provided to the calliper to further compress the spring. The calliper is fail-safe as a loss of hydraulic pressure results in the brakes being applied.

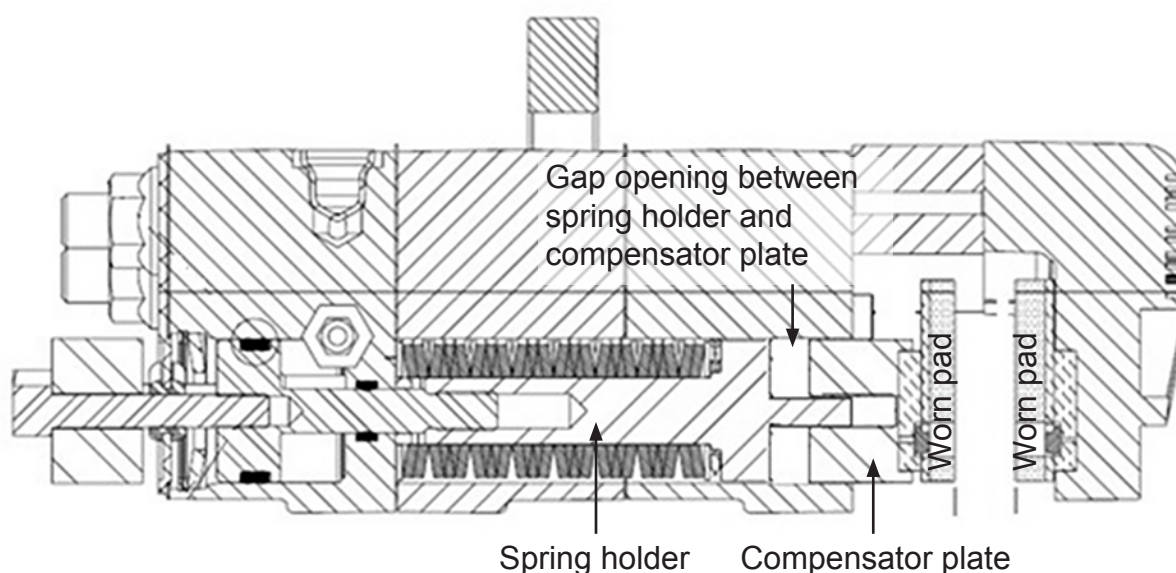
Figure 19: Calliper with worn pads, that has been adjusted

- 70 A detailed examination of the callipers fitted to the incident MEWP showed that the pads had worn to the extent that the callipers needed adjustment (combined pad wear ranging from 5 to 10 mm, across all four callipers). However, the examination also revealed that none of them had been adjusted.

- 73 The gaps at the four rail wheels on the incident MEWP were measured to be between 7.1 mm and 10.6 mm post-incident. This is consistent with the amount of wear measured on the pads, the low brake torque measured and a lack of adjustment.

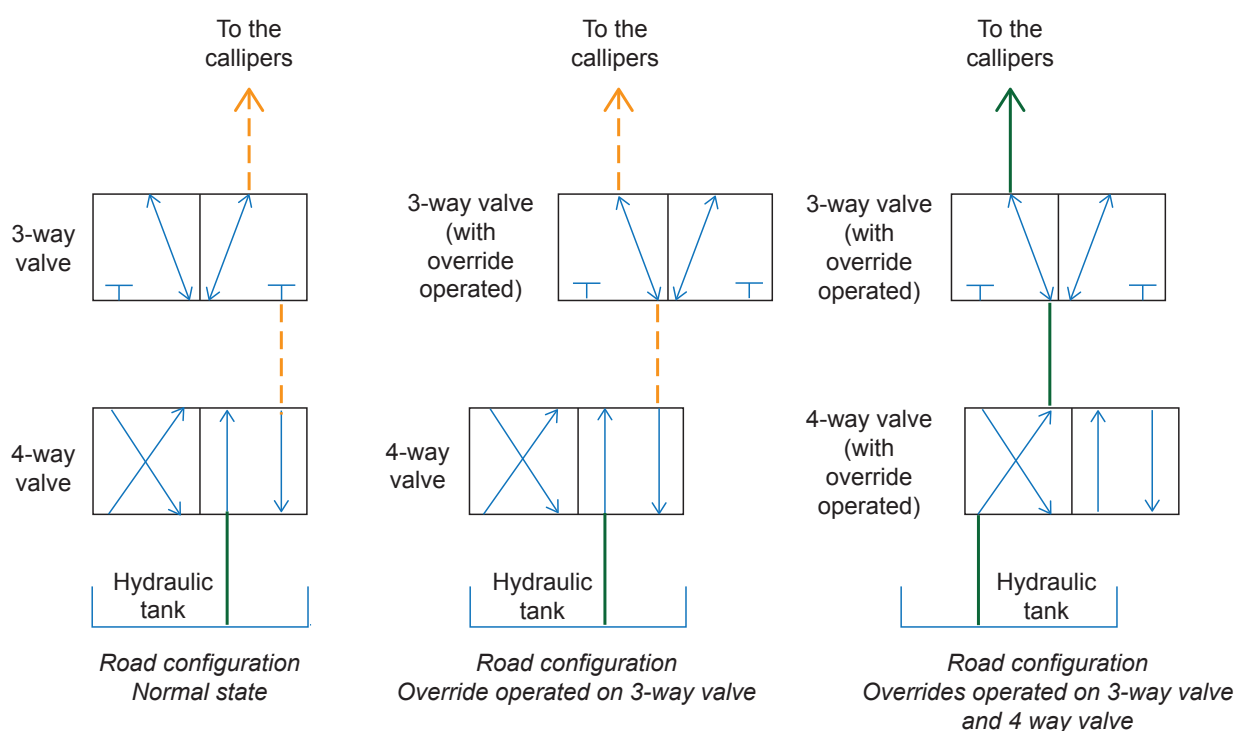
Figure 22: Hydraulic circuit for DRWB system (simplified)

- 112 Examination of the MEWP post-incident revealed that the operation of the override valve did not release the brakes when the machine was in its road configuration. This was because there was another valve in series with the three-way valve in the hydraulic circuitry detecting the position of the rail axes (figure 22). This second valve (a four-way valve) was only activated if it detected that the rail axes had been fully deployed at both ends. With the machine in its road configuration so its rail axes were off the ground, this four-way valve was not activated and did not allow hydraulic fluid to flow in the brake circuitry. As a result, operating the override on the three-way valve only had no effect. For the brakes to be released, the override on the four-way valve also needed to be operated (or the rail wheels fully deployed).

- 114 The three-way valve was part of the Hargreaves DRWB design but the four-way valve was not. It was part of the original design of rail wheel brakes that had been fitted to the Genie Z60 by the manufacturer (see footnote 5). When designing its DRWB system, Hargreaves retained some parts of the old braking system including the four-way valve.
