Rail Accident Report

Overturning of a tram at Sandilands junction, Croydon 9 November 2016

Report 18/2017
December 2017

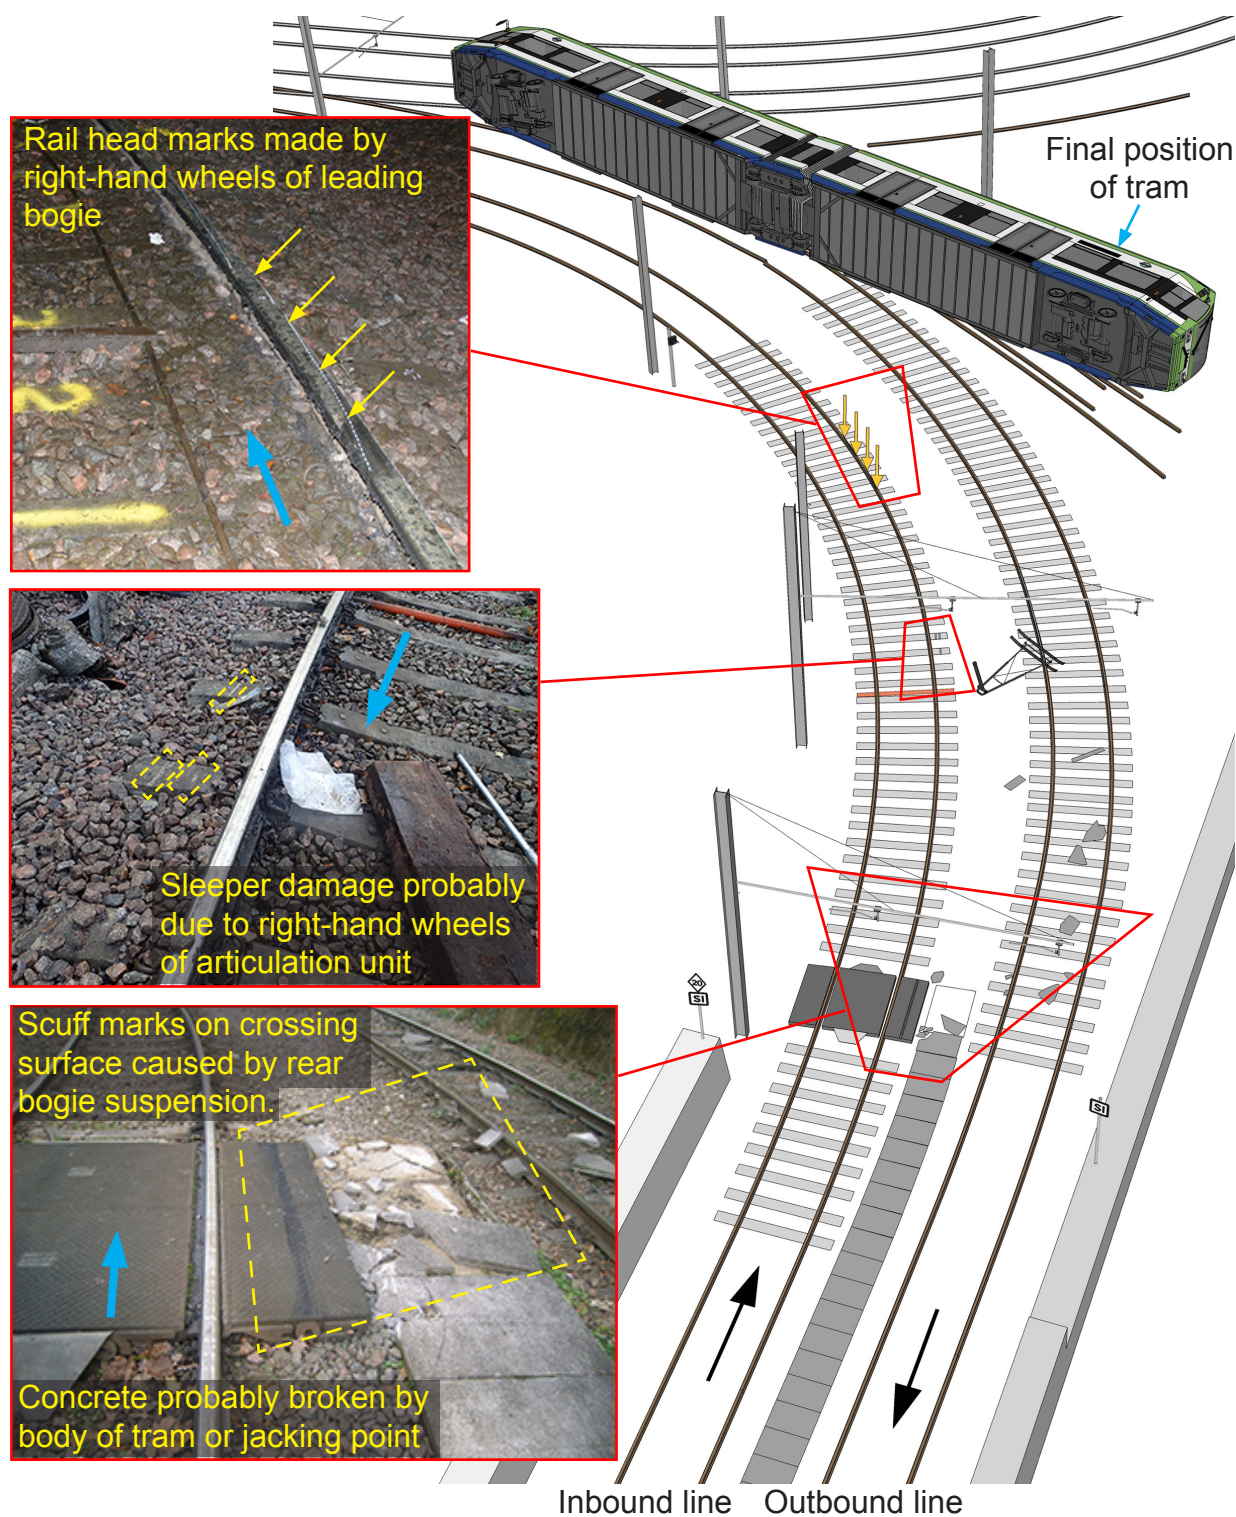
Figure 17: Marks indicating position tram derailed (blue arrows in photographs indicate tram's direction of travel)

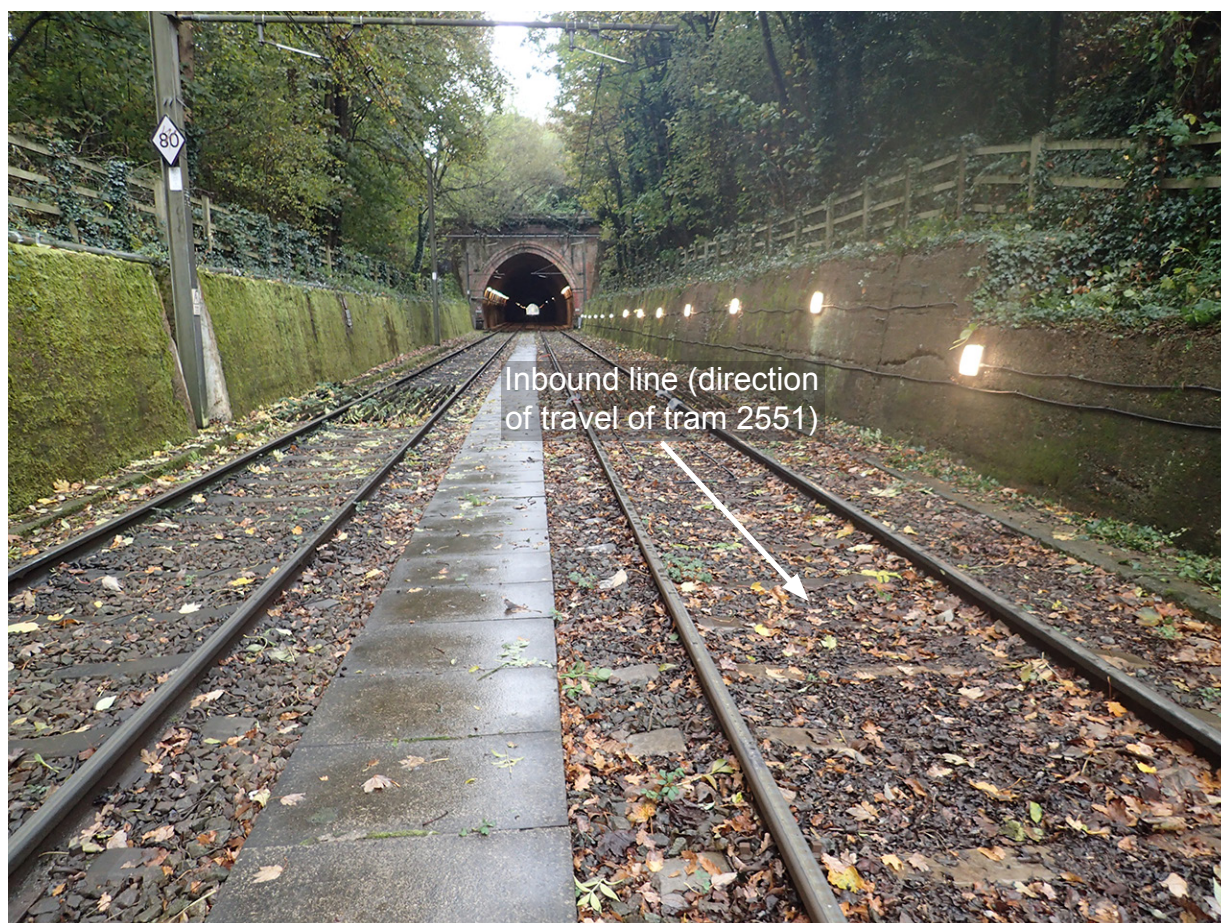
Figure 20: Inbound line between tunnels and speed sign six and a half hours after the accident. No evidence of significant leaf contamination on the rail head.

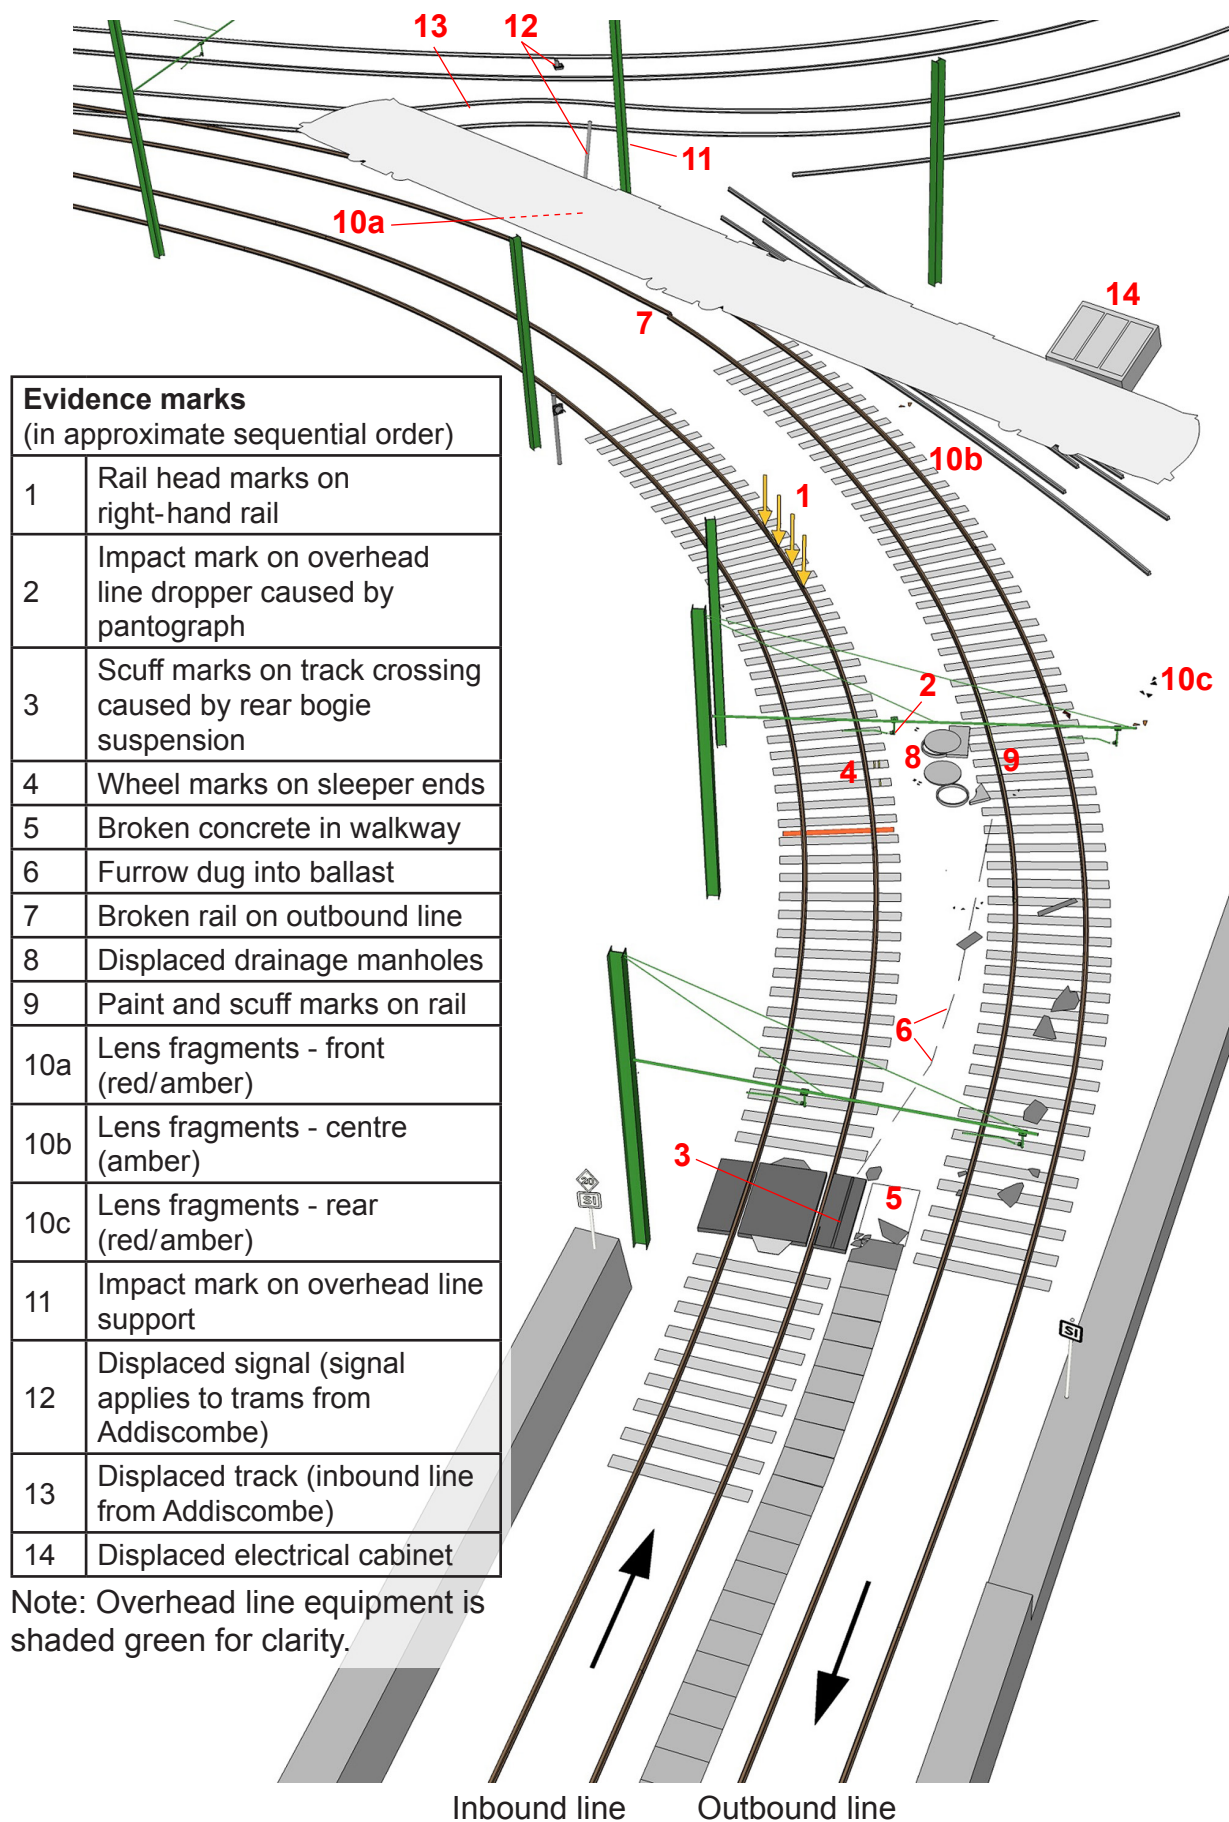
- 116 At the time the tram left the track (figure G.1), the roll induced on the vehicles as a result of the lateral acceleration led to the pantograph striking an OHLE *dropper* and the pantograph becoming detached (figure G.2). The roll also led to the outer lower edge of the trailing vehicle rubbing and breaking concrete walkway slabs on the ground (figure G.3). The tram continued to roll as the tram travelled across the gap between the inbound and outbound lines of the south curve.

Figure 22: Witness marks used to determine path of tram after leaving the track

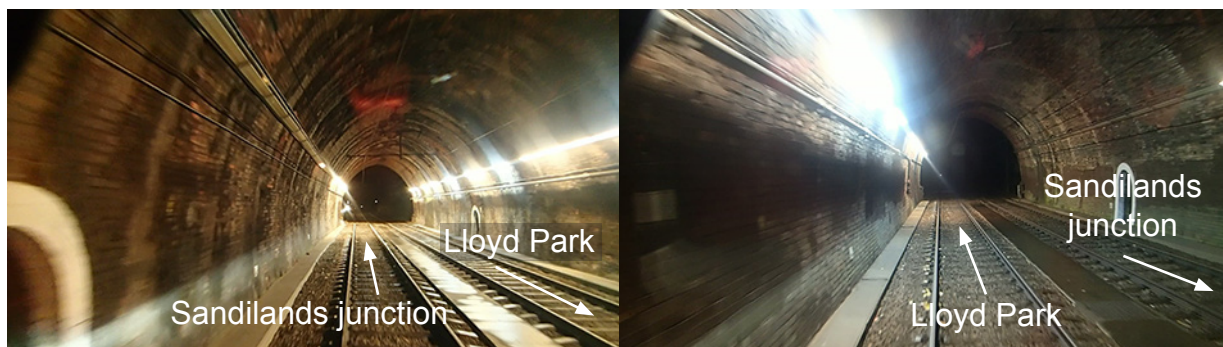
167 At the time of the accident, only some light units were illuminated in the end sections and the arrangement of lit lights was different at each end. For 58 metres at the Sandilands end of the tunnels, almost all lights were illuminated on the right-hand side of the tunnel when heading towards Sandilands, while lighting on the left-hand side was limited to the final 14 metres before the exit. Travelling through the final 58 metres at the Lloyd Park end (when heading towards Lloyd Park), almost all lights were illuminated on the left-hand side while almost none were illuminated on the right-hand side (figure 24). TRL considered the lighting in the context of its highway design expertise and reported that the lighting would not have been a strong informational cue concerning direction of travel. Some light units were unlit in the central part of the tunnel. There is no evidence that unlit light units contributed to the accident.

Figure 24: Exiting the tunnels towards Sandilands junction (left image, accident situation) and Lloyd Park (right image)

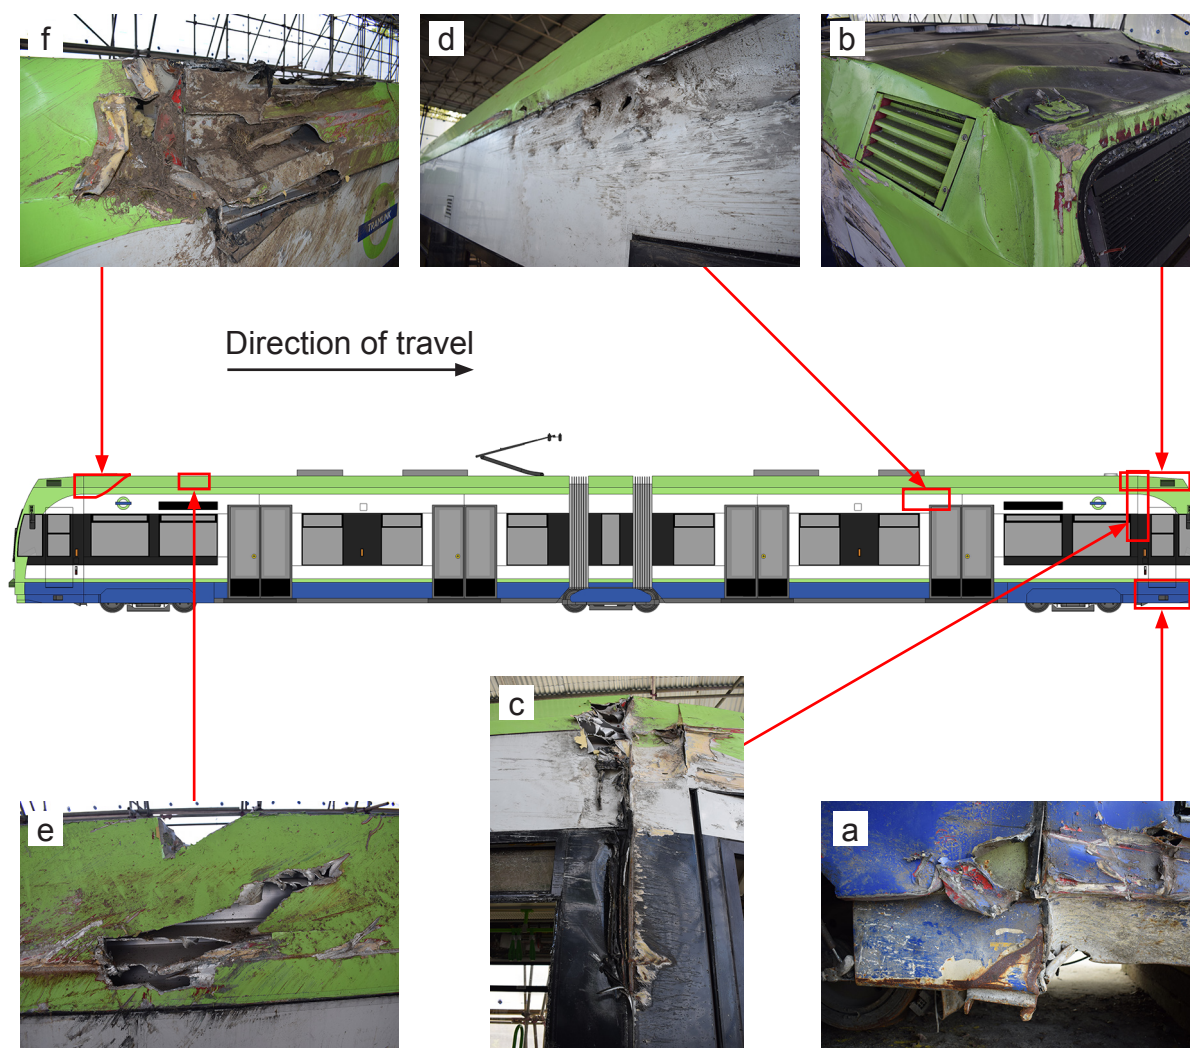
- the electrical equipment cabinet (figure G.8); and
 - spare rails and the ground.

Figure 32: Significant areas of damage to tram 2551

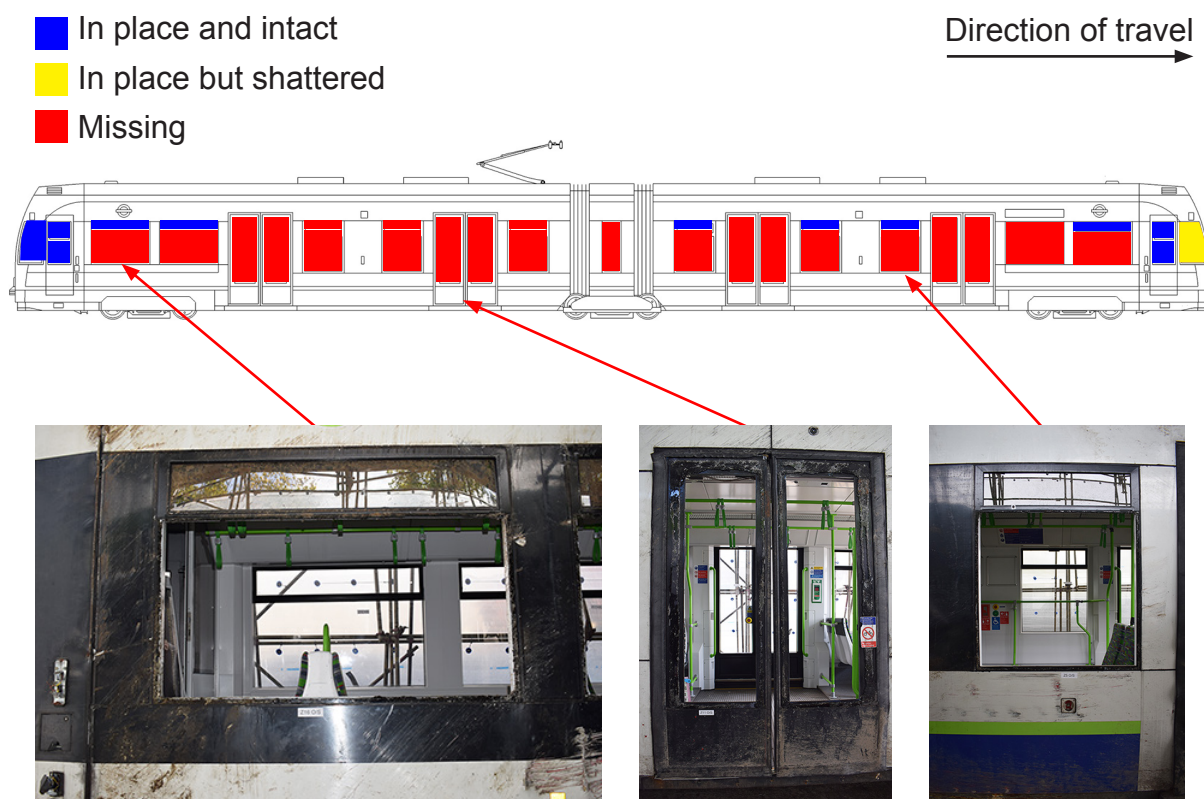
Figure 35: Damage to windows on right-hand side of tram 2551

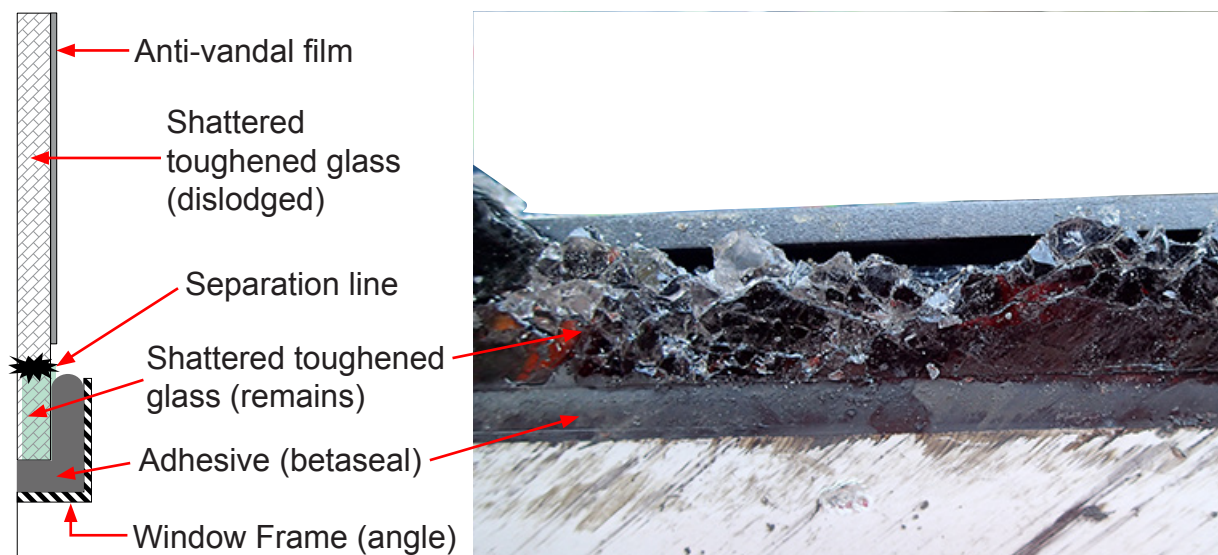
Figure 36: Typical failure mode of the tram's windows

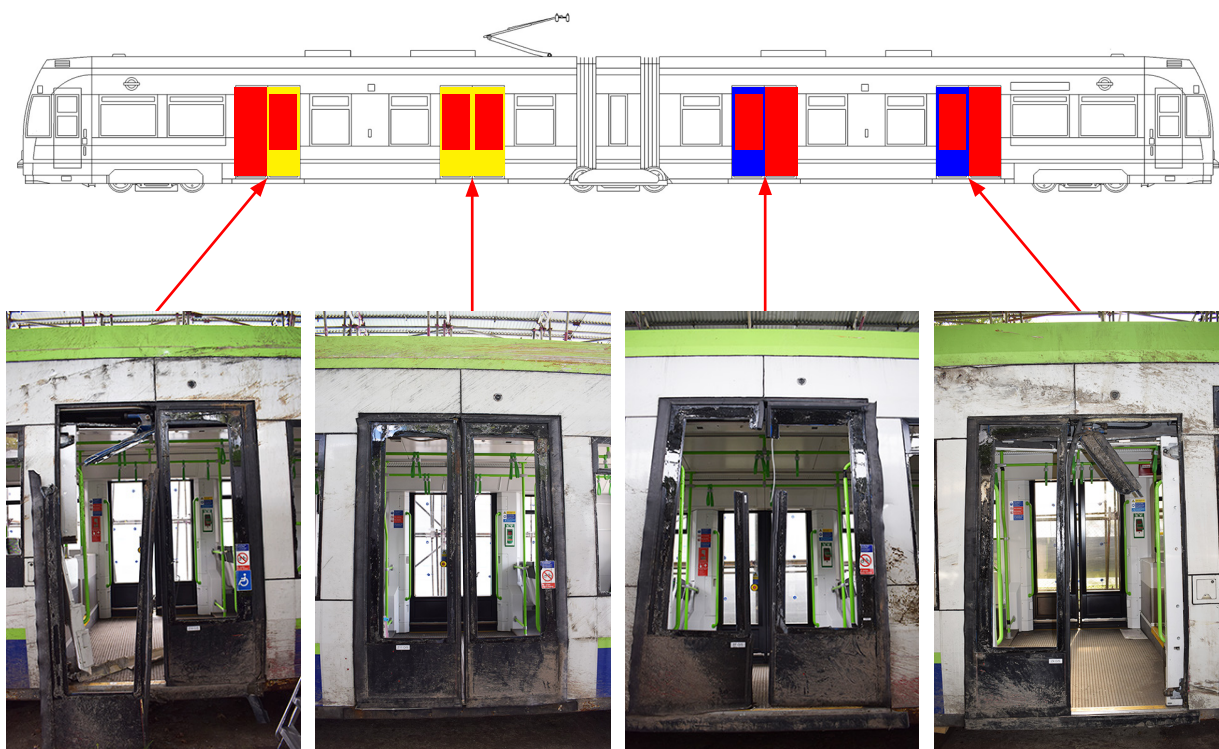
Figure 39: Damage to the tram's doors (note that in the third photograph the right-hand door has been repositioned)

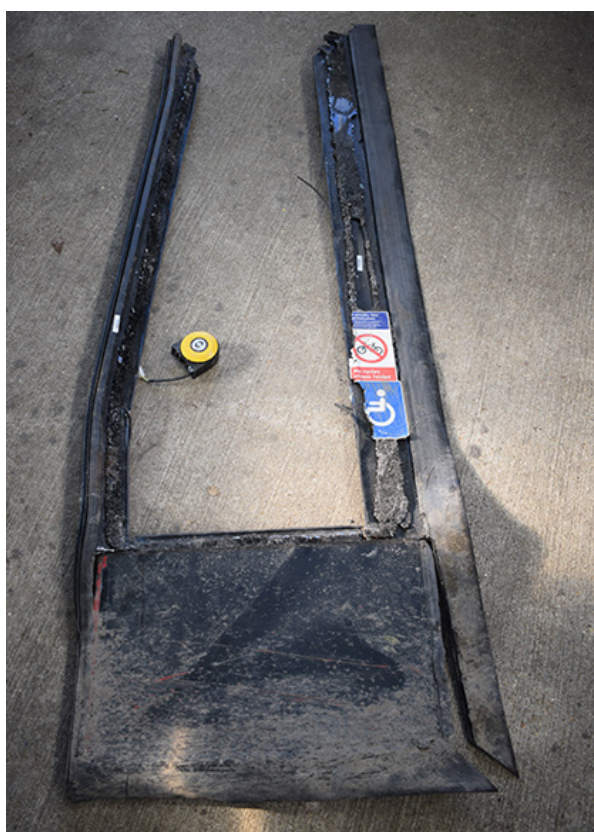
Figure 40: Typical door damage

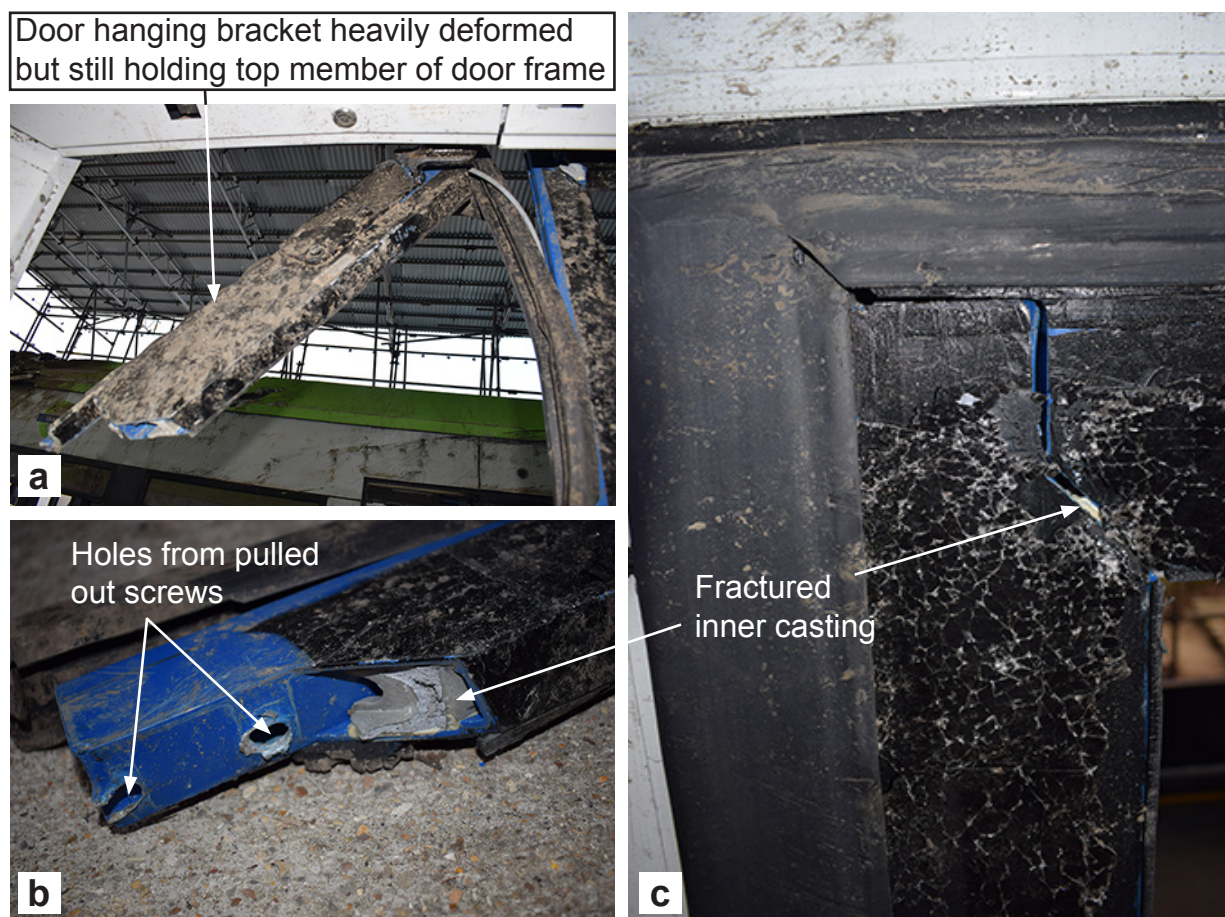
Figure 41: Typical door failure mode (see figure 37 for component locations)

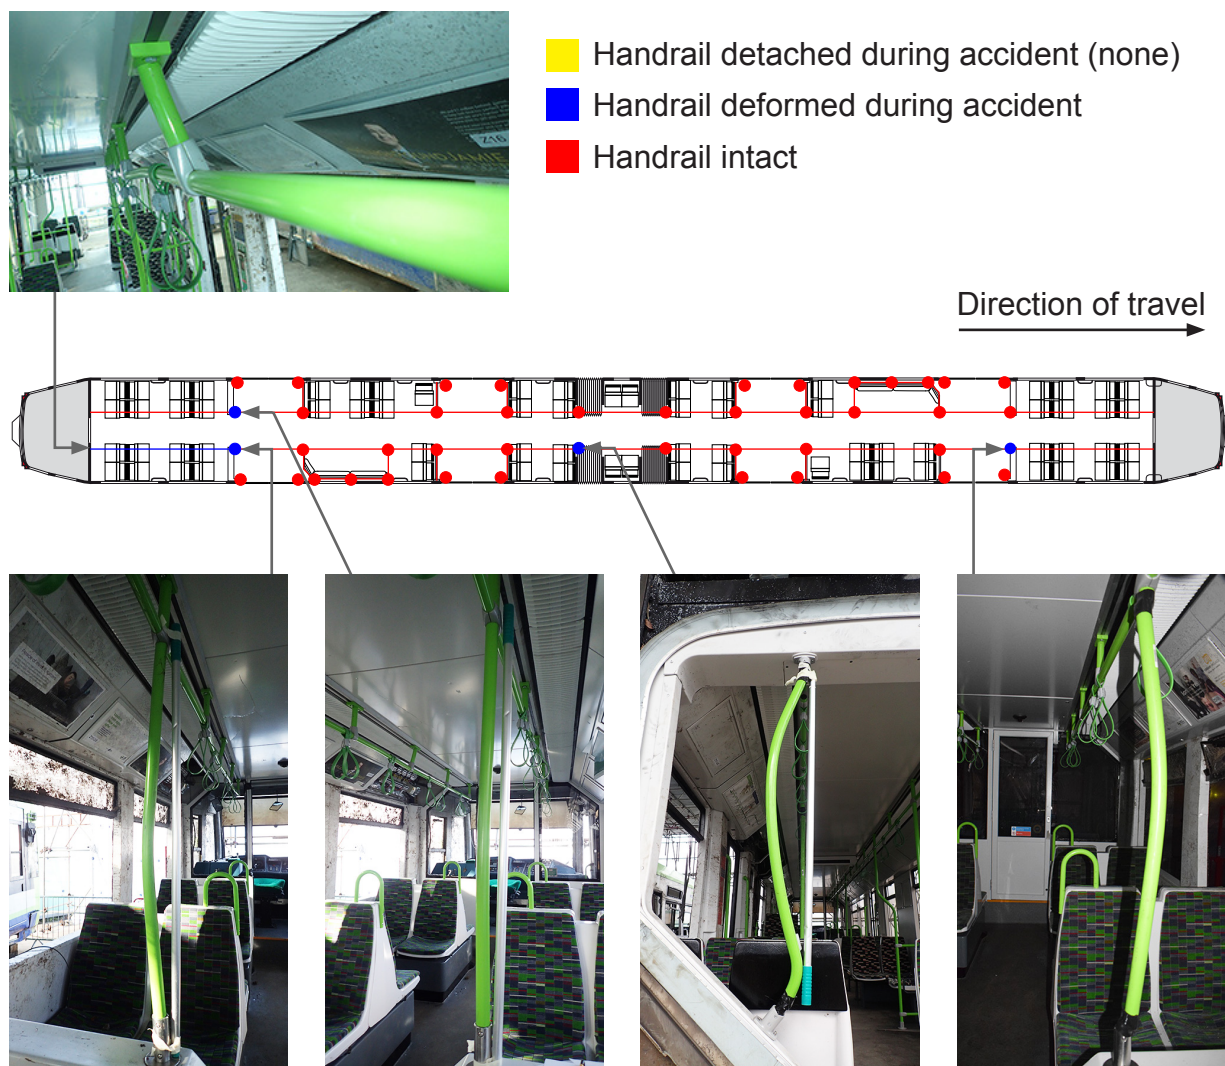
Figure 42: Extent of damage to handrails

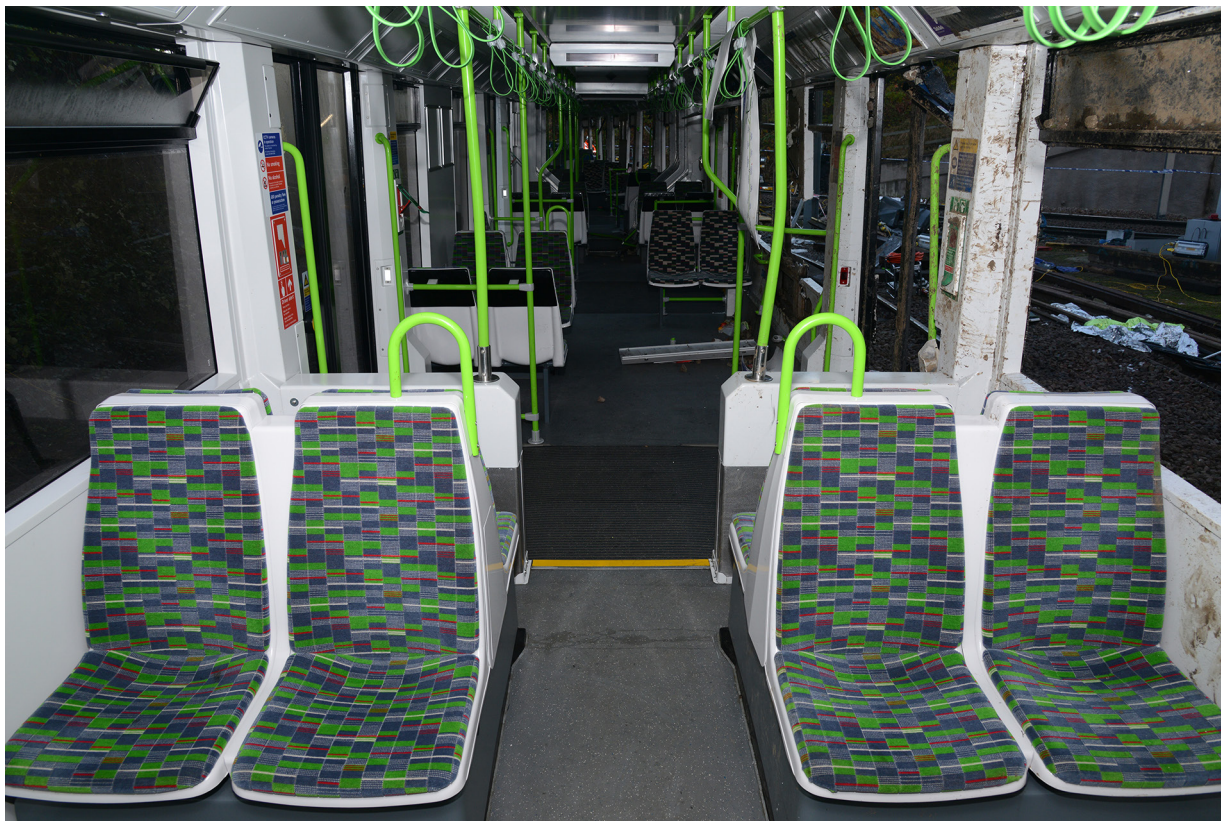
Figure 43: Typical interior area of tram, post-accident

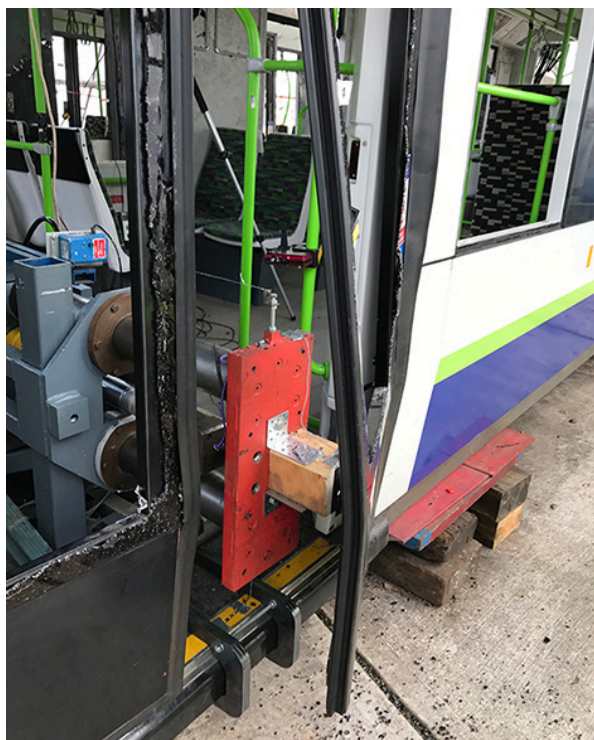
Figure 49: Door deformation due to load applied at level where people appeared to have struck the door
