Rail Accident Report

Passenger trapped and dragged under a train at West Wickham 10 April 2015

Report 03/2016
February 2016

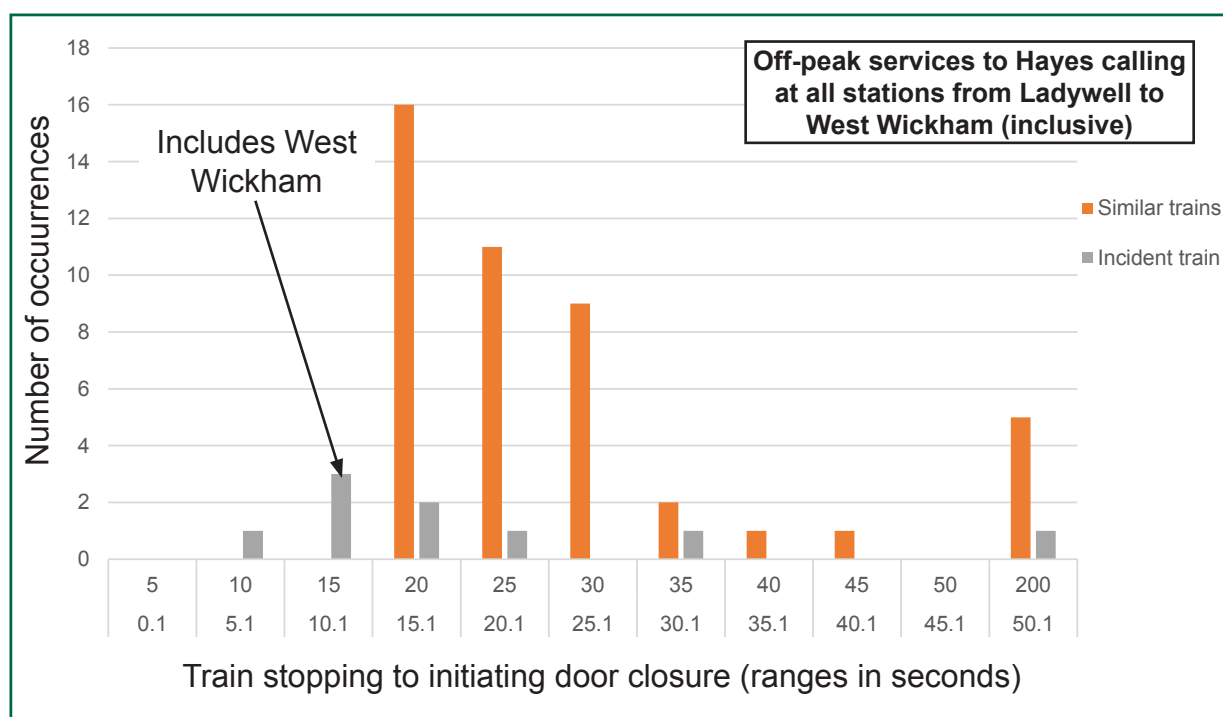
- 61 Analysis of data from five similar services (paragraph 93) showed that door closure on the incident service was sometimes initiated earlier than on all other services included in the sample (figure 9). Four of the nine closure sequences on the incident service were initiated less than 15 seconds after the train stopped, including the 10 second period at West Wickham, and a shorter period at one other station. A period of at least 15 seconds was allowed at all stops made by all other trains in the sample. The RAIB has not established the particular circumstances associated with each station stop included in figure 9 (eg whether drivers could see passengers disembarking for a considerable time period, and instances when drivers were waiting for their booked departure time). However, comparison with RAIB testing (paragraph 58), shows that at some stations the incident train driver did not allow sufficient time for mobility impaired people to disembark safely. This leads to Learning point 1 (paragraph 135).

Figure 9: Time interval between train stopping and driver initiating door closure sequence

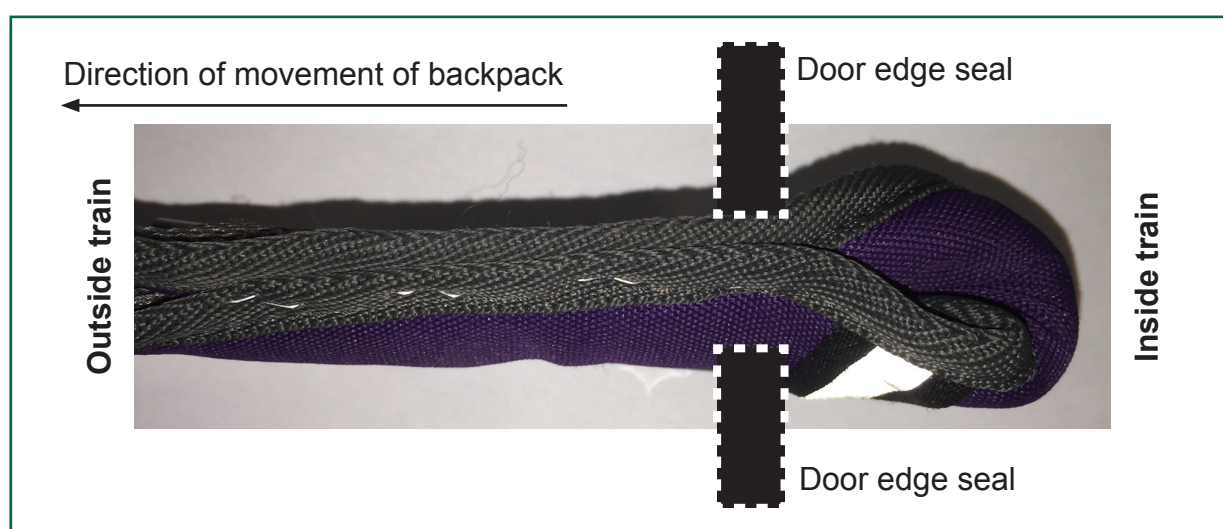
- 71 **The passenger was not able to pull the trapped backpack from the doors, and her arm may have remained in the strap⁴ while she was dragged.**
- 72 CCTV footage from the platform and the train shows the passenger trying to pull her trapped backpack from between the closed doors. The images show that the bag was outside the train, but the strap was trapped and she was not able to generate enough force to free it, even when she was seen leaning away from the train (without pushing off the side of the train). The RAIB used the backpack that was involved in the accident in a series of tests to determine the likely reasons why the passenger was not able to pull the thin backpack shoulder strap free. The tests indicate that either the backpack shoulder strap became twisted and trapped against the inside of the closed doors, or a buckle on the strap became trapped flat against the inside of the closed doors (figures 10 and 11).

Figure 10: Twisted strap trapped on the inside of the closed doors

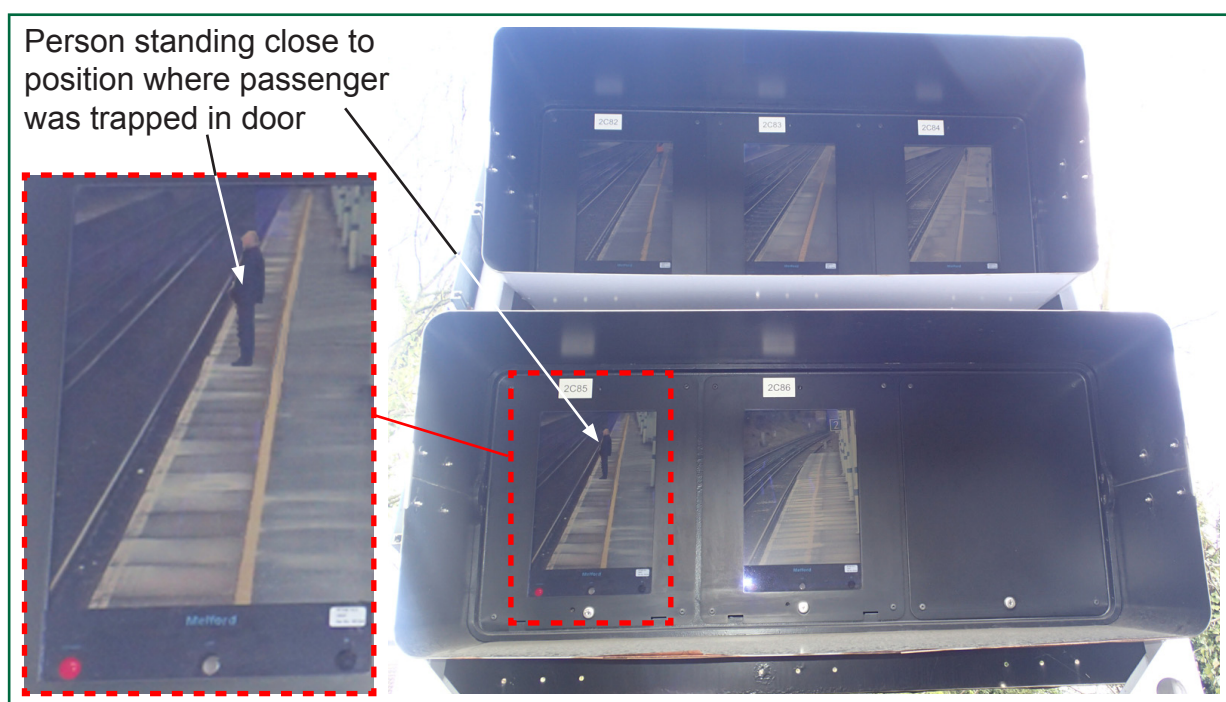
- 78 **Although shown on the DOO monitors, neither driver was aware of the trapped passenger when the train doors were closing, or afterwards.**
- 79 The RAIB established that the train stopped in the correct position with the DOO monitors visible from the driving cab. The monitors were functioning correctly and a person standing at the location where the passenger got off the train would have been visible on two of the five monitor screens, with the view of her in the top right-hand screen being less discernible than in the bottom left-hand screen (figure 12). DOO train drivers departing from West Wickham are required to use these monitors to complete a train safety check after all doors are closed, and before the train departs (paragraph 37). This check should always be carried out after the door interlock light is illuminated and is intended to make sure that the train is safe to start (eg there is no one trapped in the doors).

Figure 12: Location of passenger on the DOO monitor images (position of person superimposed on to image)

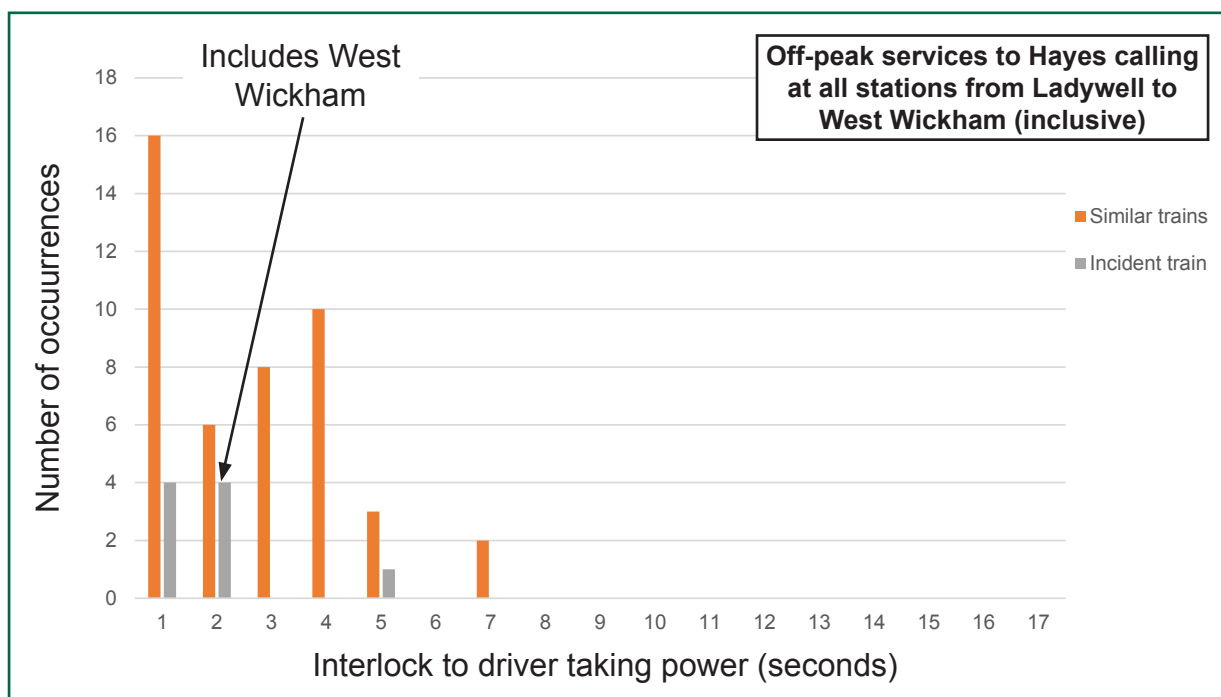
Figure 13: Time interval between interlock and taking power

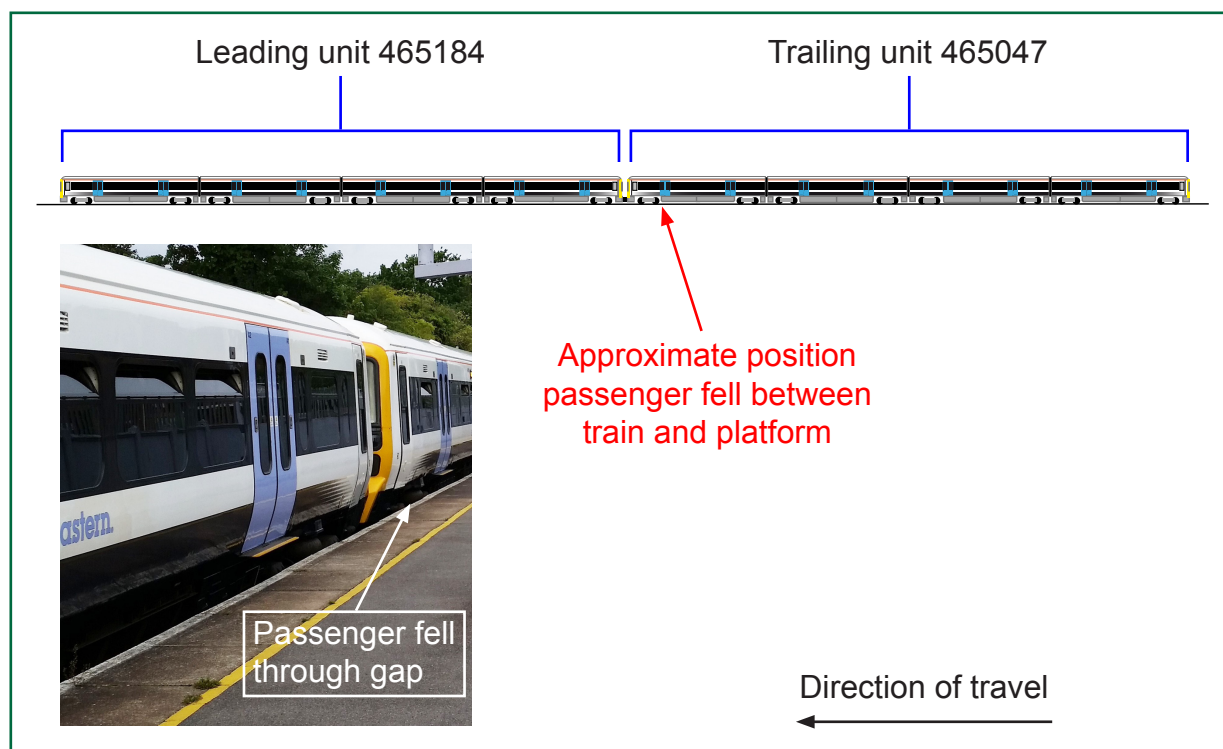
- 98 The RAIB measured a horizontal gap of 305 mm between the platform edge and the body side of a class 465 train at the approximate location where the passenger fell. The average gap between the body side of a class 465 train and platform 2 over the length of the platform was about 330 mm.

Figure 14: Approximate location where the passenger fell between the platform edge and train

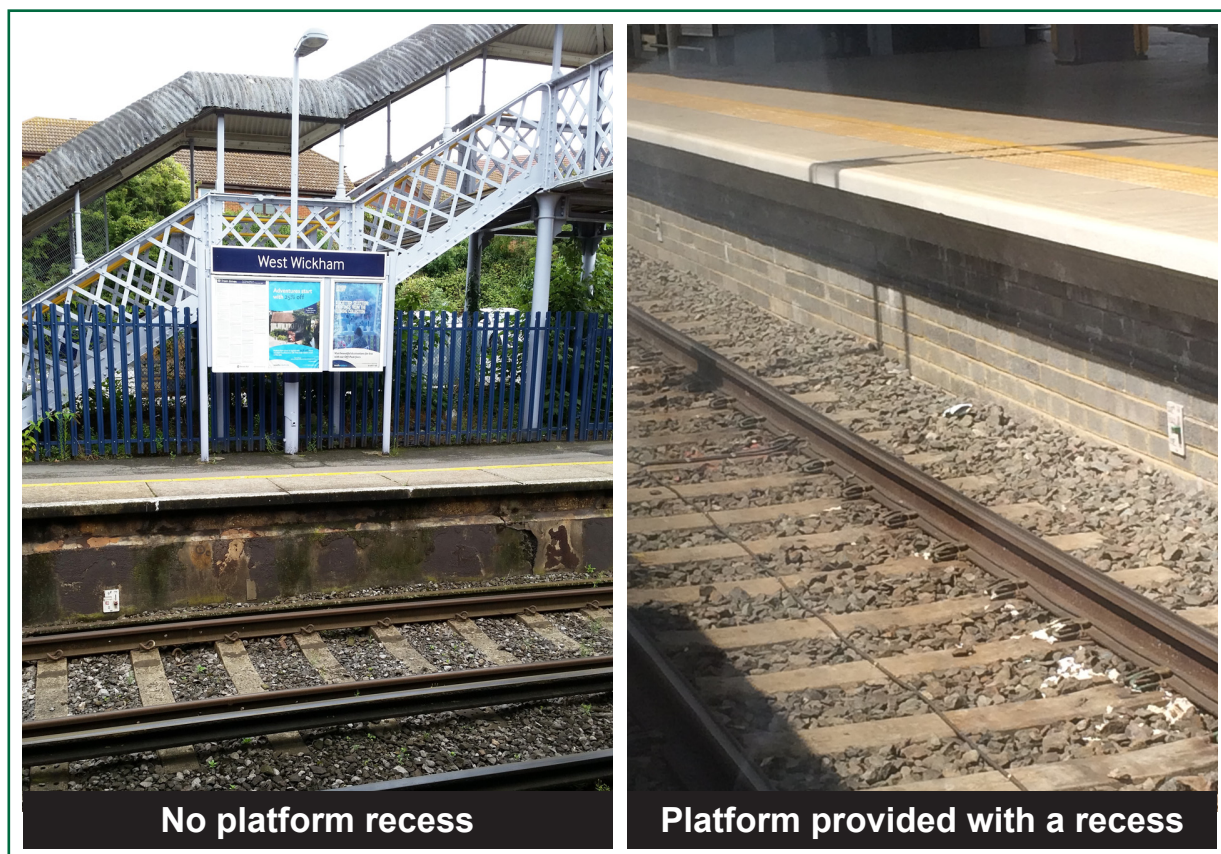
- 103 When the passenger fell through the platform edge gap she could not roll away from the train because, at the location where the accident occurred, there was no recess in the platform face beneath the platform edge (figure 15). It is possible that a recess would have allowed the passenger to move further from the train, and reduced the severity of her injuries.

- 104 This part of the platform was built before railway standards introduced a requirement for recesses in new platforms. The current Railway Group Standard GI/RT7016 'Interface between station platforms, track and trains' requires that new platforms, or existing platforms that are modernised, shall have a recess with a minimum width of 300 mm, and a minimum height of 480 mm, formed beneath the platform edge.
- 105 In 2015, the RSSB completed research into recesses under platforms¹⁰. The research recommendations included increasing the recess width in certain circumstances. Output from this research will also feature in the implementation of the *platform-train interface* (PTI) strategy (paragraph 126).

Figure 15: Recess providing survival space beneath platform

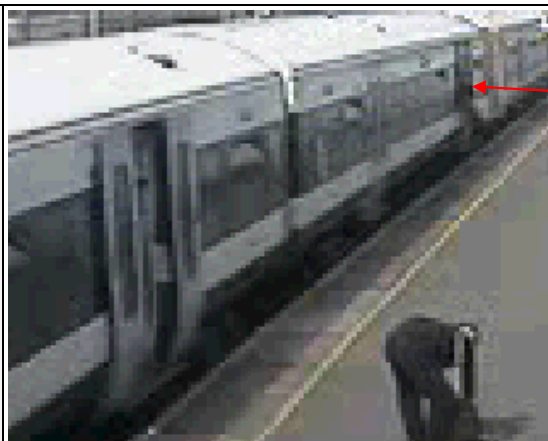
Passenger exiting through a door opened during the door closure sequence

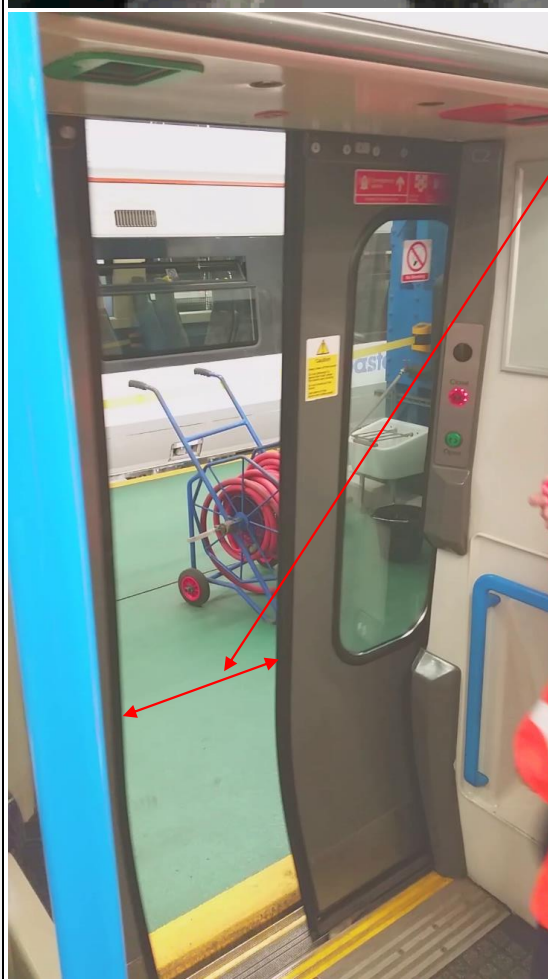
Extent to which the door opened when requested to open during hustle sequence, before reclosing rapidly (as observed during testing)
