# Rail Accident Report

**Collision between a train and tractor at  
Hockham Road user worked crossing, near  
Thetford  
10 April 2016**

Report 04/2017  
March 2017

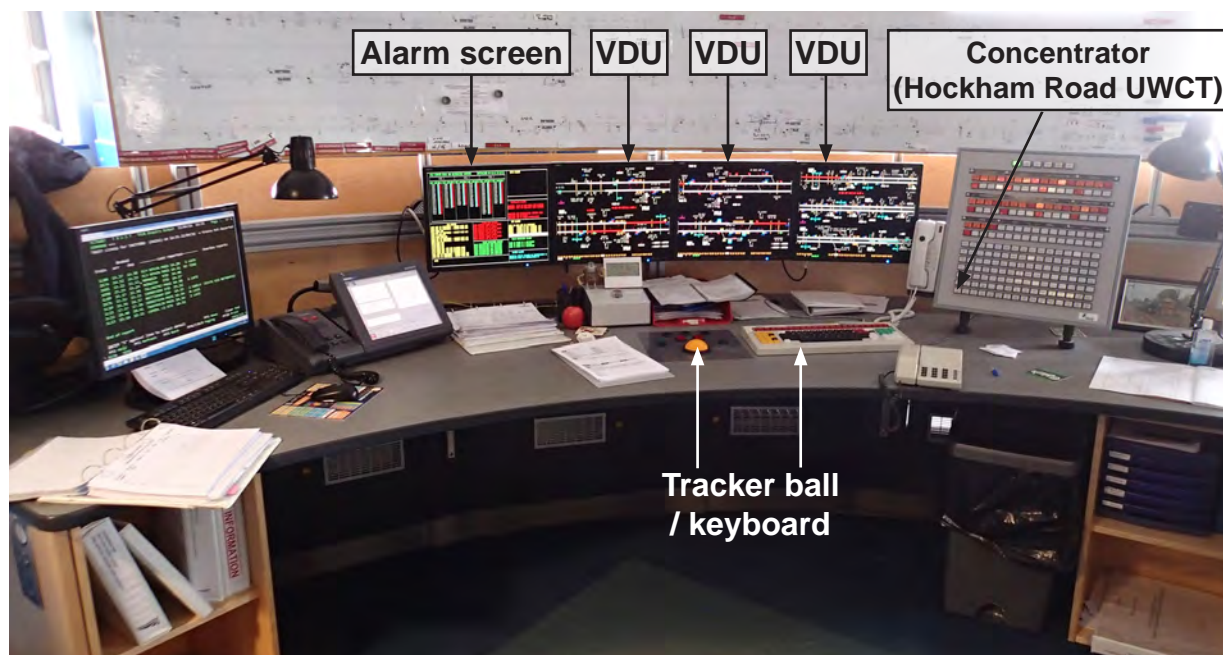
Figure 6: The Thetford workstation within Cambridge PSB

- 111 The Thetford workstation was fitted with three screens rather than four as originally designed.**
- 112 When the Ely to Norwich re-signalling was first proposed in April 2008, the Thetford workstation was designed to have four VDU screens. Subsequently, an ergonomic assessment took place at each of the signal boxes to be closed to identify the likely workload and demand for the new workstation. The report concluded that the signaller would be able to manage the infrastructure under normal operational conditions using overview screens, and that four screens would be appropriate.

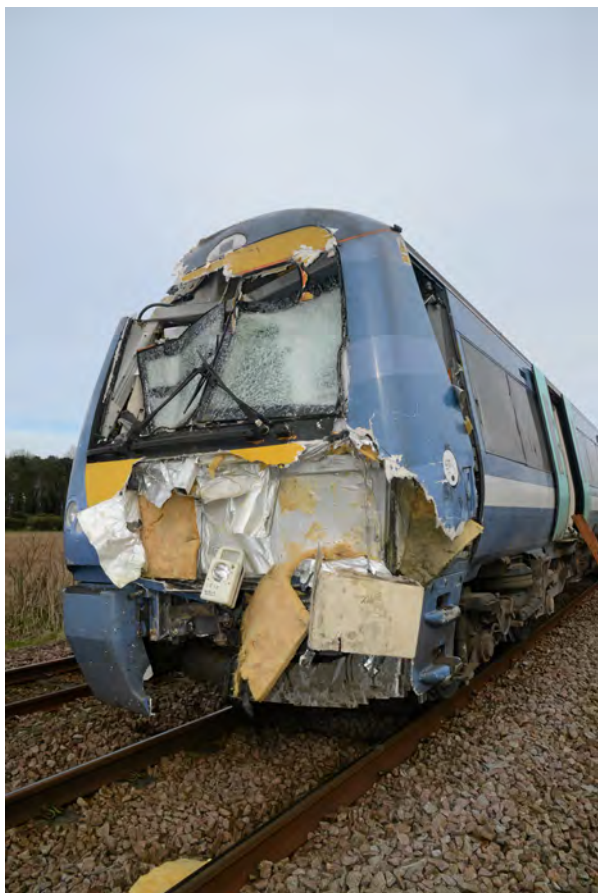
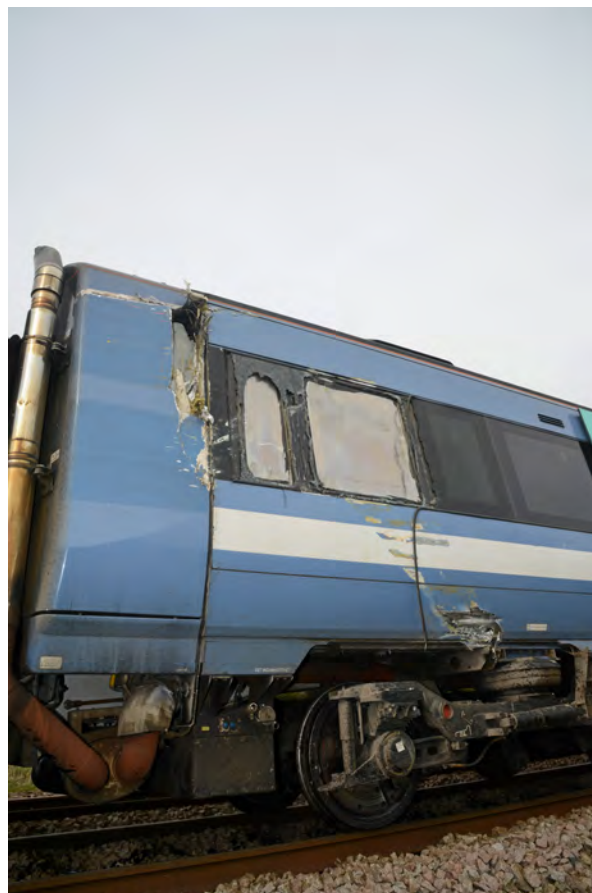
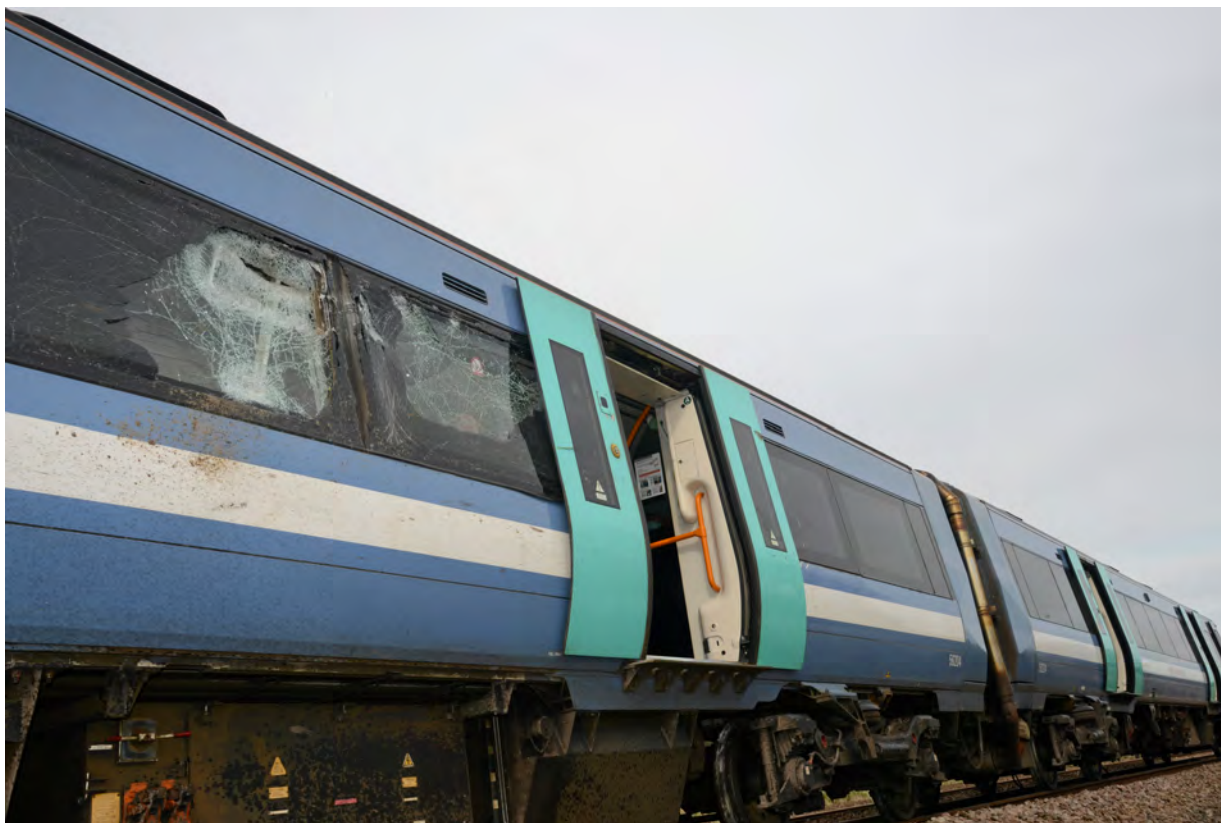
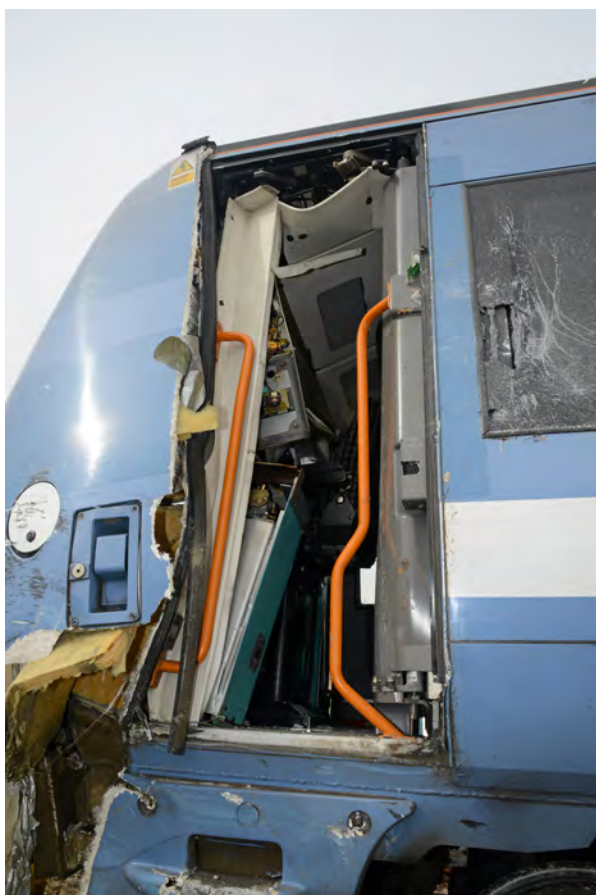
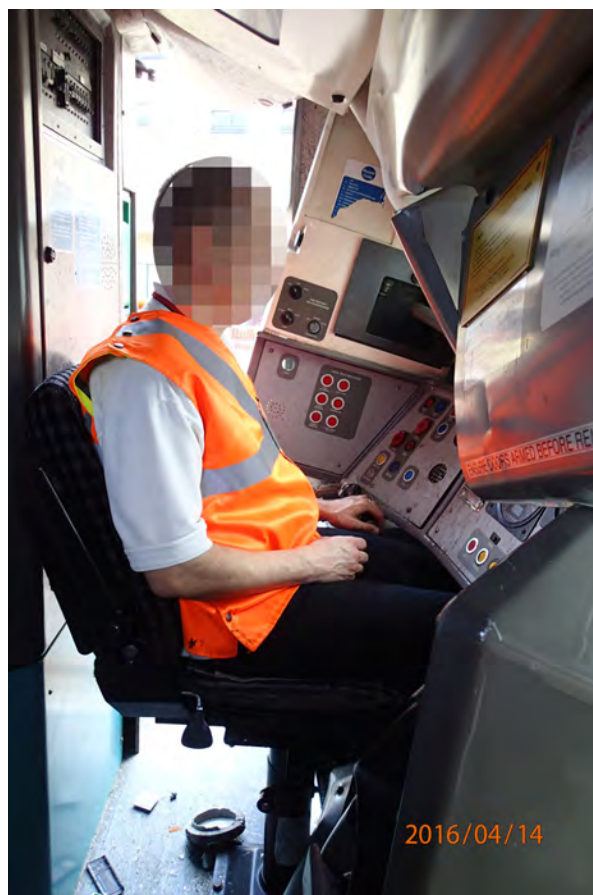
- 32 The train did not derail, but sustained substantial damage to the driving cab. It travelled 410 metres beyond the crossing before stopping (figures 10 to 14). The tractor and animal feeder trailer separated, causing the feed trailer discharge auger (a feeder pipe for discharging foodstuffs or grain) to spin around and strike the side of the train several times, breaking windows and puncturing the outer body side skin. The main part of the trailer came to rest next to the tractor unit in the up side cess, clear of the running lines (figures 16 and 17).

Figure 10: External damage to front of train 1K77

Figure 11: External damage to side of train 1K77

Figure 12: External damage to side of train 1K77

Figure 13: External damage to side of train 1K77

Figure 14: Internal view of cab distortion of train 1K77

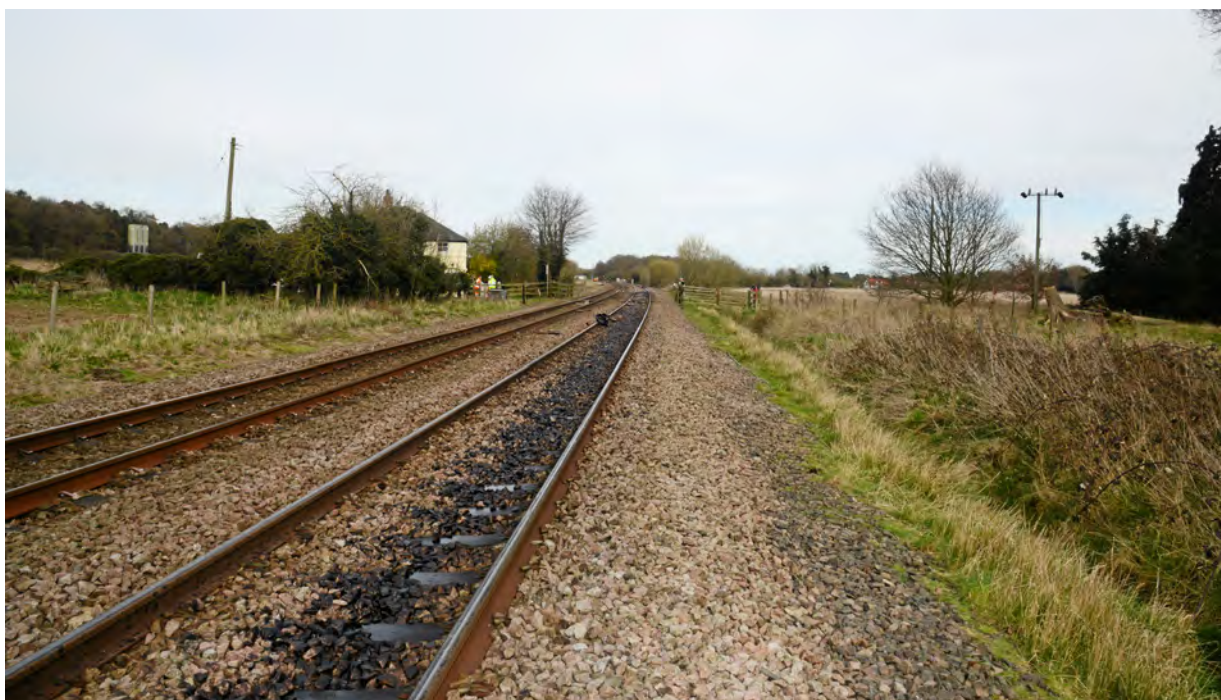
- 33 The tractor's offside wheel and hub assembly broke away from the tractor, and was dragged along the underside of the train, causing a large quantity of diesel fuel, 75 litres of engine oil, and 60 litres of hydrostatic fluid to escape (figure 15).

Figure 15: View from the rear of train 1K77 looking towards Hockham Road UWC

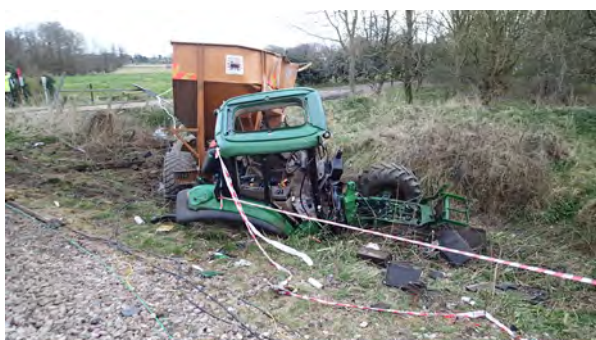
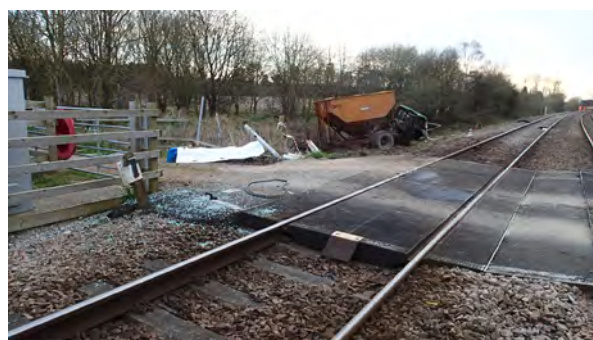
Figures 16 and 17: Remains of tractor and trailer in the up cess after the accident

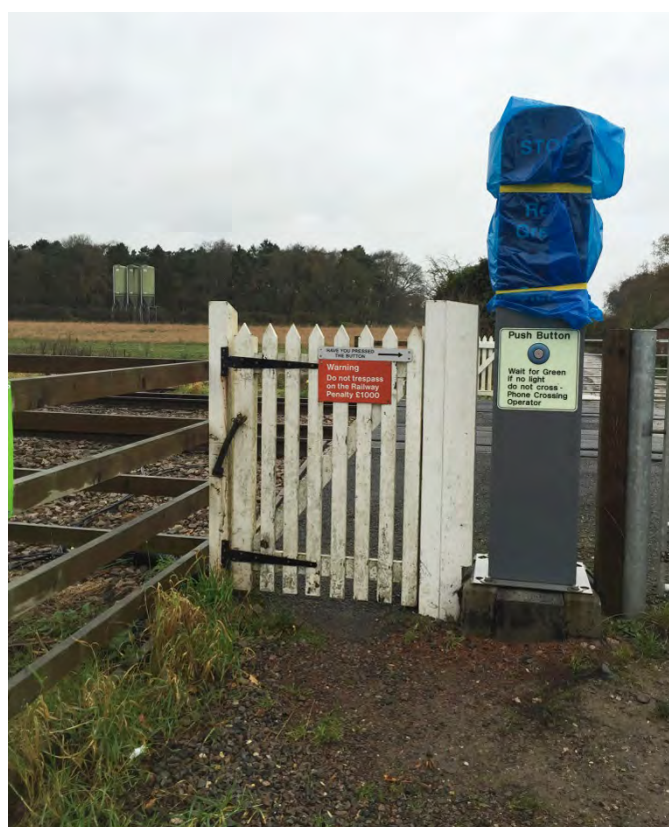
- 15 An *overlay* Miniature Stop Light (MSL) system (a system that is not integrated with the signalling system) known as EBI Gate 200 (see paragraph 49) had been commissioned and installed at Hockham UWC in October 2012, providing the crossing with red and green lights which indicated to users whether it was safe to cross. In October 2015 Network Rail withdrew its product acceptance for the EBI Gate 200 system and decommissioned the equipment at Hockham Road crossing. Further details of these events are in the analysis section of this report.

Figure 19: Decommissioned EBI Gate system – image taken on 08/12/2015 (Courtesy of Network Rail)

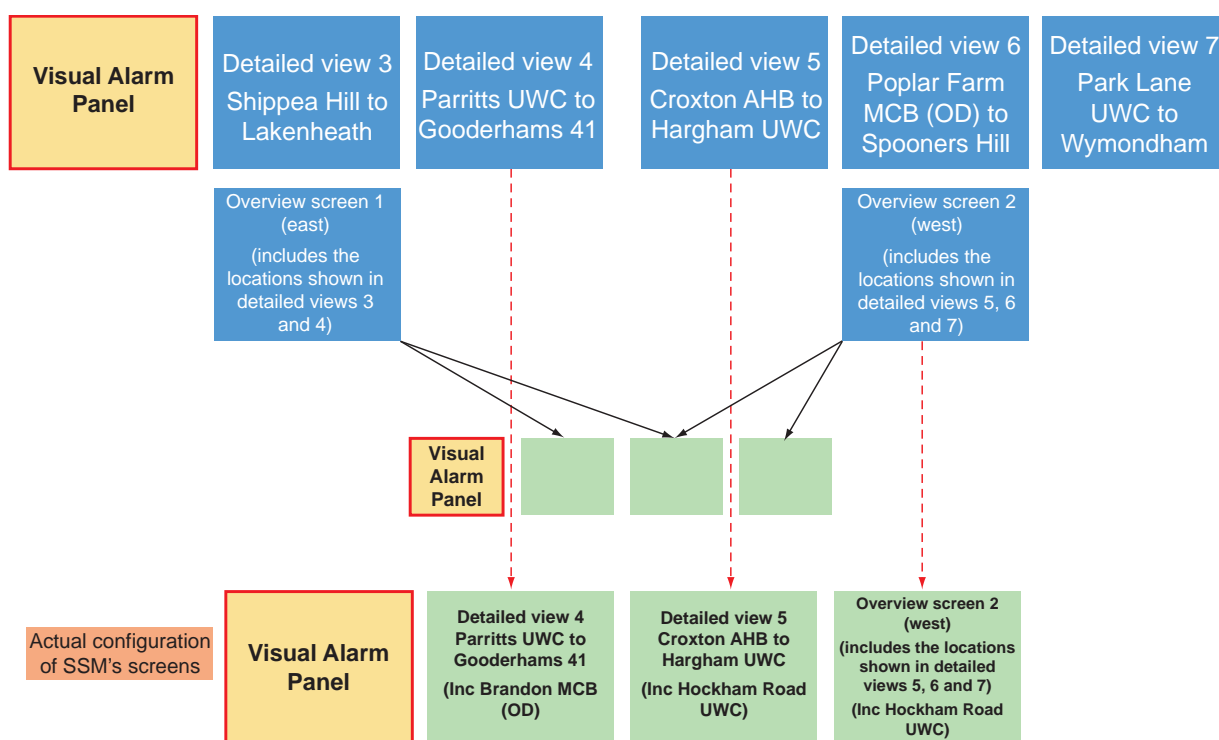
- 63 Although the previous technical issues at Brandon MCB OD (paragraph 22) had been rectified when the signaller took over the workstation, the signaller stated that he may still have had them in mind at the time the tractor driver requested to cross at Hockham Road, because there was a down train, 1K70, in the Brandon area at the time. Evidence shows that train 1K70 was 10 minutes travelling time away from Hockham Road and should not have provided any source of visual distraction on the VDU displays when the signaller was taking the decision to allow the user to cross at Hockham Road. The RAIB has therefore discounted the position of train 1K70 as a factor in the accident. Other possible reasons for why the signaller did not read the display effectively are discussed in paragraphs 72 to 79.

Figure 21: Diagram showing the possible configurations (overview and detailed screen) available to the signaller (in blue) and the actual screen views (in green) visible on the Thetford workstation at the time of the accident

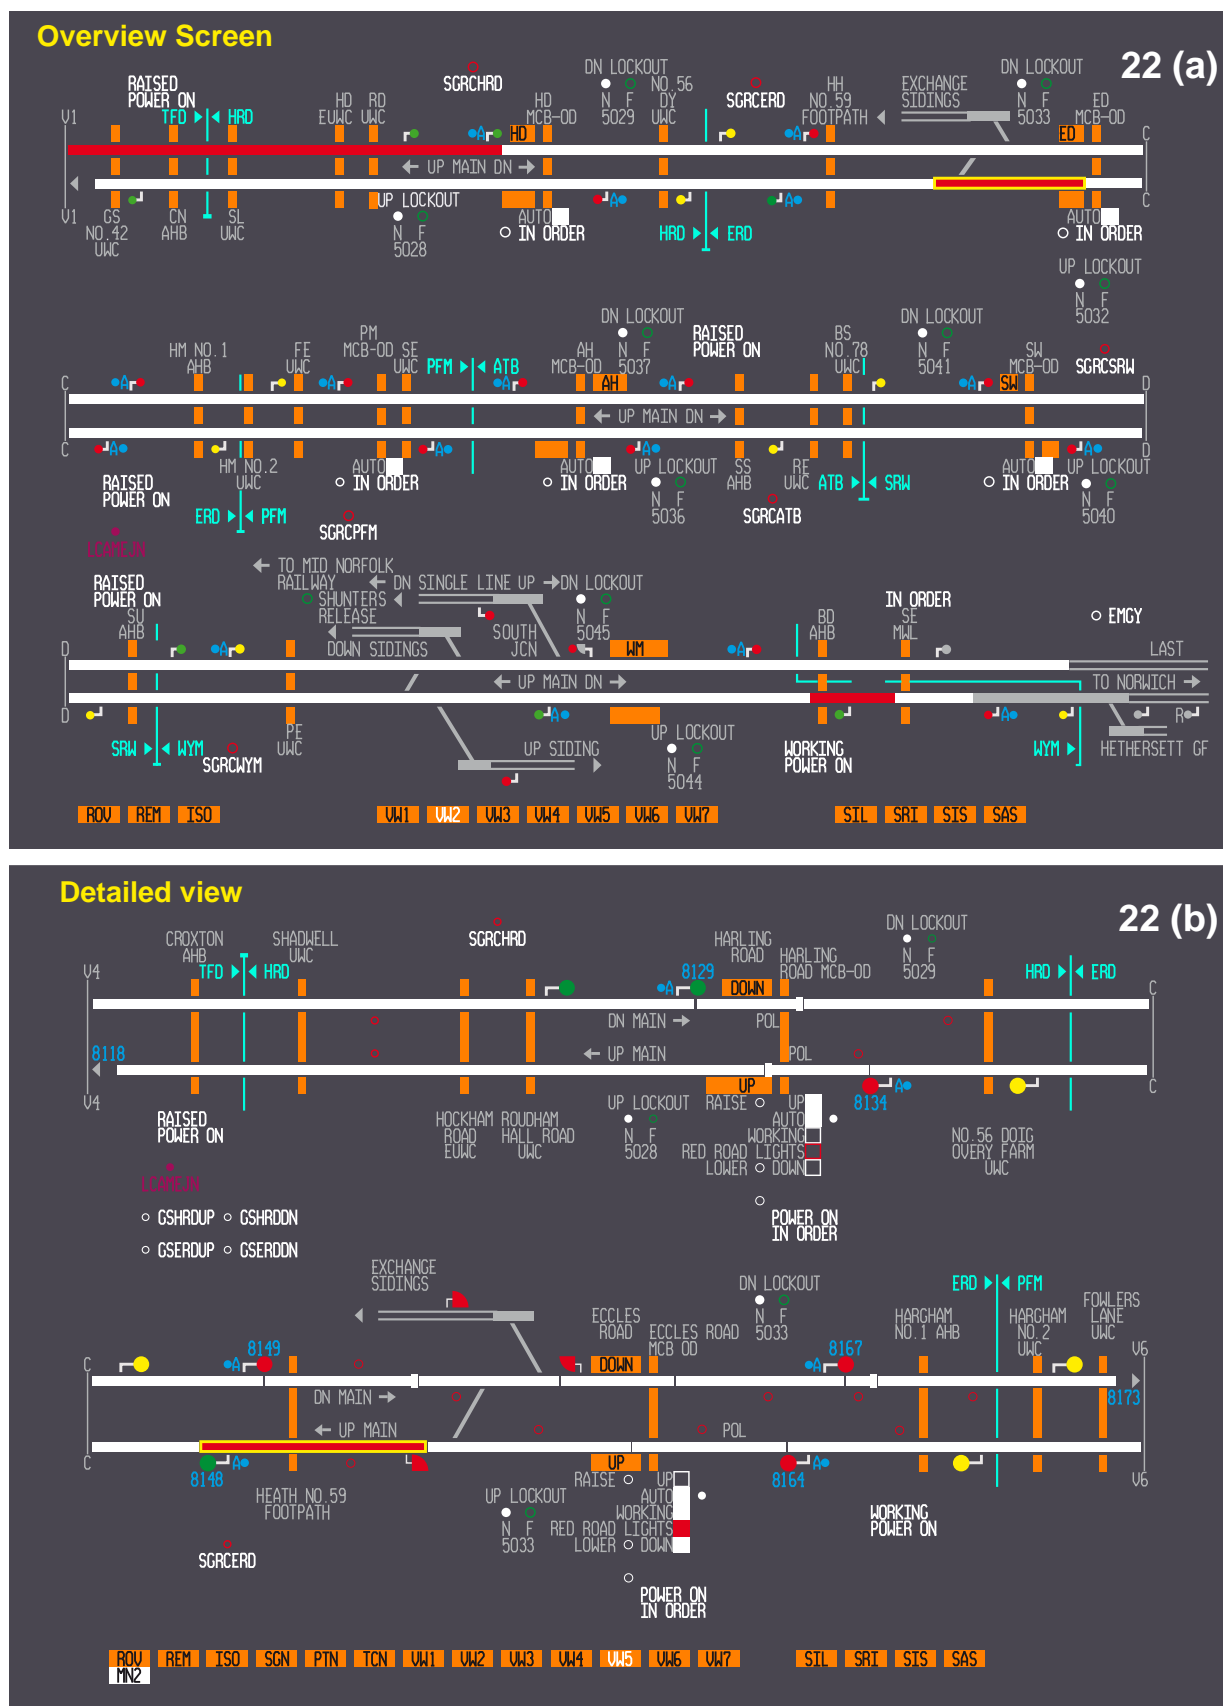
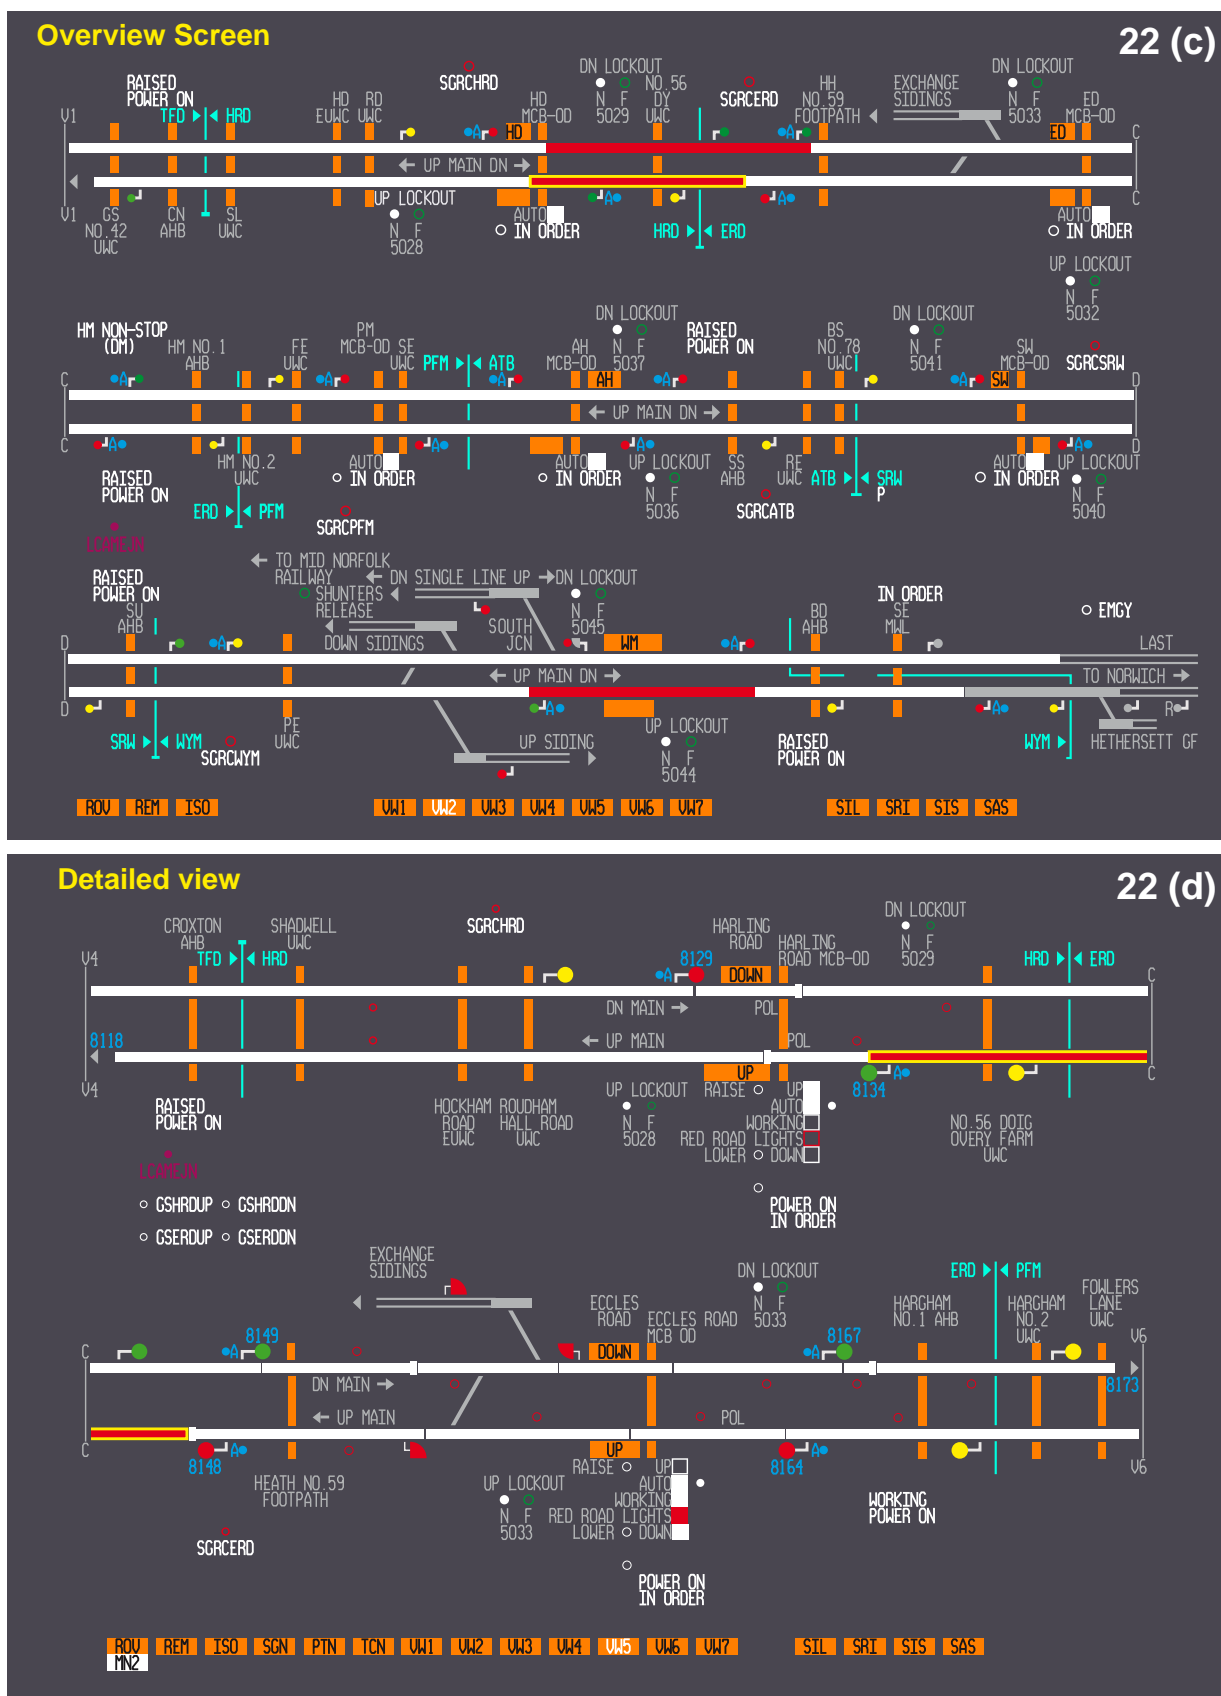
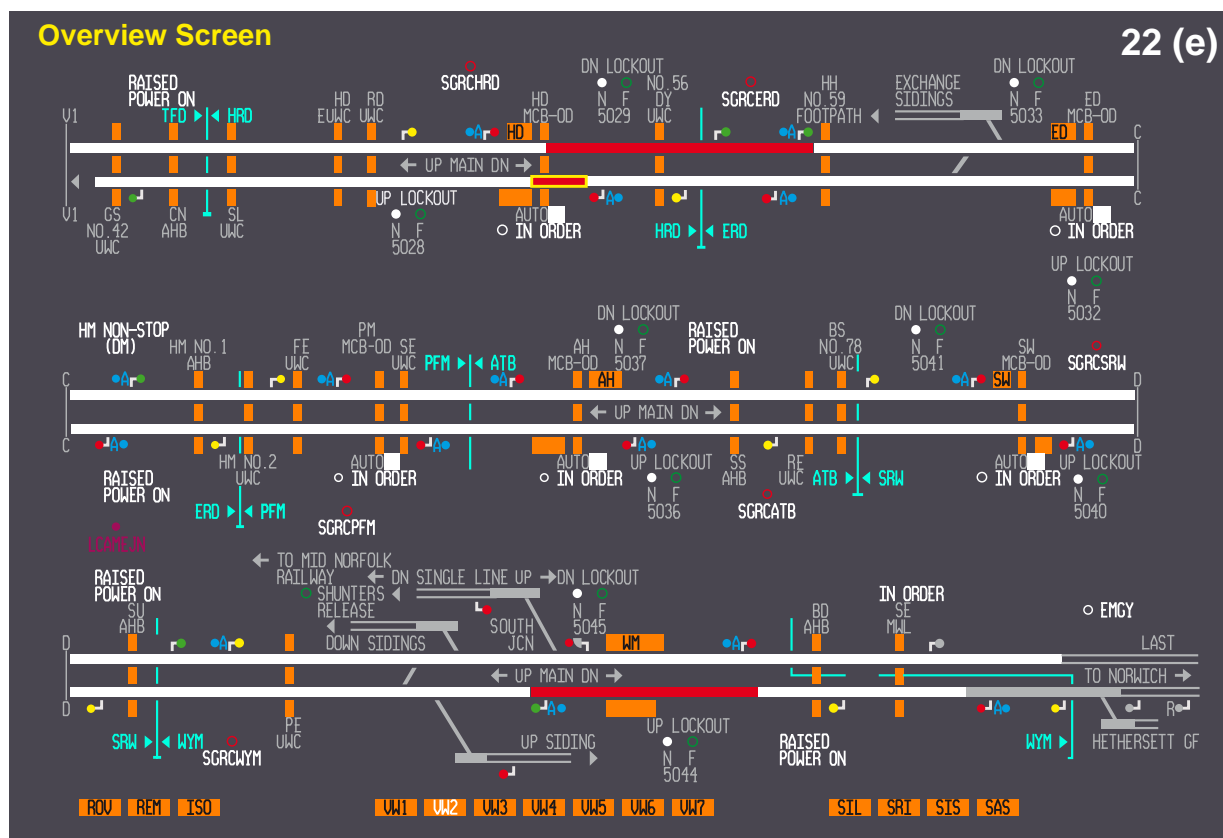
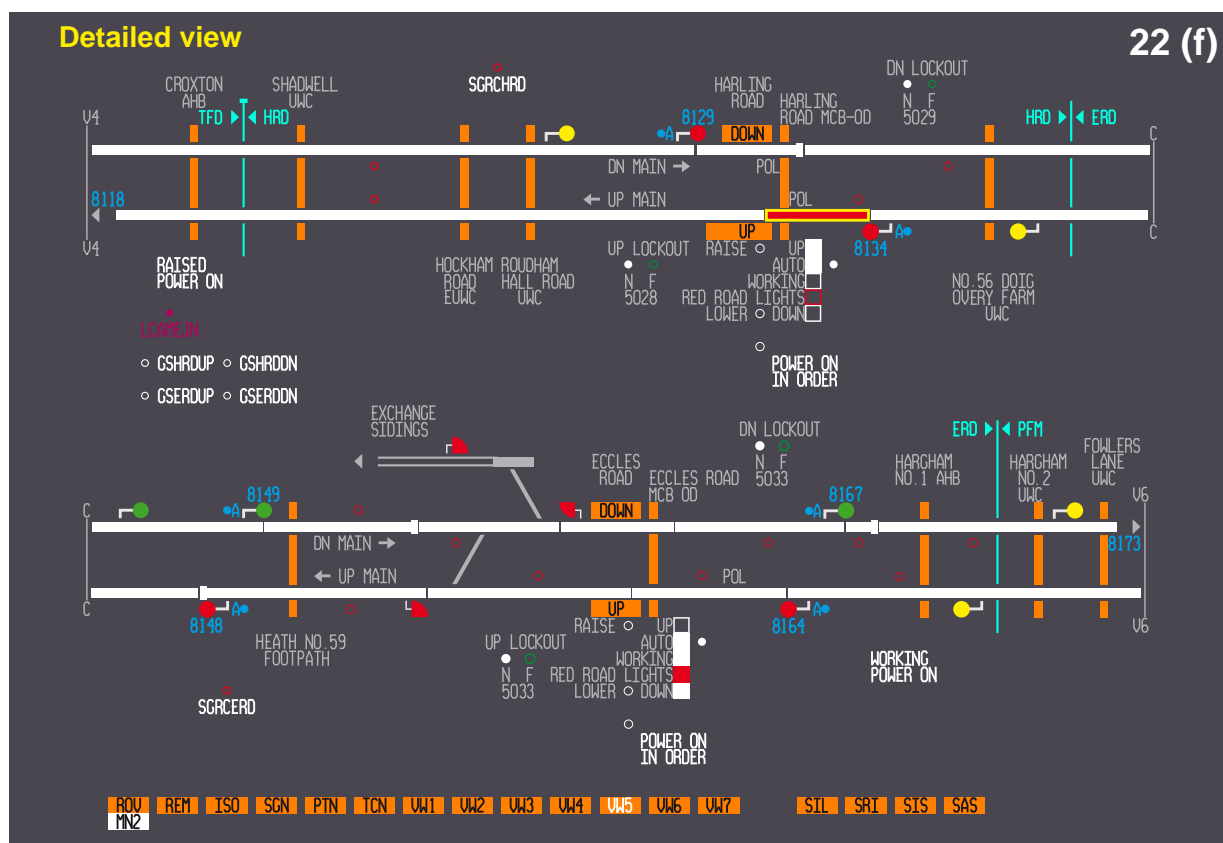
Figures 22 (a) and (b): overview and detailed views with train 1K77 travelling past Eccles Road MCB (OD) crossing at 12:24:46 hrs. Note: train 1K77 was shown as plain red on the VDU display. Highlight (yellow border) added by RAIB.

Figures 22 (c) and (d): overview and detailed views with train 1K77 travelling towards Harling Road MCB (OD) between 12:27:07 and 12:28:50 hrs. The signaller received the call from the user at Hockham Road UWC at 12:28:33 hrs. Note: train 1K77 was shown as plain red on the VDU display. Highlight (yellow border) added by RAIB.

*Figures 22 (e) and (f): overview and detailed views of train 1K77 travelling past Harling Road MCB (OD) between 12:28:50 and 12:28:59 hrs. The signaller terminated the call from the user at Hockham Road UWC at 12:29:00 hrs. Note: train 1K77 was shown as plain red on the VDU display. Highlight (yellow border) added by RAIB.*
