# Rail Accident Report

## **Parting of the live overhead wire at Walkergate station, Tyne and Wear Metro 11 August 2014**

Report 09/2015  
July 2015

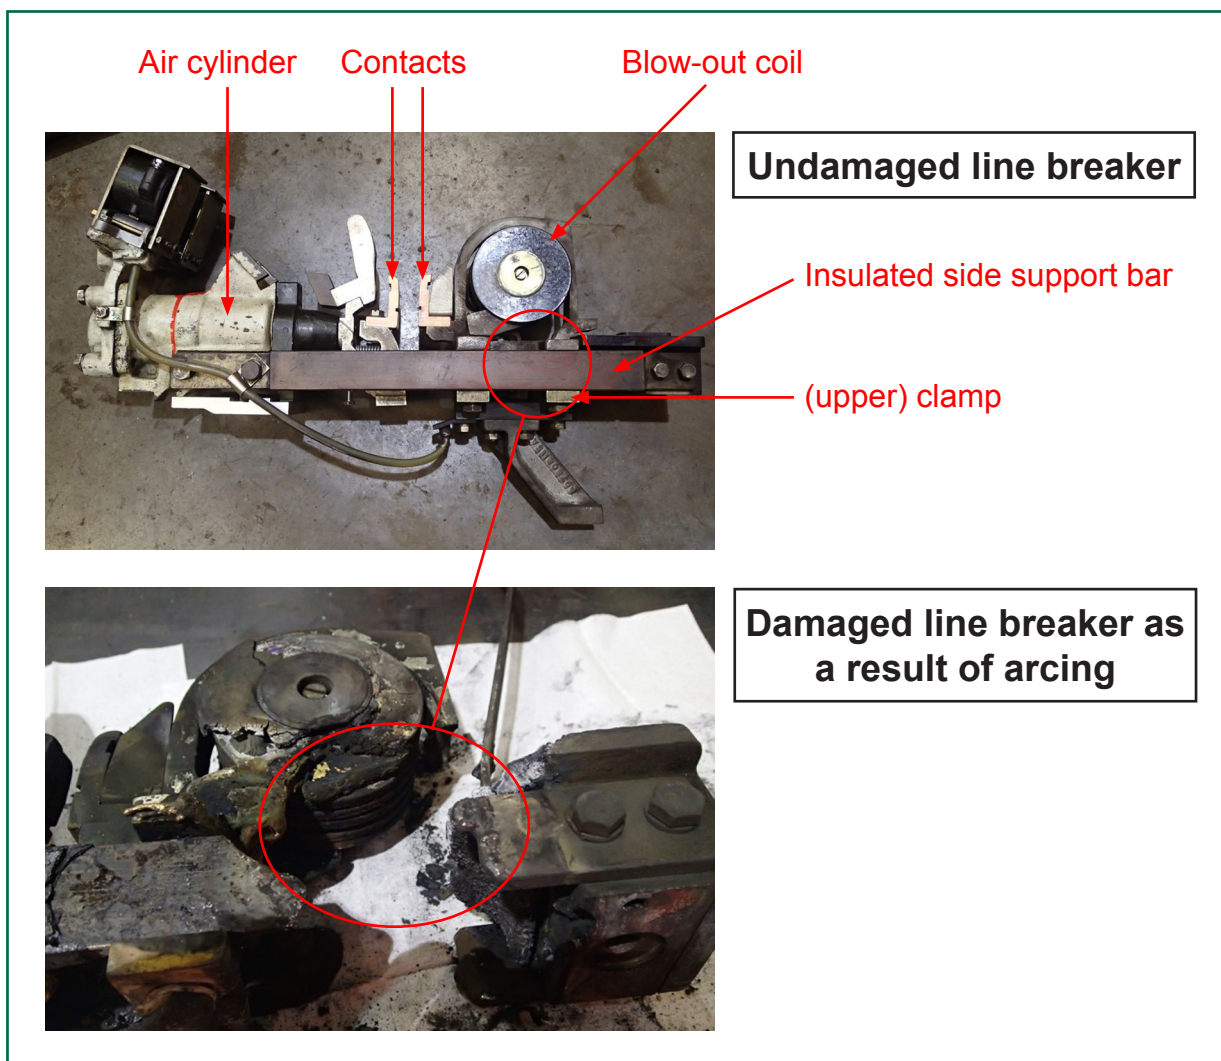
Figure 7: Undamaged and damaged line breakers

- 61 The arcing which affected LB1 appeared to have occurred in the vicinity of the blow-out coil and the insulated side supports (figure 7). The damage was similar to, but not as extensive, as occurred in the previous accident at South Gosforth.

- 63 The damage to LB1 has, in all cases, destroyed evidence of the initiating event. After the accident at Walkergate the ORR took possession of the failed LB1 and another similar line breaker and arranged for an examination and report from the Health and Safety Laboratory (HSL). HSL was unable to reach a firm conclusion on the root cause of line breaker failures but considered that an insulation failure on a line breaker side support (figure 7) would be consistent with the evidence. However, because five of the eight line breaker events have occurred in the Percy Main to Byker electrical section, the report draws a link to the possibility of an unknown external factor.

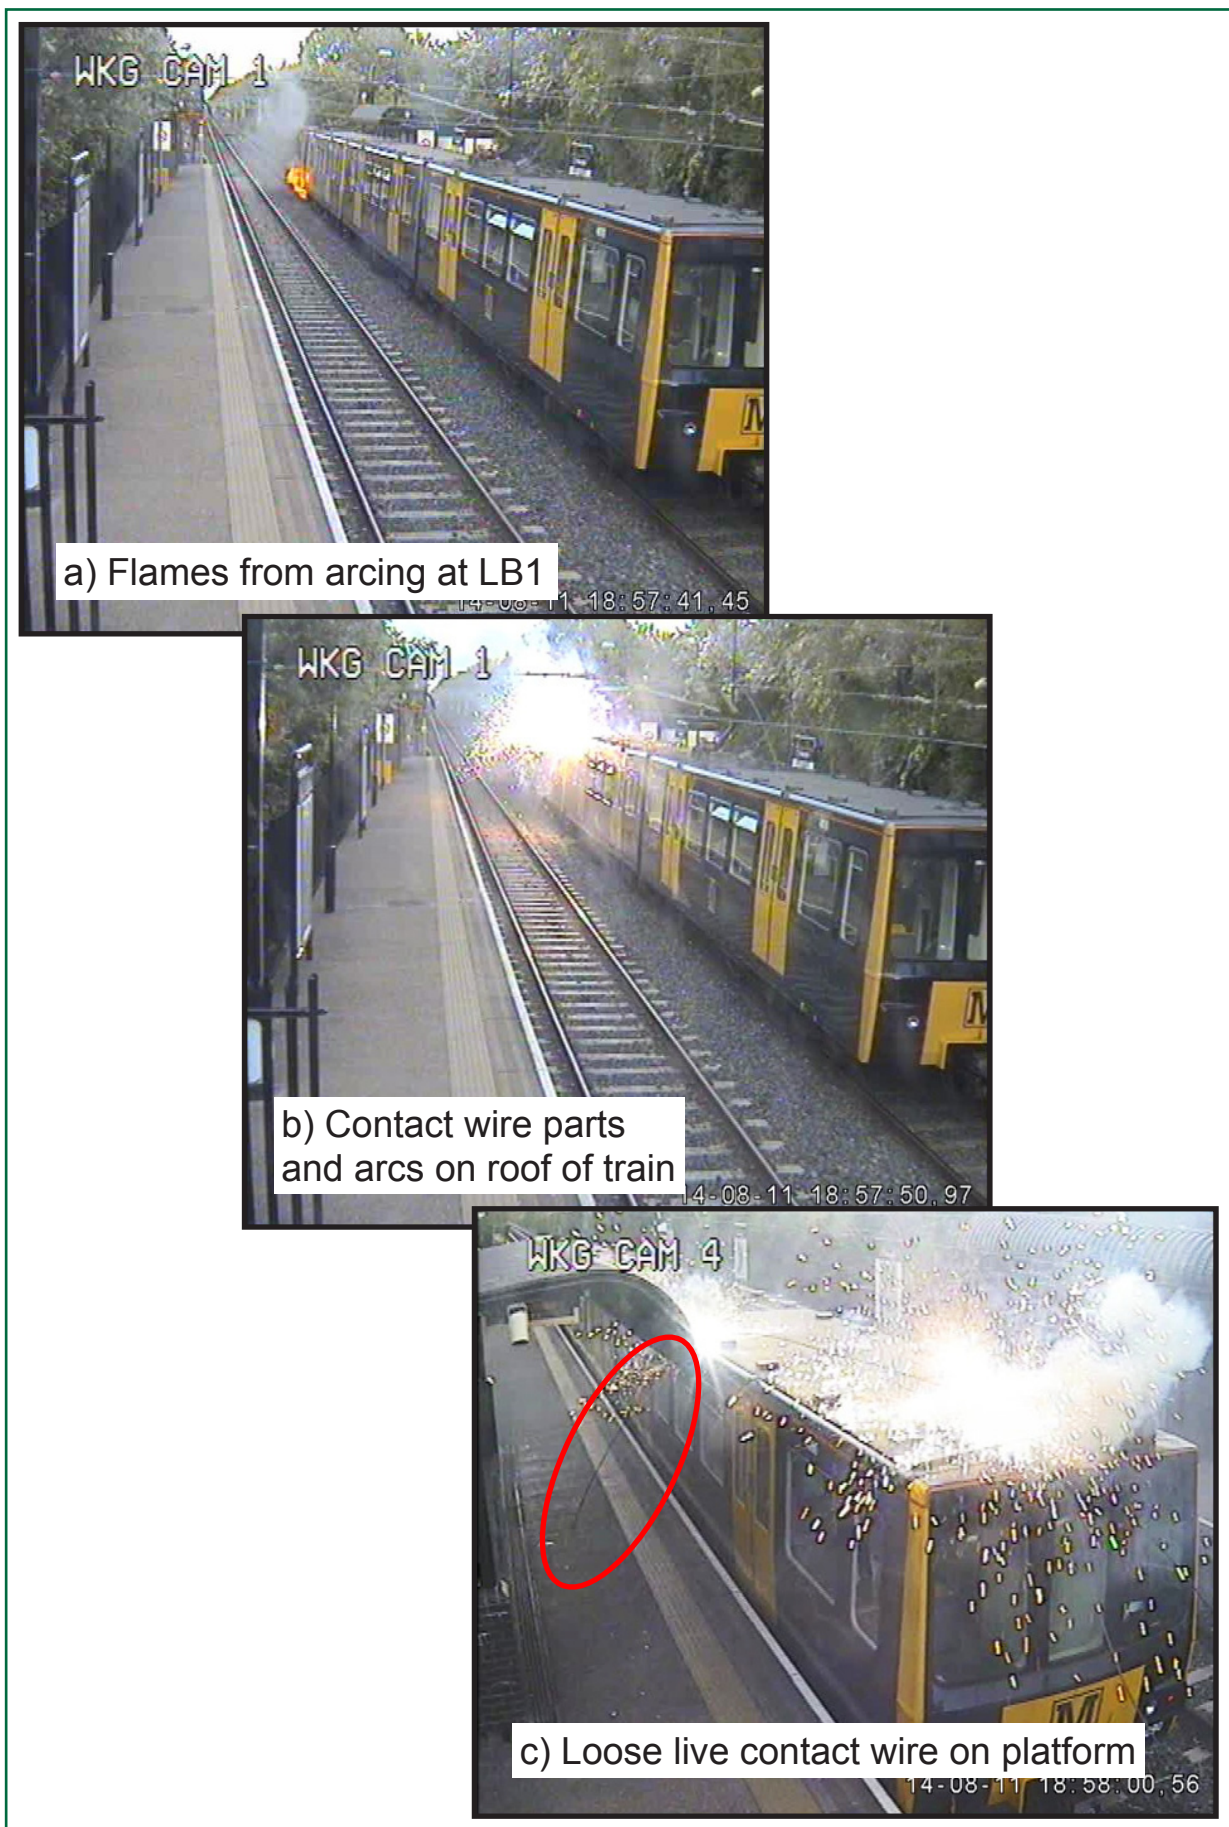
- 45 Before he got to the cab a large flash occurred on the contact wire in the area of the trailing pantograph and the contact wire parted. CCTV footage shows the loose ends of the contact wire whipping around the roofs of both cars, causing arcing and cascading sparks (figure 8b). (The contact wire also parted in two other places; around both pantographs and at a mid-point between them.) After about seven seconds one end of the live contact wire fell on to the platform (figure 8c). The electrical protection did not disconnect the power supply and the wire on the platform remained live.

- 48 The power controller immediately opened Percy Main substation circuit breaker to disconnect the traction power supply to the train. Once the power was removed, the smoke from the line breaker box quickly subsided and the de-energised contact wire came to rest on the platform adjacent to the rear-most set of doors, shown in figure 8c.

Figure 8: Sequence of events during accident (images courtesy of DB Regio Tyne & Wear Ltd)
