# Rail Accident Report

## **Near miss with track workers and trolleys at South Hampstead, London 11 March 2018**

Report 20/2018  
December 2018

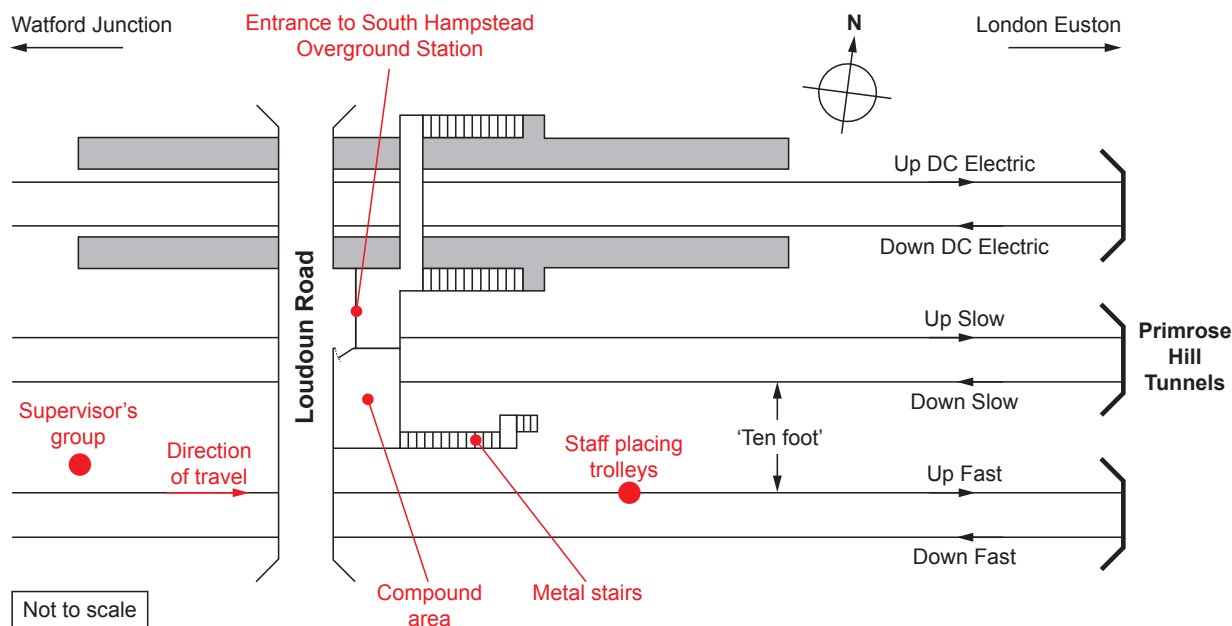
Figure 2: Schematic showing the lines at South Hampstead and the location of the work group at the time of the incident

- 9 There are a total of six running lines in the area (figure 2). In order from northernmost to southernmost they are: the up and down DC electric lines, which are mainly used by London Overground trains; the up and down slow lines; and the up and down fast lines. The up fast line, on which the train was approaching, has a line speed of 80 mph (129 km/h) at the location of the incident reducing to 55 mph (89 km/h) just before the portal of Primrose Hill tunnel, approximately 100 metres to the east.

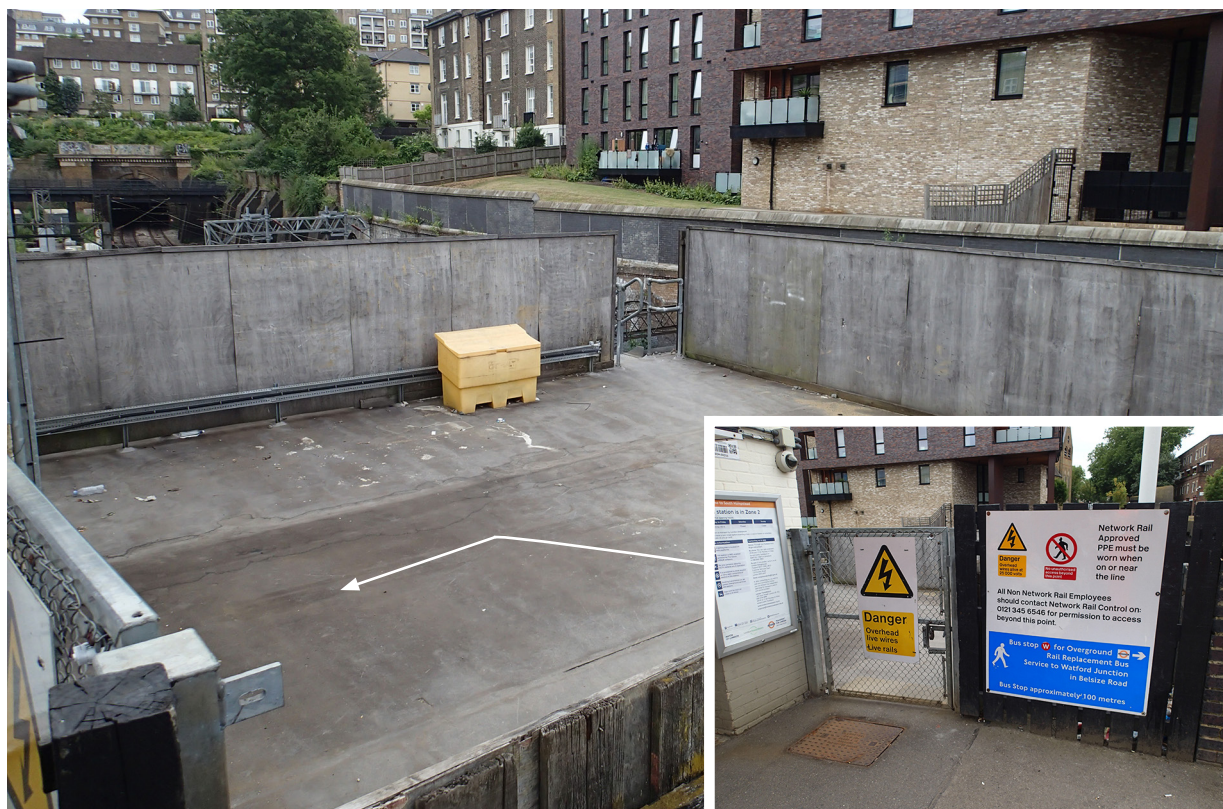
- 10 Directly alongside the station entrance is an access point, entered through a pedestrian gate into a raised compound area above the down slow line (figure 3). A flight of metal stairs leads from the compound to track level. When descending the stairs, the fast lines are to the right, the slow lines to the left. There is a wide space (known as a 'ten-foot') between the fast and slow lines at the bottom of the stairs (figure 4).

Figure 3: View of the compound area from Loudoun Road. (Inset: view of the entrance to the compound, alongside South Hampstead station.)

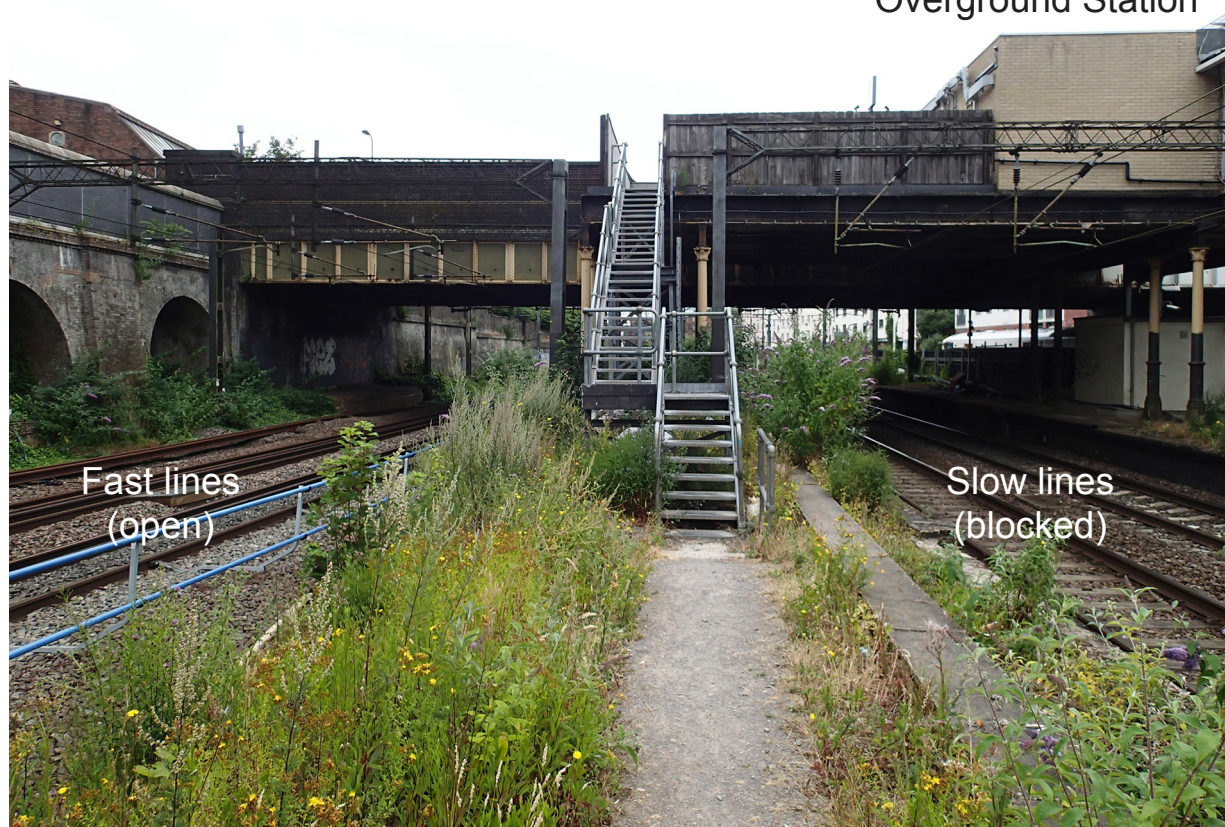
Figure 4: View of the access point stairs from the ten-foot

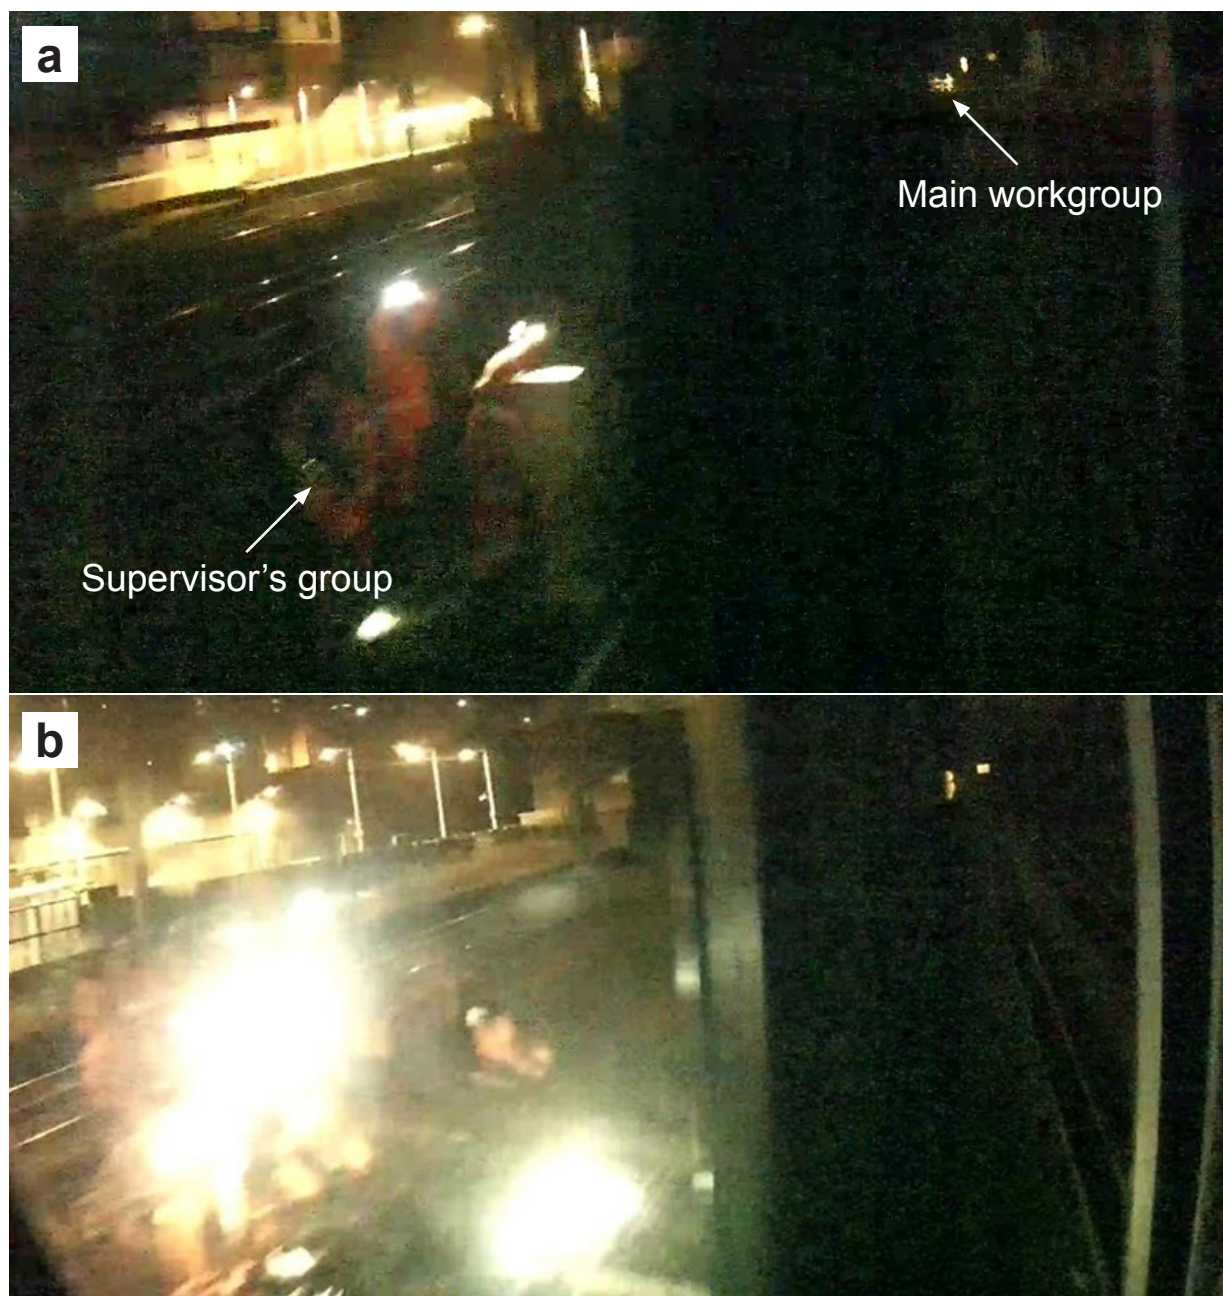
- 54 The train driver saw the supervisor and two staff alongside the line ahead, and then the main work group. He initially sounded the horn continuously for six seconds and then applied full service braking. Forward facing CCTV on the train shows that it passed the supervisor's group five seconds before it reached the main work group.

- 55 The main work group on the track heard the warning from the supervisor and the train horn and managed to remove the two trolley halves and move clear with approximately two seconds to spare. At least two members of the work group were on the up fast line as the train approached.

Figure 5: Forward Facing CCTV image taken a) five seconds before the train reached the main work group and as it was passing the supervisor and two staff; and b) as the train passed the main work group

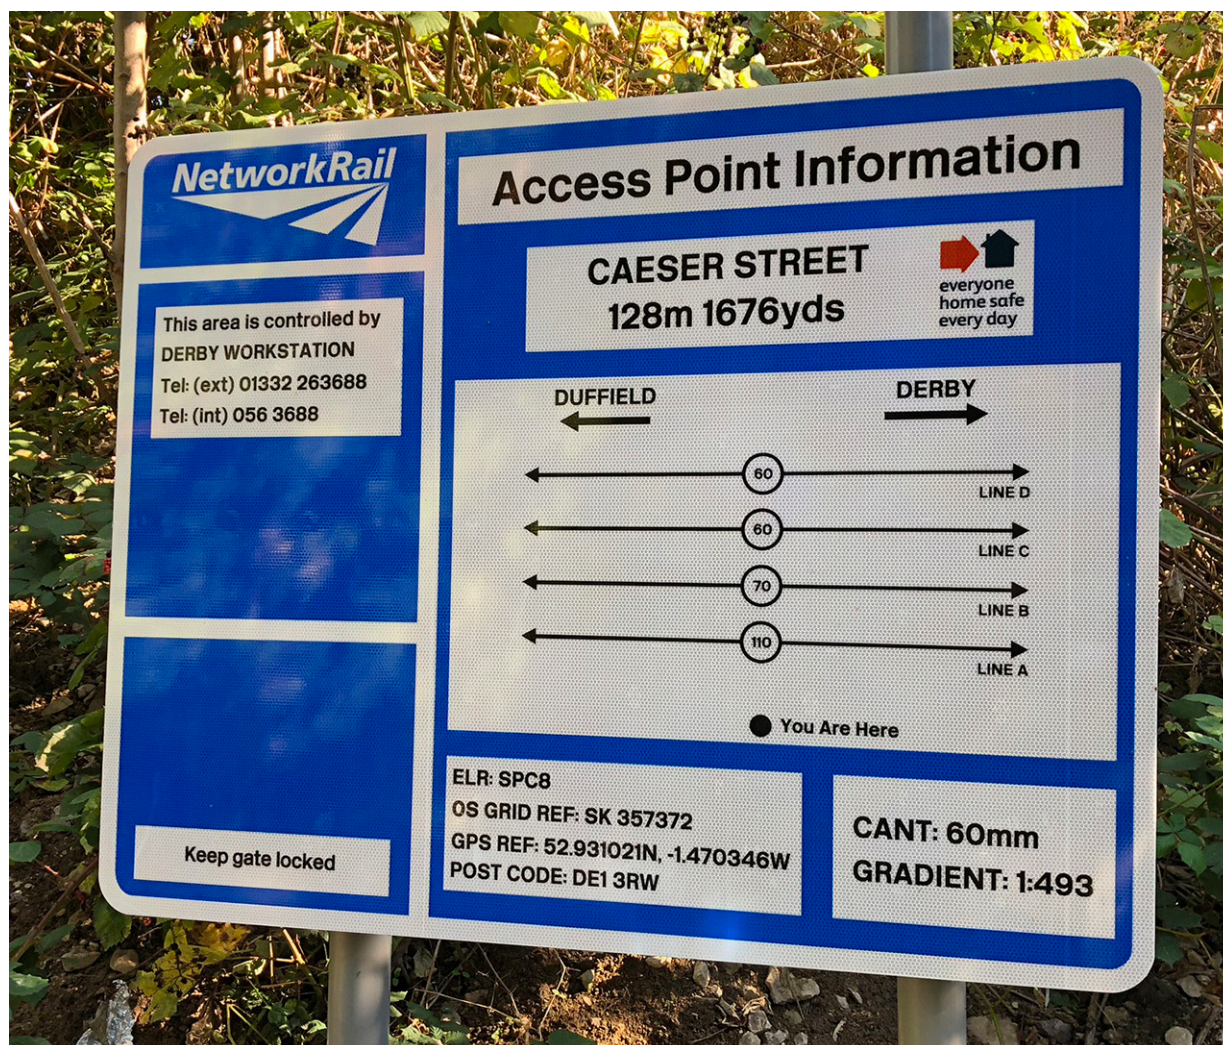
- 76 The staff on site had no visual indication of which lines were which. The RAIB investigation into a collision at Acton West ([RAIB report 15/2009](#)) recommended that Network Rail should provide track layout information at all access points (paragraph 103). Many Network Rail access points now include a sign which shows key information about the access, includes a diagram identifying the lines at the site and indicates where the reader is in relation to those lines (figure 6). If this signage had been available at South Hampstead, it is probable that the COSS and supervisor would have used it check the identity of the lines.

Figure 6: Example of Network Rail access point signage

- 77 There was no access point signage because this access point did not appear in the National Hazard Directory. This document contains details of hazards on the railway infrastructure, as well as the locations of authorised access points. The South Hampstead access point was well known and frequently used by local staff, and provided the only access to equipment rooms near the Primrose Hill tunnels. Network Rail has reported to the RAIB that the omission of this access point from the National Hazard Directory was due to an oversight that it was unaware of.

- amend its National Hazard Directory to include the access point alongside South Hampstead station; and
- provide access point signage to clearly identify each running line to staff using the access point.
