# Rail Accident Report

## Fatal accident at Frampton level crossing 11 May 2014

# Fatal accident at Frampton level crossing, 11 May 2014

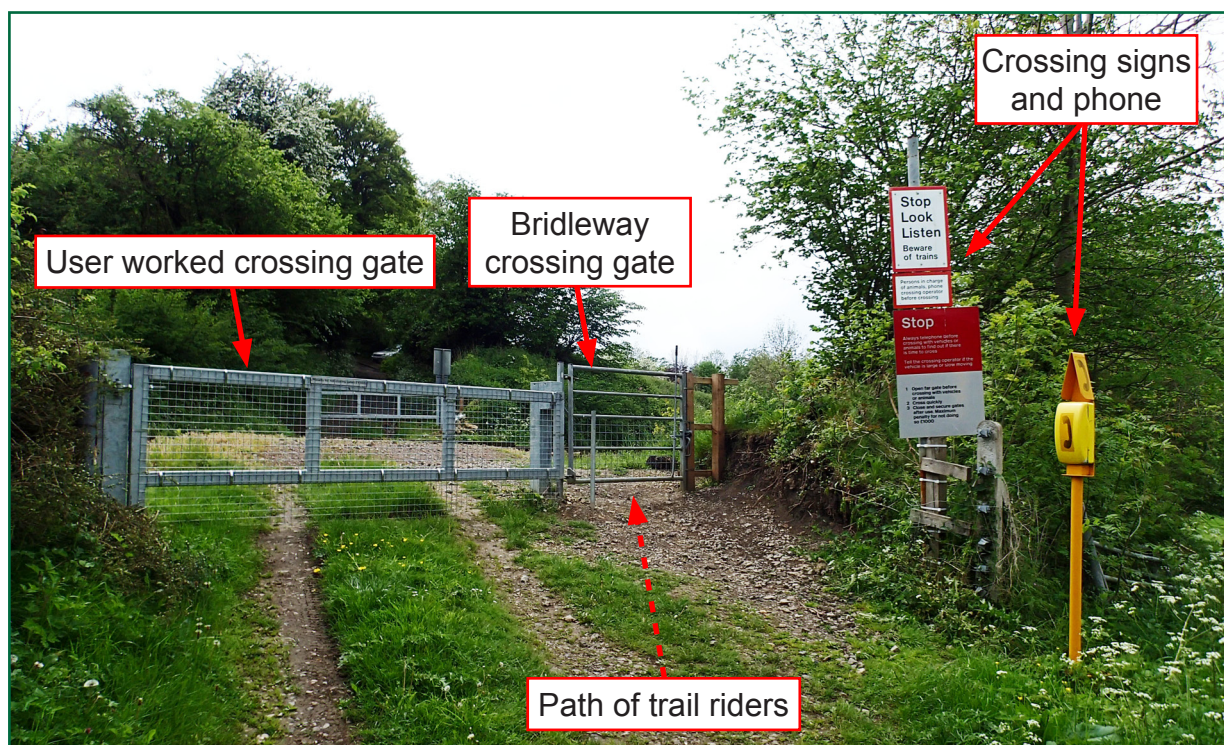
- 8 Frampton level crossing (figure 2) comprised a wide-gated crossing, known as a *user worked crossing* intended for use by *authorised users* with vehicles such as cars and tractors, and a smaller *bridleway crossing* gate intended for use by pedestrians, pedal cyclists, and equestrians (horse riders and persons leading horses). The bridleway gate has a latch and closing spring to prevent it being left open. Both gates gave access to the same crossing surface. Telephones on the approach to the crossing provided a direct line to the signaller controlling train movements in the area. Signs at the crossing instructed people to use the telephone if crossing with vehicles (which includes trail bikes<sup>2</sup>) or animals. The signs did not instruct pedestrians to use the telephones.

Figure 2: Photograph showing the arrangements on the north side of the crossing at the time of the accident

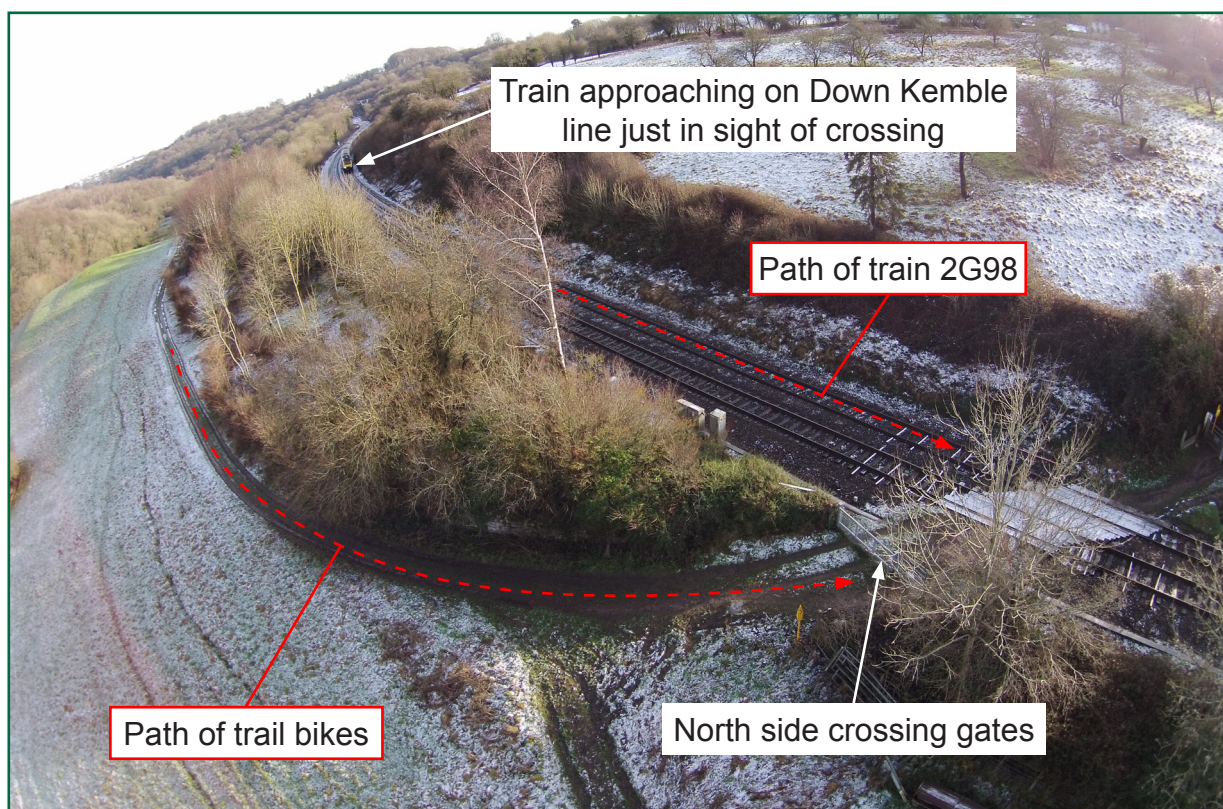
- 9 Trains travelling from Swindon approached Frampton level crossing on a curved section of track which meant that train drivers could not see the crossing until the train was around 175 metres from it (figure 3).

Figure 3: The curved approach to Frampton crossing (January 2015 photograph, altered to show crossing signs at the time of the accident)

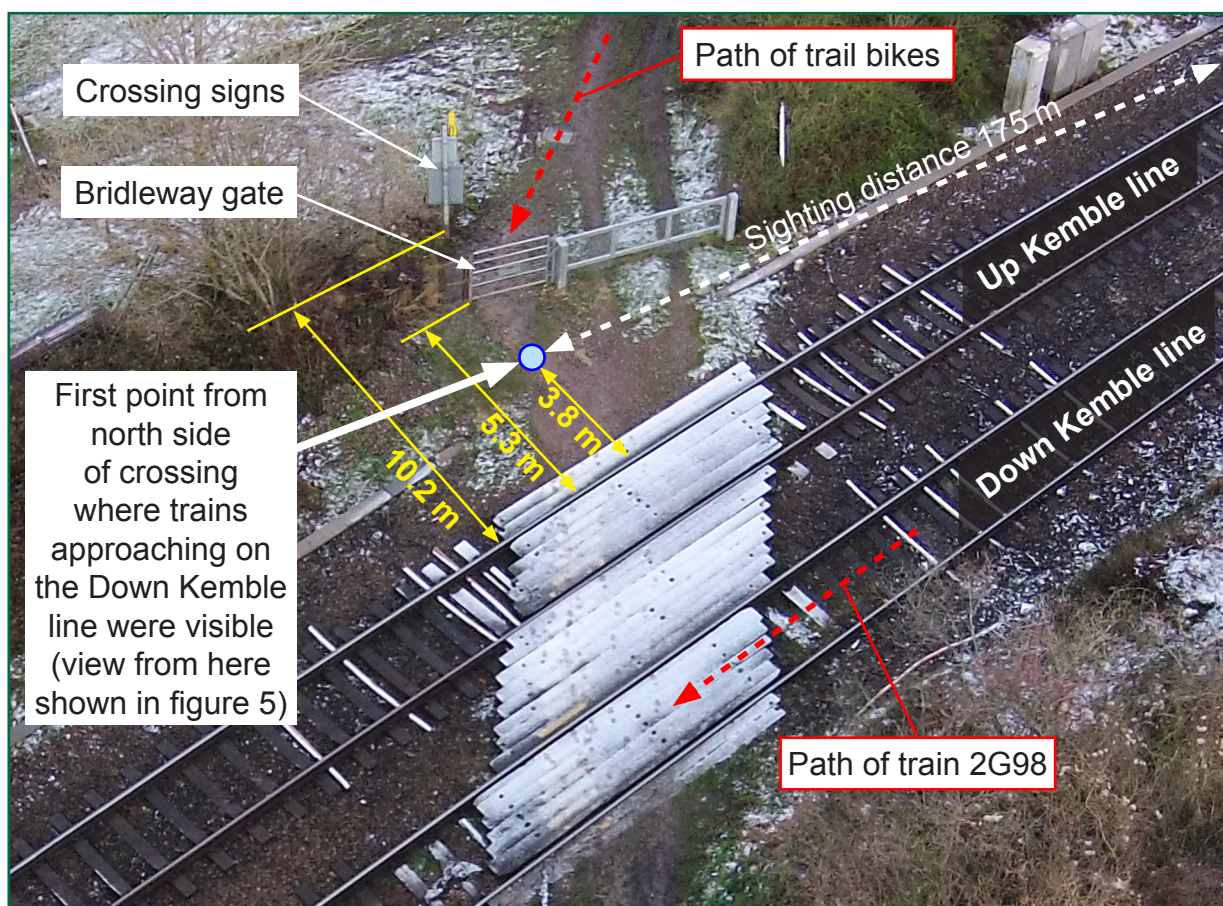
- 10 People approaching the crossing from the north side, the side from which the three riders approached, passed through a crossing gate. At the time of the accident, vegetation growth meant that they then had to reach a position about 3.8 metres from the nearest rail of the Up Kemble line, before they could see trains approaching from the Swindon direction along the Down Kemble line (figures 4 and 5). Because of the track curvature, their *sighting distance* for these trains (the distance to the first point where they could see them) was 175 metres, and their *warning time* (the time taken for a train to travel this distance at the maximum permitted speed) was about 8 seconds.

Figure 4: North side of crossing (January 2015 photograph altered to show crossing signs at the time of the accident)

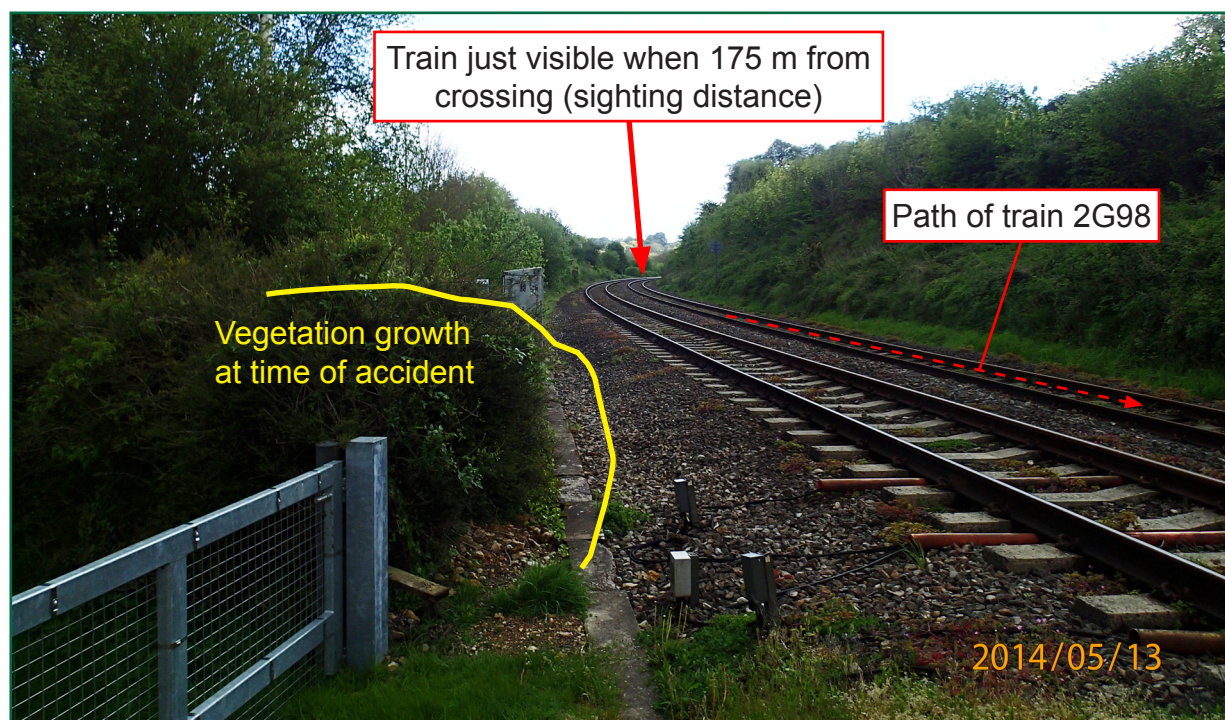
Figure 5: View from north side of crossing towards trains approaching from Swindon (May 2014 photograph)

- 74 At Frampton level crossing, the level crossing signs and bridleway gate were not located at the decision point. On the north side of the crossing the bridleway gate was located around 5.3 metres from the nearest rail, and the signs were located around 9 metres from the nearest rail. When standing at the bridleway gate or at the level crossing signs, it was not possible to see approaching trains because vegetation blocked the view (figure 5).

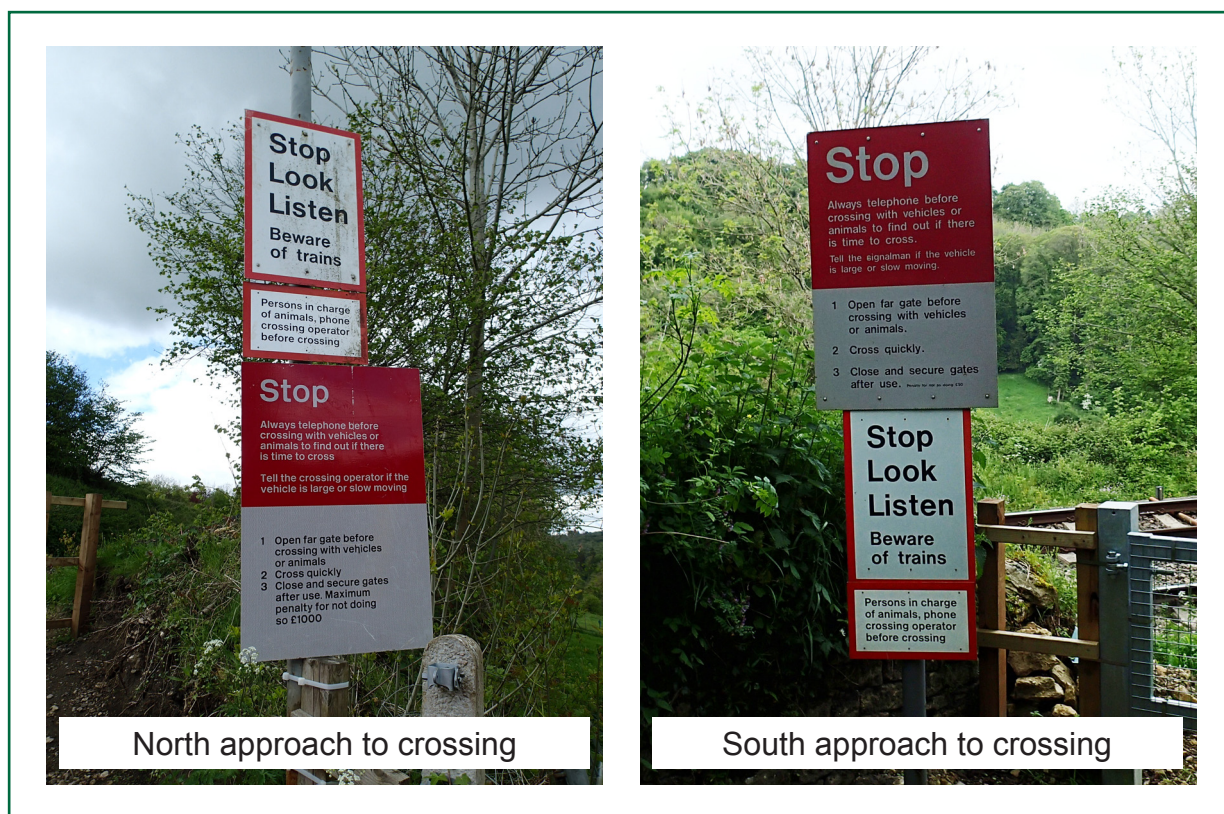
- 61 Signs giving instructions to crossing users are provided on both sides of the crossing and, although the layout of the signs varied, the content was similar on both sides (figure 8). Sighting of trains from the south side of the crossing was more restricted than from the north side (the side on which the trail bikers actually approached the crossing). This meant that risks associated with not acting on the instructions on signs were greater, in some circumstances, for people approaching the crossing from the south side than for those approaching from the north.

Figure 8: Frampton crossing signs

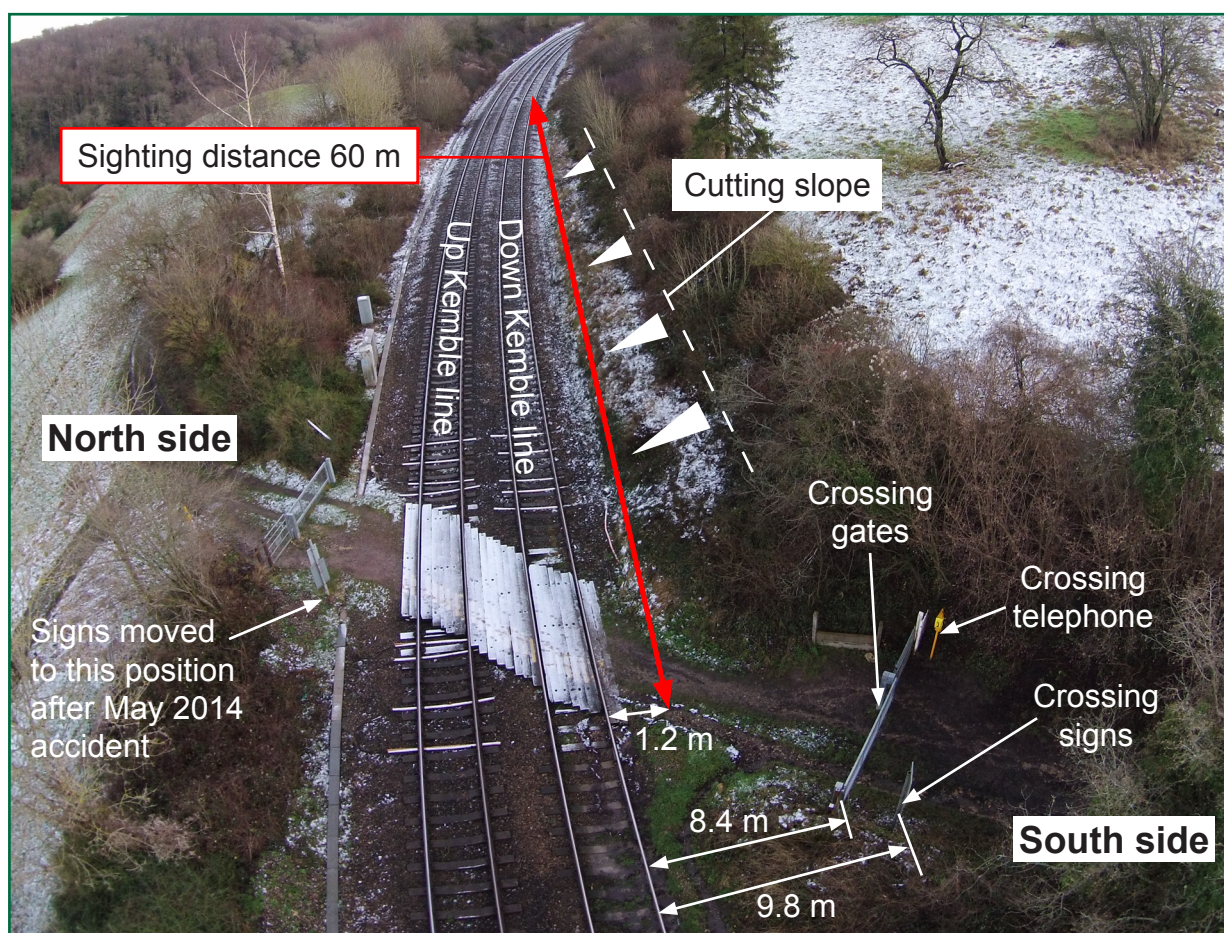
- 75 Although the approach to the south side of the crossing was not relevant to the accident on 11 May 2014, the RAIB noted that the bridleway gate on this side was located around 8.7 metres from the nearest rail, and the signs were located around 10 metres from the nearest rail. Approaching trains could not be seen until a crossing user was around 1.2 metres from the nearest rail because foliage obscured the view in both directions. Even with the foliage removed, sighting distance was limited by track curvature and cutting slopes to around 110 metres (around 5 seconds sighting time) when looking for trains travelling from Gloucester on the Up Kemble line, and to around 60 metres (around 3 seconds sighting time) when looking for trains travelling from Swindon along the Down Kemble line (figure 9).

Figure 9: South side of crossing

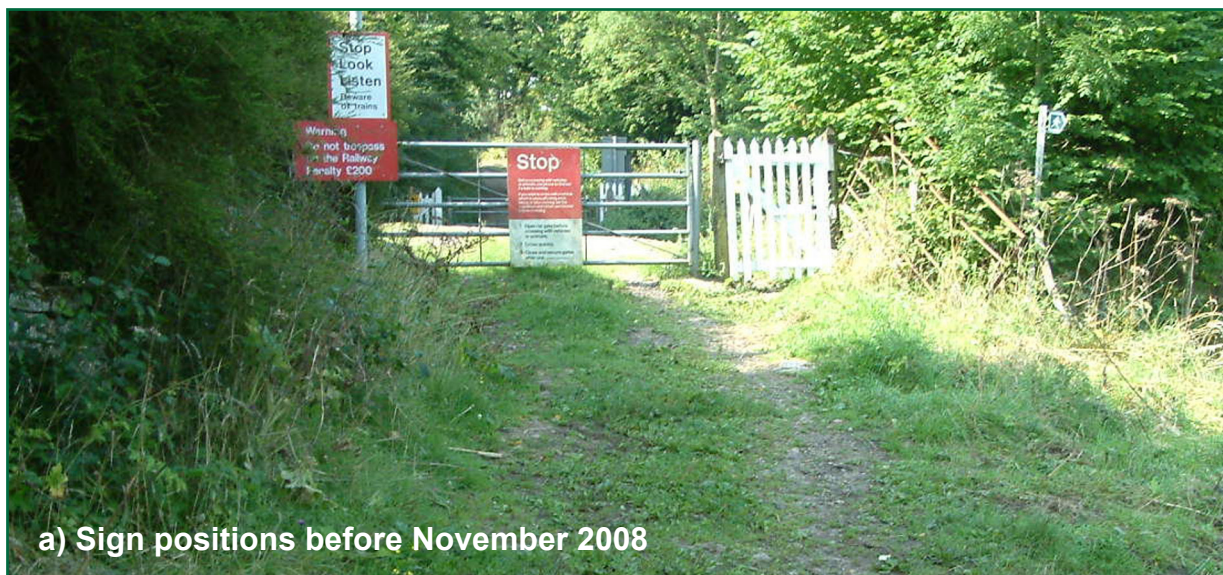
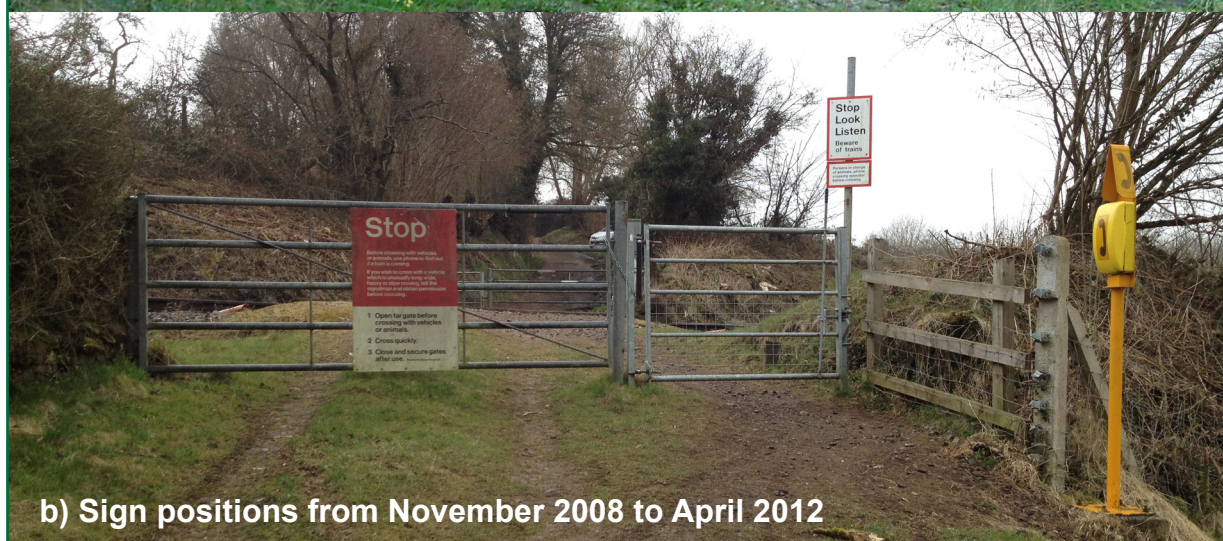
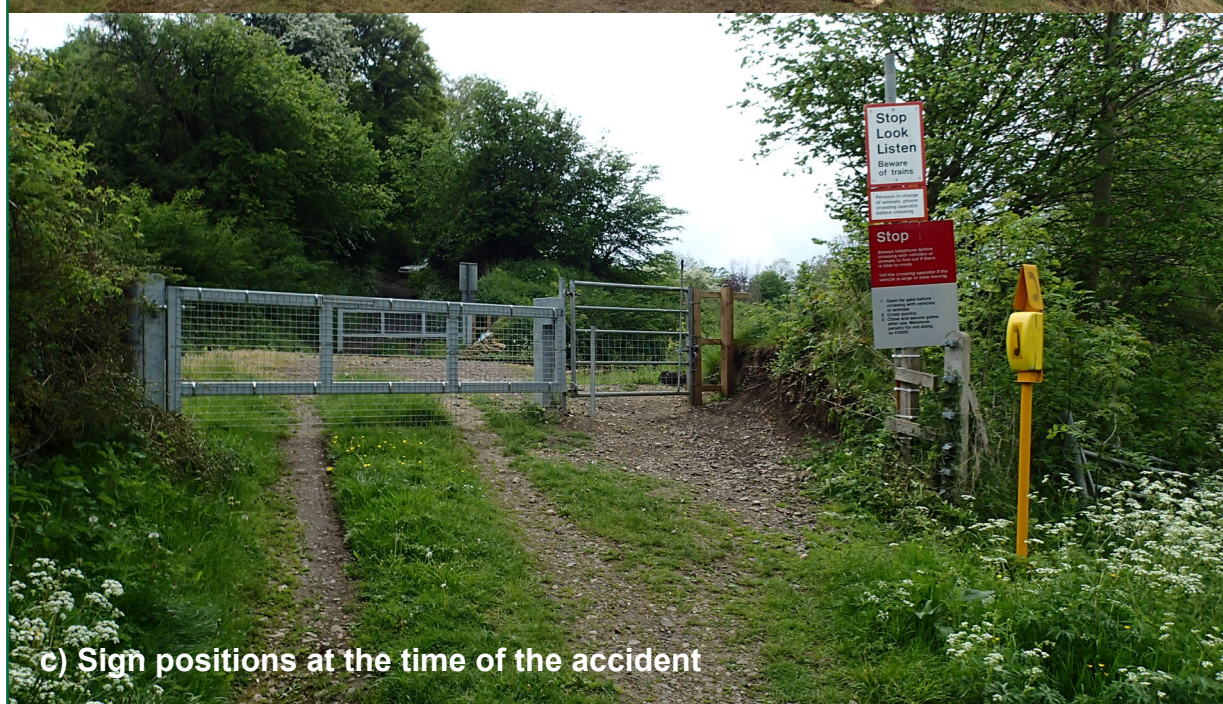
Figures 10a, 10b and 10c: Frampton crossing north side signs
