Rail Accident Report

Overspeed at Fletton Junction, Peterborough 11 September 2015

Report 14/2016
August 2016

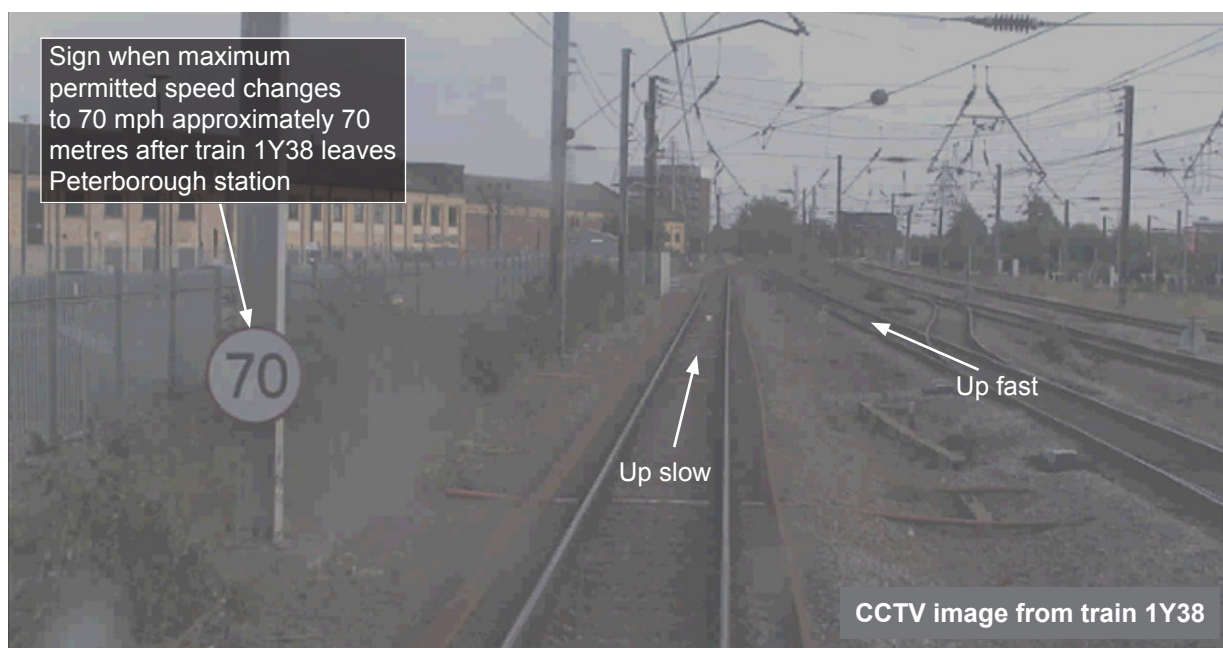
Figure 4: Speed limit sign at location where speed changes (courtesy VTEC)

- 15 Speed limit signs (referred to as *permissible speed indicators* in the railway rule book) are provided on both the up slow and up fast lines at the locations where a new maximum permitted speed applies (figure 4). A 115 mph sign is provided on the up main line, shortly after Fletton Junction, to advise drivers joining from the up slow line that they are now subject to the limit which already applies to trains travelling from the up fast line.

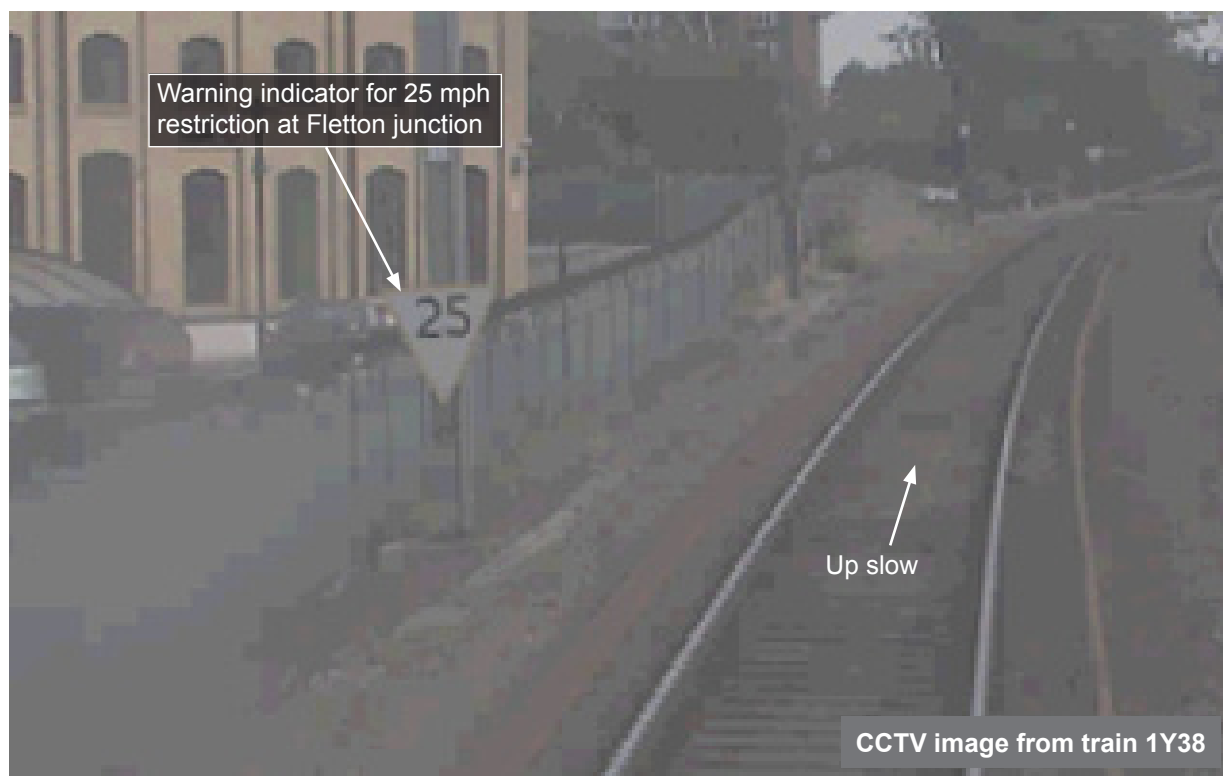
Figure 6: Warning indicator (courtesy VTEC)

- 19 A *warning indicator* for the 25 mph (40 km/h) speed restriction at Fletton Junction is provided by a triangular sign (figure 6) 1200 metres from the start of the restriction (400 metres from Peterborough station). This has an associated AWS permanent magnet which always gives a warning signal and is located 1390 metres from the start of the speed restriction (210 metres from Peterborough station). Paragraph 59 explains why this particular 25 mph (40 km/h) speed restriction requires a warning indicator.

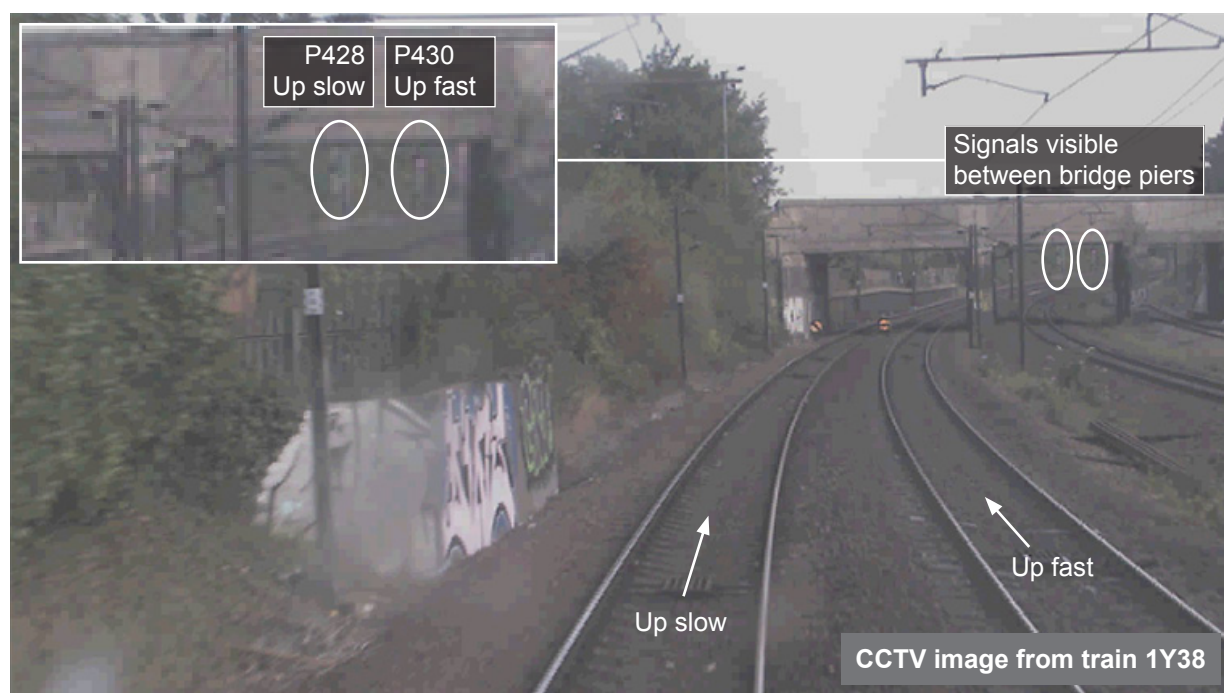
Figure 8: First sighting of signal P428 (courtesy VTEC)

- 37 The driver stated that he was using *commentary driving* between Peterborough and signal P428 to maintain an awareness of the need to stop at this signal if it was displaying a red aspect (this was a response to the yellow aspect of signal P436). Information collected by the *on train data recorder* (OTDR) is consistent with this style of driving and it was appropriate for the train to be driven on the basis of a possible red aspect at signal P428 until the driver saw the actual signal aspect. This means that his driving style before seeing signal P428 provides no indication of whether or not he was aware of the speed restriction at Fletton Junction.

- 40 The driver stated that he was conscious of trying to make up time where possible, but that this was not his main focus. The VTEC professional driving policy acknowledges that punctual train running is an integral part of the process of being a professional driver. There is no evidence to suggest that a desire to make up time led the driver to deliberately exceed the permitted speed. However, it is possible that distraction and fatigue caused by his home-related stress meant that this desire took increased prominence when he saw the green aspect of signal P428.

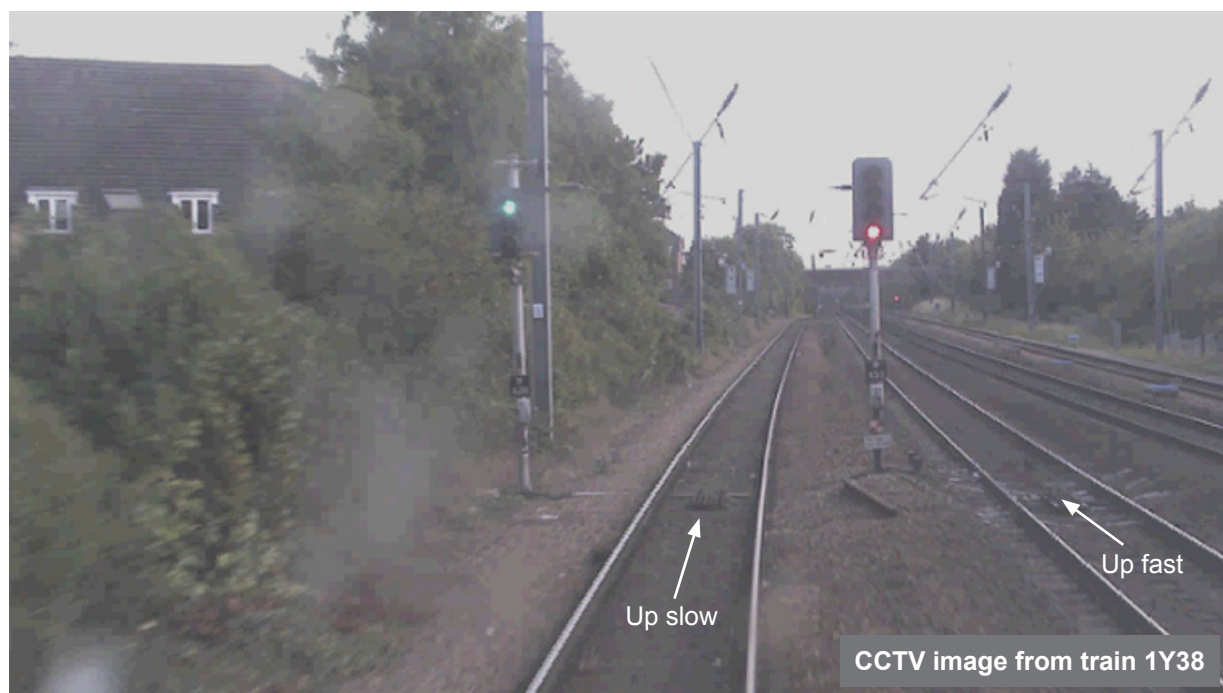
Figure 9: Passing between signals P428 and P430 (courtesy VTEC)

- b. When applying full power after sighting signals P428 and P430, signal P430 (the fast line signal) was displaying a red aspect which should have caused the driver to stop if he believed he was on the up fast line (table 1, 125 seconds, figure 8).

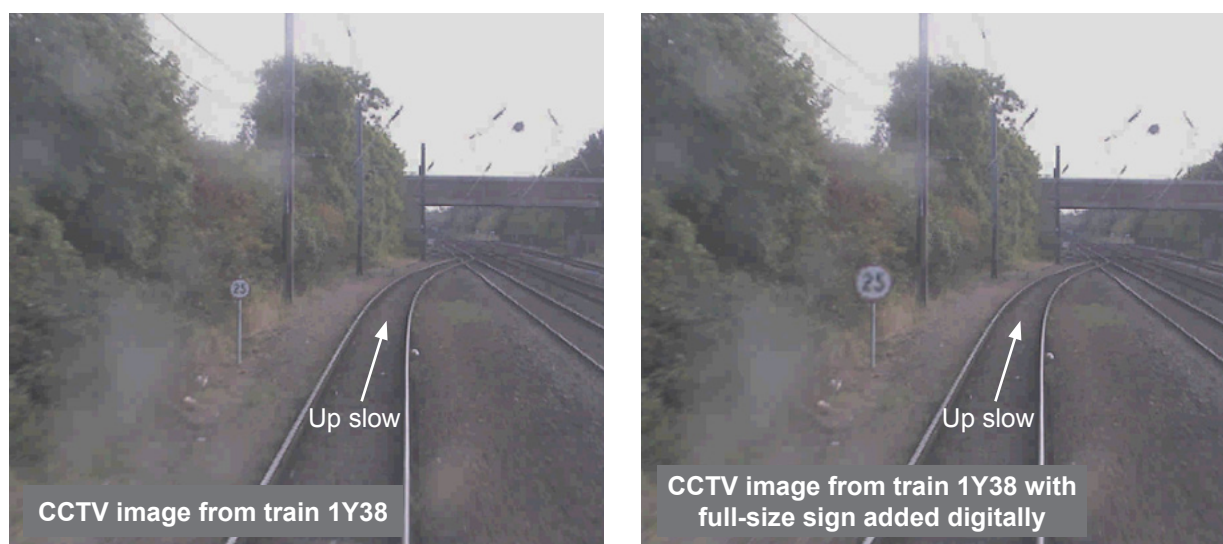
Figure 10: Speed limit sign size comparison (original image courtesy VTEC)

- 65 A full-size sign would have been more apparent (figure 10) and, if noticed by the driver of train 1Y38 at the sighting distance for this type of sign (in excess of 200 metres⁹), it would have provided enough distance for him to slow the train to comply with the speed restriction. The driver did not notice the miniature sign, probably due to distraction (paragraph 39), so it is not certain whether, or when, a bigger sign would have caught his attention.

- 122 Network Rail has replaced the non-compliant miniature permitted speed restriction sign at Fletton Junction with a full-sized sign compliant with current standards.

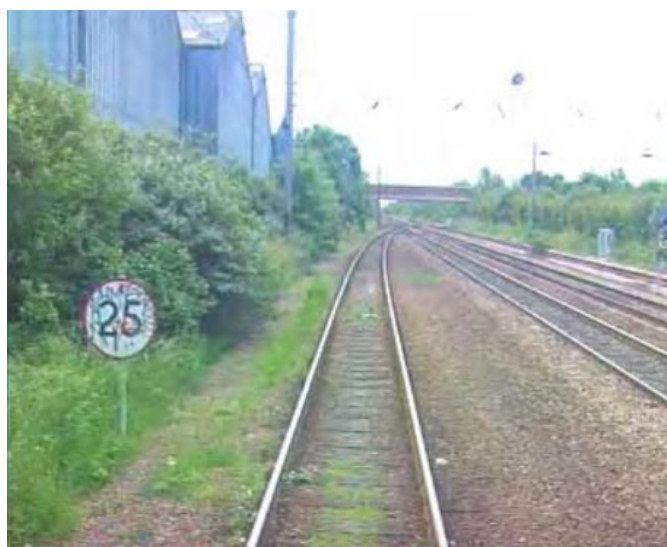
Figure 11: Full-size permissible speed indicator at Fletton Junction in 2002 (image courtesy of Network Rail)

- 87 **Network Rail's procedures did not identify that the speed restriction sign at Fletton Junction was smaller than required by its standards and this is a possible underlying factor.**
- 88 It is possible that a full-size permissible speed indicator at start of the 25 mph (40 km/h) speed restriction, rather than the miniature sign actually provided, would have caught the driver's attention and resulted in the driver reducing the train's speed before reaching Fletton Junction (paragraph 63).
- 89 A forward facing closed circuit television (CCTV) image taken on 18 June 2002 shows a full-size permissible speed indicator at Fletton Junction (figure 11). Network Rail has not been able to determine when the sign was replaced by the miniature sign, or why.
