Rail Accident Report

**Fatal collision between a tram and a pedestrian,
near Saughton tram stop, Edinburgh
11 September 2018**

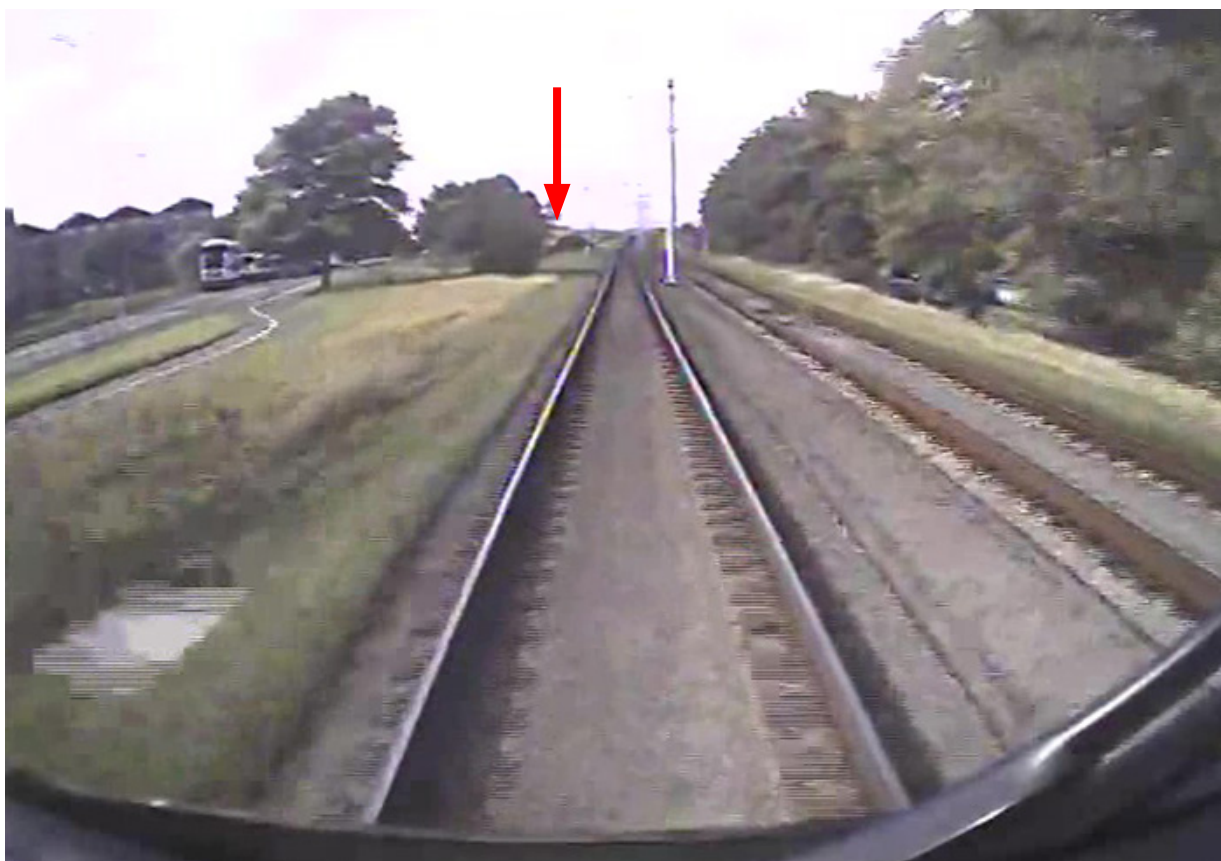
Figure 4: Image from the FFCCTV of tram 260 at around 73 metres from the crossing and 4.6 seconds before the collision. The arrow indicates the location from which the pedestrian emerges very shortly afterwards.

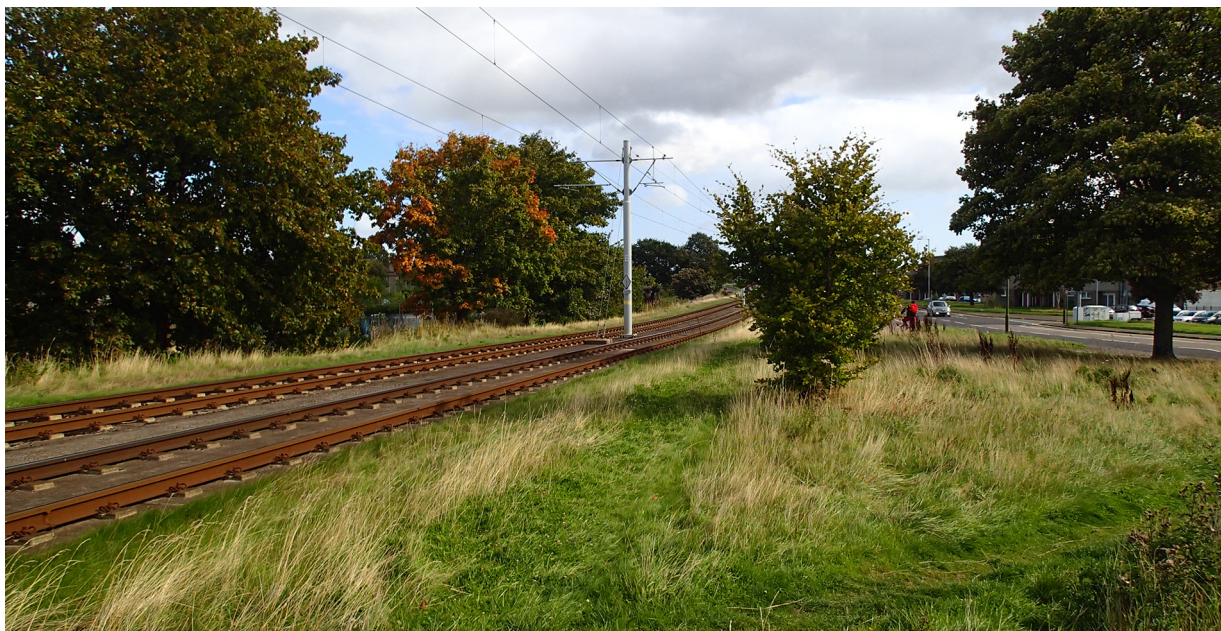
42 Photographs taken following the accident show that airport bound trams would be visible from the footpath when viewed from distances closer than approximately 6 metres from the nearest running rail of the crossing (figure 6). Images from the FFCCTV of the tram show that the pedestrian became visible when at this distance from the crossing, and the images suggest that the pedestrian did not look, or change his stride beyond this point until just before the collision.

Figure 6: The view to the east from the footpath at 6 metres from the crossing

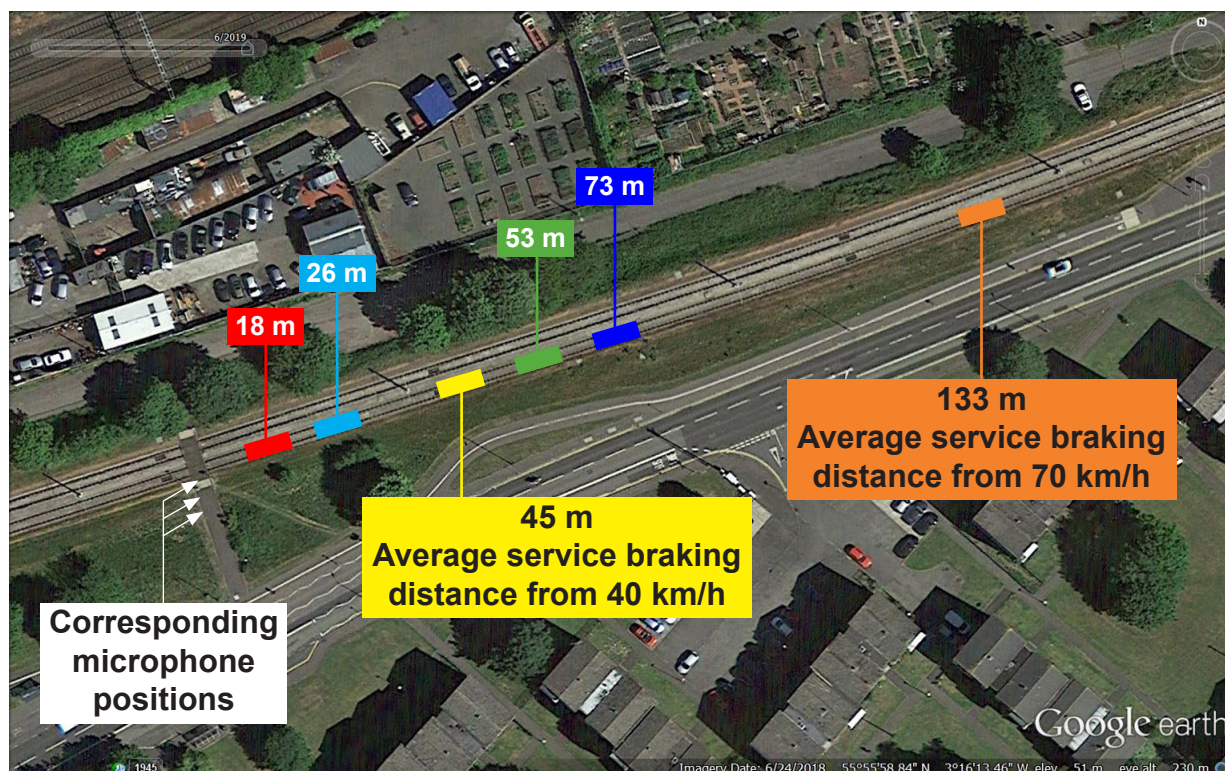
- 58 Following the accident, the RAI B commissioned a specialist consultant to carry out acoustic measurements to investigate the audibility of the bell as tram 260 approached the crossing (figure 9). Sound pressure level measurements of the tram's horn were also taken as this is an alternative method of warning provided on the tram, although it was not used on this occasion until the tram was very close to the crossing (paragraph 28). Additionally, measurements were taken of the sound pressure levels of the bell and the horn of another tram which were found to be of a similar level as those of tram 260, when both were measured on level ground in the depot.

Figure 9: Distances of tram 260 from the crossing during the sound pressure level measurements

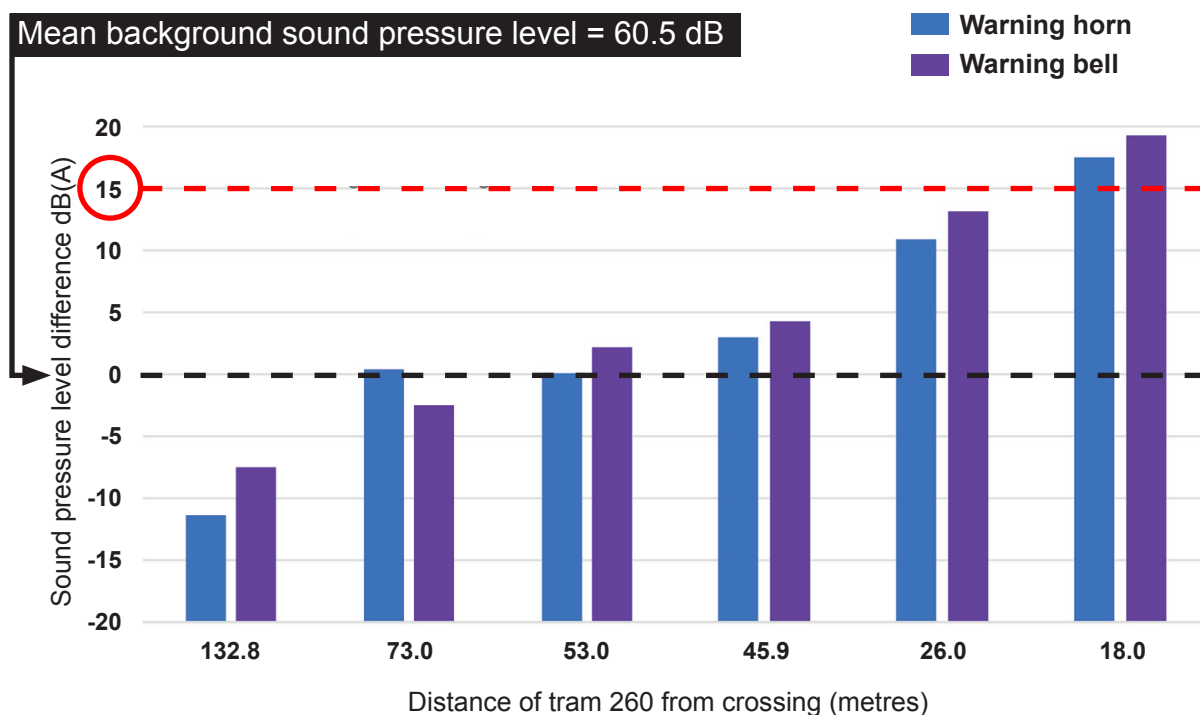
Figure 10: Sound pressure level differences of the bell and horn of tram 260 compared with the mean typical background sound level measured at the crossing, with zero on the y-axis being equivalent to the background sound pressure level of 60.5 dB(A). The red line represents a 15 dB(A) increase over the background level.

- 65 The test results also indicated that the sound pressure level of the horn is lower than that of the bell. Therefore, had the tram's warning horn been sounded earlier instead of the bell, it is unlikely to have been any more effective as a warning to the pedestrian.

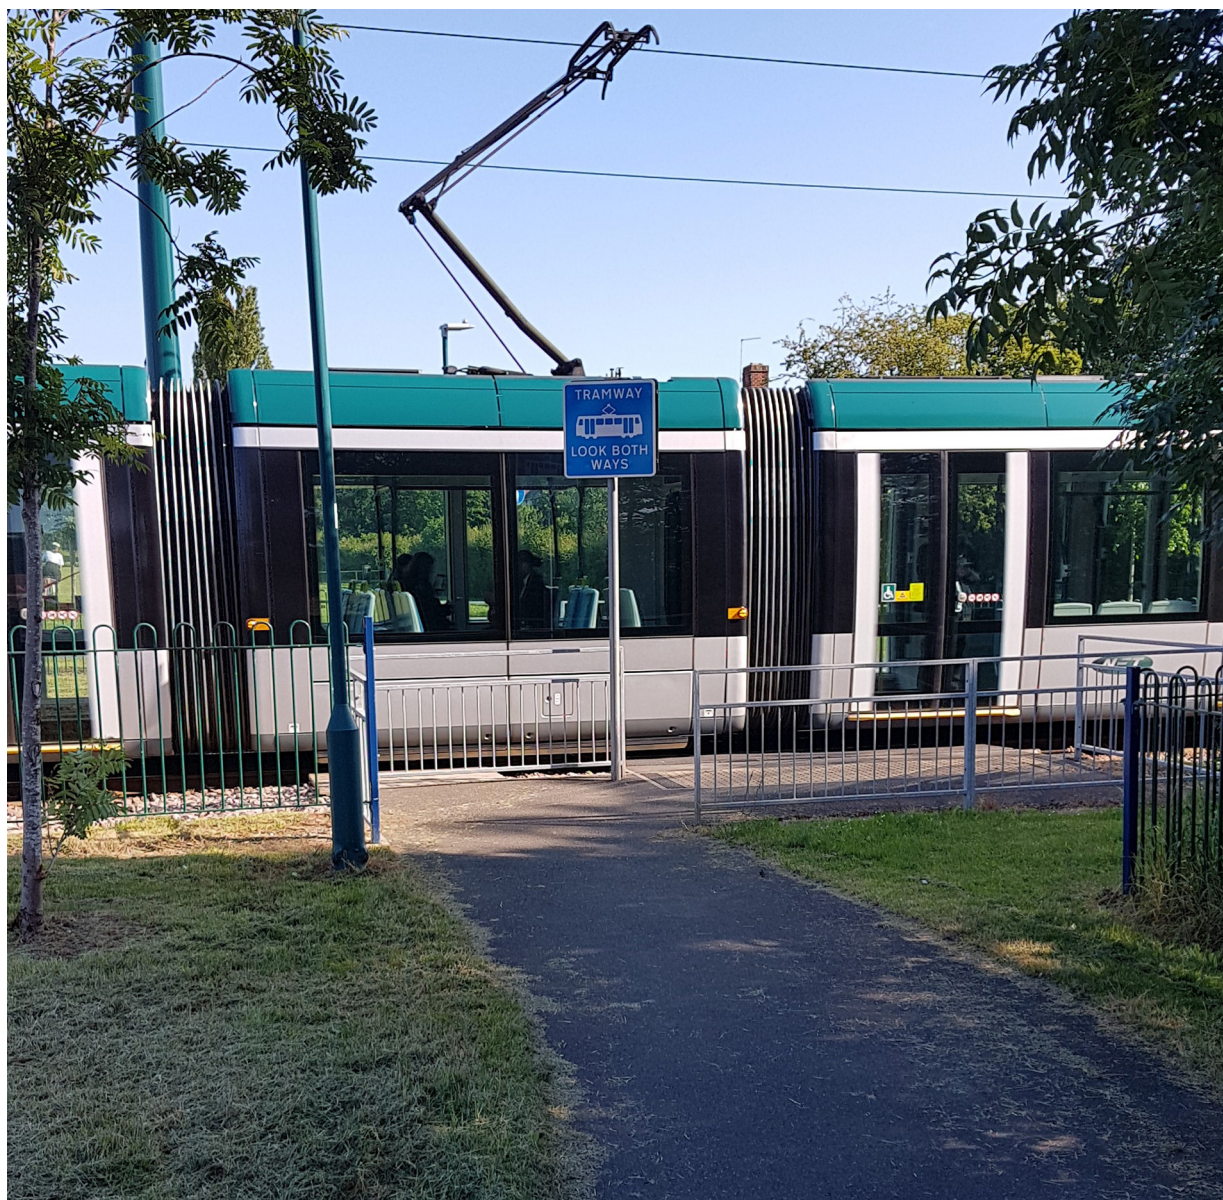
- 78 The RSP2 guidance stated that fencing or pedestrian guard rails should be provided where necessary, to guide pedestrians to face oncoming trams before they cross the track, although specific situations are not described. Chicane fencing has been used at some locations on other tramways to make pedestrians visually aware that they are entering an area of increased danger, make them alter their walking pattern and turn them to face approaching trams on the nearest track (figure 12).

Figure 12: An example of chicane fencing on a footpath crossing on the Nottingham tram system. The tram in the picture is travelling on the closer of the two tracks from right to left.
