Rail Accident Report

Passenger trapped in train doors and dragged at Clapham South station 12 March 2015

Report 04/2016
March 2016

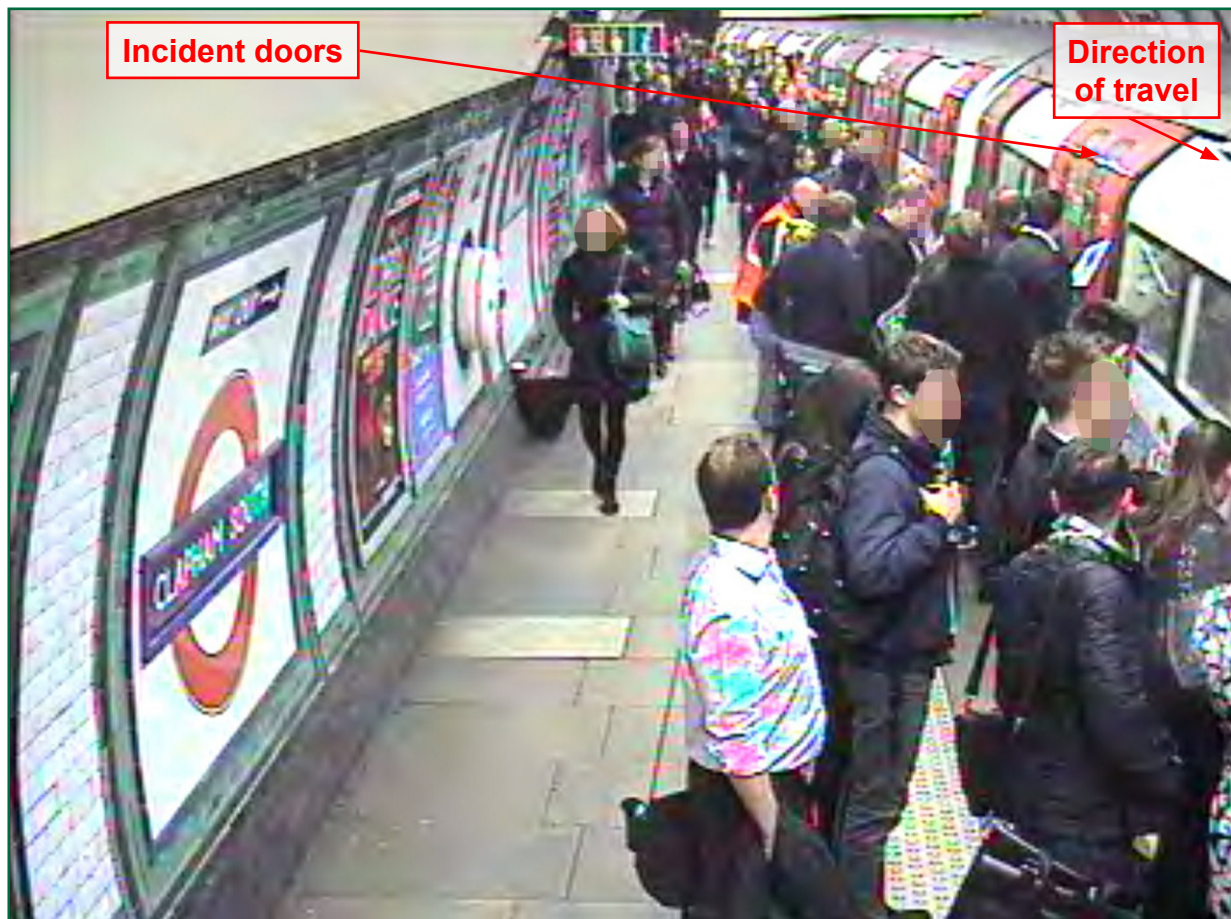
- 4 The *train operator* saw unusual movements on the platform (figure 2) after the train had started moving and he immediately stopped the train. The electrical power supply to the train was switched off and the emergency services attended to the passenger.
- 5 The passenger sustained a broken arm, and injuries to her shoulder and face. There was no damage to the train, or to the railway infrastructure, and London Underground staff authorised reopening of the station at 09:11 hrs.

Figure 2: Platform scene at the time of the accident (station CCTV courtesy London Underground)

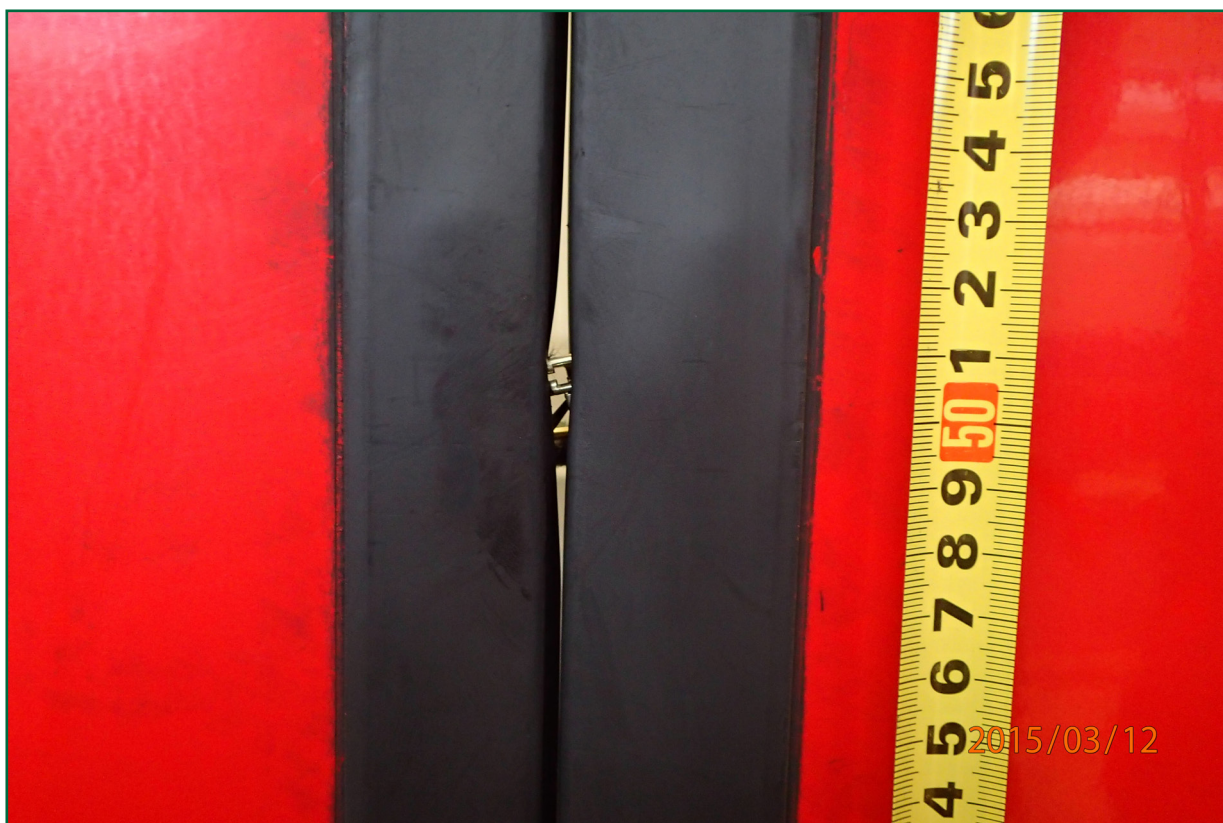
- 31 Another passenger on the platform pulled the coat from between the door leaves, where it was still retained, after the train had stopped. The zip was broken and the zip slider remained stuck between the door seals after the coat had been removed (figure 7).
- 32 The injured passenger was attended by paramedics at the site of the accident before being taken to hospital. The other passengers on the train were evacuated, after which the train was returned to Golders Green depot and the platform returned to service.
- 33 The RAIB attended Clapham South station to examine the scene of the accident, and Golders Green depot to examine the train. The RAIB, London Underground and Alstom carried out tests on the train doors and other systems immediately after the accident and subsequently as part of the investigation.

Figure 7: Zip slider, as found in door showing height above train floor

- 39** The zip slider was found trapped between the door leaves at about 0.5 metres above the train floor after the accident (figure 7). There is no evidence to show at what point during the accident sequence the coat was pulled from the position in which a large part of the corner was trapped, to having only the zip slider trapped. It is possible that this happened while the passenger was being dragged.

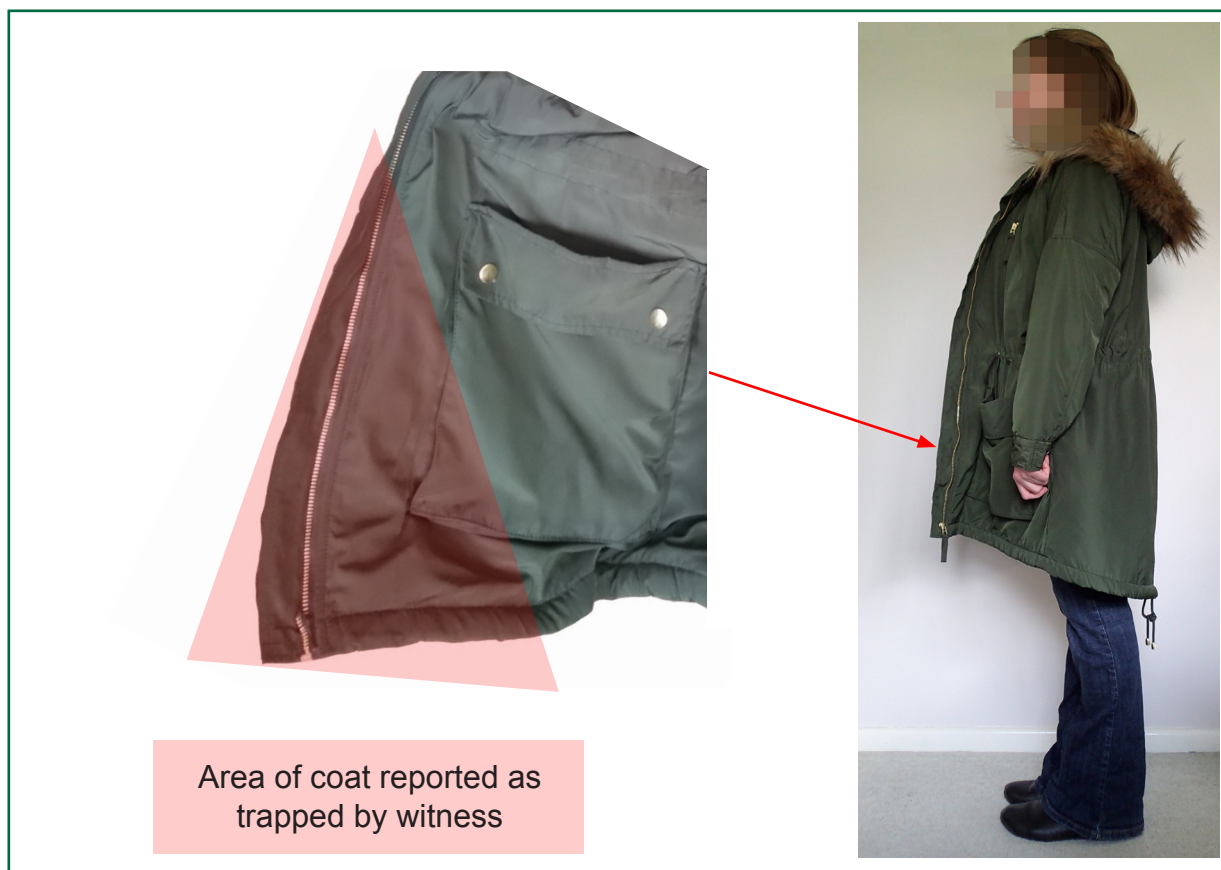
- 38** The passenger was wearing a mid-length parka type coat which was unzipped at the time of the accident and so the lower part hung in front of the passenger. The bottom left corner of the coat, including part of a pocket, was trapped in a position which is consistent with the passenger stepping back off the train onto the platform (figure 8).

Figure 8: Coat hanging forward when unzipped

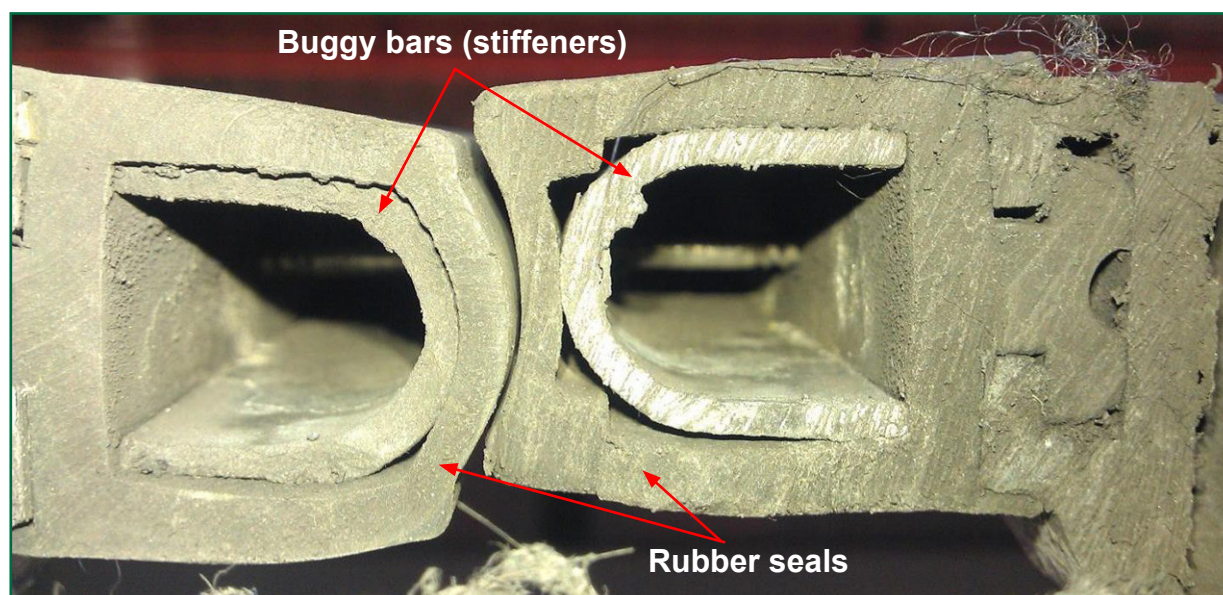
- 49 A '*buggy bar*' is fitted inside the lower 535 mm of the door seals, with a tapered section on the top 60 mm (figure 15). The buggy bar restricts the ability of the seal to deform around small objects, and is intended to prevent the leaves closing sufficiently for them to be detected as fully closed when small objects, such as tubular parts of a child's push-chair, are still in the doorway close to ground level. The bar is intended to ensure detection of an 11 mm diameter object trapped in the bottom 450 mm of the door as required by London Underground standard 2 - 55, 'Rolling stock bodyside doors and door control system'.

Figure 11: Buggy bars

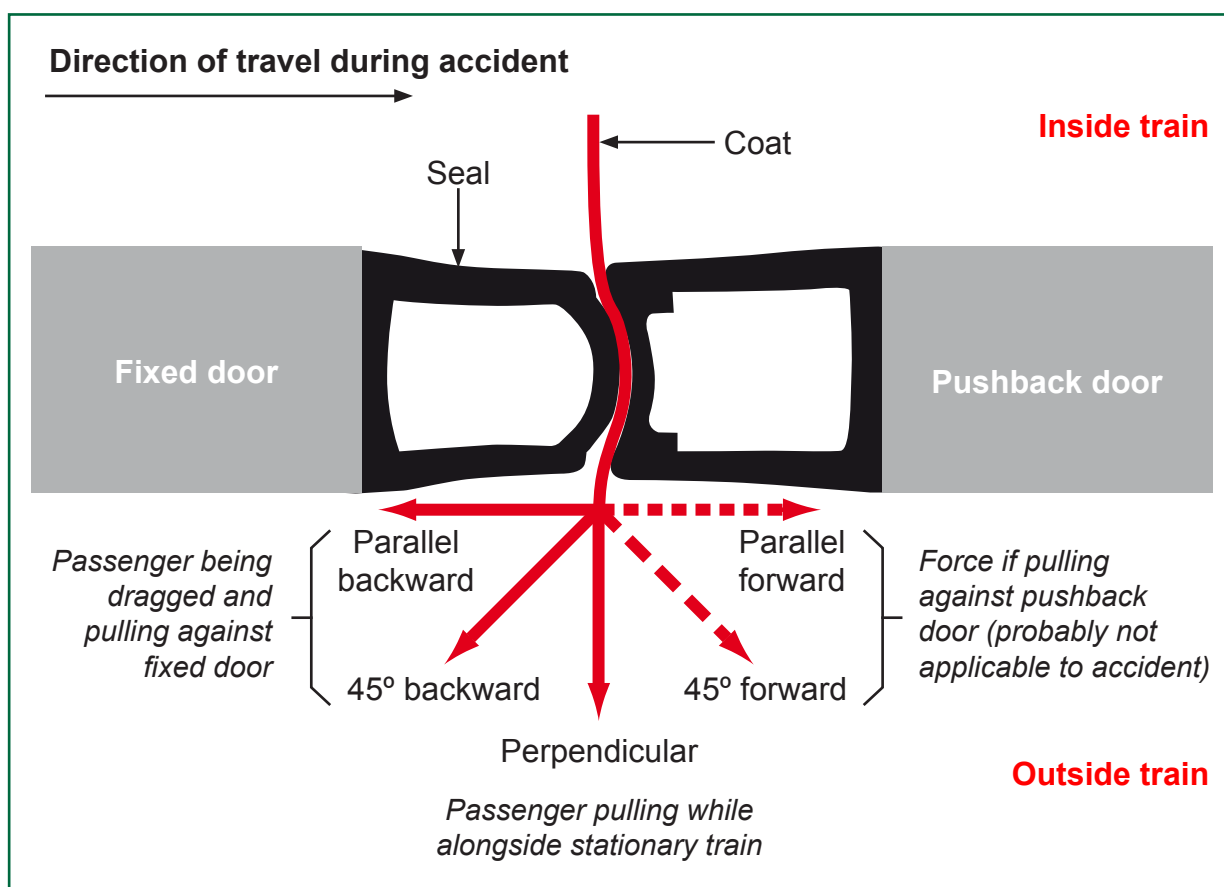
- 57 The tests involved pulling the coat in a number of directions relative to the door faces (figure 13). These modelled the passenger pulling directly away from the train (the direction she probably pulled before the train started moving) and the passenger pulling towards the rear of the train (the likely situation while she was being dragged). Tests were also undertaken with forces applied towards the front of the train to demonstrate the differing responses of the fixed and pushback leaves.

Figure 13: Pull test directions

- 59 The RAIB has compared these pull-out test results with the 350 N maximum force that the passenger was likely to have applied as established by RAIB tests (paragraph 50). A force greater than the passenger could reasonably have applied in good conditions was required to remove the coat when pulling at an angle backwards from the direction of travel (ie pulling against the fixed leaf), even if there was nothing in the pocket. When pulling perpendicular to the door with the test object in the pocket, the force required to pull the coat out was still higher than 350 N. Without the object in the pocket, the required force was smaller and it would have been feasible, but not easy in the cramped conditions and short time available, for the coat to be pulled out. All of the pulls at an angle forward of the direction of travel required much smaller forces to pull the coat out, regardless of whether the test object was in the pocket or not. This is because the pull was against the pushback leaf, which was able to move.

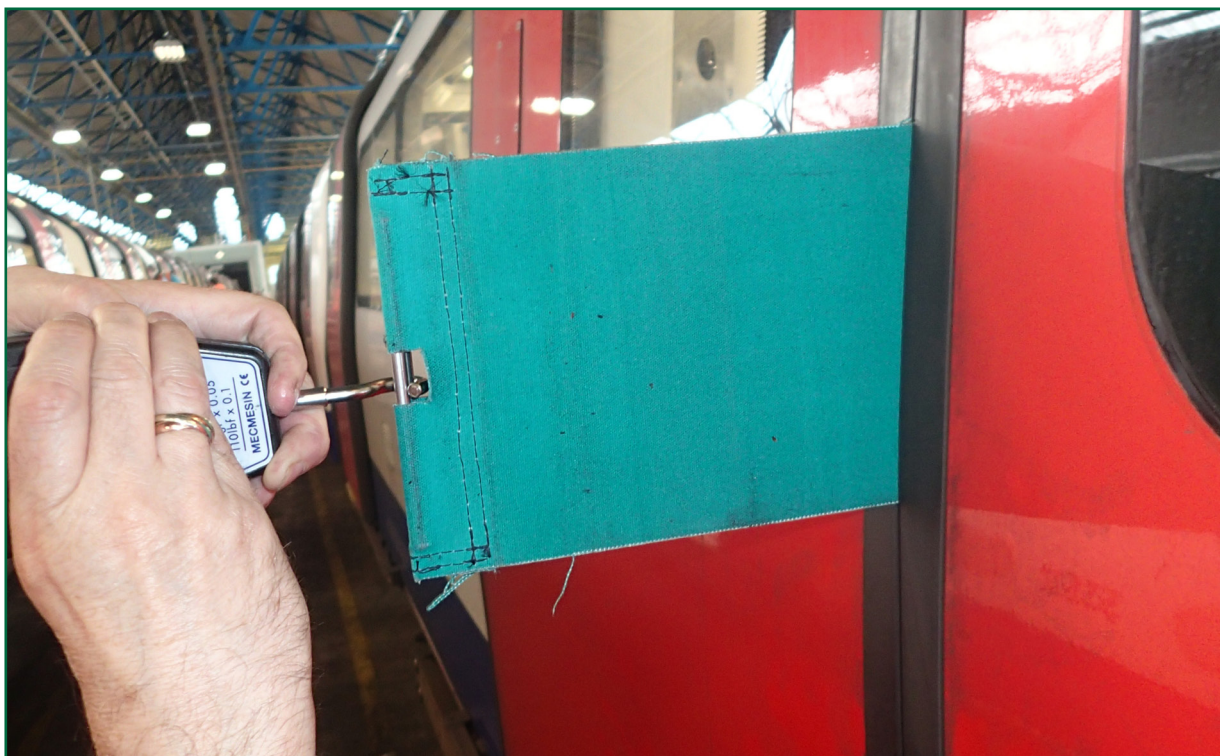
- 60 Tests with the canvas test piece (figure 14) showed that, for each direction of pull, the canvas could be pulled out with a lesser force than the coat. This difference is because the canvas piece was smoother and thinner than the coat.

- 61 London Underground standard E6721, 'Rolling stock (side sliding doors)', requires that the canvas piece can be removed from doors at a height of 1.25 metres above the floor with a perpendicular force of no more than 90 N. London Underground and Alstom carried out this test after the accident and a compliant pull-out force of 75 N was obtained.

Figure 14: Pull-out testing with canvas piece

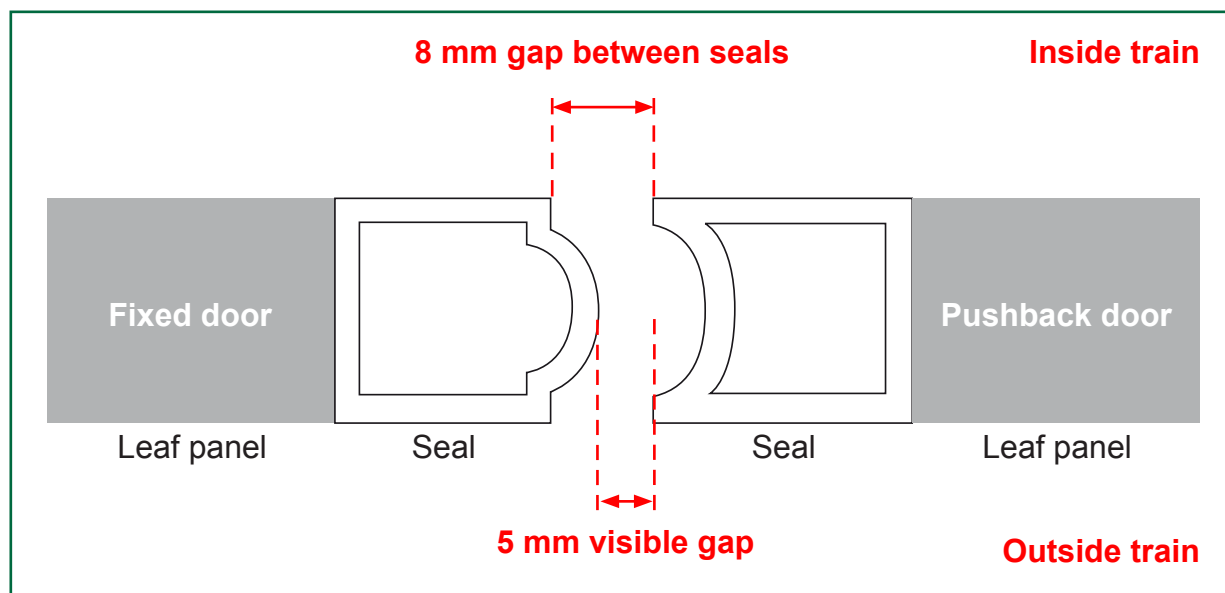
66 The design and maintenance of train doors is intended to ensure that they will not be detected closed (ie interlock will not be obtained) if there is an 8 mm gap, or more, between the door seals. Because of the profiles of the rubber seals, this equates to a 5 mm visible gap between the door seals when these are not compressed (figure 15).

Figure 15: Door seal gap for loss of interlock

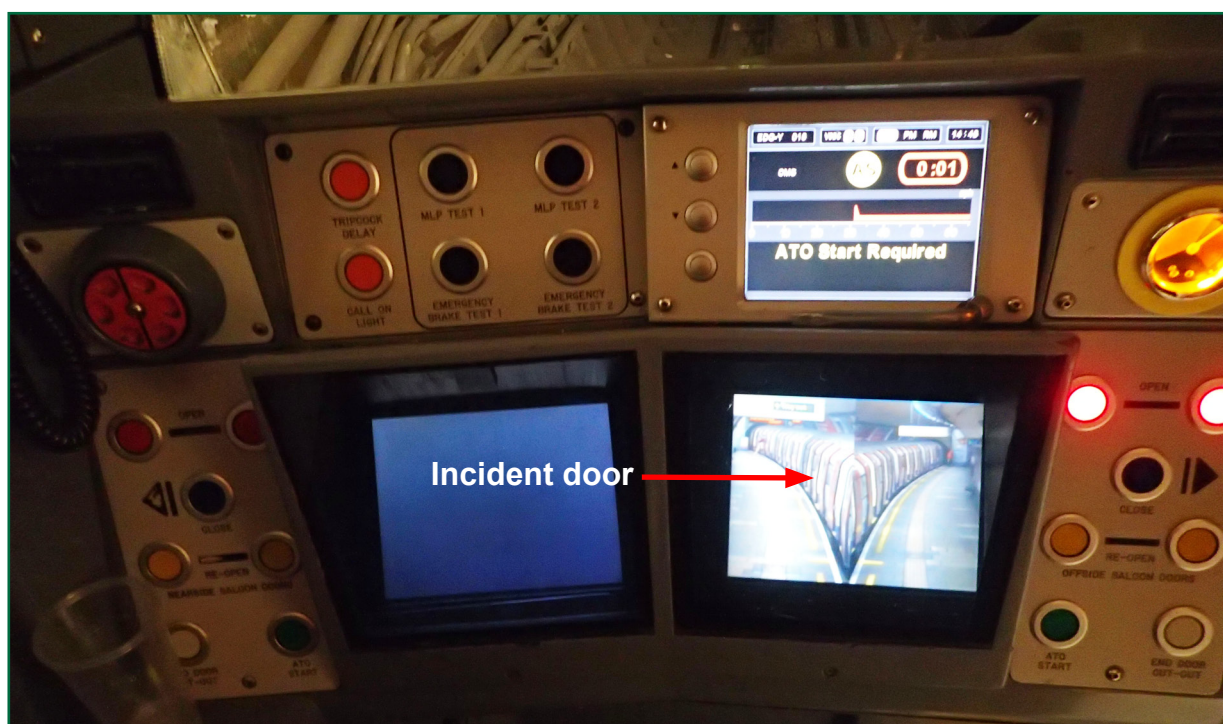
- 72 The number of cameras varies depending on the station layout and the curvature of its platform. The northbound platform of Clapham South station is convex but less curved than some others on the Northern line. Two cameras are positioned near the station roof, close to the centre of the platform, facing opposite directions with overlapping views, each covering the length from the mid point to the end wall. The two camera views are arranged side by side on a single in-cab monitor which shows a view from one end of the train to the other (figure 16).

Figure 16: Train operator cab display at Clapham South station (image does not show accident situation)

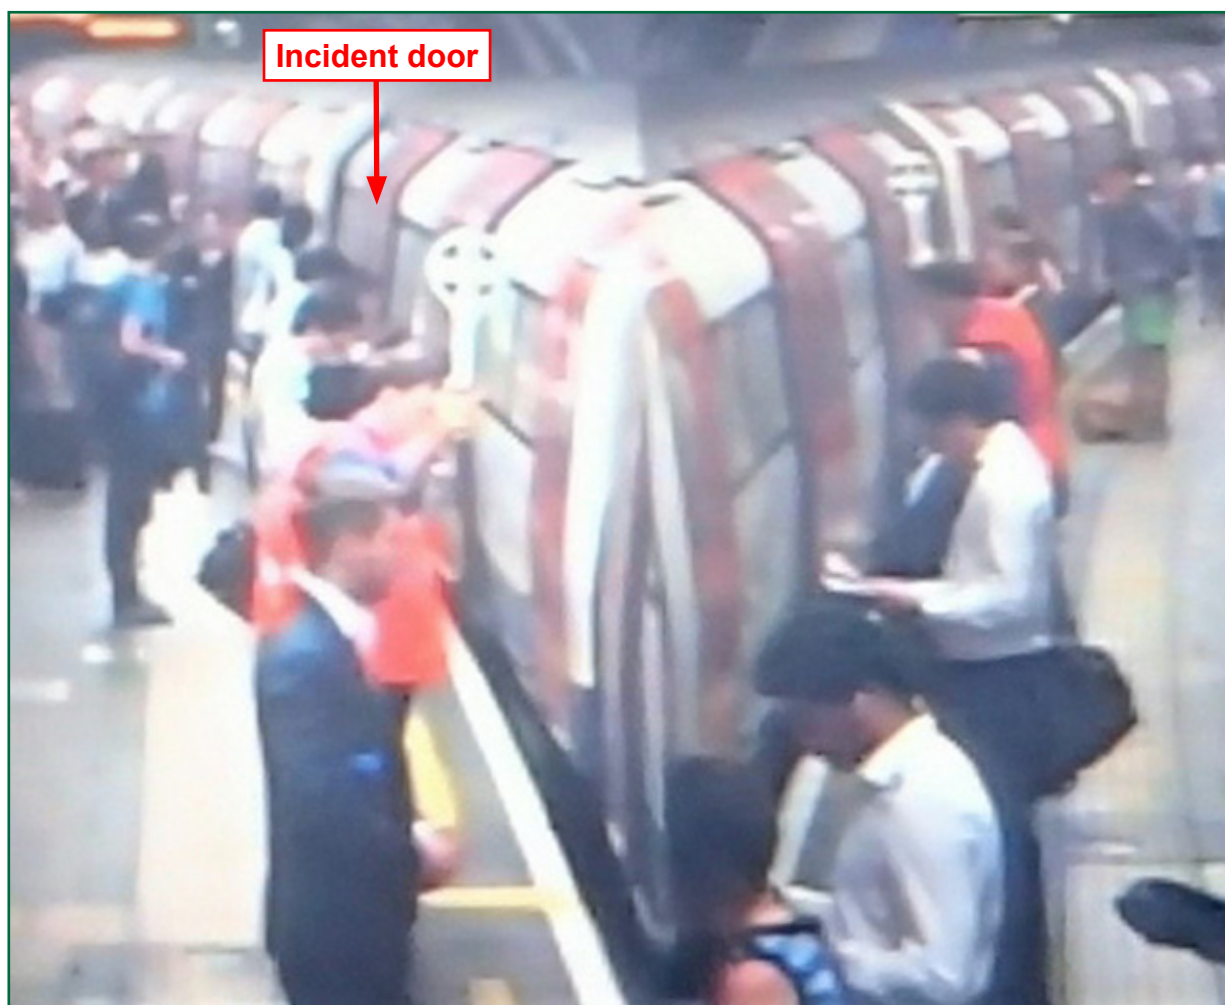
- 74 When the platform is busy and some passengers do not board a train, the train operator cannot always see the full height of all of the train doors and so cannot be certain that nothing is trapped. This is because the camera view can be obscured by passengers (figure 17). In these circumstances, train operators are trained to look for unusual passenger behaviour and other signs that indicate a possible problem (paragraph 78).

Figure 17: Train operator's view of moderately busy northbound platform at Clapham South (in-cab monitor omitting outer edges of image and not showing accident situation)

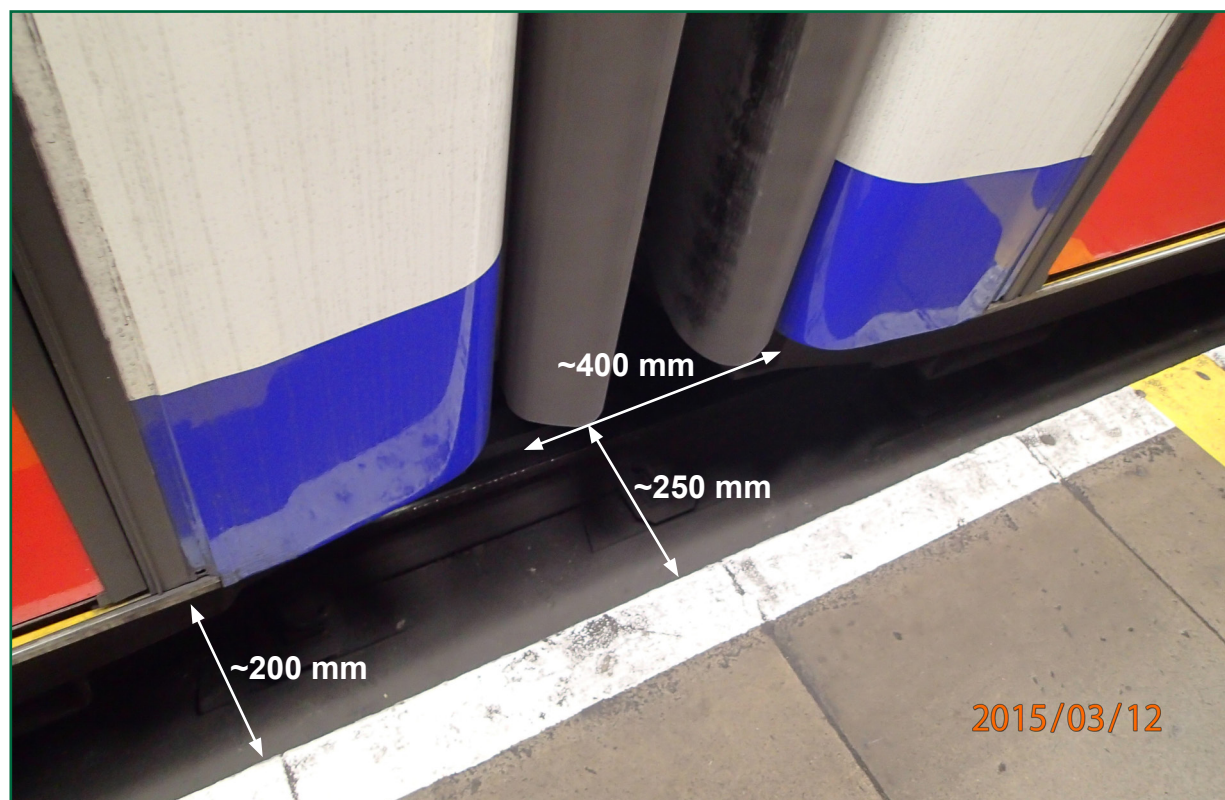
- 95 The gap between the train and the platform edge varies between 100 mm and 200 mm except at the connection between adjacent cars where there was a clear gap of approximately 250 mm over a length of approximately 400 mm (figure 19). It is probable that she fell between two cars because she would probably have sustained more serious injuries if she had fallen through the smaller gap at other locations. It is uncertain whether she fell between the 4th and 5th cars or between the 5th and 6th cars. The nature of her injuries suggest that she fell directly into the recess under the platform (paragraph 96).

Figure 19: Platform gap at car ends

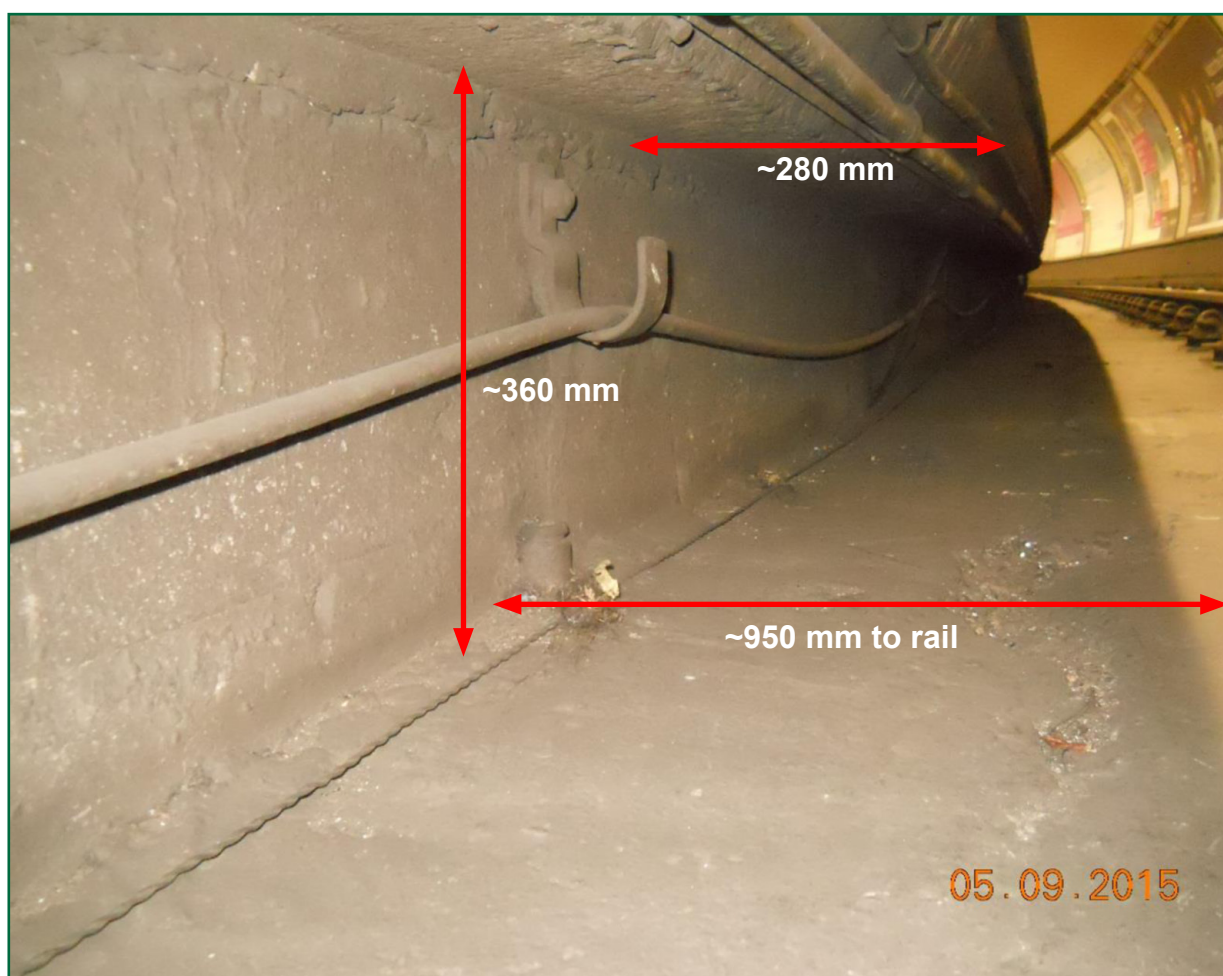
- 96 **The platform has a recess into which the passenger fell, probably reducing her injuries.**
- 97 London Underground standard S1131 (Premises - Station Platforms) requires a 300 mm wide recess under new and altered platforms to provide a refuge in an emergency, unless platform edge doors are fitted. The northbound platform at Clapham South station pre-dates this standard and has a 280 mm recess (figure 20). Although slightly smaller than current requirements, the recess was sufficient to allow the passenger to be positioned clear of the train after she had fallen from the platform.

Figure 20: Clapham South platform recess
