Rail Accident Report

**Runaway and subsequent collision near to
Loughborough Central station, Great Central
Railway
12 May 2014**

Runaway and subsequent collision near to Loughborough Central station, Great Central Railway, 12 May 2014

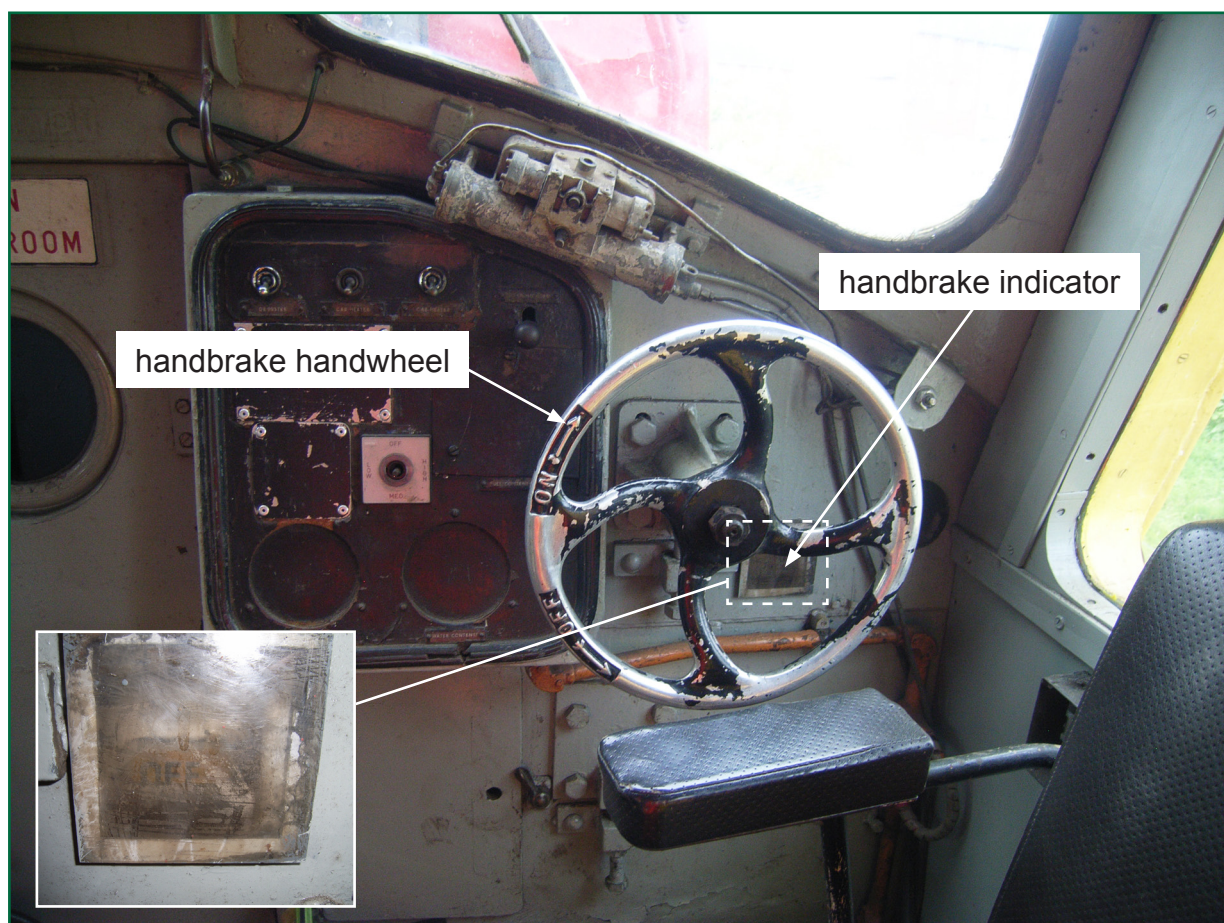
Figure 4: Class 37 handbrake hand wheel and indicator

- 35 Damage to locomotive 37198 meant that only the No. 2 end handbrake (which would have been the trailing cab on the incident train) could be tested by the RAIB following the accident. During this test, the brake blocks were observed to have become fully applied to the middle wheel on the secondman's side after 60 turns of the hand wheel and on the driver's side after 80 turns. This indicated that the No.2 end handbrake was not correctly adjusted. The maintenance of the locomotive is discussed further in paragraphs 123 to 134.

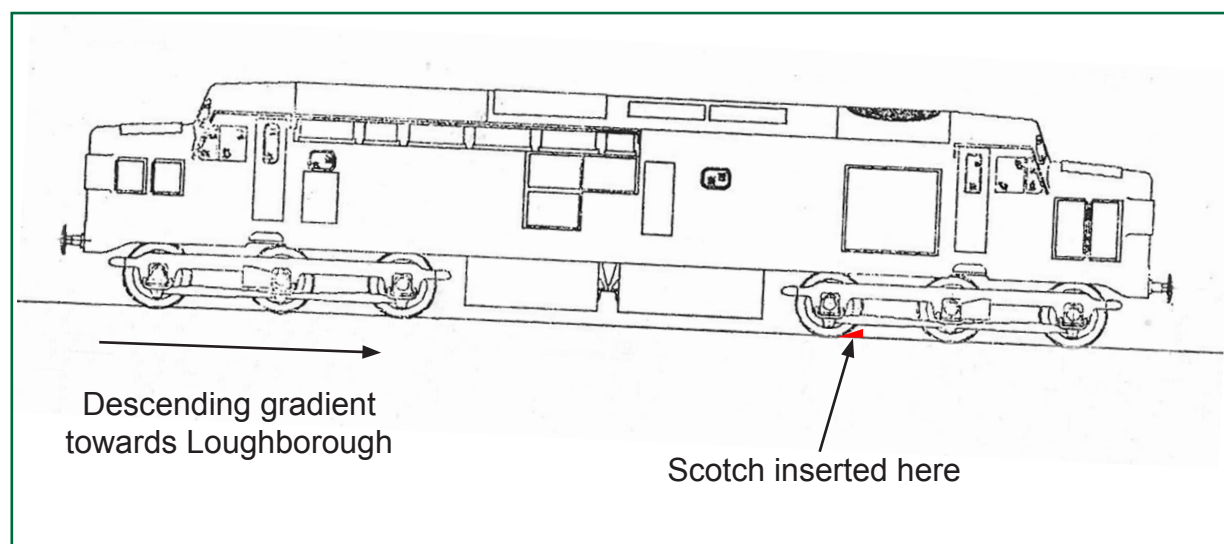
- 59 As the PICOP was shutting down the locomotive, the permanent way team started to disembark from both cabs. Trackworker A descended from the cab and was passed a scotch. He stated that he positioned this scotch against the leading (downhill) face of the right-hand (secondman's) side wheel of the rear axle of the locomotive's leading end bogie (figures 6 and 7) and drove it home against the wheel tread using his boot (figure 8). The POS coach (which was downhill of the locomotive) was not secured with a scotch.

Figure 6: The position on the locomotive where Trackworker A placed the scotch

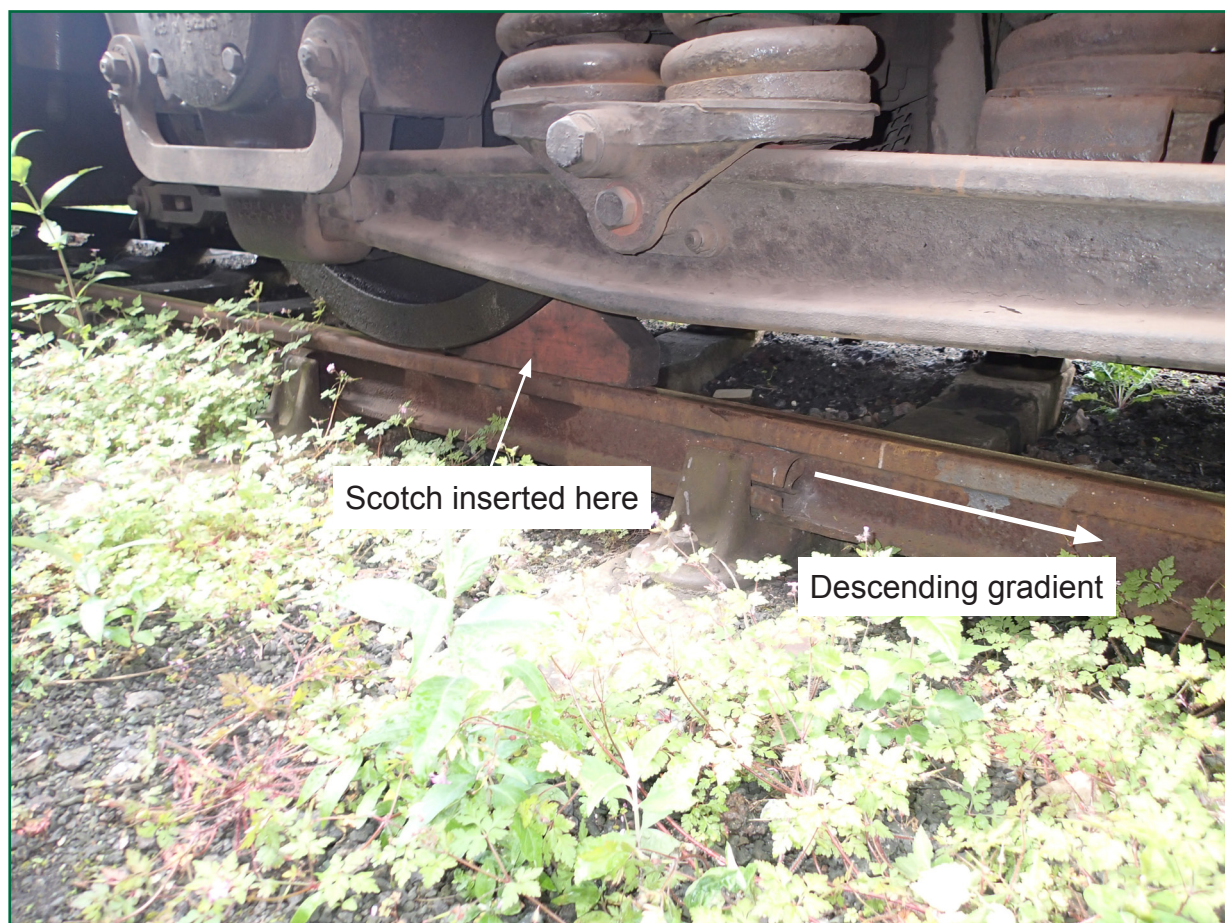
Figure 7: The position of the scotch as it was placed during a post-incident reconstruction

- 75 To be effective, a scotch has to be positioned squarely on the rail head and snugly against the face of the wheel tread. Failure to do this may allow the scotch to fall out or reduce its available holding force. Trackworker A stated that, when he placed the scotch, he was certain that it was 'well in place' and that he was 'very conscious' of the need not to leave a gap between the wheel and the scotch.

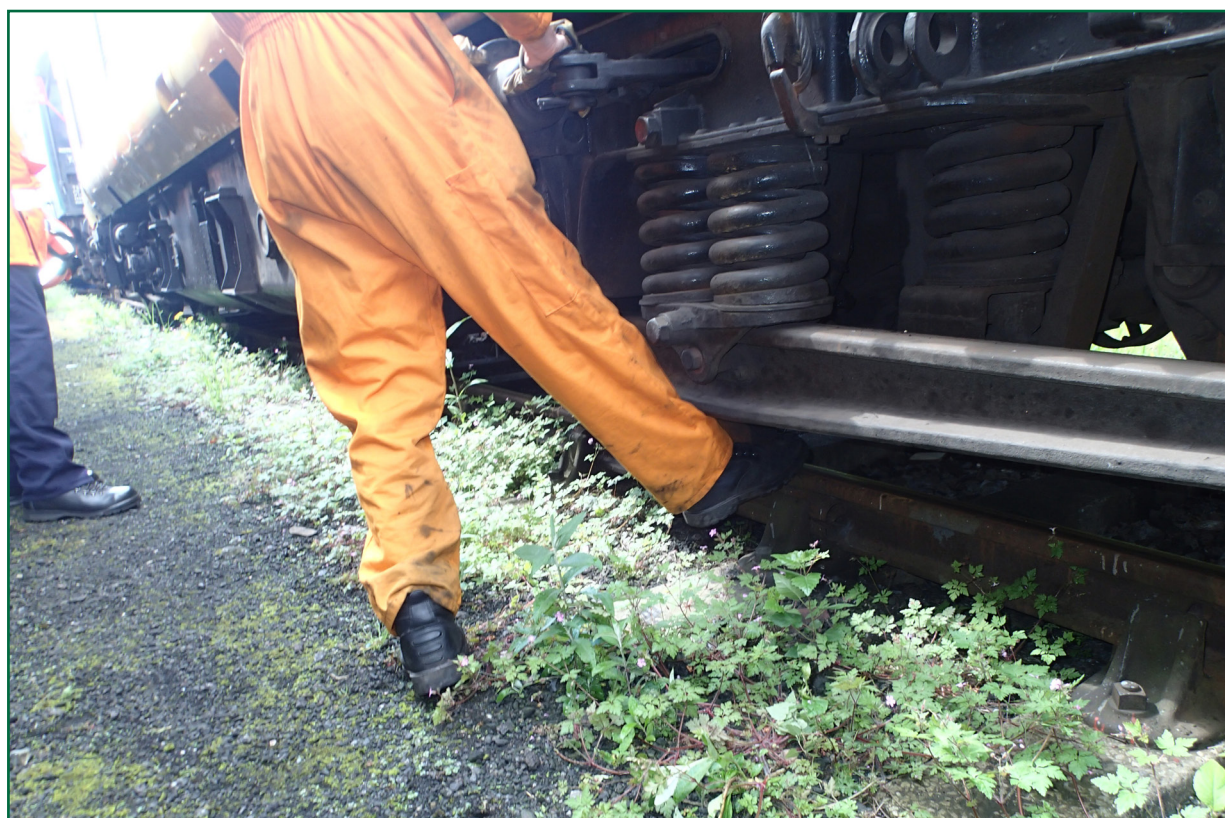
Figure 8: A post-incident reconstruction of how the scotch was driven against the wheel tread

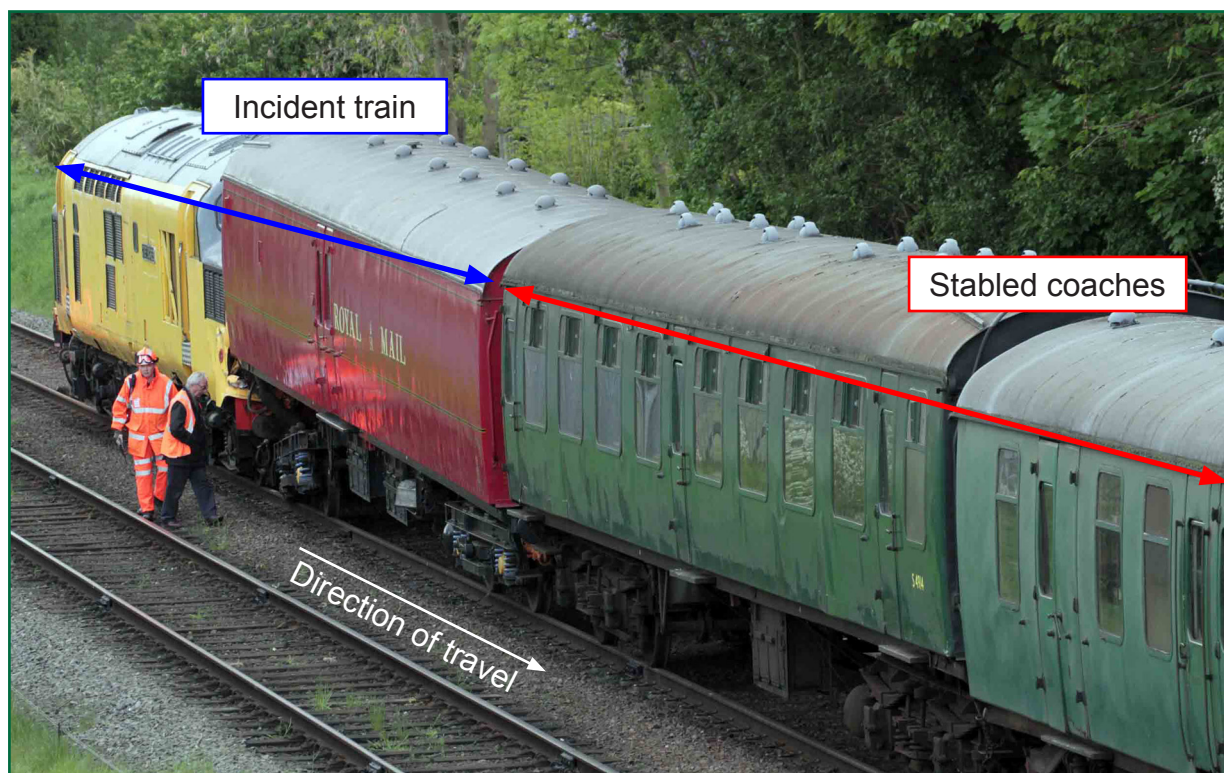
- 62 The PICOP telephoned the operations manager, who was at Loughborough, in order to warn him about the runaway. The operations manager asked a signaller to go to Loughborough North signal box in order to check the status of the track circuits. The signaller concluded from the indications within the signal box that the stabled set of coaches had moved and that a collision had occurred (figures 9 and 10).

Figure 9: The positions of the incident train and stabled set of coaches following the collision (image courtesy of Chris Milner, *The Railway Magazine*)

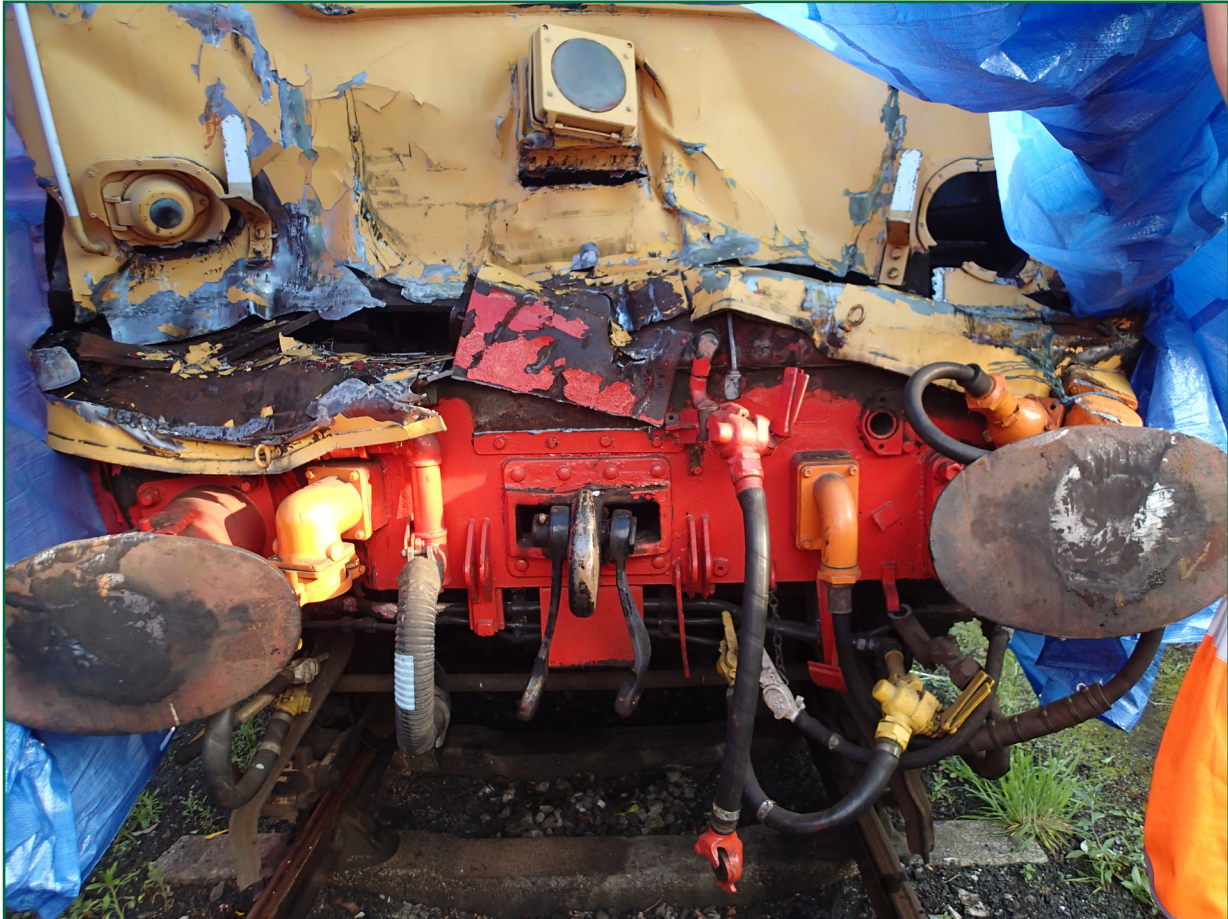
Figure 10: Damage sustained by locomotive 37198 following the collision

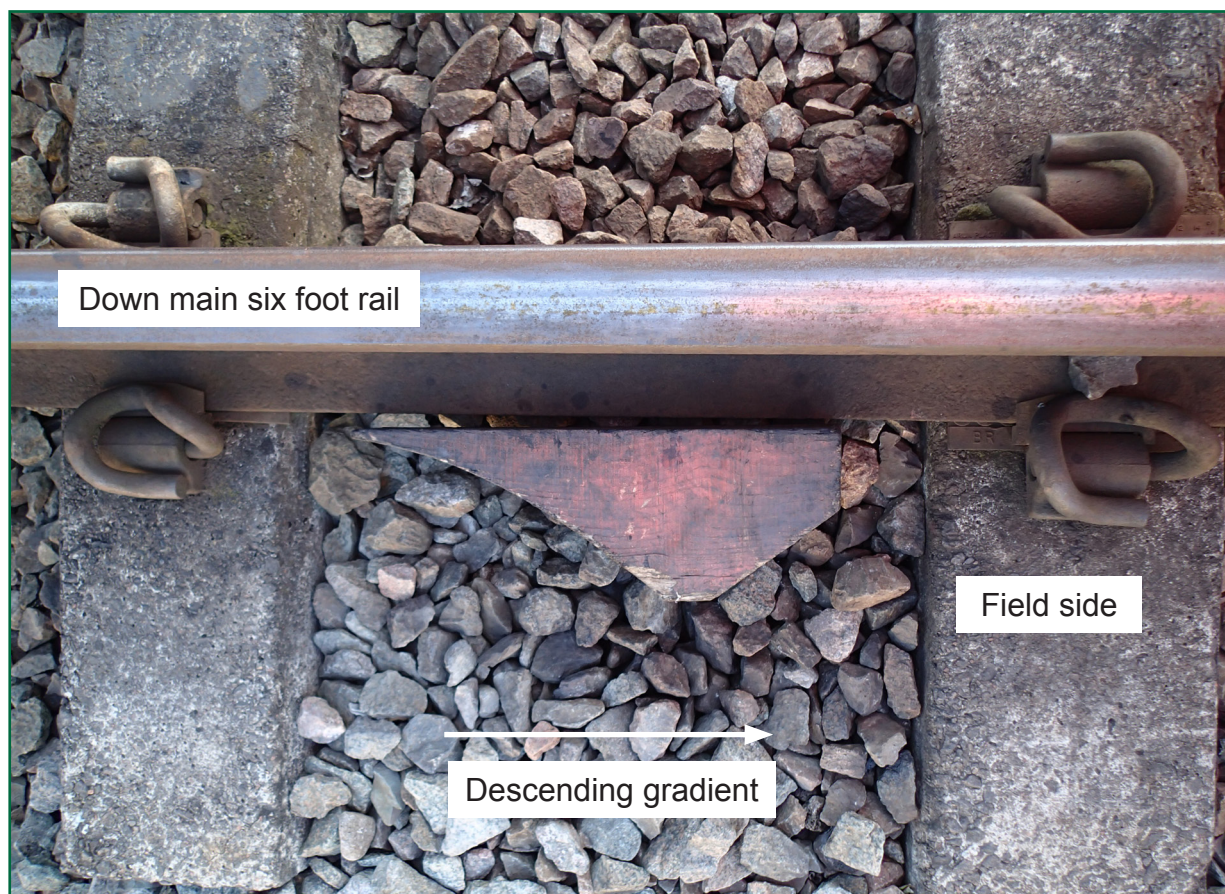
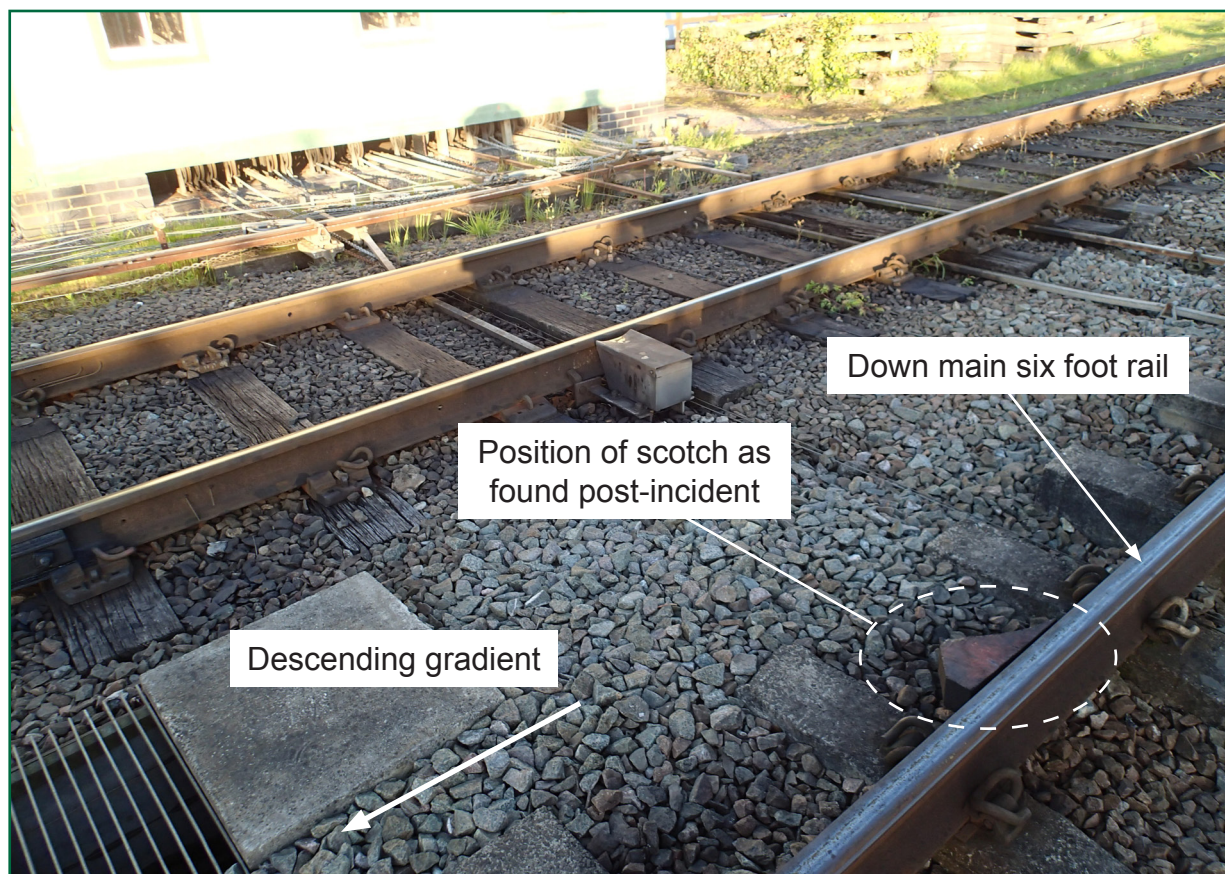
- 64 There is witness evidence that, following the runaway, members of the permanent way team found a scotch on the *field side* of the six foot rail of the down main, a short distance north of where the incident train had been stabled. The RAIB subsequently recovered this scotch during its post-incident examination of the railway at Quorn and Woodhouse (figures 11 and 12).

Figure 11: Position of the scotch as found post-incident by the RAIB at Quorn and Woodhouse

Figure 12: Position of the scotch as found post-incident by the RAIB at Quorn and Woodhouse

- 82 The RAIB examined the scotch which was recovered post-incident (paragraph 64). This showed that the scotch was in a reasonable state of repair and that it had not been crushed or over-ridden by rail wheels. It was also evident that the base of the scotch was not heavily contaminated with either oil or grease.
