Rail Accident Report

Tram collision with pedestrian near Market Street tram stop, Manchester 12 May 2015

Tram collision with pedestrian near Market Street tram stop, Manchester, 12 May 2015

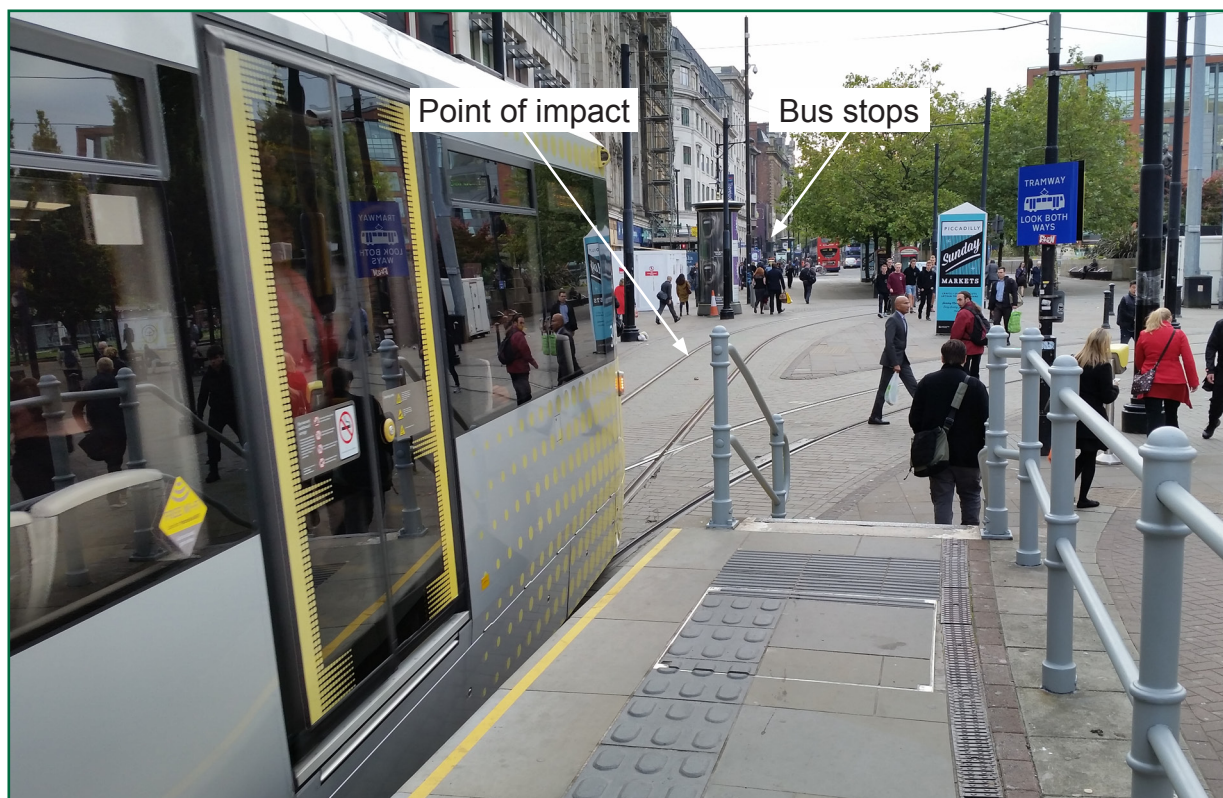
- 4 The pedestrian had alighted from the same tram at the Market Street stop and was walking along the track towards Piccadilly (figures 2 and 3). He suffered serious injuries as a result of the collision; no-one else was injured.
- 5 Tram services were suspended for approximately 45 minutes following the accident.

Figure 2: Market Street tram stop showing initial route of pedestrian after alighting from the tram

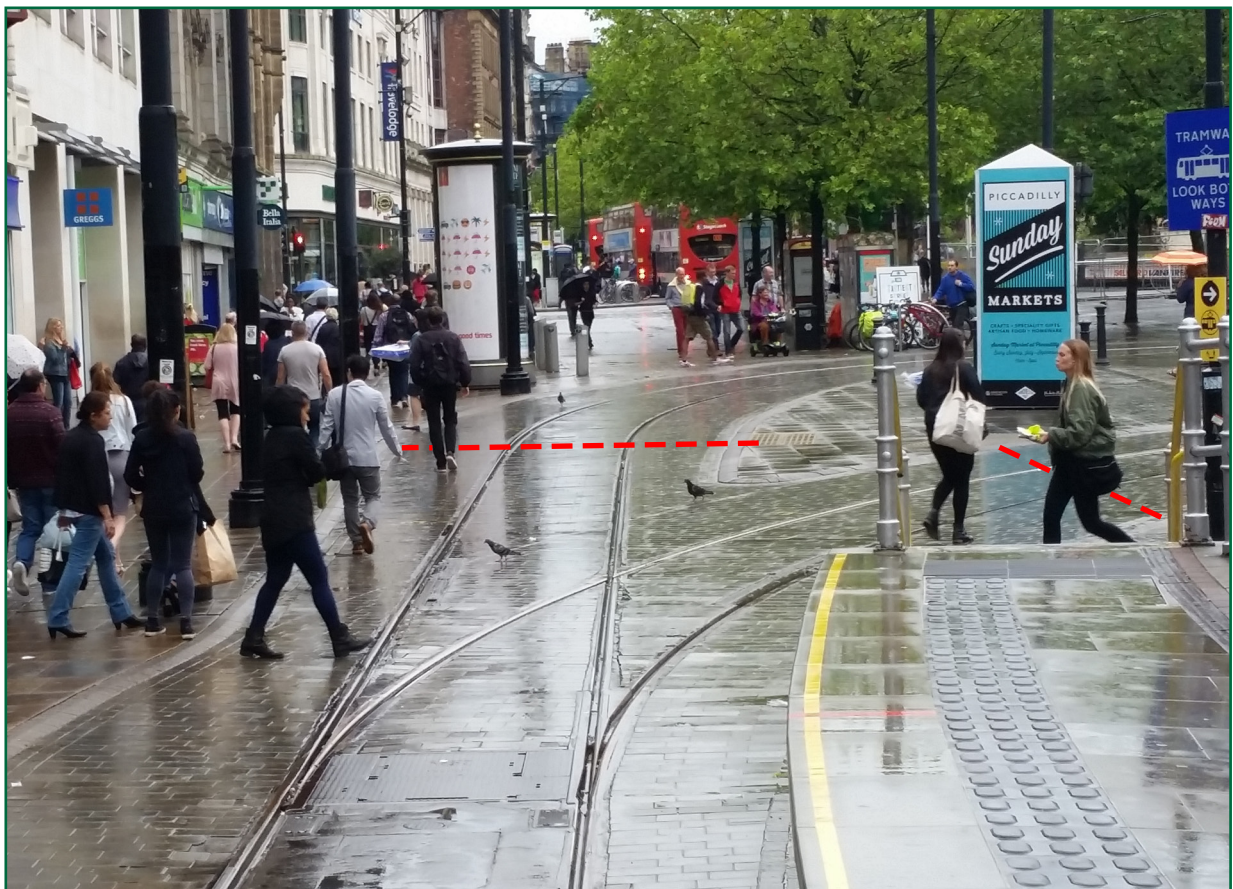
Figure 9: View from Market Street tram stop showing shortest routes between areas of tactile paving
