# Rail Accident Report

## **Collision between a train and a piece of equipment at Barrow-upon-Soar, Leicestershire, 14 February 2016**

Report 21/2016  
October 2016

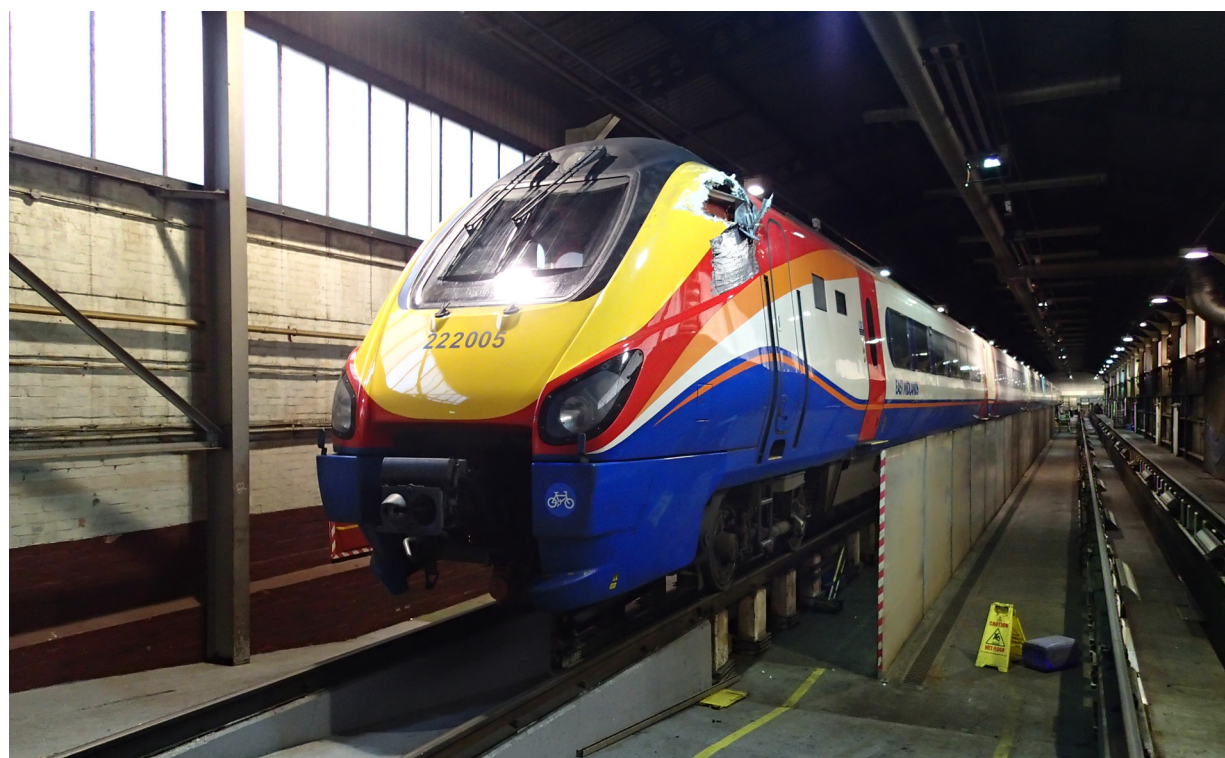
- 4 Two of the cars of the train were damaged by the impact, but did not derail (figure 3). The unloading wagon conveyor boom was also damaged.
- 5 A *fitter*, who had been working on the unloading wagon, was seriously injured and was taken to hospital by air ambulance. Nobody on the train was injured, but the driver was badly shaken.

Figure 3: The damaged train

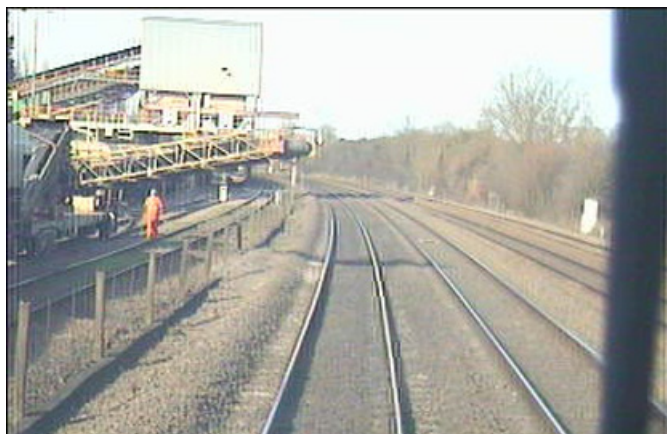
*Figure 7: View from train's FFCCTV just before the collision (image courtesy of East Midlands Trains)*

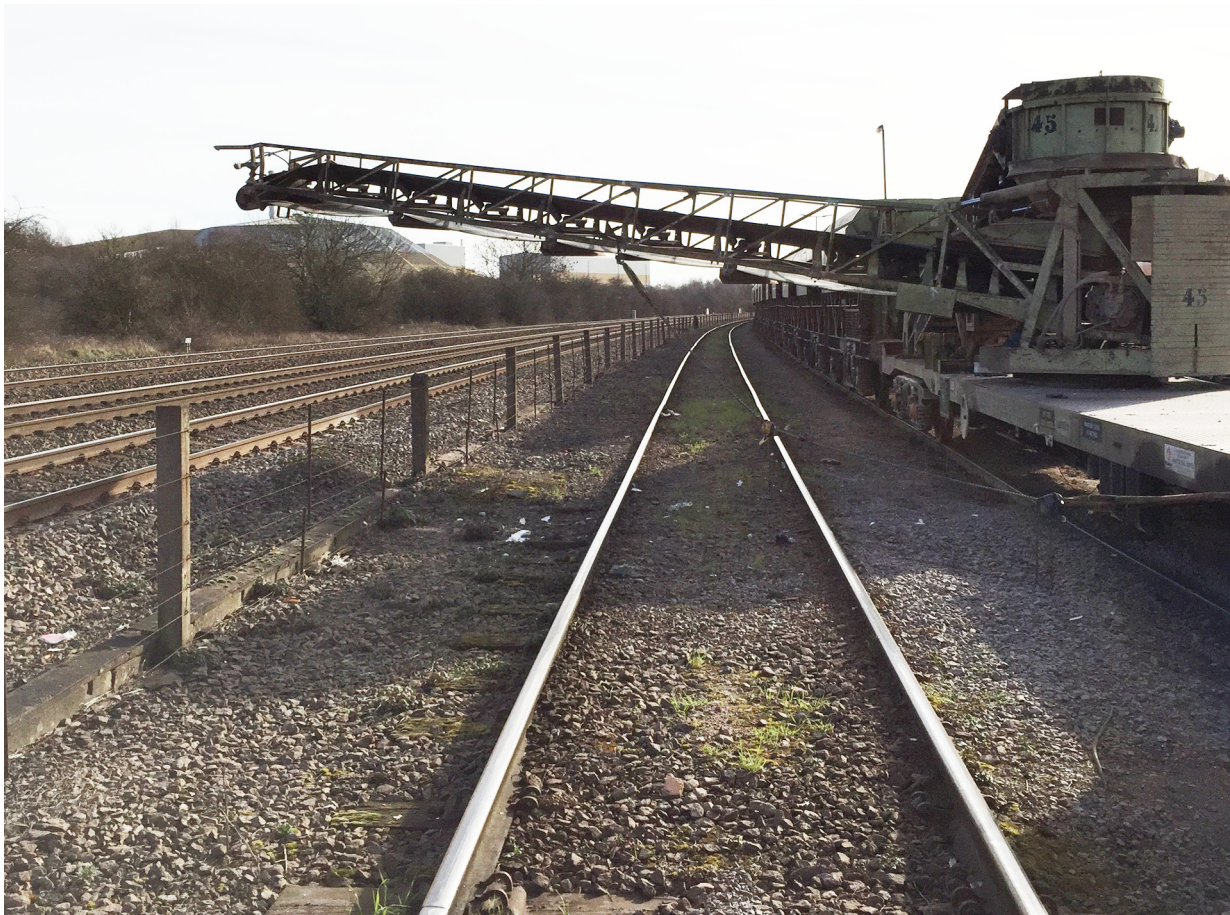
- 40 The incident train was then taken to the EMT depot at Derby where the RAIB later examined it. The damage to the train is shown in figure 3. Figure 8 shows the wagon shortly after the collision, and after a winch had been attached to the boom ready to pull it back clear of the main line.

*Figure 8: Position of the conveyor boom shortly after the collision (and after a winch had been attached in preparation to move it) (image courtesy of Network Rail)*

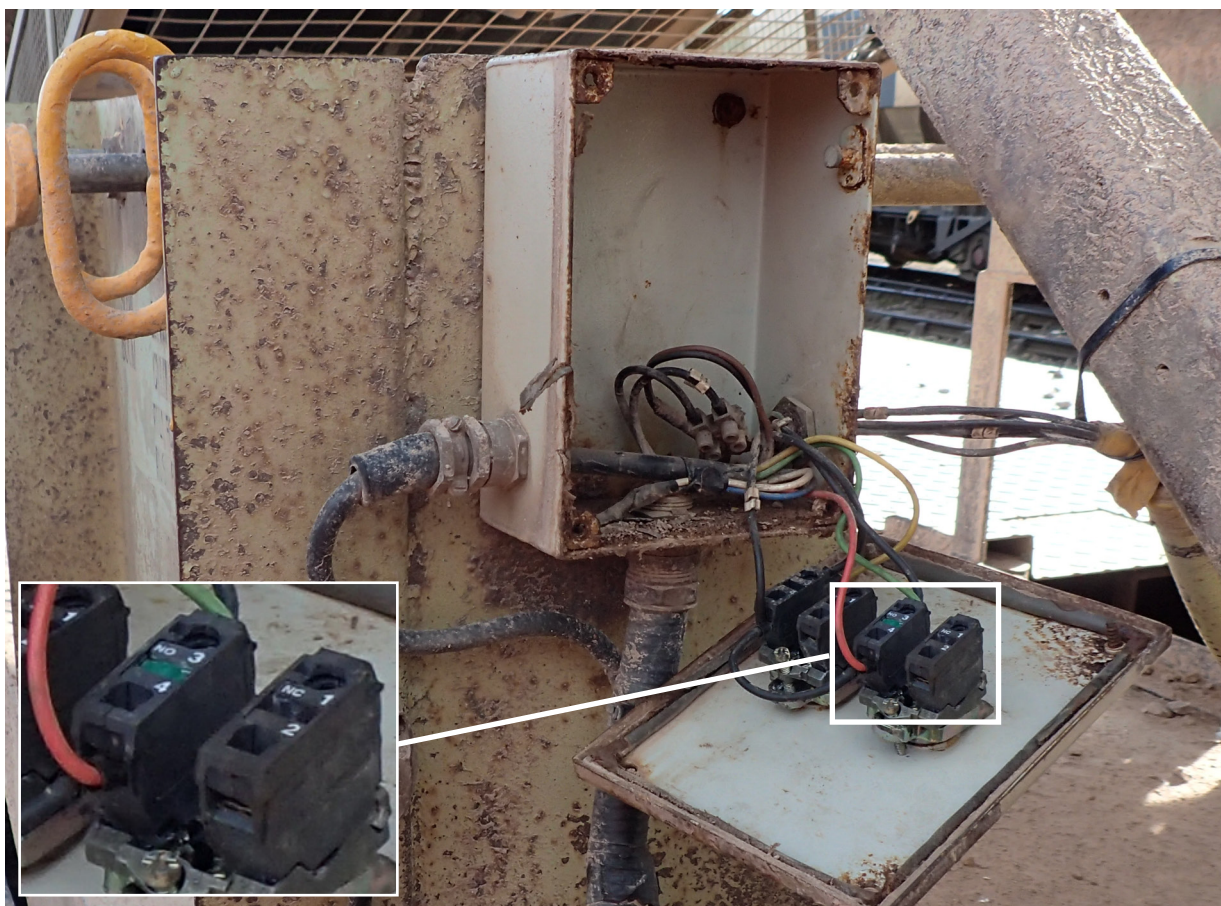
65 Fitter 1 pressed the main line side out button and released it, but the boom continued to slew. The button itself sprung back to its normal position (paragraph 49) but the switch behind it remained stuck in the on position. The switch contact block was still stuck in this position when photographed by the RAIB shortly after arrival at site (figure 10). The normally closed switch contact block on the same button had returned to its normal position, showing that the push button had moved back out and it was the normally open switch contact block that had stuck closed.

Figure 10: Control panel on mainline side of wagon after the incident

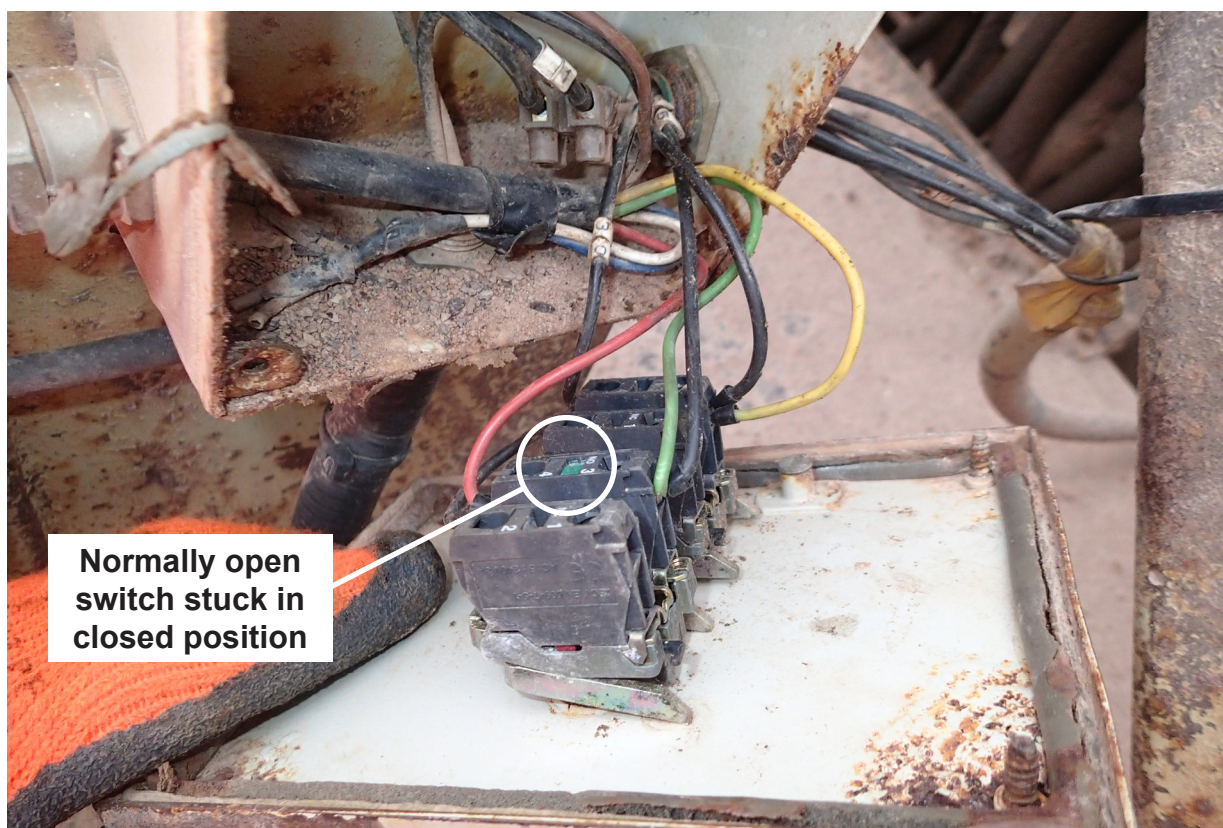
Figure 11: Normally open switch on 'out' button on main line side of wagon stuck in closed position during RAIB test of wagon on 8 March 2016

- 67 The solenoids were reconnected and the accident sequence recreated. The out button on the main line side was held in while the out button on the other side of the wagon was pressed. The test found that the movement of the boom continued in the outwards direction towards the main line when the button on the other side was pressed. This demonstrated that, during the accident with the out switch on the main line side stuck in the 'on' position, pressing the out button on the other side of the wagon would have had no effect on the boom.
- 68 It is probable that this switch stuck because:
- the moving part of the normally open switch contact block had become coated with corrosion product (paragraph 69);  
which in turn was most likely caused because;
  - the switch was used in environmental conditions that it was not rated to withstand (paragraph 76).

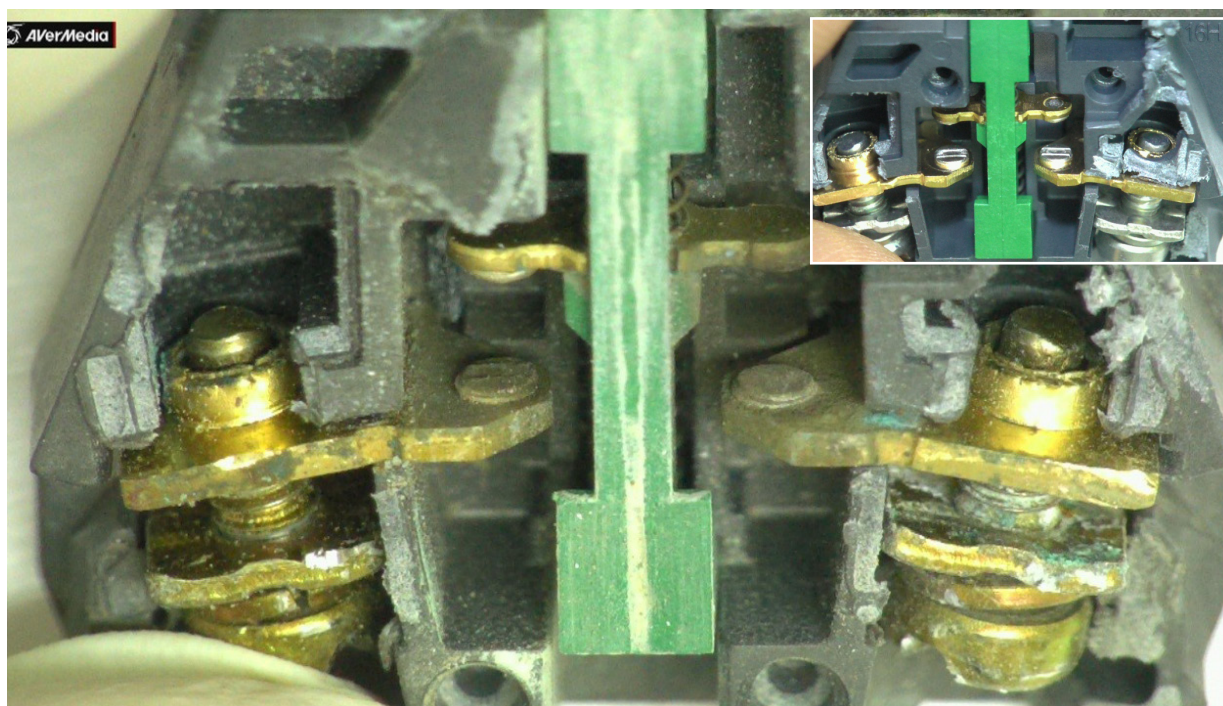
- 74 The switch contact block was then broken open (it is not designed to be taken apart). No foreign bodies or defects were found inside. There was evidence of some corrosion of the metal parts (figure 12), but not sufficient to have caused the switch to stick. There was some blackening of the contacts, as would be expected from a switch that was 15 years old, but no evidence of welding of the contacts.

Figure 12: Interior of normally open switch from 'out' button on main line side of wagon (inset shows corresponding view of new switch) (images courtesy of Schneider Electric)

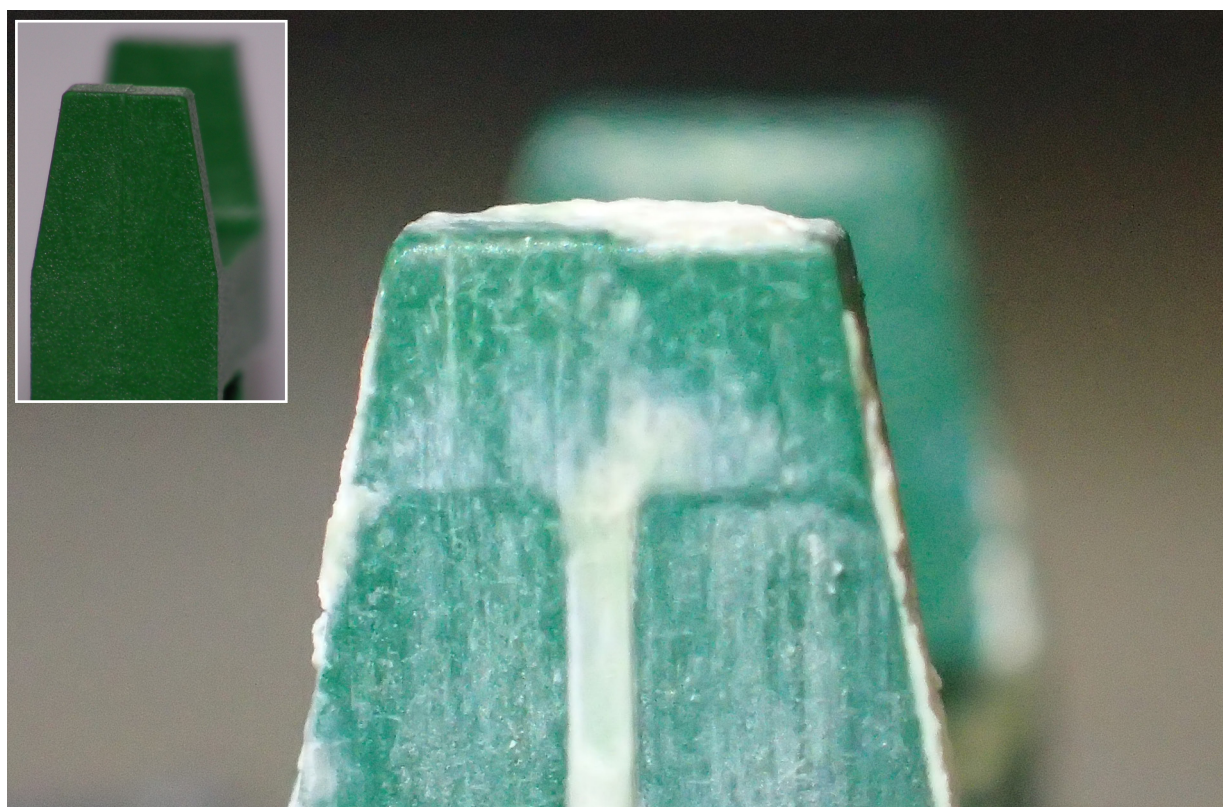
- 75 The plastic moving part of the switch contact block was coated with a hard white deposit (figure 13). Chemical analysis showed this to consist of oxides of zinc and aluminium. This was most likely to have come from corrosion of the zinc/aluminium alloy used for the casting on which the switches were mounted (figure 9). There were also traces of silicon, which is not present in any of the materials the switch is made from, but is a major component of granite. This corrosion deposit is probably the cause of the switch sticking. Figure 14 shows a close up view of the bracket on which the switch was mounted showing where the moving part of the switch had been rubbing against the corrosion deposit.

Figure 13: Close-up of moving part of switch from 'in' button on quarry side of wagon (inset shows corresponding view of new switch) (images courtesy of Schneider Electric)

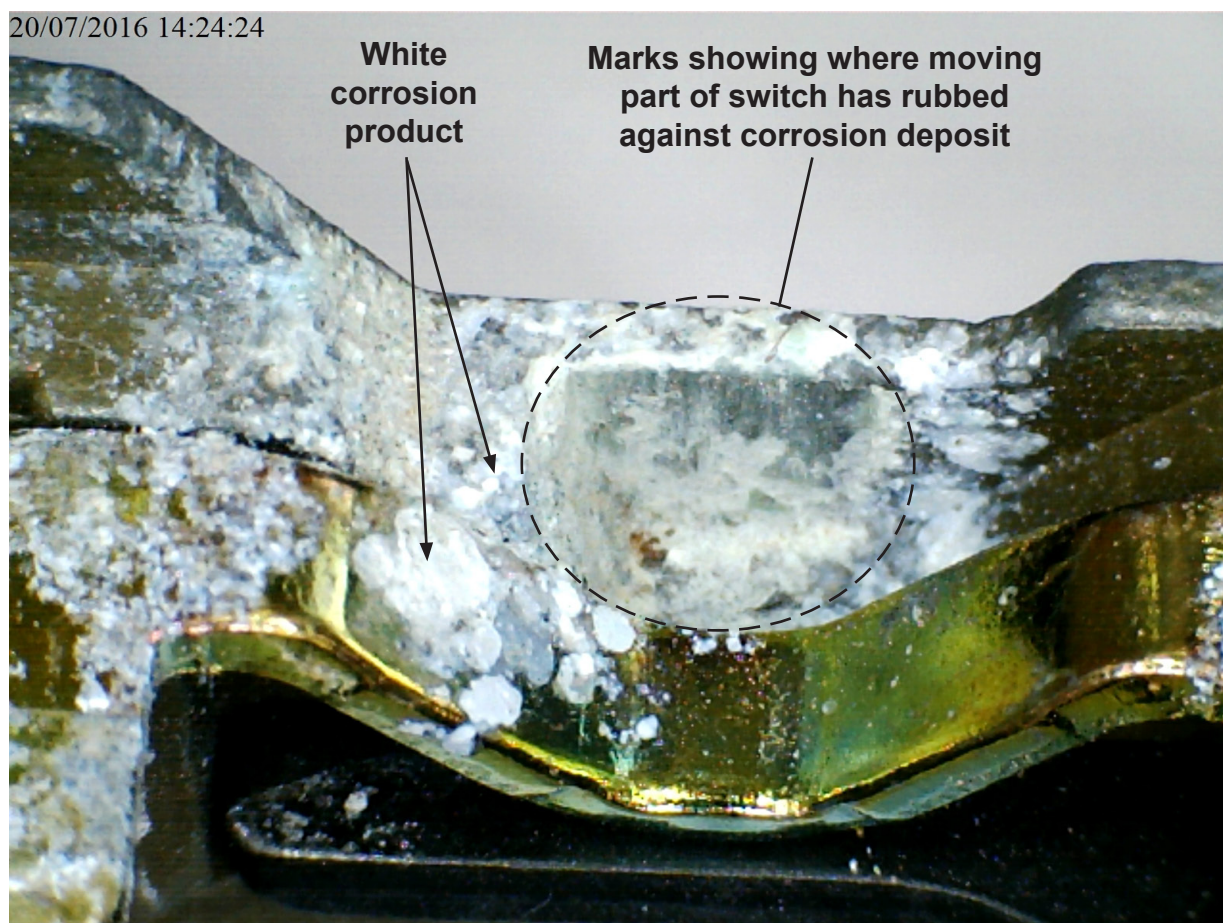
Figure 14: Close-up of diecast metal bracket (collar) from 'out' button on main line side of wagon

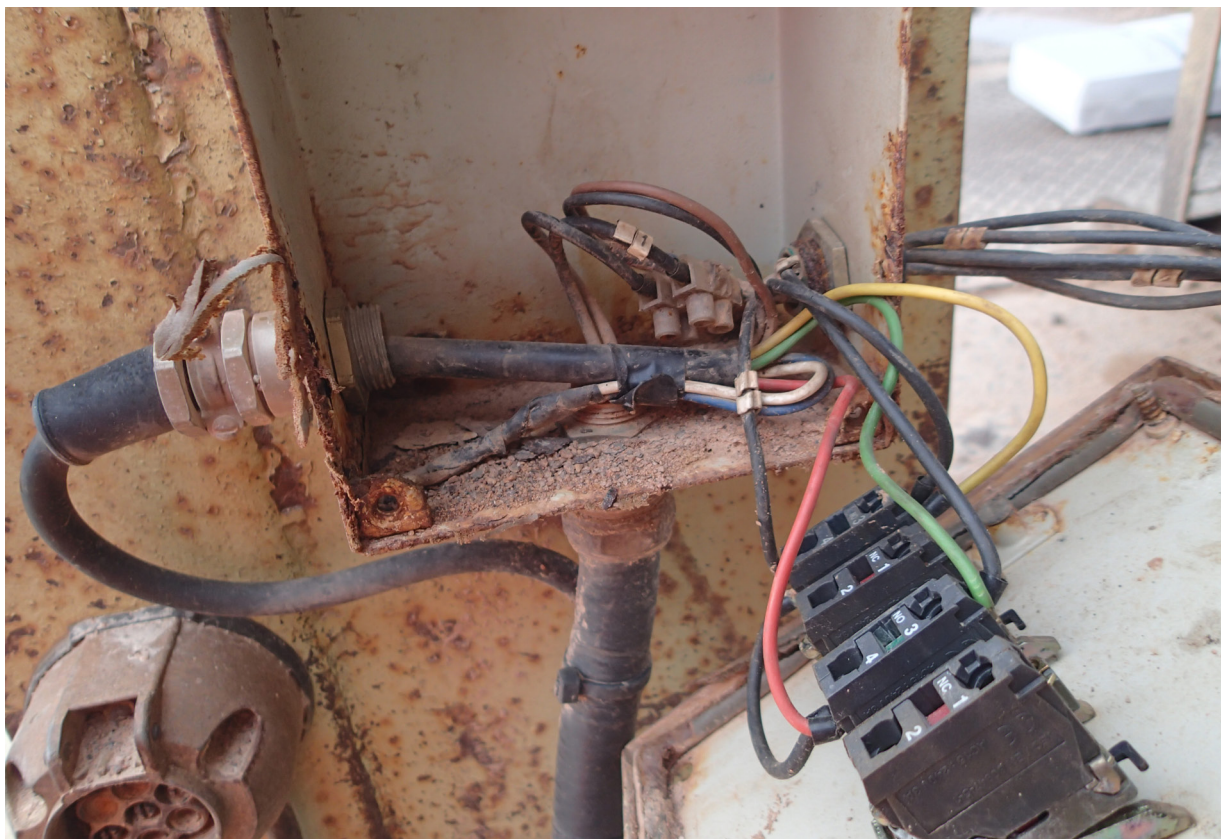
- 79 The switch contact block was designed to be mounted in an enclosure which would protect against moisture and dust to a degree suitable for the environment in which the equipment would be required to operate. The enclosure used on the SDT wagon was a steel box with a sealed lid and glands where the cables enter it. The boxes on both sides of the wagon had deteriorated to the extent that the lid seal was no longer effective and the cable entry points were no longer sealed (figure 15). The box was corroded inside and contained dust and debris. The corrosion indicated that moisture had penetrated the box. As there are no records of the electrical system on these wagons, the intended IP rating of the box is unknown.

Figure 15: Switch enclosure box on main line side of wagon

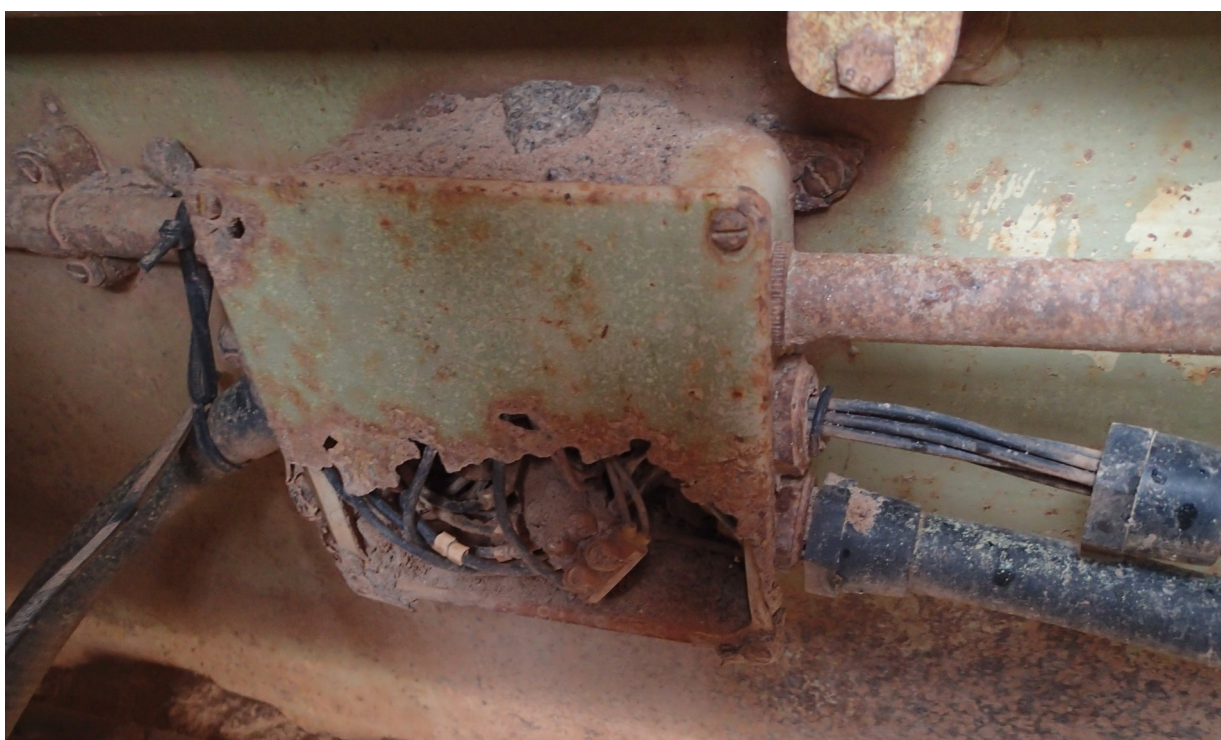
80 The RAIB examined other electrical junction boxes and panels on the wagon. These were also found to be badly deteriorated, with part of the lid completely corroded away in one case (figure 16 shows the junction box for the 'spider' switch cables).

Figure 16: Wiring junction box beneath 'spider' switch

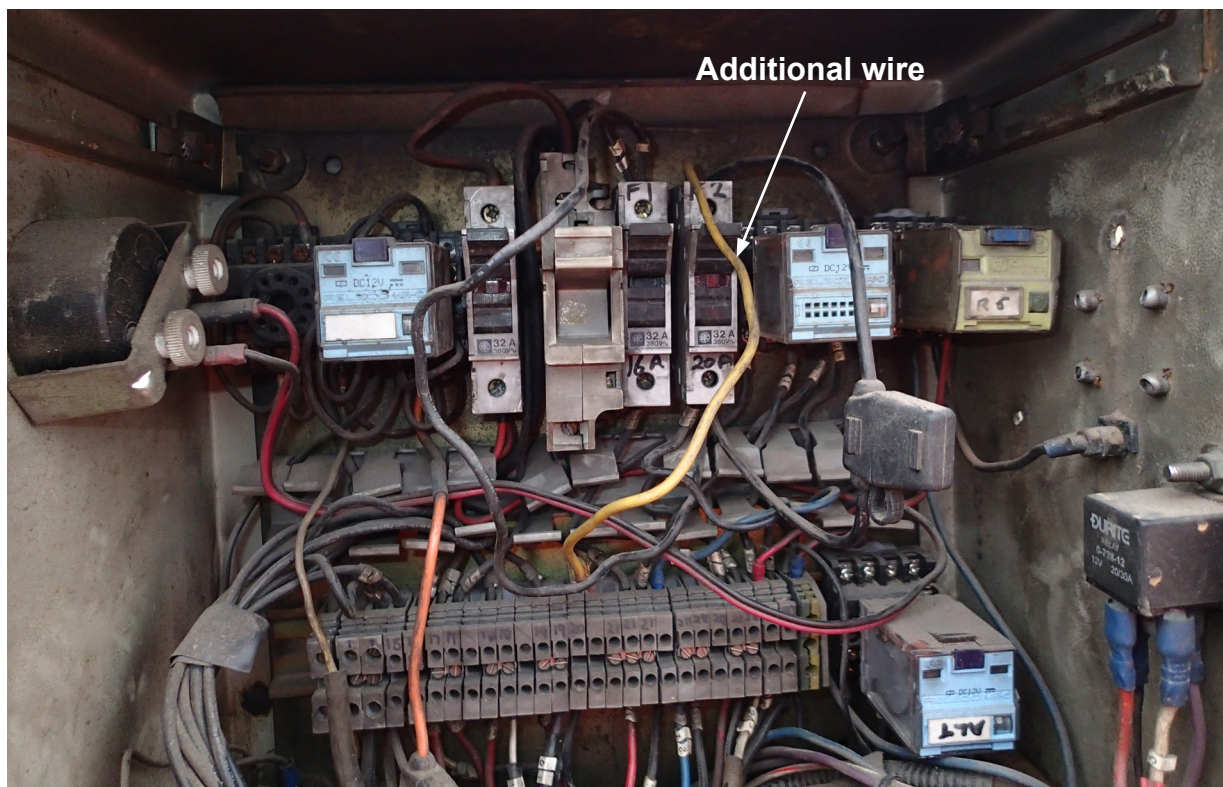
- 124 When tested by the RAIB after the accident, the push button on the side furthest from the main line was jammed with stone dust and could not be operated. The stop button on the main line side of the wagon was free to operate but did not stop the conveyor belt or the engine, as it was intended to do. The control circuit for the emergency stop buttons was traced and tested. It was found to contain an additional feed wire (figure 17). This wire supplied 12V from the battery to a point in the circuit which should have been capable of being de-energised by the push buttons. This false feed prevented the push buttons from having any effect.

Figure 17: Interior of engine control panel enclosure
