Rail Accident Report

Collision between a train and a tractor at Oakwood Farm User Worked Crossing, Knaresborough 14 May 2015

This report is published by the Rail Accident Investigation Branch, Department for Transport.

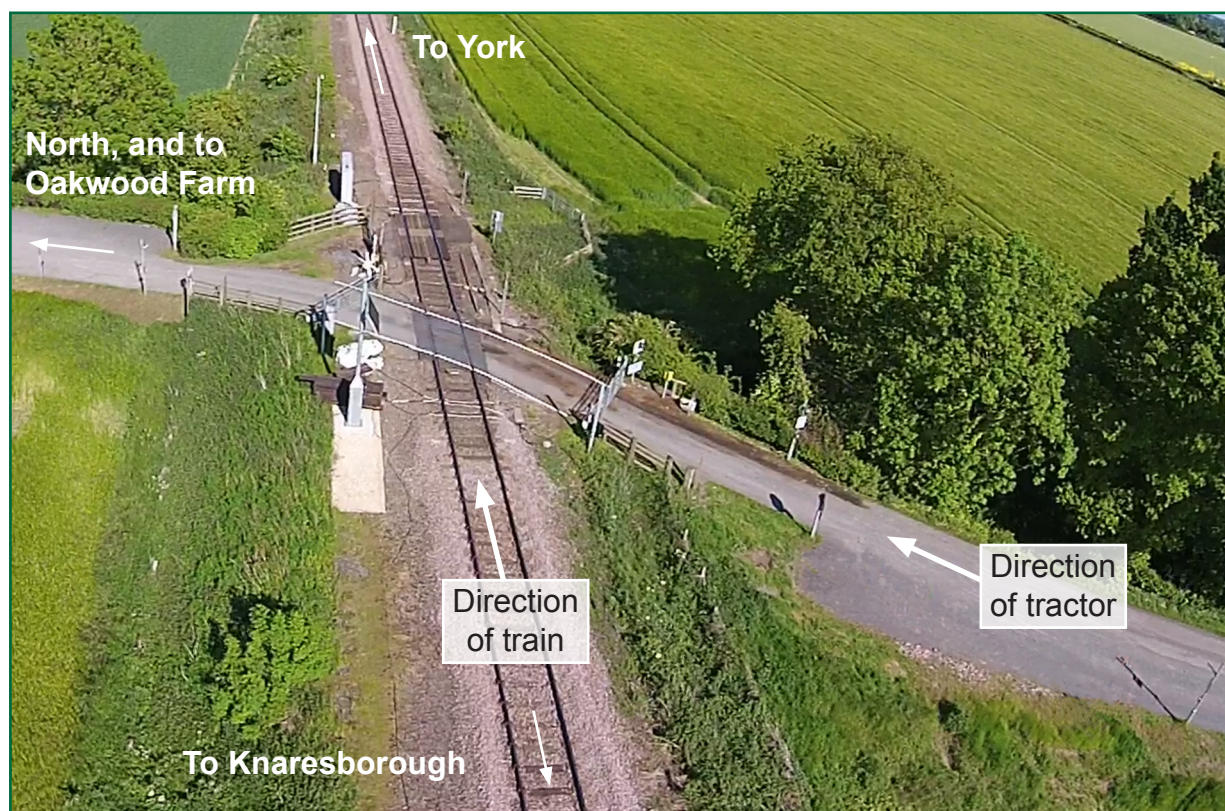
Figure 2: Oakwood Farm UWC

- 15 Oakwood Farm crossing is a user worked crossing on a private road. It consists of two crossings, ten metres apart (figure 2). Immediately to the east of the crossing on which this accident occurred, is another user worked crossing giving access from the private road on the north side of the railway to the fields on its south side. This crossing played no part in the accident, and this report is only concerned with the western crossing which allows users to travel along the private road between the A59 and Oakwood Farm.

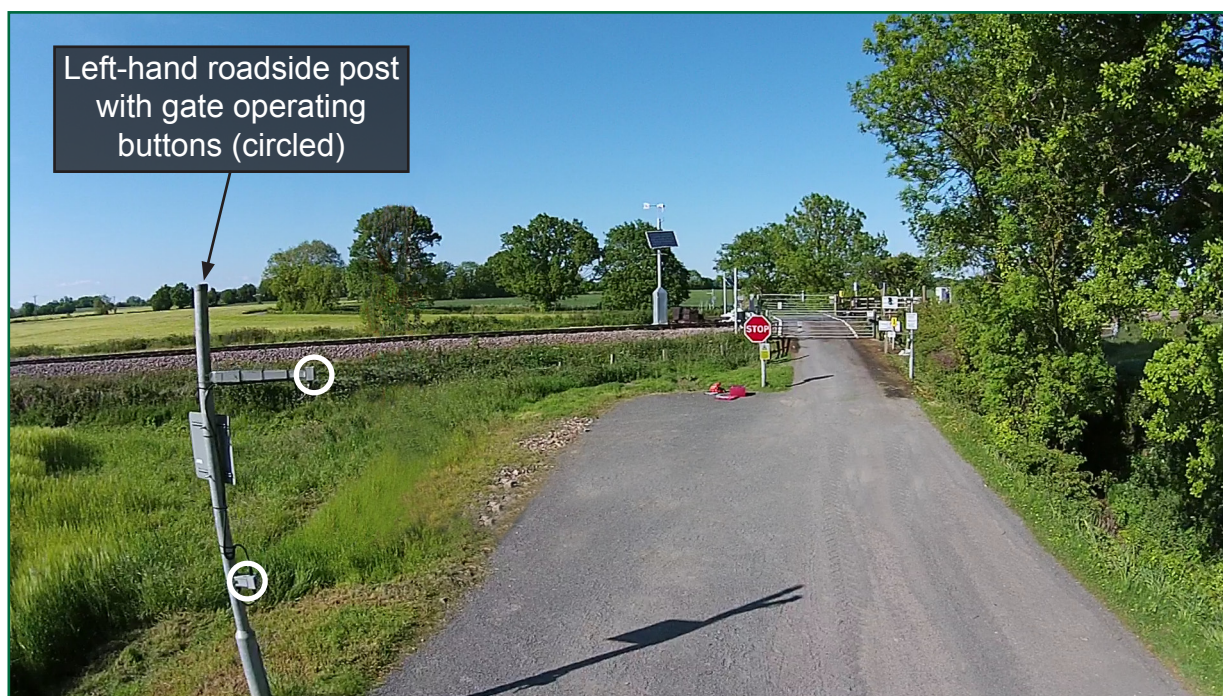
Figure 4: The approach to the crossing towards Oakwood Farm showing the left-hand roadside post

- 25 Shortly after 18:15 hrs the tractor arrived at the crossing. The driver stopped the tractor on the left-hand side of the road beside a post on which were two buttons to operate the gates (figure 4). He opened the left-hand side tractor door, stood on the step of the tractor and pushed the higher of the two buttons. He then re-entered the cab, closed the door and drove slowly towards the crossing as the gates were opening.

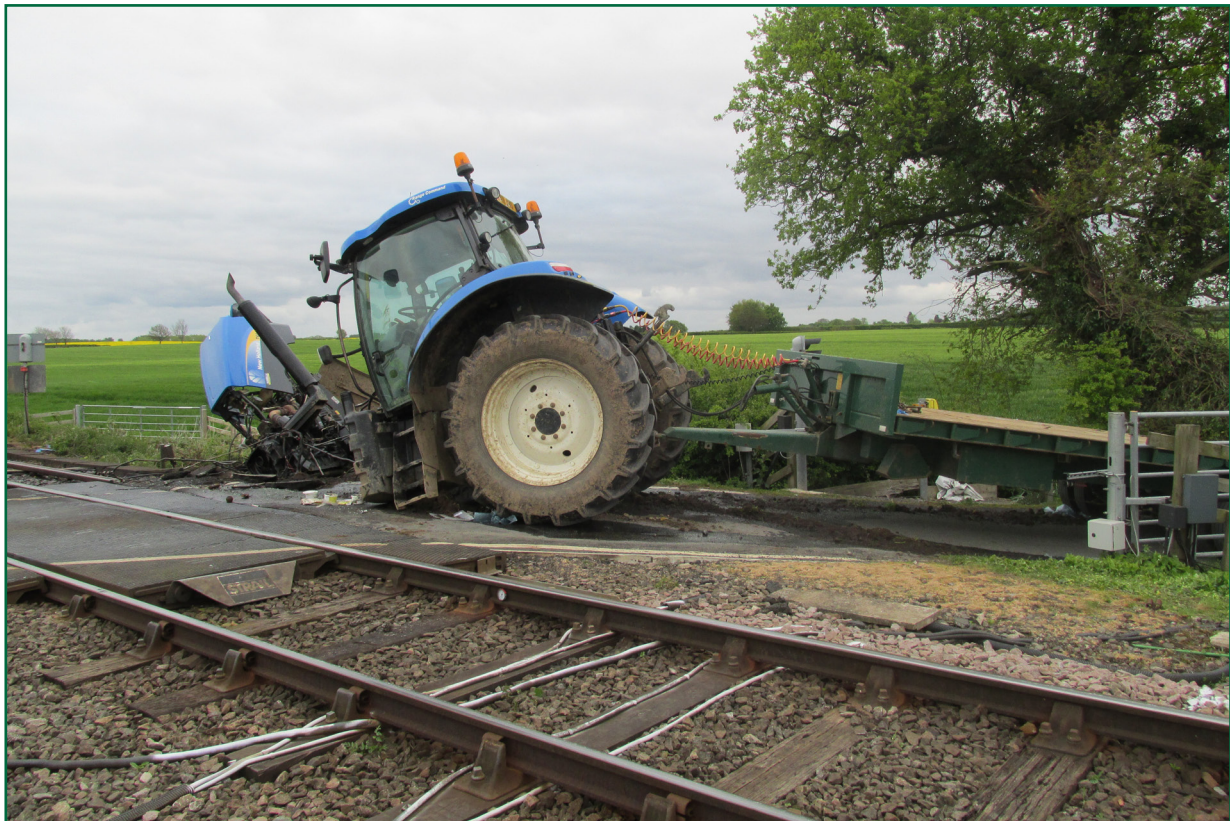
Figure 5: The damaged tractor following the accident (image courtesy of British Transport Police)

- 29 The train's speed was not reduced in the short period between the emergency brake application (paragraph 27) and train's arrival at the crossing and it collided with the front of the tractor at around 18:18 hrs, still travelling at 65 mph (105 km/h) on impact. The right-hand side front corner of the train collided with the front left-hand wheel of the tractor. The impact caused the portion in front of the cab to become separated from the rear portion (figure 5).

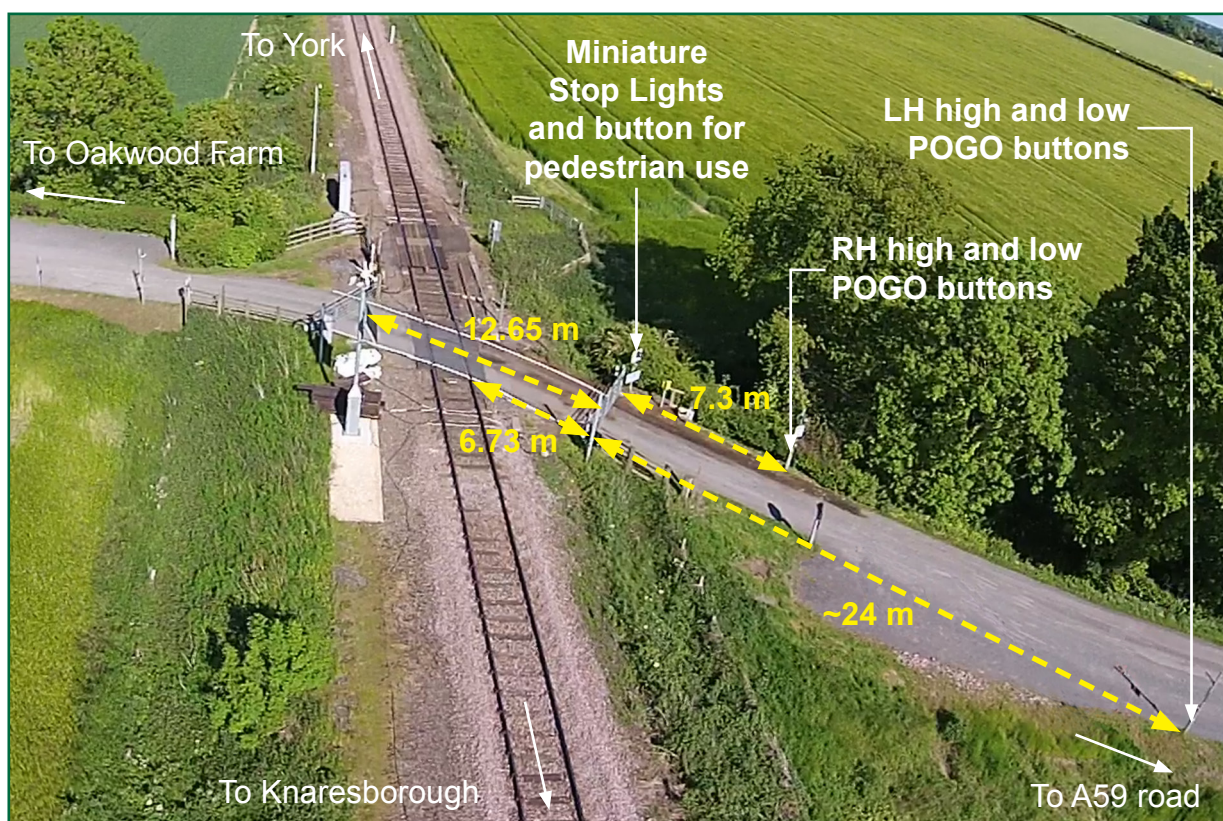
Figure 7: Location of the POGO operating buttons

- 40 On the southern approach to Oakwood Farm crossing there is one button for pedestrian use located by the latch on the gate post. Two buttons are located on a post on the right-hand side of the road approximately 7 metres from the gate (figure 7). The remaining two buttons are on a post on the left-hand side of the road, 24 metres from the gate. The purpose of these buttons is further discussed in paragraph 53. The buttons mounted on each of the road-side posts are at different heights; the lower button is for use by car and van drivers, and the upper button is for lorry and farm vehicle drivers. At the time of the accident, any of the buttons could be pressed to either open or close the gates, depending on their pre-existing position. Each single opening or closing operation takes approximately 15 seconds.

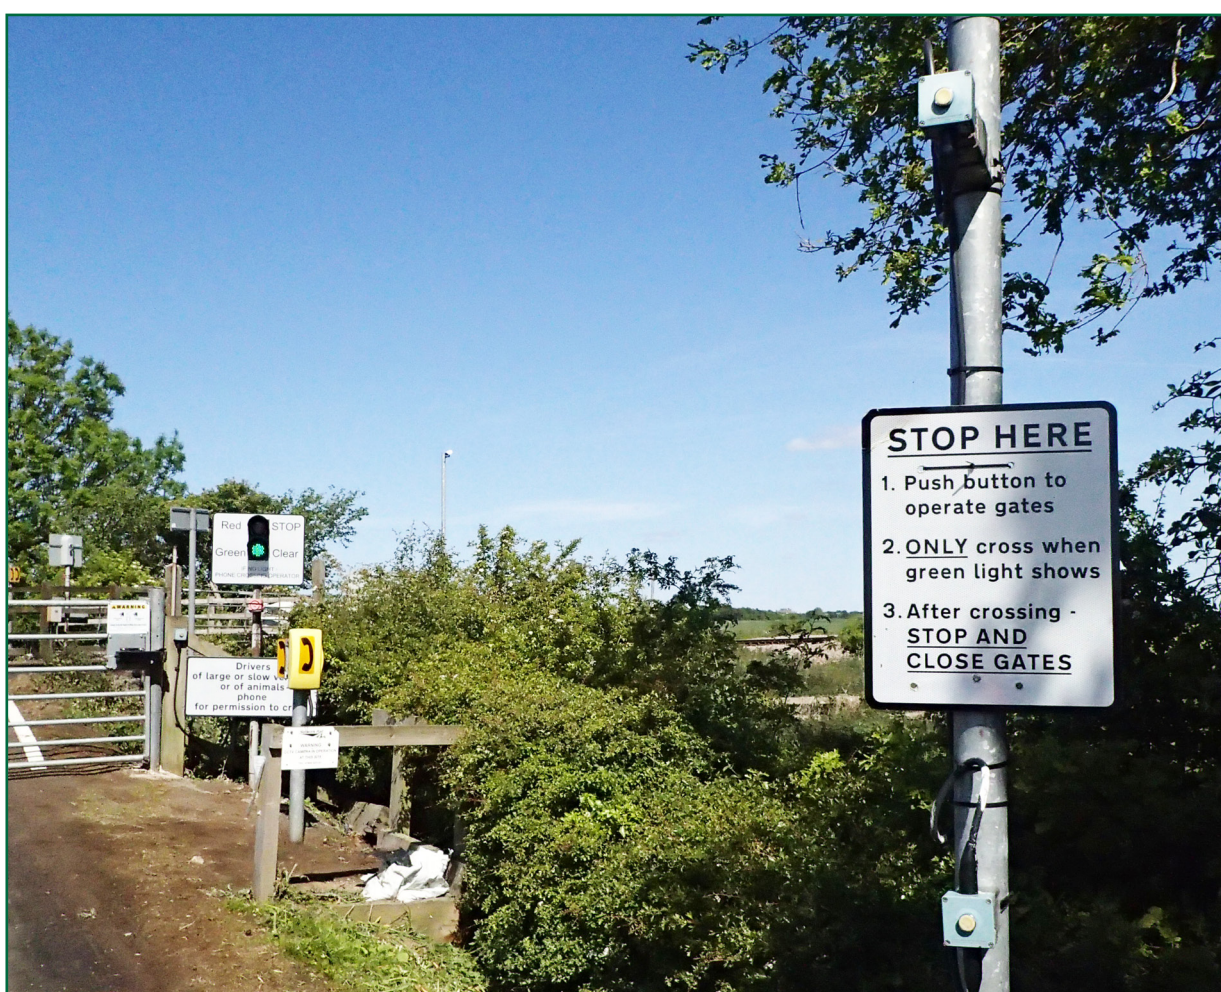
Figure 8: The instruction sign on the right-hand roadside post

- 57 There was a sign mounted on the right-hand roadside post instructing users how to use the crossing (figure 8). This sign, although not of the correct type authorised by Network Rail in September 2013 for the nationwide use of the POGO equipment, instructed users to push the button and to cross only when the green light was showing. Although there is conflicting evidence, the RAIB's view is that the tractor driver did not see these instructions because he had already used the button on the left-hand post. There was no such sign on the left-hand post as Network Rail did not consider that this button would be used to open the gates (paragraph 74). Had there been a sign at the left-hand post, it might have prompted the driver to recheck the MSL before crossing.

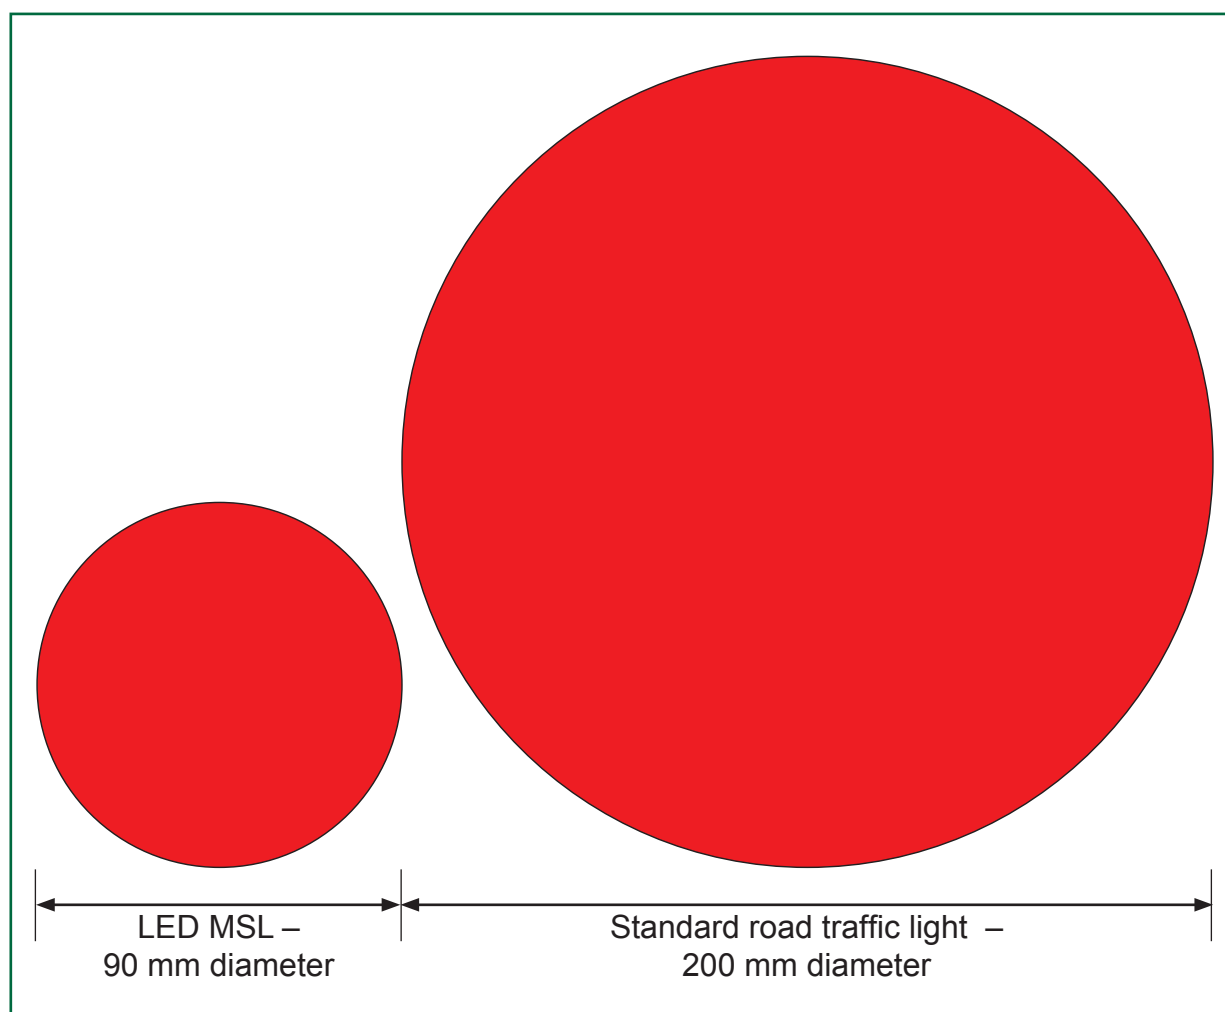
Figure 10: Relative sizes of a LED MSL and a standard road traffic light

- 64 The red light of the LED MSL is a single light, situated on the right-hand side of the road. It has a diameter of 90 mm and is small compared to a public road traffic light which has a diameter of 200 mm (figure 10). It is below the tractor driver's eye line. It is likely that it was fitted at this location and height to be visible to pedestrian users of the crossing. In addition, the lights of the MSLs are mounted on a board on which there is text (figure 3). That, combined with the many other signs present, cause the MSL's to be less conspicuous (figure 11).

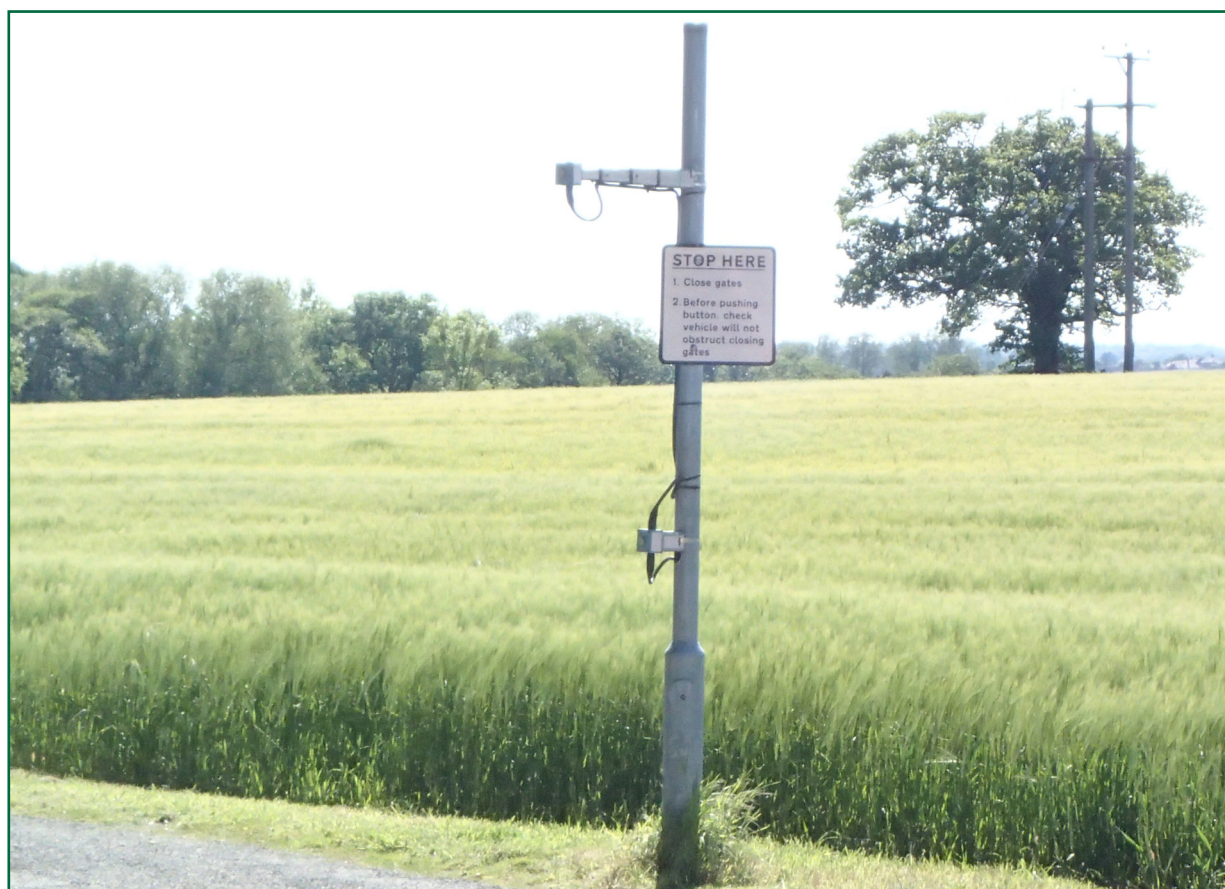
Figure 13: View looking away from the crossing towards the left-hand roadside post showing the sign instructing users to close the gates

- 75 The layout plan also shows that a sign was to be fitted to each left-hand roadside post, facing towards users leaving the crossing, instructing them to stop and close the gates. Such a sign was on the post that the tractor driver stopped at to operate the gates (figure 13), although he would not have seen it on his approach as it was facing in the opposite direction.
