Rail Accident Report

Runaway hand trolley at Ramsbottom, East Lancashire Railway 15 March 2018

Report 18/2018
November 2018

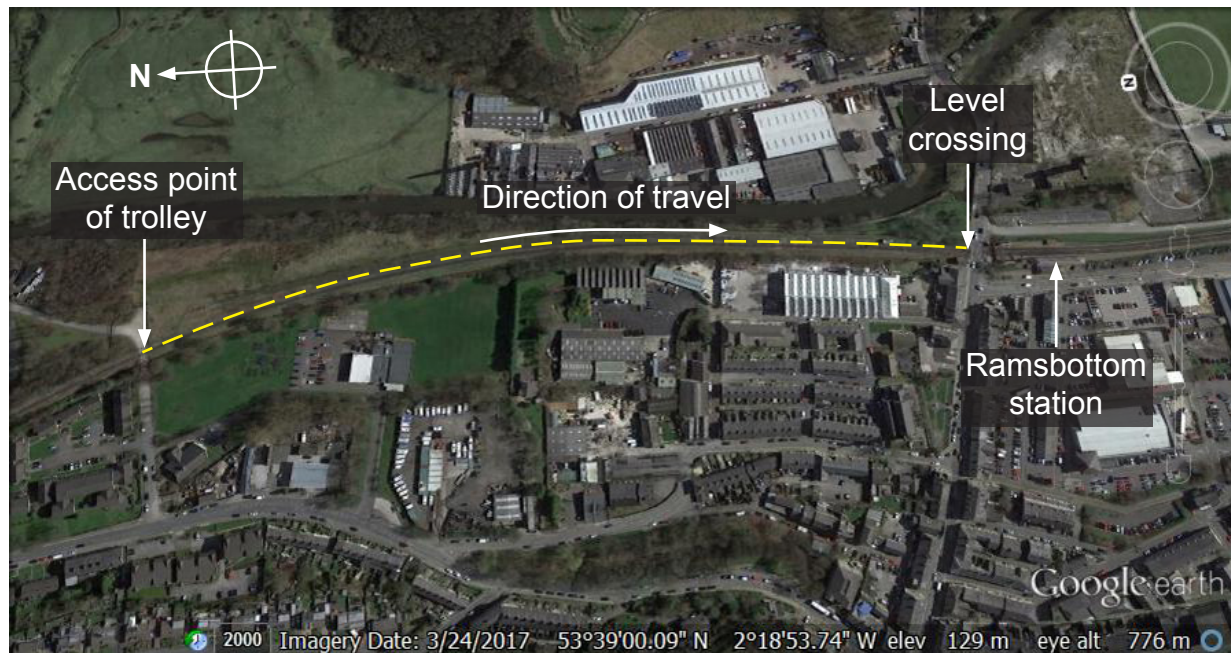
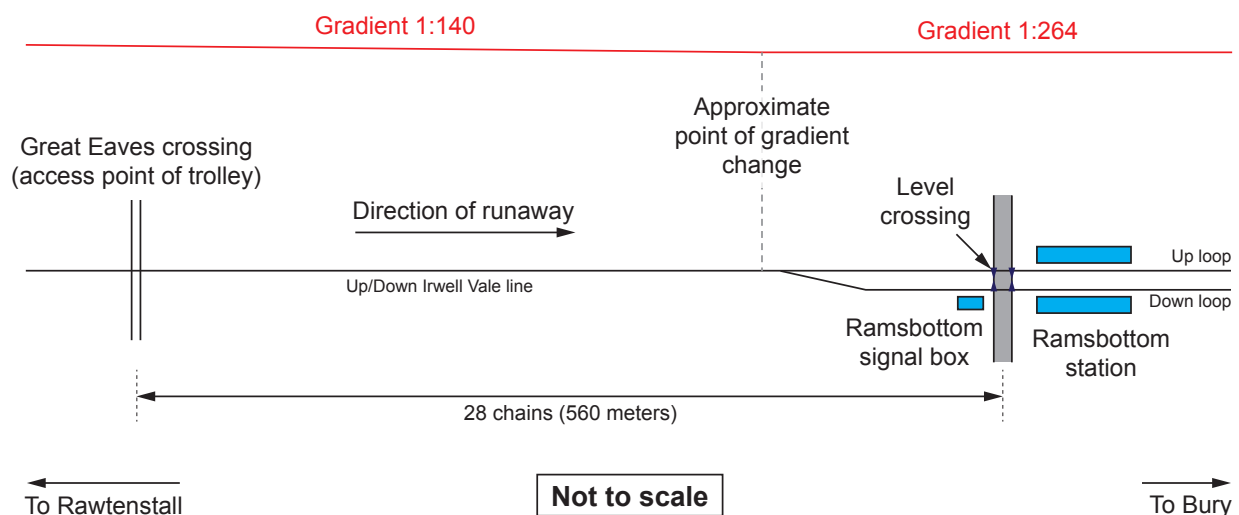
Figure 2: Diagram showing track layout

- 6 The incident began near Great Eaves Road level crossing, 28 chains (560 metres) north of Ramsbottom level crossing. This is on the section of single line running from north of Ramsbottom signal box to just south of Rawtenstall. At Ramsbottom signal box the line divides to create an 'Up' and a 'Down' loop through Ramsbottom station. Ramsbottom level crossing, where Bridge Street crosses the railway, is at the northern extent of the 'Up' and 'Down' loops (figure 2).
- 7 Travelling south (in the 'Up' direction) towards Ramsbottom the gradient is downhill. North of Ramsbottom the gradient is 1 in 140 although at Ramsbottom level crossing and station it is a shallower 1 in 264.

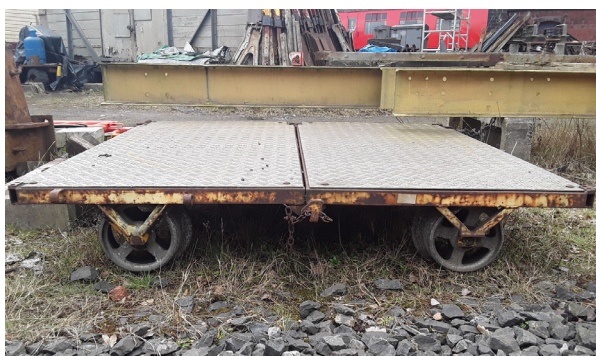
Figure 3: Photograph of similar hand trolley (courtesy of East Lancashire Railway)

- 10 The trolley involved was a four wheeled flatbed trolley typically used to transport materials or tools along the railway (figure 3). This type of trolley is made up of two sections for ease of handling. Trolleys of this type are normally transported in these sections and joined together on site. When new, the trolley was fitted with brakes. These would have been spring applied and released using a manually operated lever.

- 37 The condition of the trolley when it was donated is not known with certainty. However, ELR considers it likely that it was donated without brakes. Other similar trolleys at ELR had been donated without brakes.

- 78 ELR has withdrawn all of its manually-propelled trolleys and replaced them with a new industry-standard, braked trolley. All ELR Permanent Way department staff and volunteers have been trained in using the new trolley, including pre-use brake tests, in accordance with the manufacturer's instructions.
- 79 ELR are assessing the withdrawn trolleys and arranging for them to be repaired or disposed of, as appropriate. All retained trolleys will be given asset numbers and suitably labelled.
- 80 ELR have trained all Permanent Way staff in the responsibilities of the role of 'Person in Charge of Work'.
- 81 ELR has engaged a safety consultant who is reviewing the SMS and underlying procedures that support its implementation. The output from this review is to be used to support revision of the SMS and develop the required procedures to enable its efficient implementation.

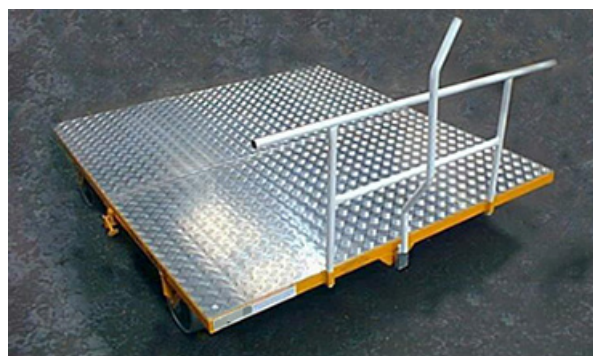
Figure 4: Photograph showing a correctly configured manually-propelled trolley

- 11 When new, a push-handle would have been provided to allow the operator(s) to propel the trolley (figure 4). The bottom ends of the push-handle are inserted into brackets fitted to the ends of the trolley deck. The trolley is intended to be propelled by one or more persons walking along behind it holding the brake off and pushing the push-handle. The trolley involved no longer had any brake shoes or springs fitted. It was still fitted with some parts of the braking system and brackets for the push-handle. No push-handle had been provided with the trolley on the day of the runaway.
- 12 Ramsbottom level crossing has two pairs of wooden crossing gates that are operated from the adjacent Ramsbottom signal box (figure 5). The operation of the crossing is not a factor in this incident.

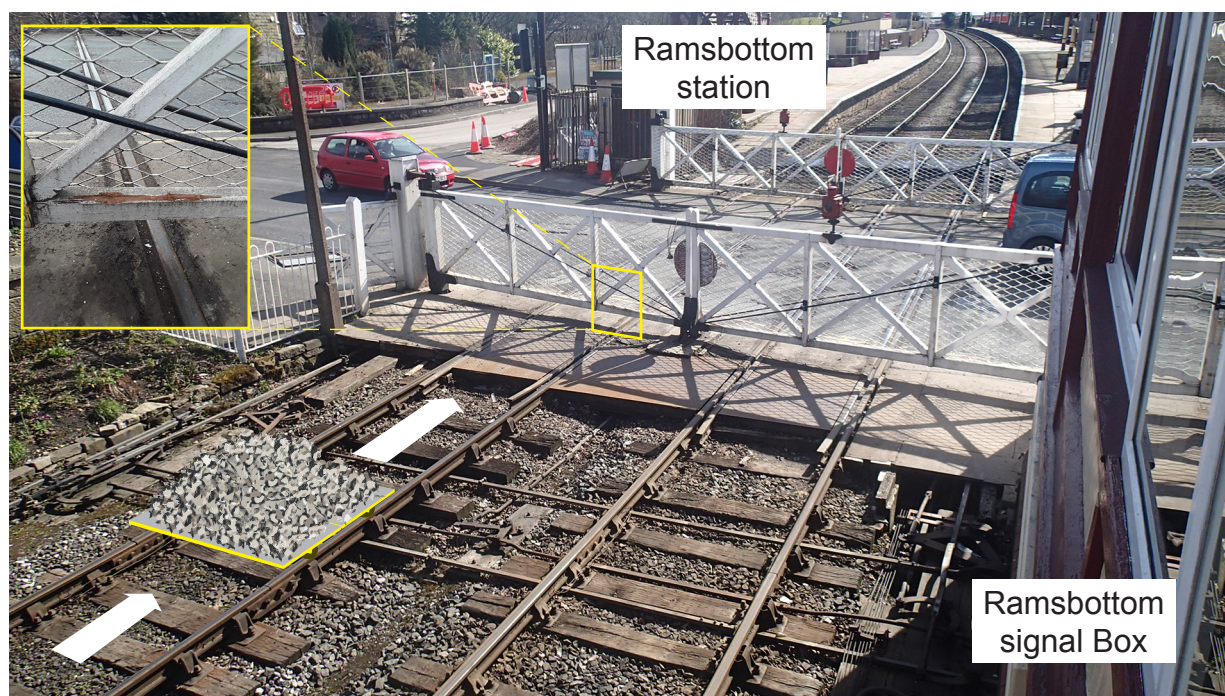
Figure 6: Representation of the trolley striking the level crossing gate (inset image courtesy of East Lancashire Railway)

- 24 The trolley started rolling along ahead of the two volunteers. It is not clear how far ahead of them it was or how far they had gone when they realised that the gap between them and the trolley was increasing. Up to this point they had not needed to stop the trolley and had not attempted to. When they realised it was running away one of them ran after it. He was unable to catch it, but saw it collide with the level crossing gates (figure 6).

- 25 The trolley struck the eastern gate on the north side of the crossing. It derailed and some ballast spilled onto the road. The impact damaged the woodwork and the gate mechanism causing the gate to be partially displaced across the road. A passing motorist was forced to alter course to avoid the gate. He stopped briefly and spoke with one of the volunteers.
