Rail Accident Report

Fatal accident near David Lane tram stop 15 August 2016

Report 06/2017
April 2017

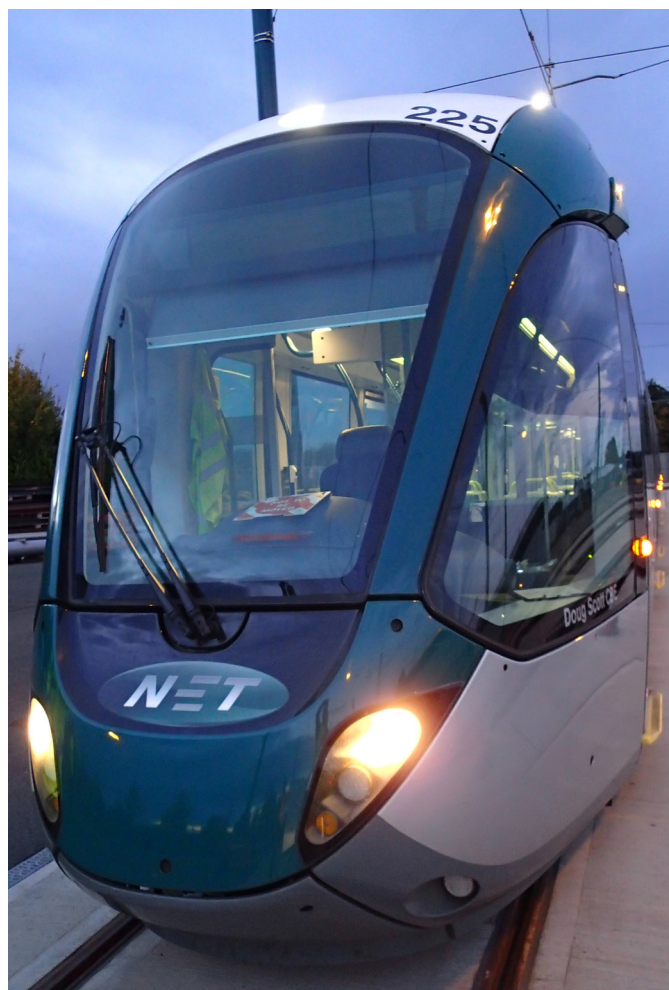
Figure 4: Tram 225

- 8 The tram involved, number 225, was manufactured and supplied by Alstom as part of the network extension (figure 4). It is a derivative of Alstom's Citadis brand. Tram 225 entered service in summer 2015.

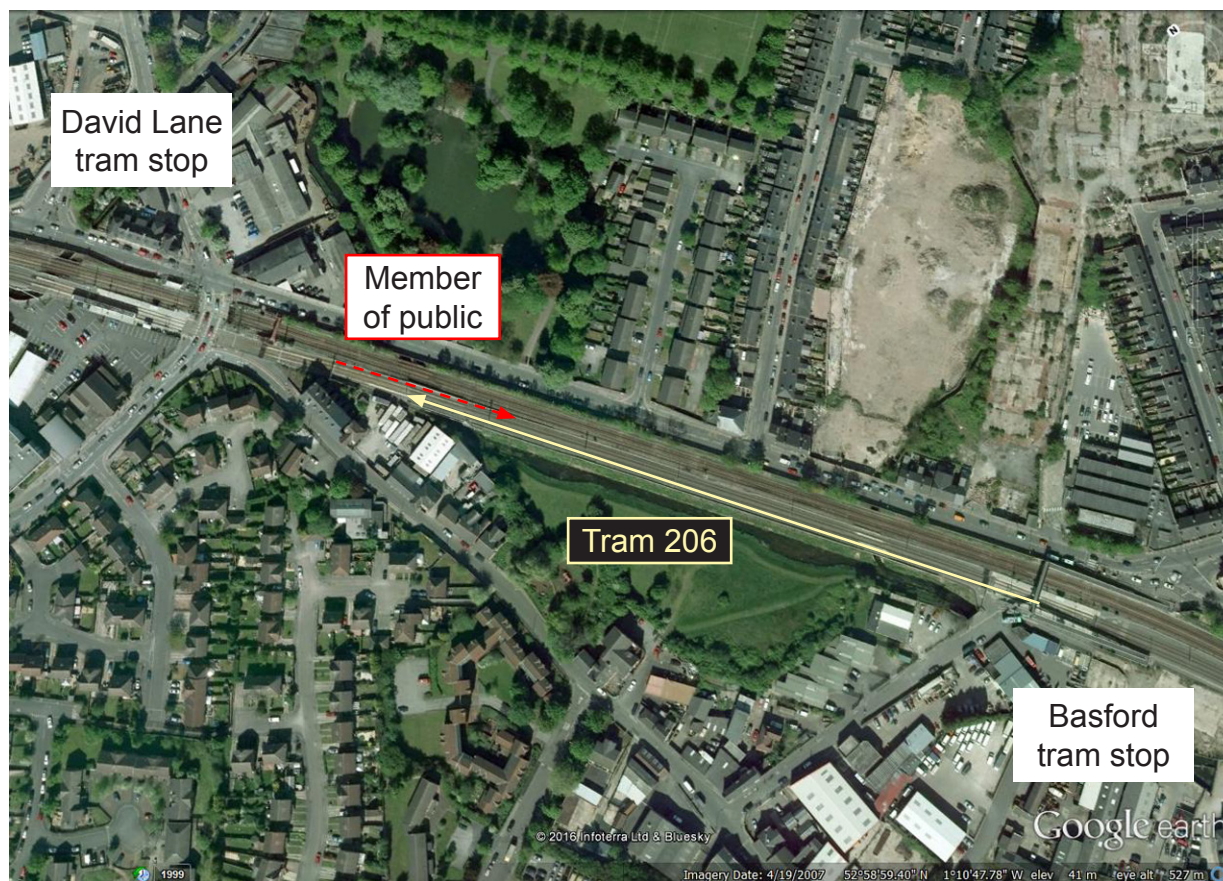
Figure 7: Passage of tram 206 at 22:48 hrs

- 19 The next tram through the area between the tram stops was tram 206 heading northbound from Basford to David Lane tram stop (figure 7). Soon after departing from Basford tram stop, the driver identified that there was a person on the adjacent line ahead of his tram. He proceeded cautiously at a reduced speed and passed the member of the public. At 22:48:18 hrs, the driver of tram 206 called the control room³ and spoke to SDS3 to report encountering a person walking southbound on the southbound track a 'couple of hundred metres' from David Lane tram stop.

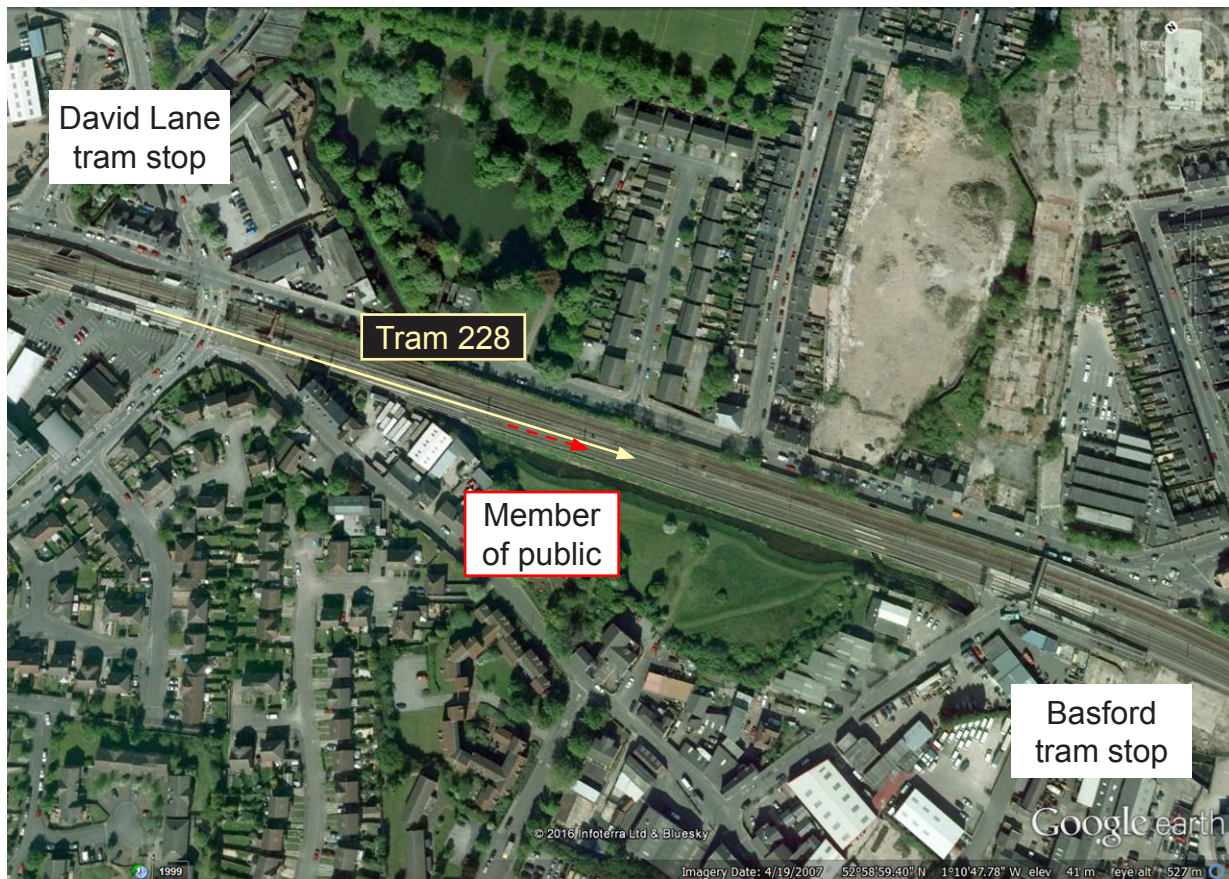
Figure 8: Passage of tram 228 between 22:49 hrs and 22:51 hrs

- 20 At 22:48:45 hrs and while the conversation between the driver of tram 206 and SDS3 was still taking place, SDS2 placed a call to the next tram through the area, which was tram 228 (heading southbound). Having overheard the report from the driver of tram 206, SDS2 instructed the driver of tram 228 to exercise caution through the area between David Lane and Basford tram stops. Tram 228 was on its approach to David Lane tram stop at the time of the call.
- 21 At 22:49:34 hrs, tram 228 stopped at David Lane tram stop (figure 8). At 22:49:49 hrs, tram 228 departed from David Lane tram stop at low speed. The CCTV footage from that tram shows that the member of the public was still walking southbound but that he was now in the area between the two tramway lines (an area known as the *six-foot*). Tram 228 approached the member of the public from behind at walking pace.

- 22 At 22:50:51 hrs, the member of the public reached one of the overhead power line stanchions located in the six-foot and held onto it. As he was now standing still, the driver of tram 228 decided that it was safe to pass, still driving at walking pace. Tram 228 is fitted with rearward facing cameras which look along the sides of the tram (they are used by drivers at the tram stops to confirm that it is safe to close the doors). The footage from one of these cameras shows that the member of the public left the stanchion shortly after the front of tram 228 passed him and started walking alongside tram 228. At 22:51:18 hrs, the rear of tram 228 passed the member of the public who then disappeared from the footage into darkness.

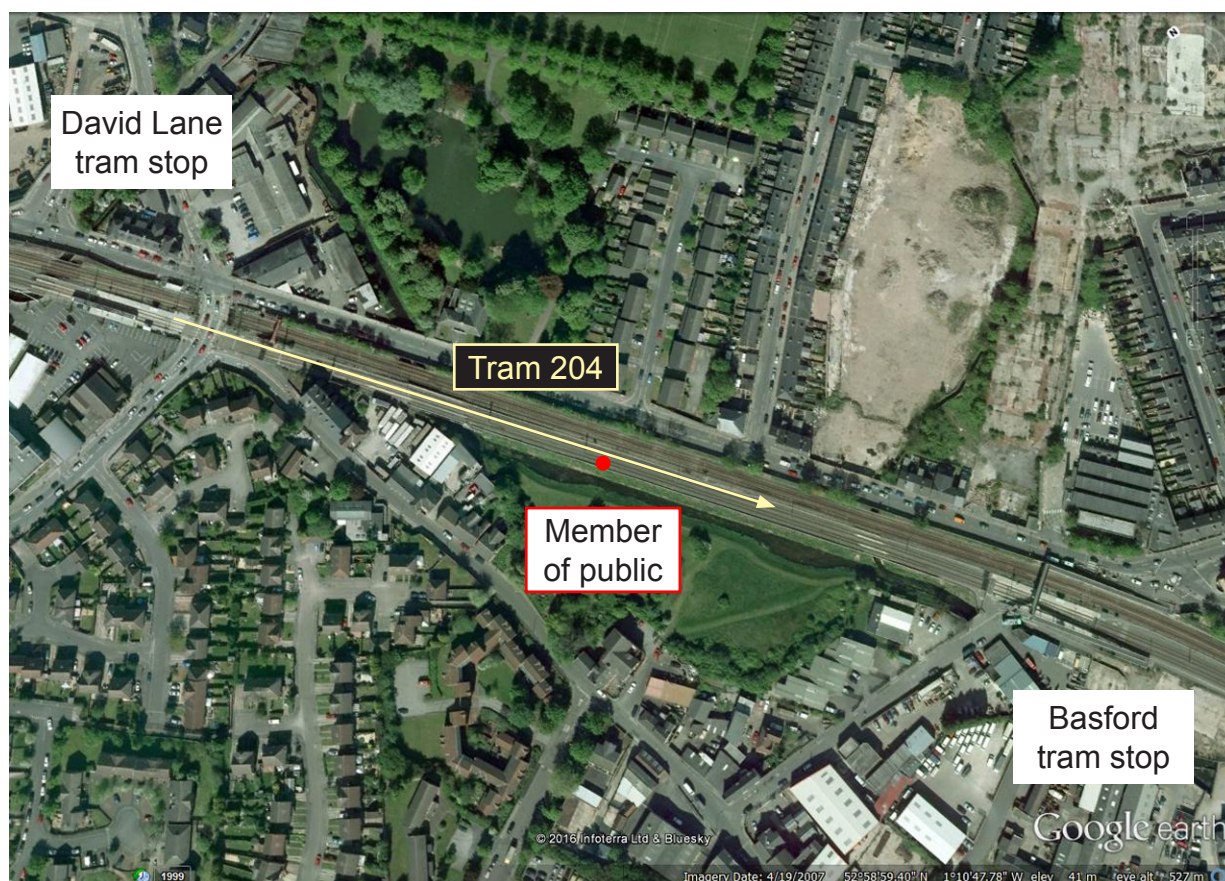
Figure 9: Passage of tram 204 at 22:56 hrs

- 28 At 22:56:09 hrs, tram 204 left David Lane tram stop heading towards Basford at normal speed (figure 9). Tram 204 reached Basford tram stop at 22:57:00 hrs, just as tram 225 was about to depart. As instructed, the driver of tram 204 placed a call with the control room at 22:57:10 hrs during which he was asked by SDS3 to exercise caution between Basford and Wilkinson Street.

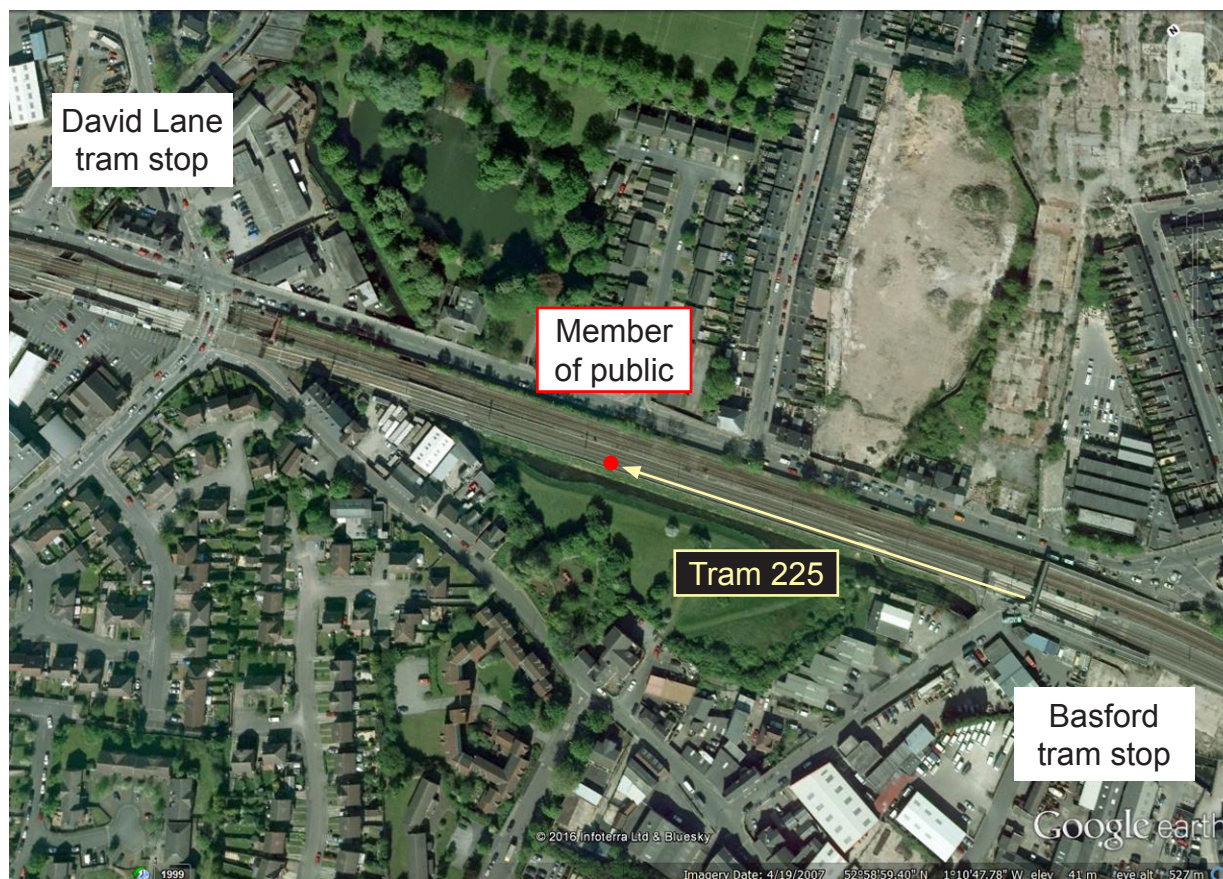
Figure 10: Passage of tram 225 at 22:57 hrs

- 29 At 22:57:02 hrs, tram 225 left Basford tram stop (figure 10). The tram accelerated and reached a speed of approximately 50 km/h about 130 metres away from Basford tram stop at which point the driver stopped accelerating.
- 30 Approximately 180 metres from Basford tram stop, the on-tram data recorder (OTDR) shows that the driver started to apply the service brake. This was in response to the driver detecting that there was something in between the rails on the track used by his tram (an area known as the *four-foot*). The driver was unaware that this was the member of the public who was now lying in the four-foot of the northbound track close to the position where he was last seen on the footage from tram 228.

- 31 At 22:57:25 hrs, one second after applying the service brake, tram 225 struck the member of the public at a speed of 48 km/h. One second later, the OTDR shows that the driver applied the emergency brake and the tram came to a stop 42 metres from the point of collision.
