Rail Accident Report

Collision at London Waterloo 15 August 2017

Report 19/2018
November 2018

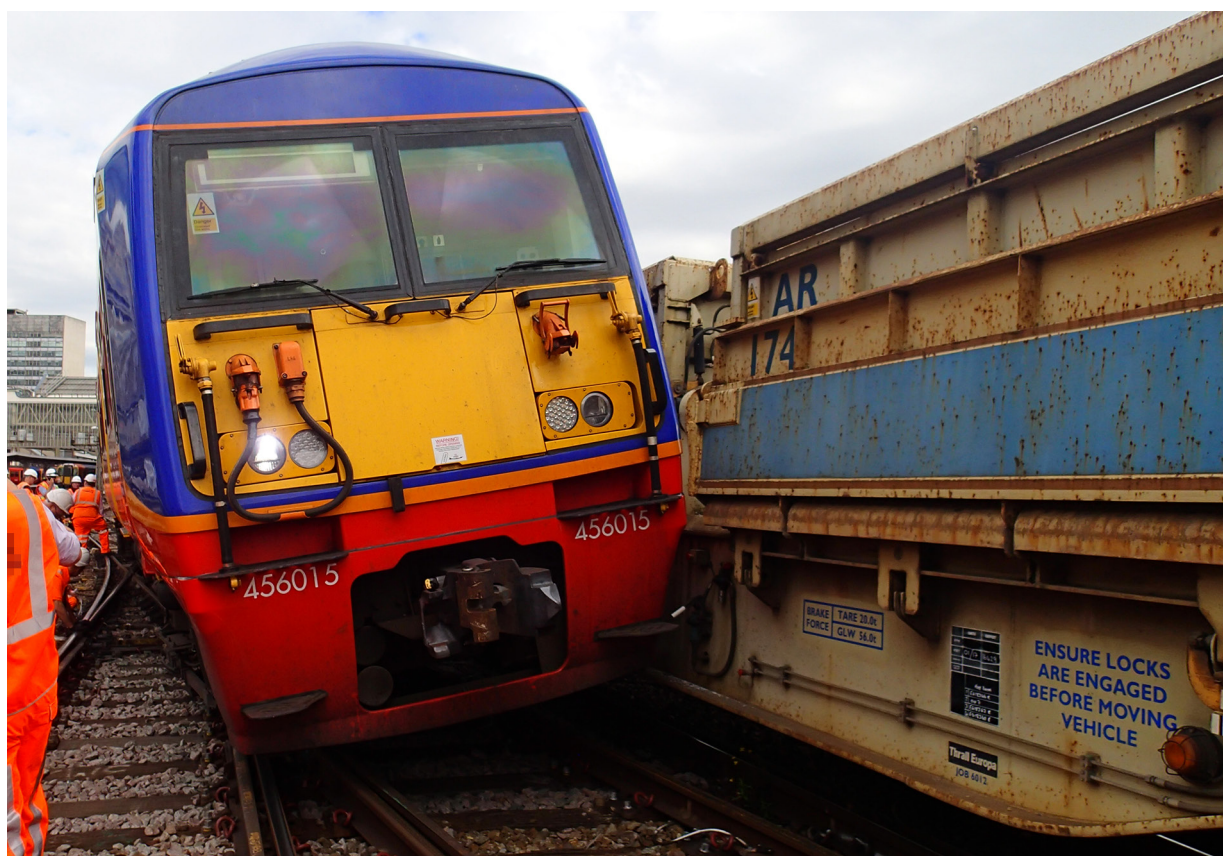
Figure 2: Passenger and engineering train after the collision

- 31 After the collision, the passenger train slid along the side of the engineering train for around four seconds before coming to a stop with the left-hand wheels of the leading coach above the rail and the right-hand side wheels remaining on the rail (figure 9).

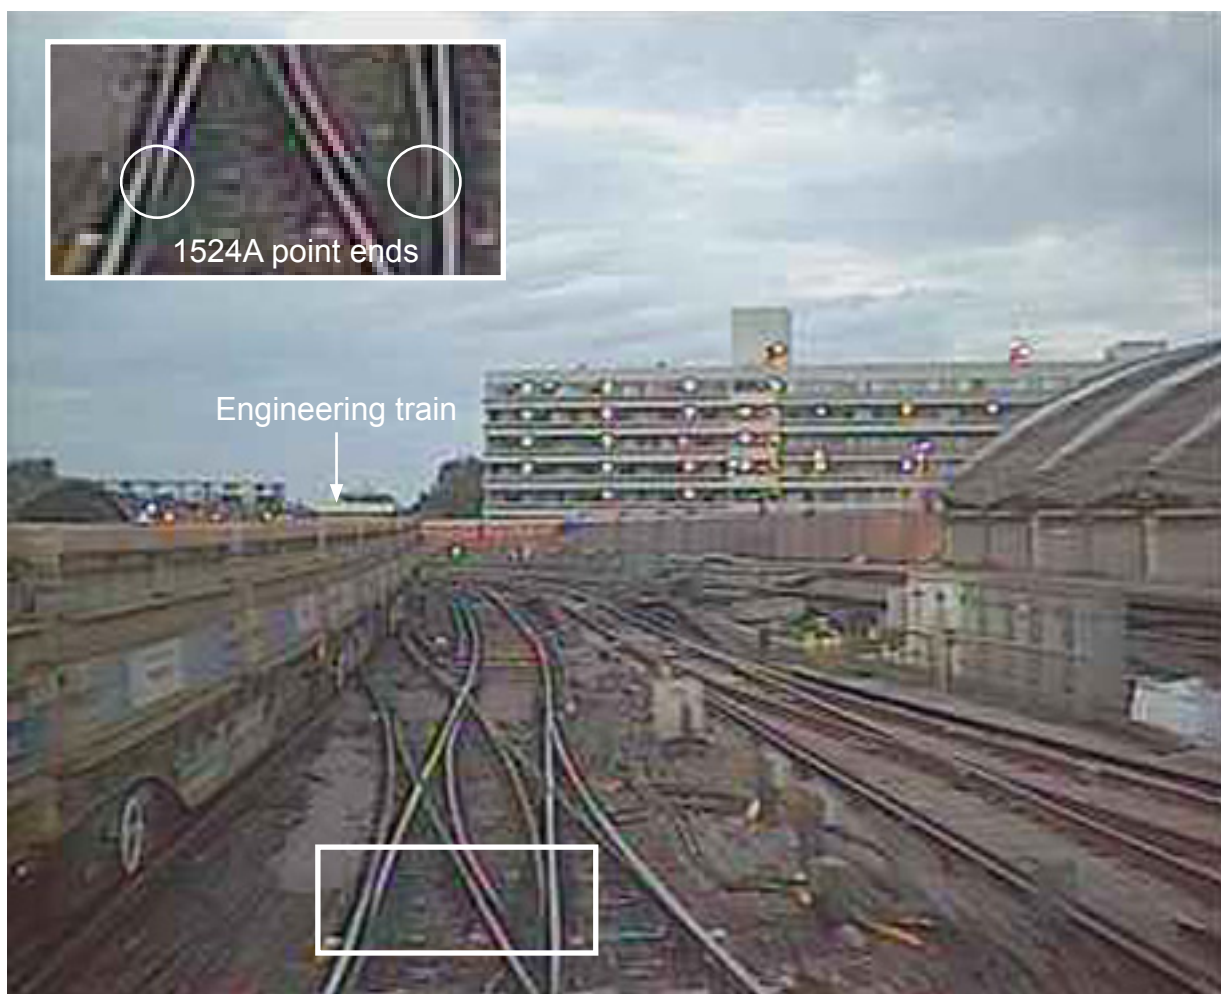
- 30 Soon after moving away from the platform, the train was travelling at about 15 mph (24 km/h) when the driver noticed that 1524 points were not correctly set and applied the train's brakes (figure 8). The points should have been set to direct the train straight on, but were incorrectly lying in an intermediate state and directed the train to the left and into the side of the engineering train. The collision occurred about three seconds after the brake application which had reduced the train's speed to 13 mph (21 km/h). Drivers are not required, and not expected, to check point positions in these circumstances. The driver of train 2D03 is to be commended for noticing that they were lying incorrectly and for his prompt brake application.

Figure 8: View from the train's forward facing CCTV showing 1524A points lying approximately midway between normal (wide gap at right-hand point end, no gap at left-hand point end) and reverse (gap only at left-hand point end)

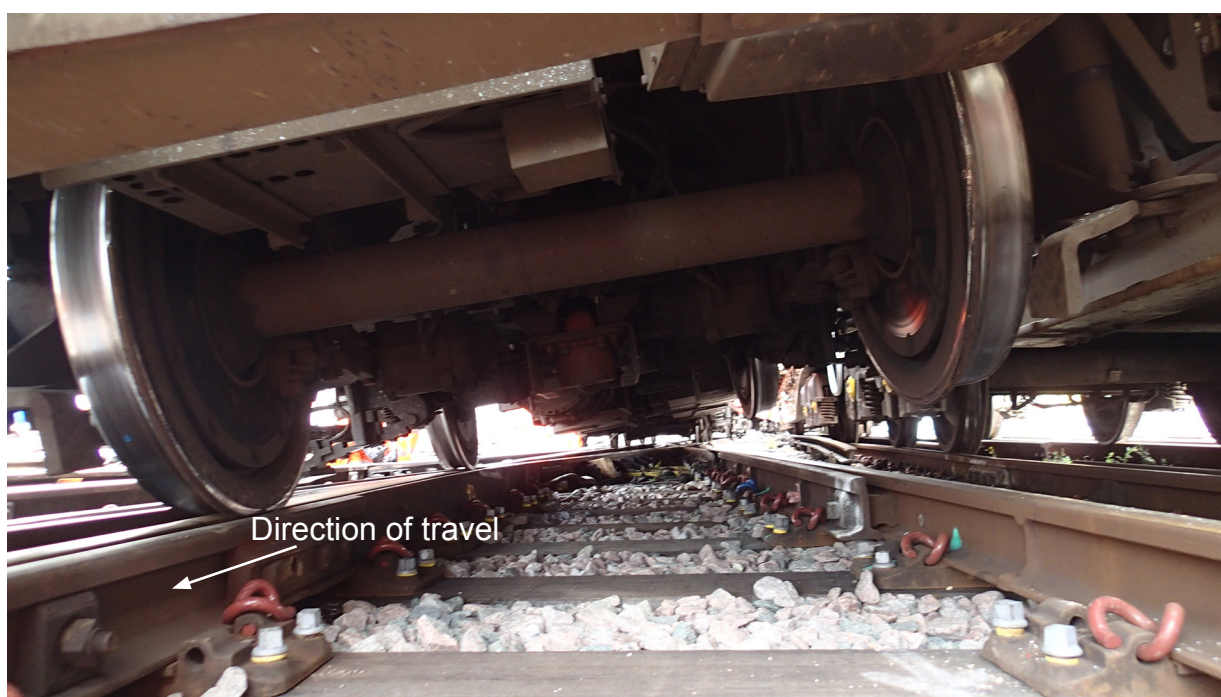
Figure 9: Train 2D03 with left (in direction of travel) wheels of the leading bogie above the rail

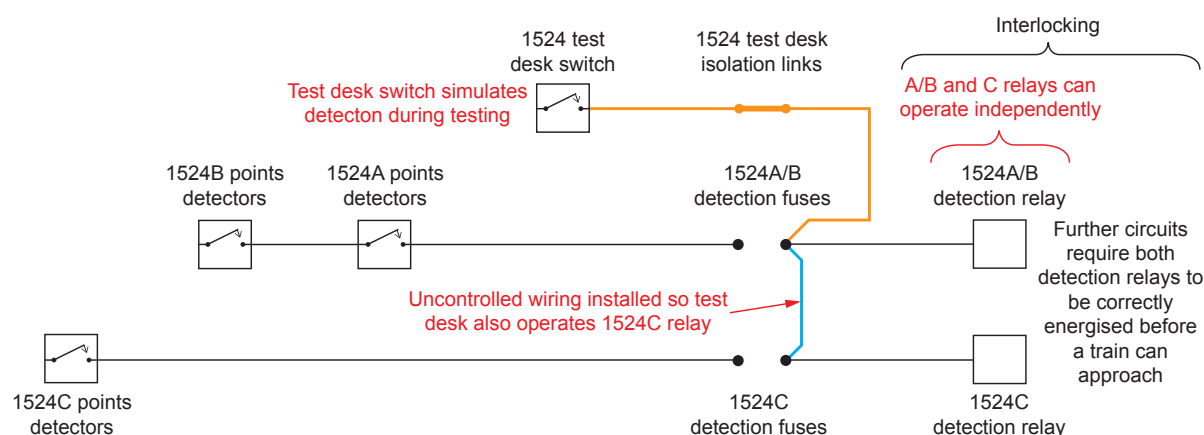
Figure 17: 1524 points in test mode after replacement of location case W14 and addition of uncontrolled wiring

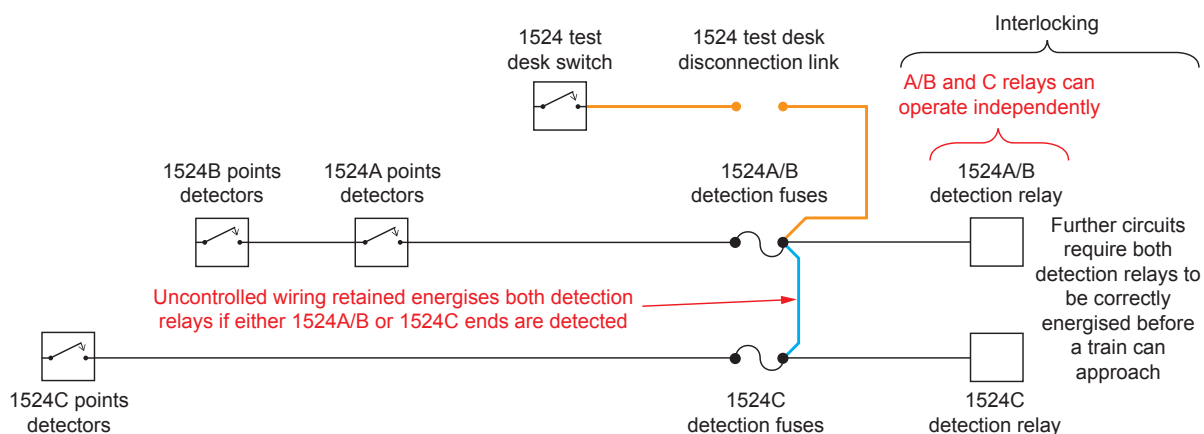
Events following the accident

- 32 Immediately after the accident, the train driver made a GSM-R⁷ railway emergency call which caused an emergency stop message to be broadcast to all trains in the Waterloo area.

Figure 18: 1524 points detection at time of derailment

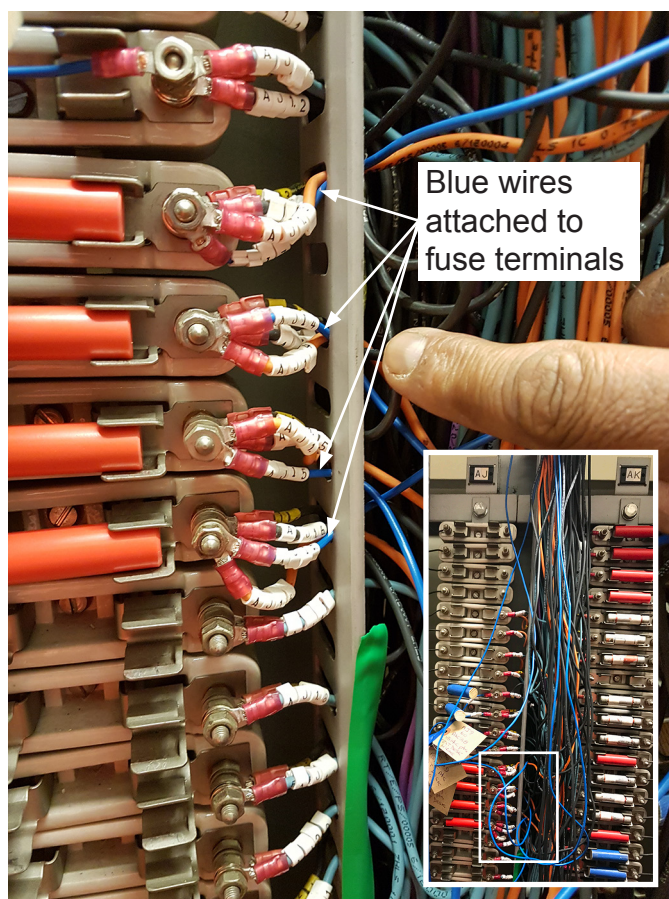
- 55 The Waterloo interlocking is a 'free wired route relay interlocking' containing electro-mechanical relays. Wiring links these relays to each other and to equipment including points, signals and devices adjacent to the track. This allows the interlocking to operate equipment and to obtain information including the location of trains and the position of points. The arrangement of relays and wiring is intended to prevent the operation of points and signals if this could result in conflicting train movements. The arrangement is also intended to prevent trains being permitted to pass across points which are not locked in the correct position.

- 56 Equipment controlled by the Waterloo interlocking includes 1524 points. These comprise three pairs of point ends which need to be set and locked in the required normal or reverse position before trains can pass over them. When locked in these positions, detectors attached to the point ends allow electric current to flow in the appropriate (normal or reverse) detection circuits. The interlocking uses these circuits to determine whether the point ends are correctly set to allow the safe passage of trains.

Figure 19: Uncontrolled wiring attached to the fuses for 1524 points detection relays

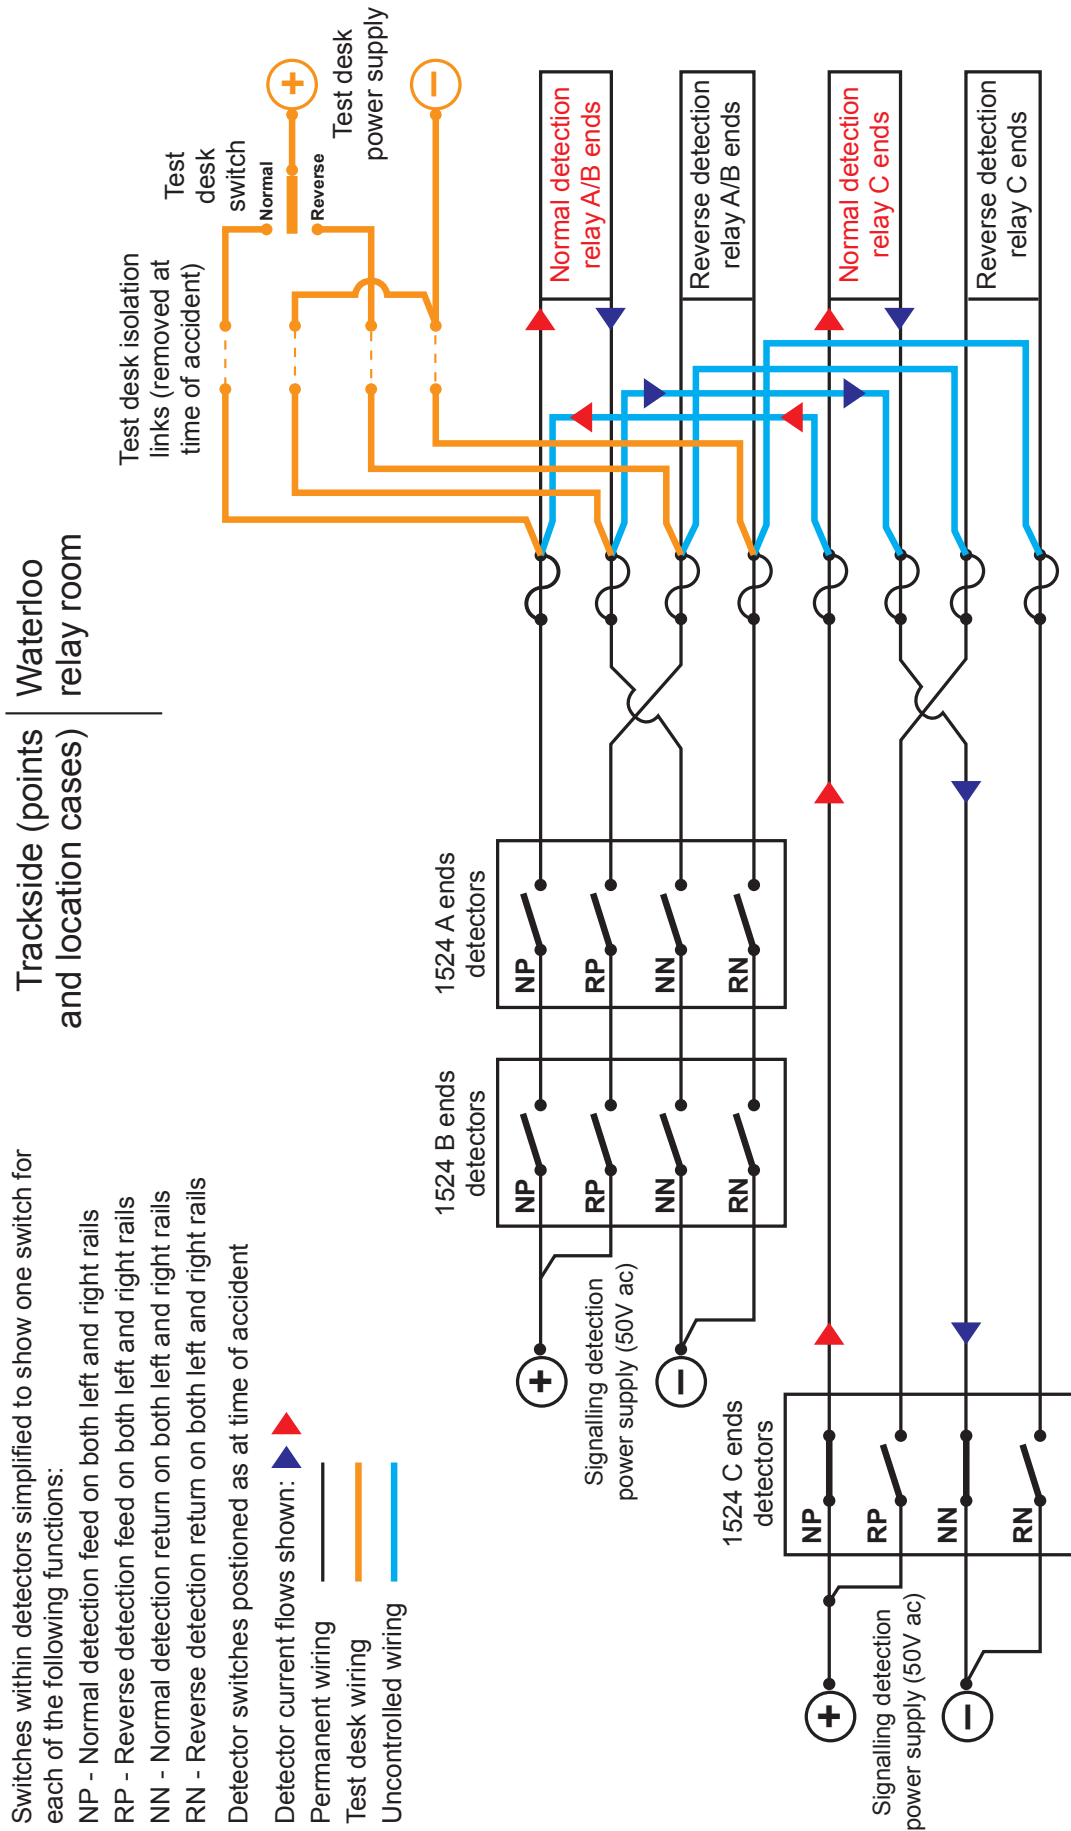
Appendix C - 1524 points wiring at the time of derailment

This diagram corresponds with the simplified arrangement shown on figure 18.
