Rail Accident Report

**Pushchair trapped in tram doors and dragged,
Nottingham
15 December 2017**

Report 15/2018
September 2018

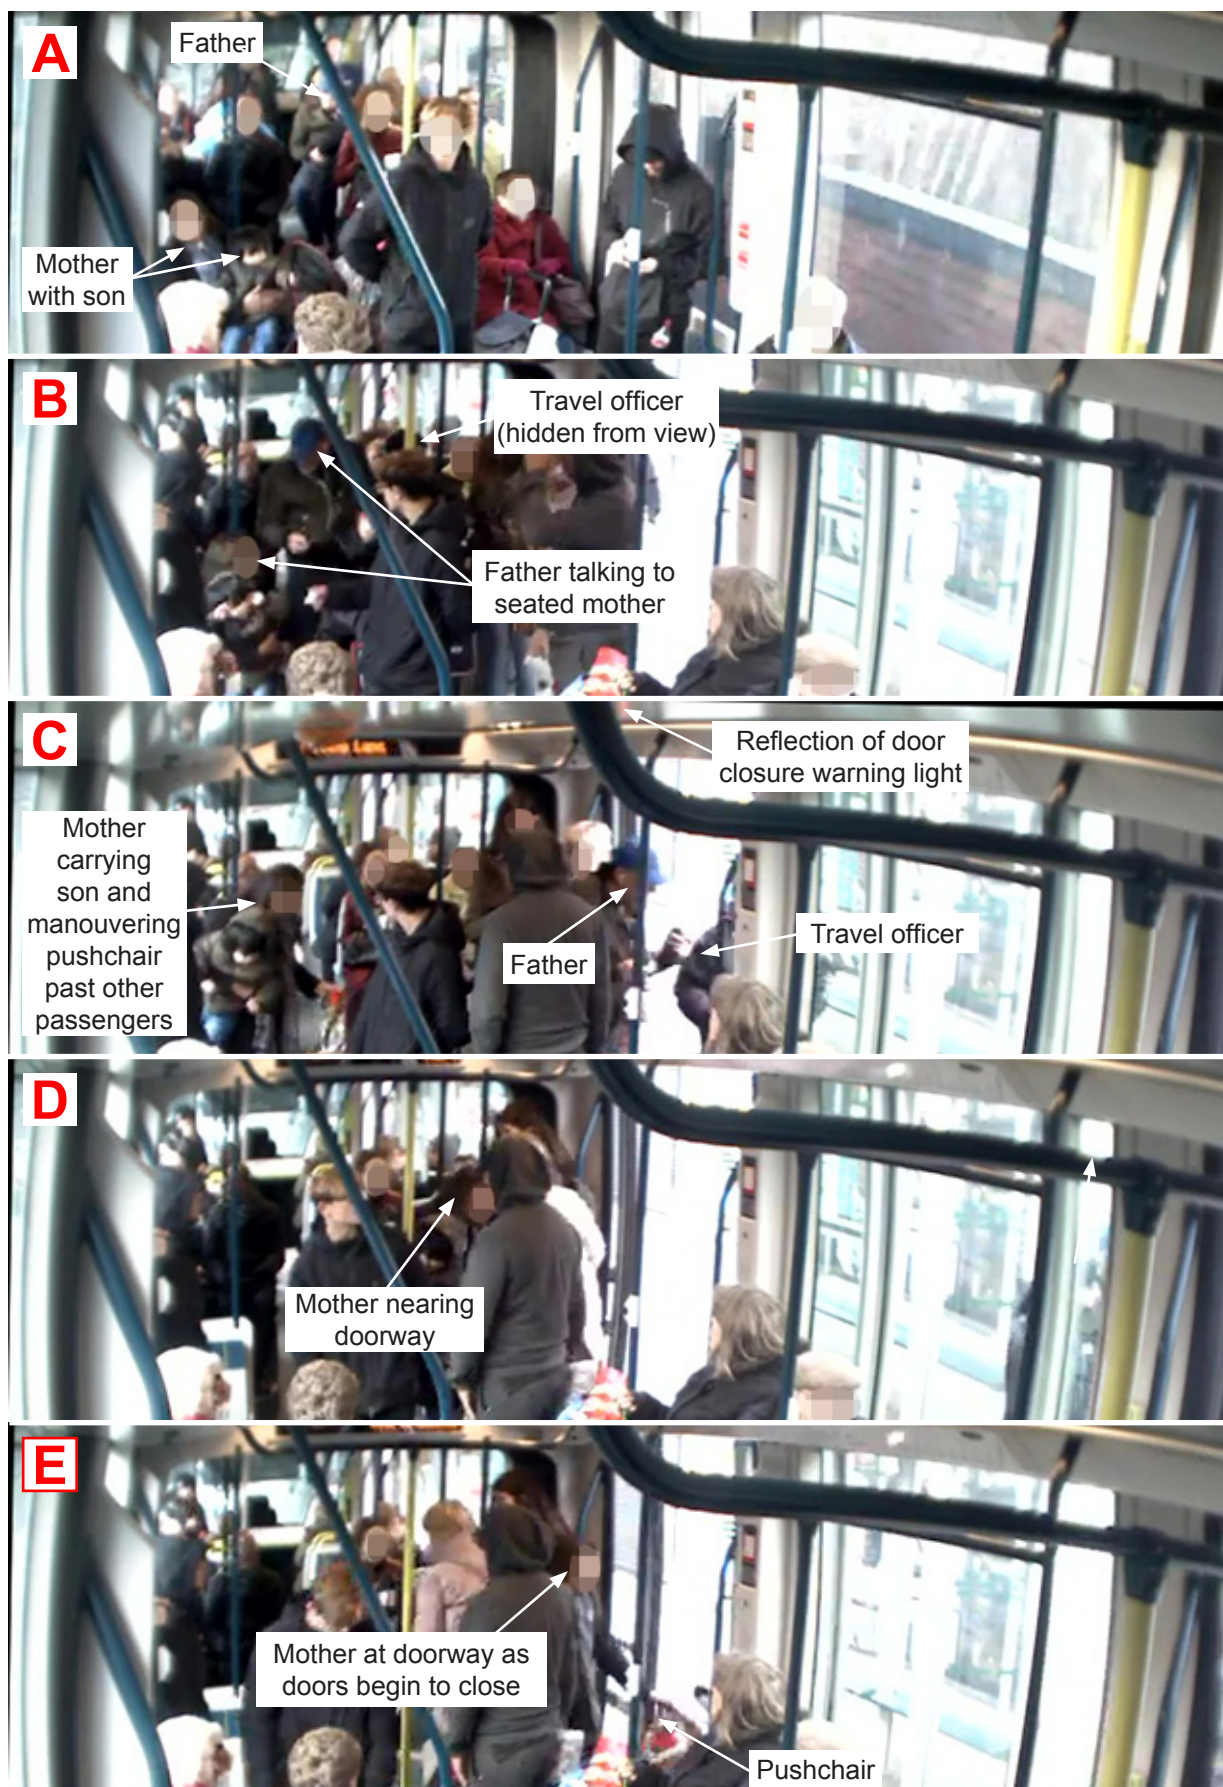
- 24 The family involved in the incident boarded tram 237 at Moor Bridge, seven stops from Radford Road, at around 13:15 hrs. Initially they sat adjacent to each other in the fourth module. The father gave up his seat to an elderly passenger at Bulwell, and found an empty seat in the rear (fifth) module as the tram travelled between David Lane and Basford. The mother remained where she was, holding her young son in her arms with their pushchair close by (figure 9a).

Figure 9: Passengers and travel officer movements (internal tram CCTV images courtesy of Nottingham Trams): a) Initial positions at tram stop; b) Father speaking to mother; c) Father and travel officer leaving tram; d) Mother nearing door; e) Mother at doorway

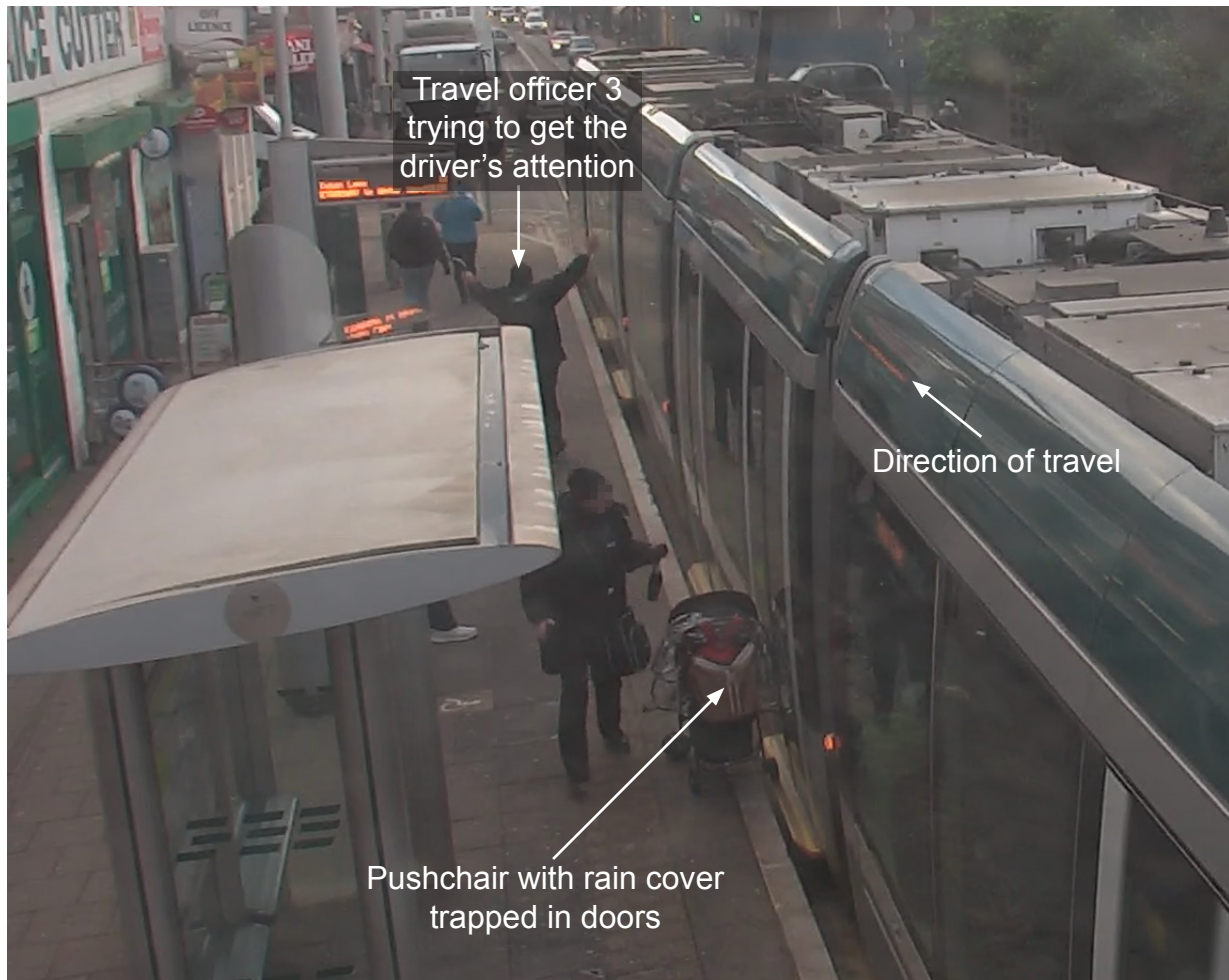
- 28 When the tram doors had closed and locked, travel officer 3 saw the trapped pushchair (figure 10). He brought it to the attention of travel officer 1 who then tried to free the pushchair. At the same time, travel officer 3 and travel officer 2 turned to the front of the tram to try and get the drivers attention by waving their arms above their heads. As the tram began to move travel officer 1 grabbed hold of the pushchair but was not able to pull it free and the tram left the tram stop with the pushchair trapped in the doors.

Figure 10: Travel officers trying to attract the tram driver's attention (tram stop CCTV image courtesy of Nottingham Trams)

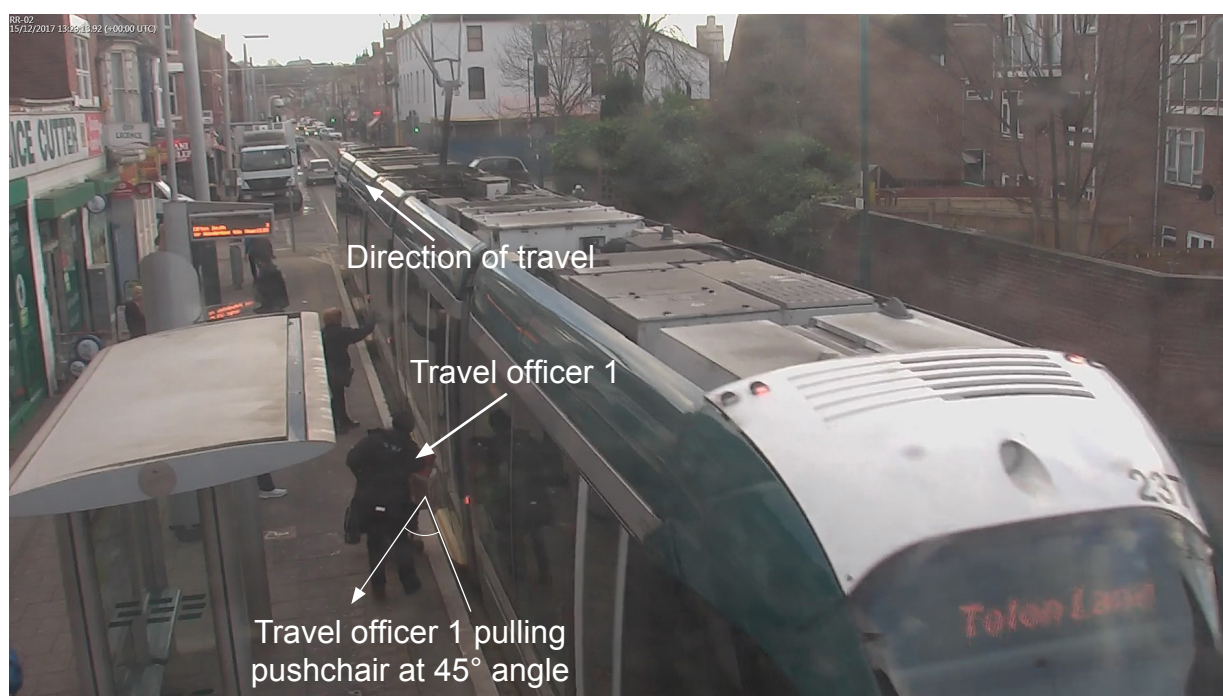
- 48 Travel officer 1 made a grab for the trapped pushchair as the tram began to move but was not able to pull it free. Tram stop CCTV shows that she managed to get hold of one of the pushchair's handles but was not able to pull hard enough to release the pushchair. She was pulling it towards the rear of the tram at an angle of about 45° (figure 11).

Figure 11: Travel officer 1 pulling pushchair (tram stop CCTV courtesy of Nottingham Trams)

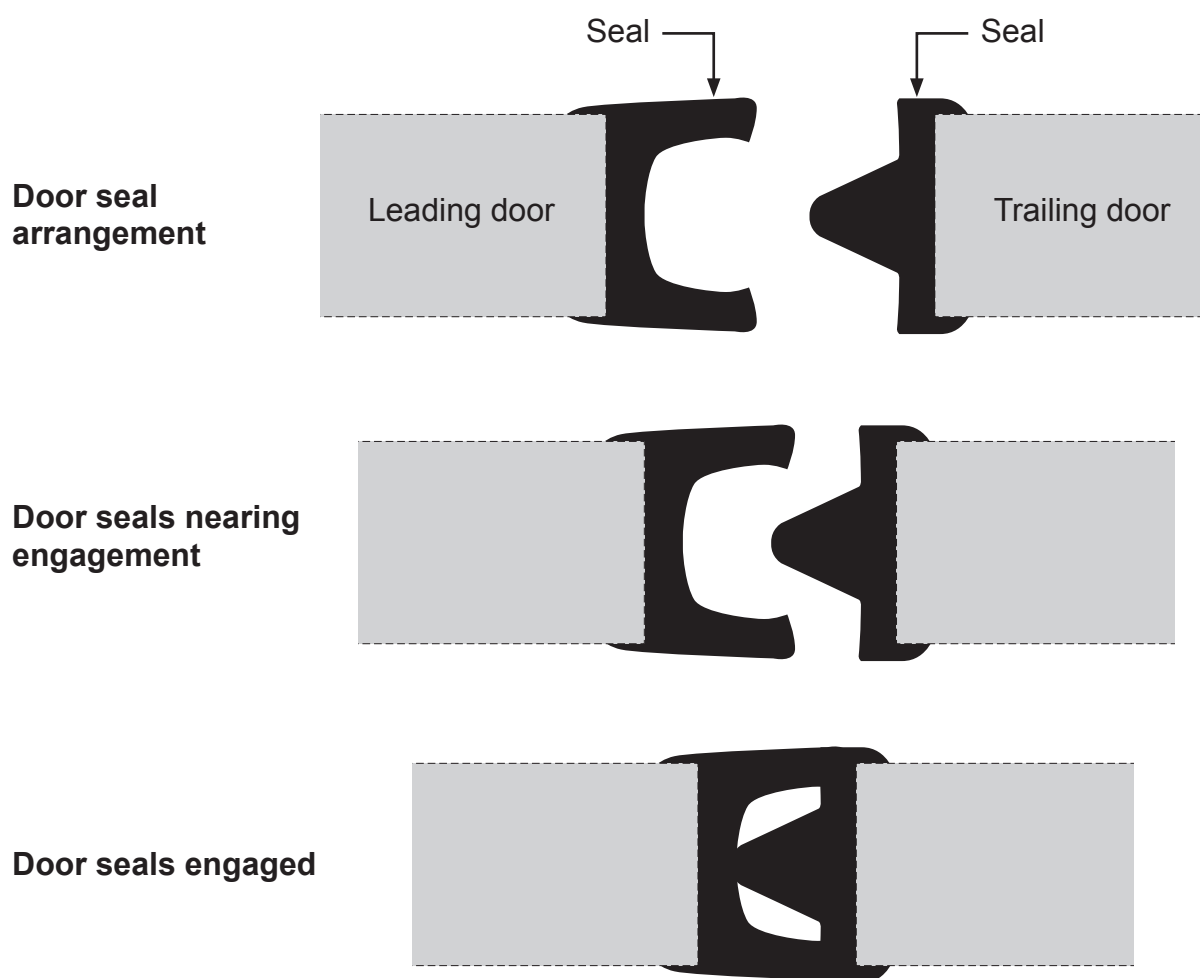
- 52 The force required to pull the rain cover free was affected by the shape of the rubber seals fitted to the edges of the doors and the high level of friction between the rubber door seals and the plastic rain cover. The seal shape (figure 12) is intended to make a water tight seal between the door edges, but the shape of the seal edges means that thin flexible objects can be extremely difficult to pull free.

Figure 12: Door seals fitted to Nottingham Trams' fleet of Citadis trams (leading and trailing refer to direction of travel at time of incident)

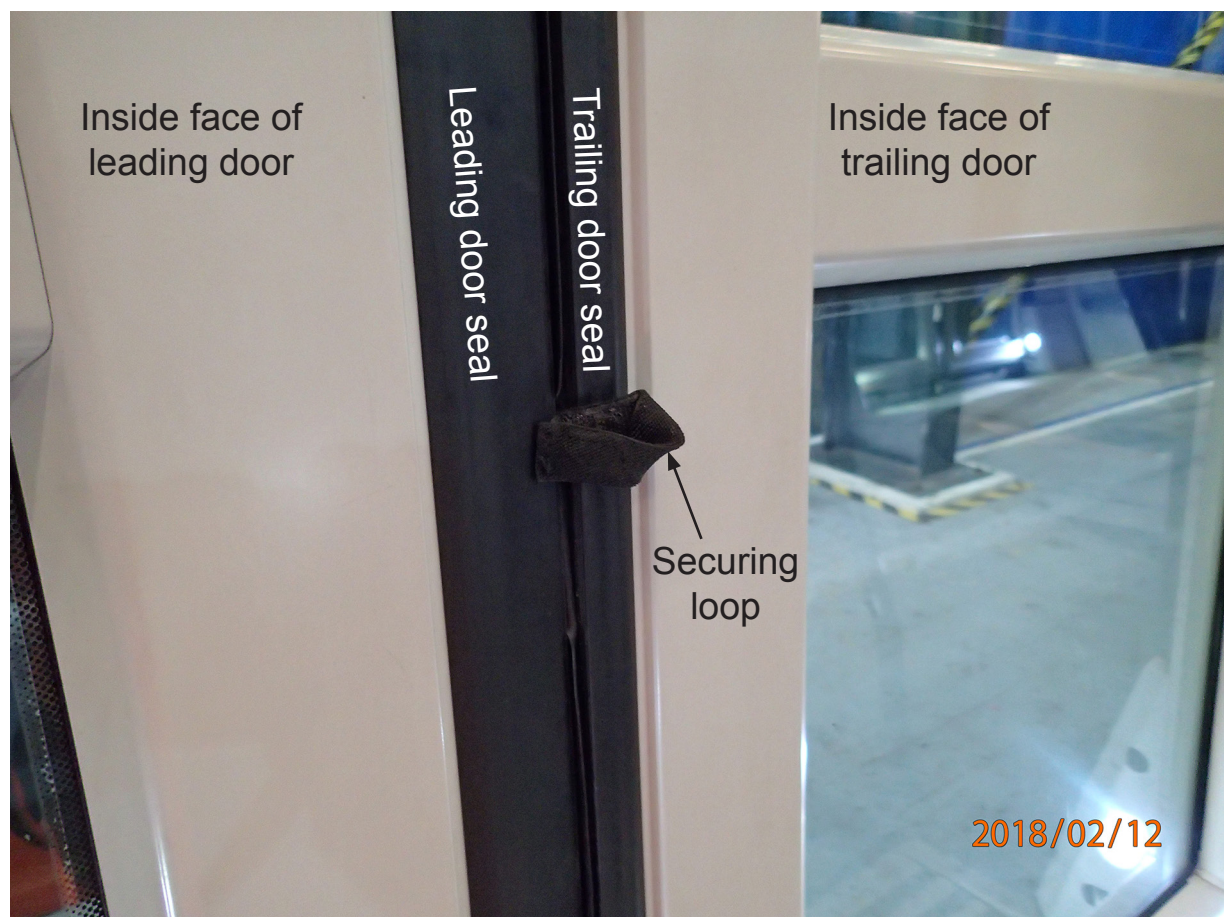
- 53 In addition to the gripping effect of the door seals, it is possible that one of the securing loops (designed to keep the rain cover closed when it was not needed) was trapped on the inside face of the doors (figure 13). During two RAIB tests with the securing loop trapped inside the tram doors, the rain cover split apart and could not be pulled free in one piece. The pull forces, measured at right-angles to the doors immediately before the rain cover split apart, were 264 N (about 27 kg) and 289 N (about 29 kg).

Figure 13: Securing loop trapped inside tram doors during RAIB testing (leading and trailing refer to direction of travel at time of incident)

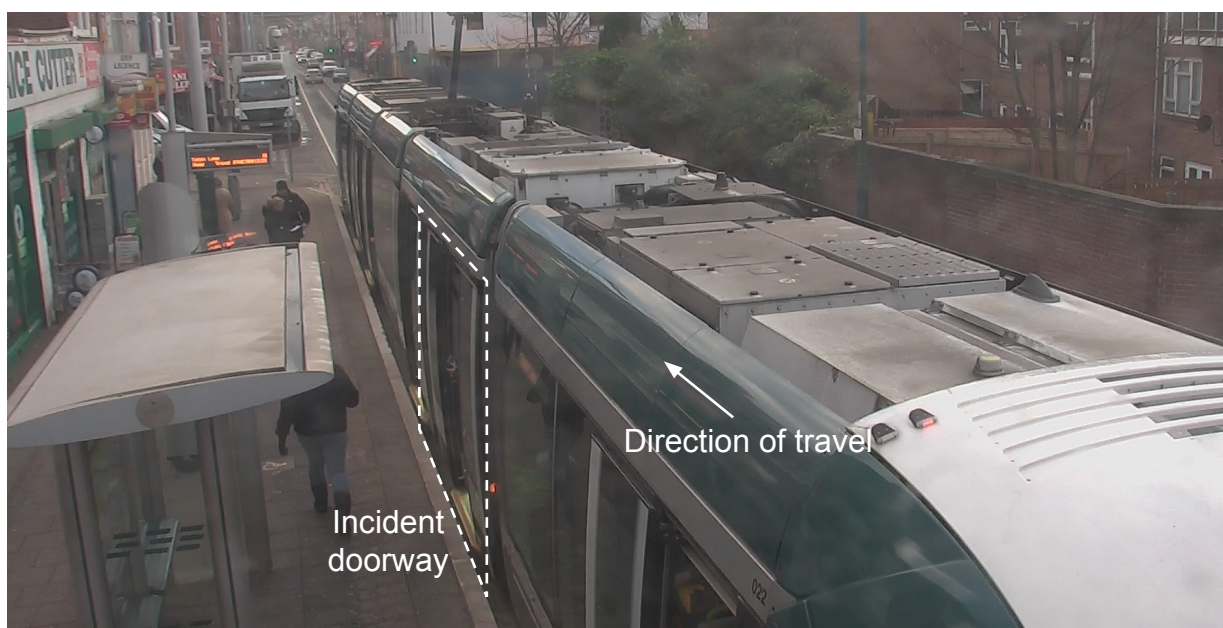
- 56 The tram driver decided to close the tram doors at Radford Road tram stop when it appeared that people had stopped getting off and on the tram. Travel officer 1, the family, and the pushchair were still on the tram and so not visible to the driver (figure 14).

Figure 14: Tram stop when driver closed the tram doors (tram stop CCTV courtesy of Nottingham Trams)

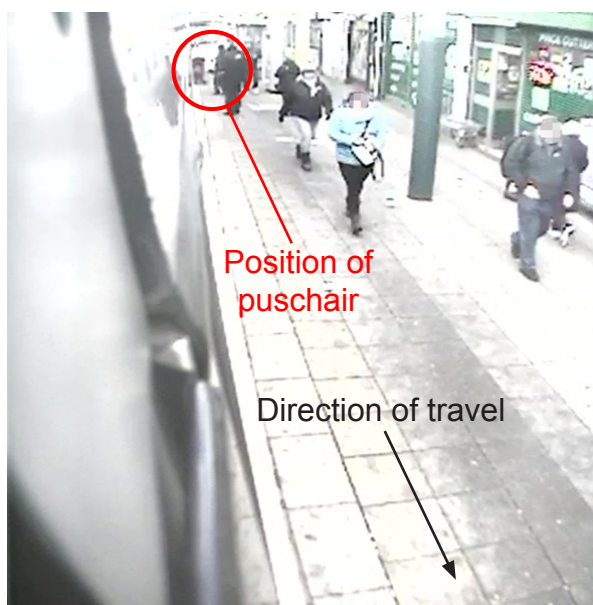
- 57 When the doors were detected closed and locked, the image on the right-hand monitor in the driving cab immediately changed from the rear CCTV on the tram stop (left) side of the tram, to the right-hand 'wing mirror' view (paragraph 14). The pushchair, trapped in the doors near the rear of the tram, was now only visible in the left-hand monitor. In this view the pushchair was near the far end of the tram and was small in size relative to the overall size of the image (figure 15).

Figure 15: Driver's view of the side of the tram when doors detected closed and locked (tram CCTV courtesy of Nottingham Trams Ltd)

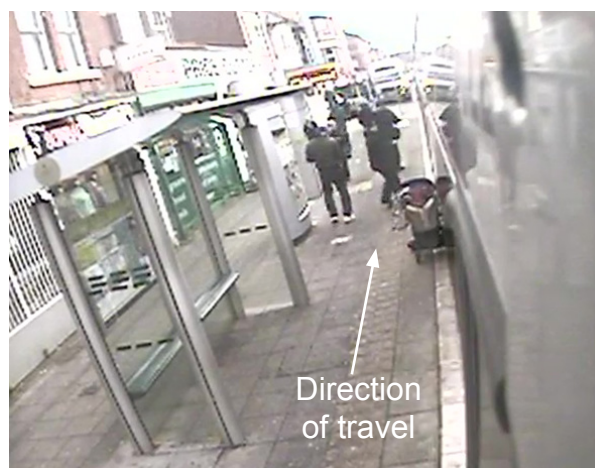
Figure 16: Driver's view of push chair if rear CCTV camera view available after doors closed and locked (tram CCTV courtesy of Nottingham Trams Ltd)

- b. Changing CCTV views just before the final visual door check has the potential to divert a tram driver's attention to road traffic conditions before completing this check. It is possible that this occurred during the Radford Road incident.
- c. Loss of the rear CCTV images before completing the final visual door check is a possible influence on the importance attached to this check both by the driver at Radford Road and by all drivers when departing from tram stops. Loss of the better view of parts of the tram implies that the subsequent check is of relatively low importance⁹.
- d. Although not an influence on the incident at Radford Road, the RAIB observes that the CCTV modification also prevented drivers carrying out a final visual door check of some doors (paragraph 91).

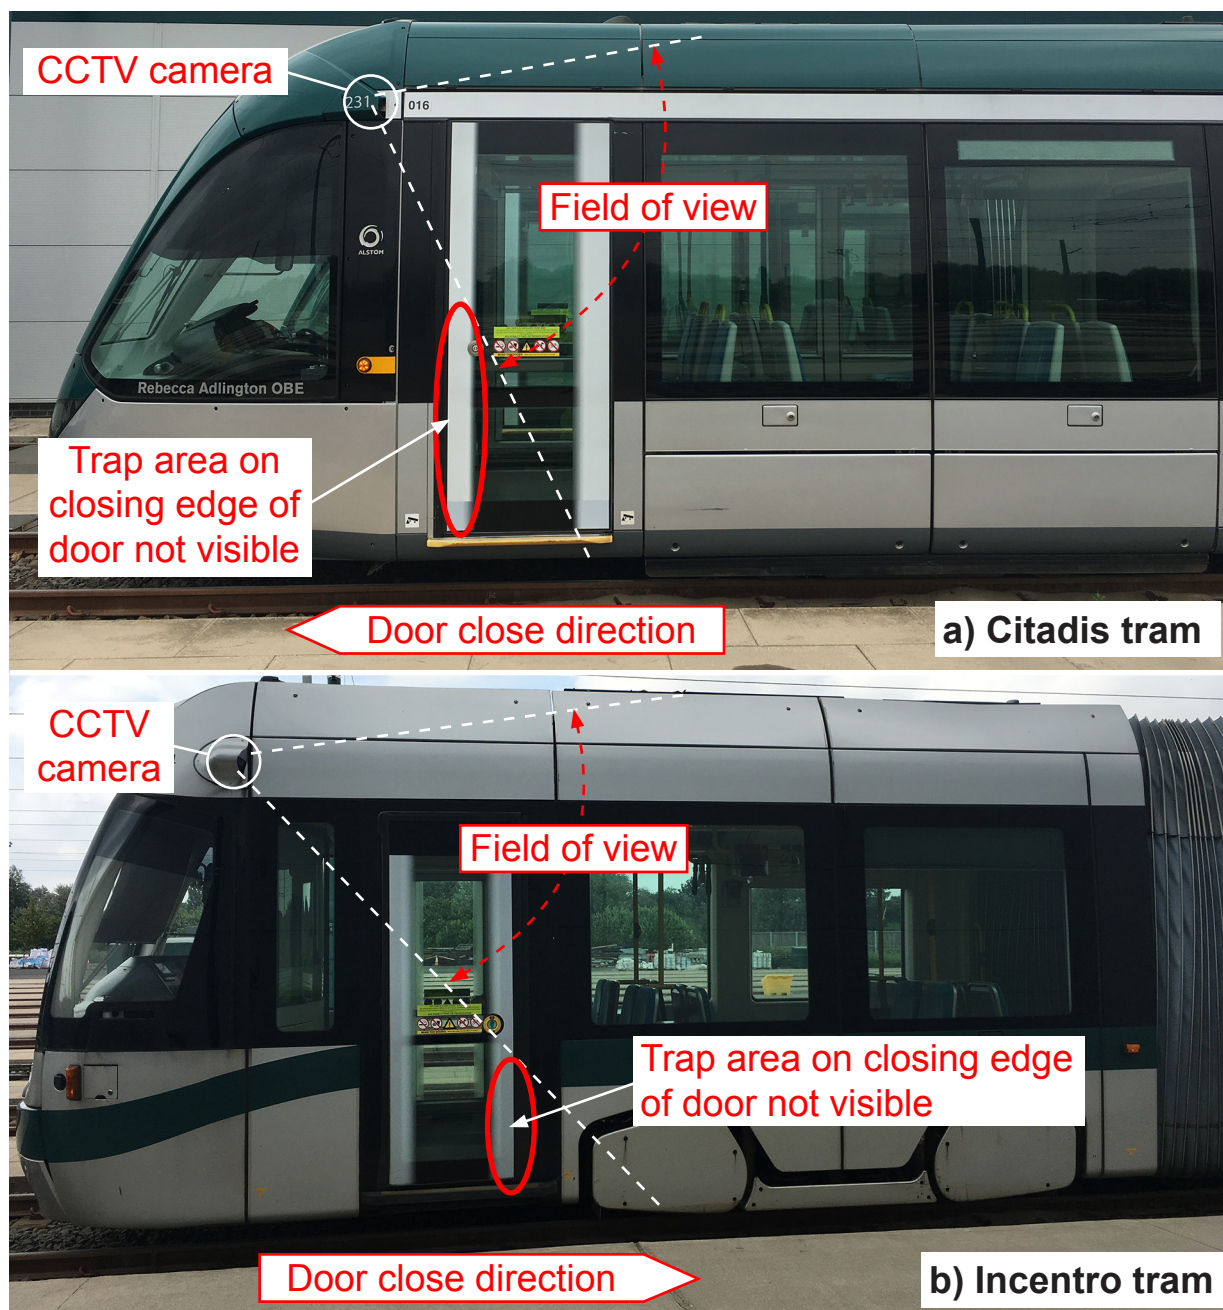
- 91 **The Citadis and Incentro trams bodyside cameras do not provide a full view of the nearest door, so do not allow drivers to check for objects trapped in the lower part of the forward most door before departing from a tram stop.**
- 92 The field of view of the CCTV cameras fitted to the outside of the Citadis and Incentro trams does not cover the full height of the nearest door. RAIB testing found that these cameras did not show the lowest 1520 mm of the closed edge of the nearest door on the Citadis trams, and the lowest 880 mm of the closed edge of the nearest door on the Incentro trams (figure 17).
- 93 This means that a small person or an object could be trapped in the front door of a tram and not be seen by the front CCTV camera, the only camera view available when the driver is required to carry out the final visual door check after the doors are detected closed and locked.

- 94 The position of the front CCTV camera relative to the front door differed between the Incentro and Citadis trams, and the doors on the two types of tram open in opposite directions (figures 17a and 17b). This means that coverage of the front door by the CCTV systems was likely to be different so it was inappropriate to rely on an Incentro risk assessment when modifying the Citadis CCTV arrangement (paragraph 69).

Figure 17: Door trap areas not covered by leading CCTV cameras: a) Citadis tram; b) Incentro tram
