Rail Accident Report

**Derailment due to a landslip, and subsequent
collision, Watford
16 September 2016**

Report 11/2017
August 2017

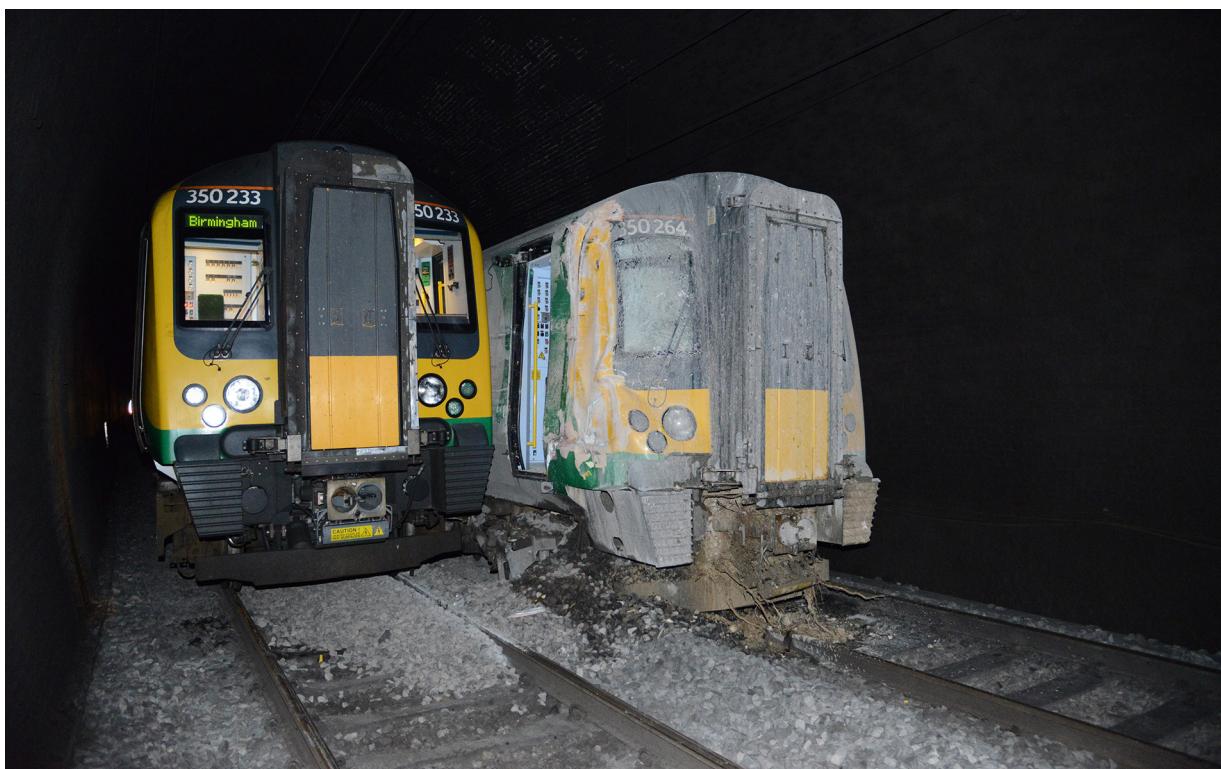
- 5 Train 2Y59, the 06:34 hrs London Midland service from Euston to Birmingham was already in Watford slow lines tunnel and approaching on the down slow line at 79 mph (127 km/h) when its driver received an emergency stop message triggered by the driver of train 2K04. The driver of train 2Y59 applied the brakes which reduced the speed of the train to about 34 mph (55 km/h) by the time the collision occurred. Train 2Y59 did not derail and stopped alongside the derailed train (figure 2).

Figure 2: Rear of train 2Y59 (left) stopped inside the tunnel adjacent to derailed train 2K04 (photograph courtesy of British Transport Police)

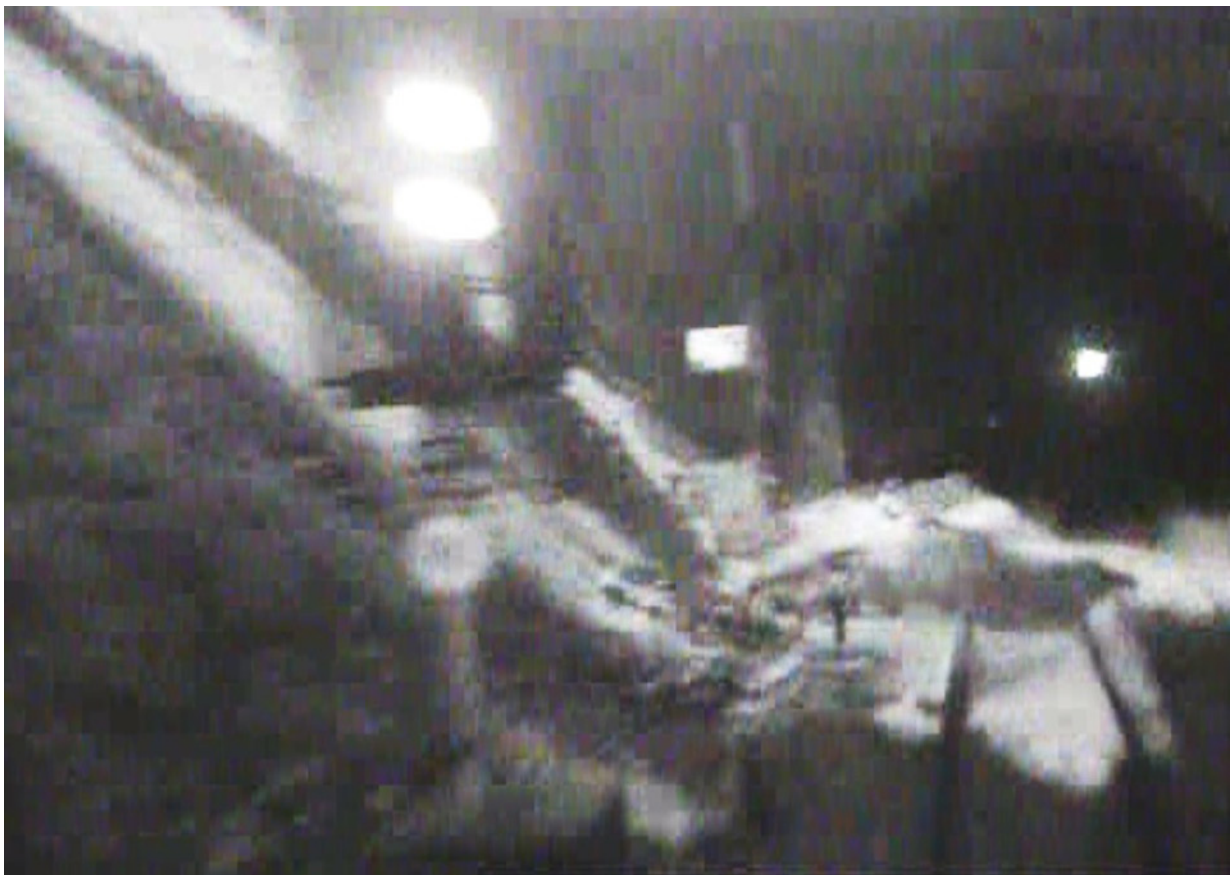
- 31 The landslip was located immediately beyond a signal (number WT5126) which was showing a *double yellow* aspect (figure 4). As train 2K04 approached the tunnel at 66 mph (106 km/h), its driver did not see the debris on the track until just before the train hit it.

Figure 4: Image from forward-facing CCTV camera on train 2K04. The headlight of train 2Y59 can be seen in the tunnel ahead.

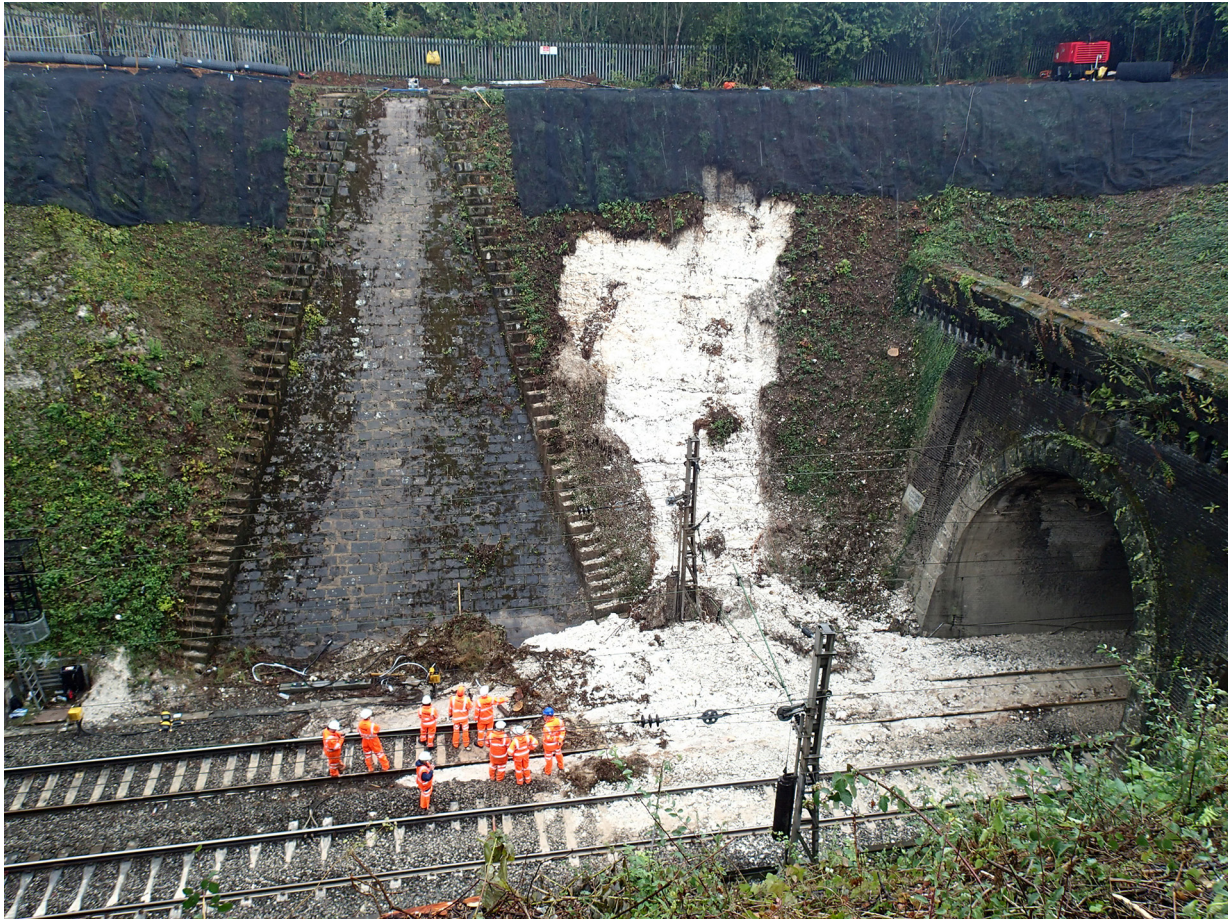
- 53 At 07:32 hrs, track maintenance staff arrived on site and reported that debris was still falling onto the up slow line, that the down slow line was also affected, and that flood water was up to rail height in the cutting (figure 5).

Figure 5: View of landslip and debris on track. The adjacent masonry structure is a face wall (refer to paragraph 90).

- 143 Slope protection works have been completed on the north approach to Watford slow lines tunnel. Loose material has been removed and rock-fall netting installed over the failed area.
- 144 The RAM (drainage) has informed the RAIB that Network Rail is intending to undertake some local reinstatement to the drainage in the vicinity of the landslip to better capture and contain water from the third party. Timescales for this work are currently unknown.
- 145 LNW control offices have been instructed to hold an emergency EWAT meeting after a forecast for rainfall has been upgraded to amber or red at short notice.
- 146 LNW geotechnical and drainage RAM teams have started a programme to review cutting slopes and tunnel portals to identify any water concentration features and the adequacy of any associated drainage arrangements.

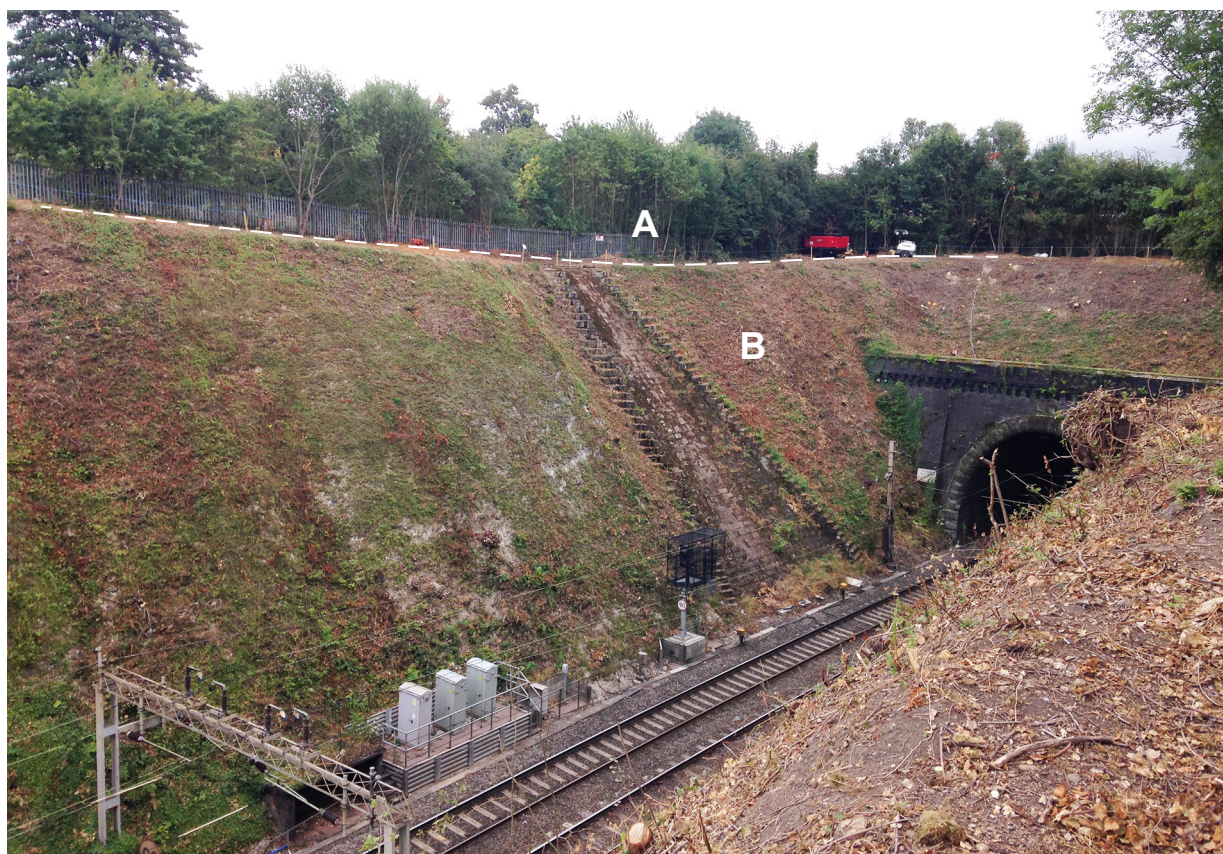
Figure 6: Photograph of cutting taken in July 2016 following vegetation clearance looking east (courtesy of Network Rail). The white dashed line indicates the profile of the cutting crest with the low point marked 'A'. The location of the future landslip is marked 'B'.

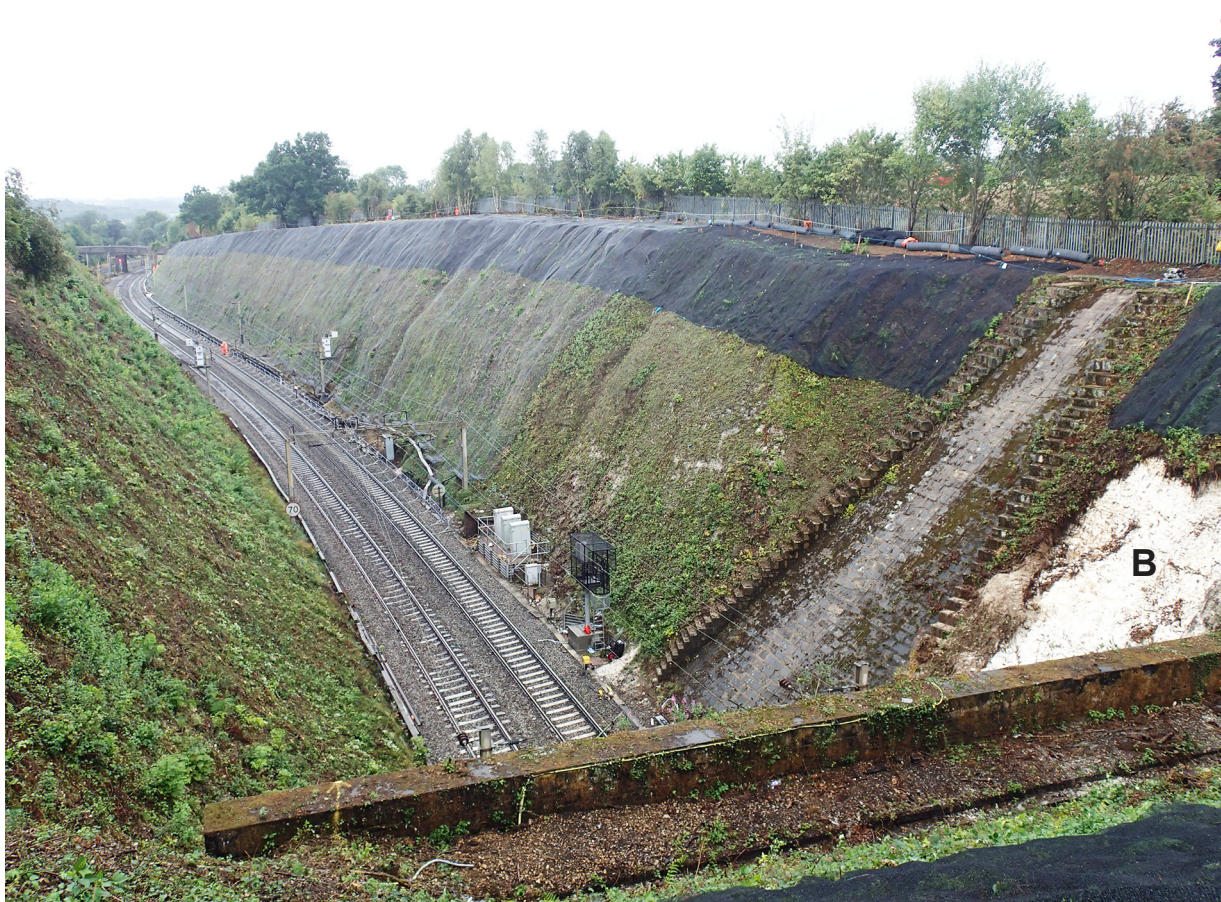
- 75 An evaluation of surface water run off was made by the design consultant in their Geotechnical Assessment Report which led to the conclusion that drainage for surface water run off was not required (paragraphs 95 to 98 and figure 7).

Figure 7: View of slow lines cutting from above tunnel portal, looking north-west towards Gypsy Lane bridge on 16 September 2016. The partly completed slope protection works are visible. The landslip is marked 'B'.

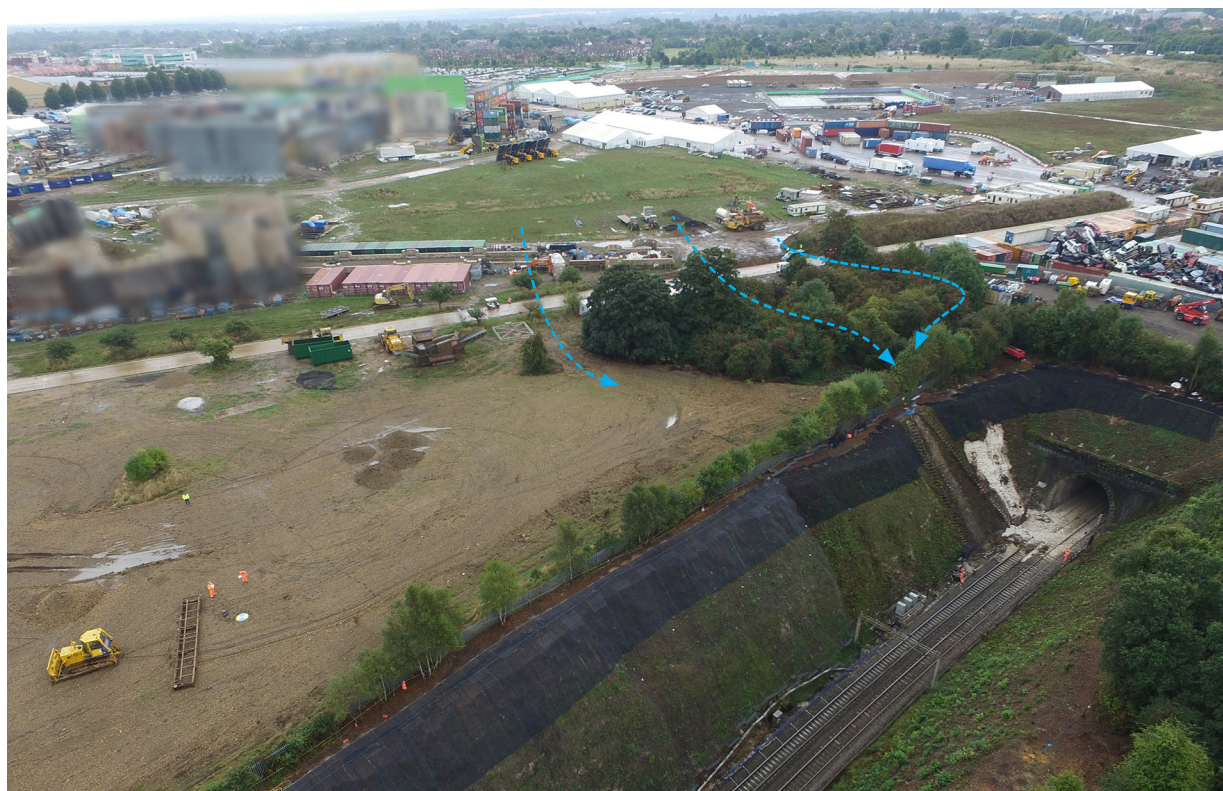
- 32 At 06:55:44 hrs, train 2K04 passed signal WT5126 and hit the landslip on the track. The impact caused the leading coach to lift and derail to the right, towards the down slow line. Some passengers in the leading coach fell from their seats and luggage fell from the overhead racks. The derailment caused a vacuum circuit breaker (VCB) to open on the front unit (350264). This caused its pantograph to lower and disconnect from the overhead power supply. The pantograph on the rear unit (350117) remained raised as the train entered the tunnel.

Figure 8: Aerial photograph of catchment area on 16 September 2016 showing water paths. Part of this image has been deliberately blurred.

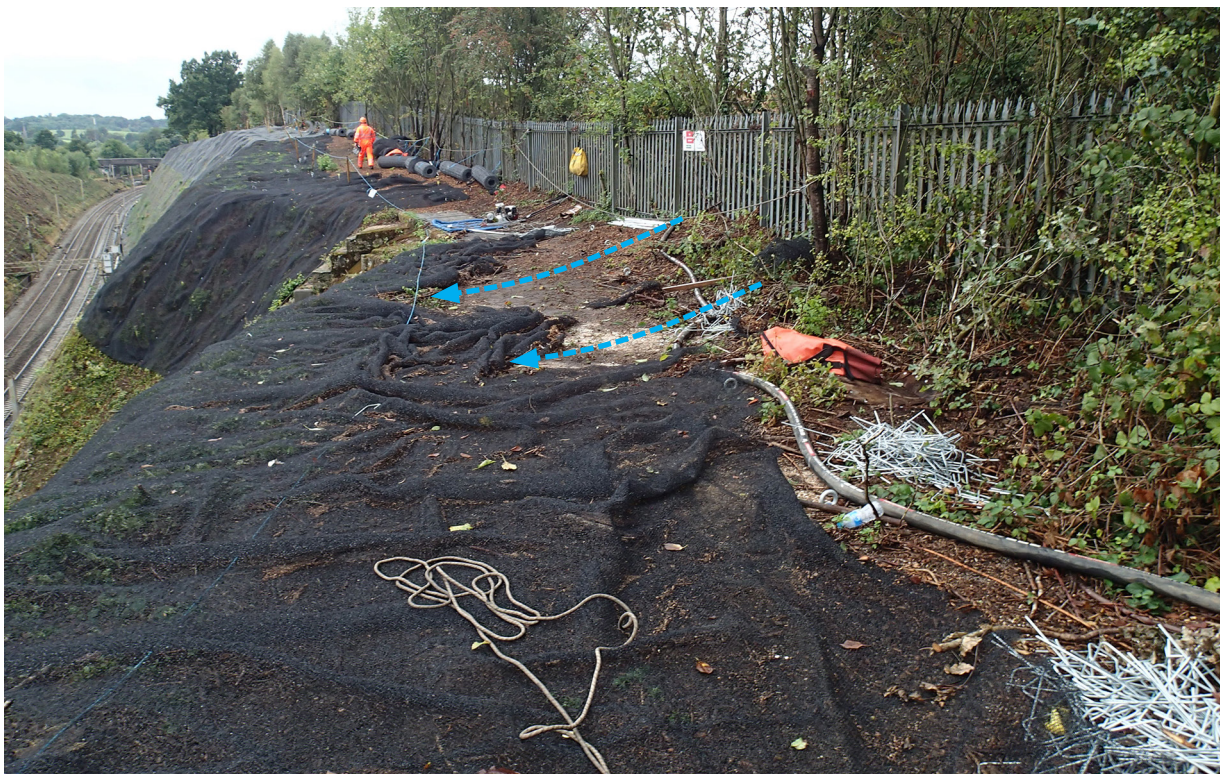
Figure 9: Crest of cutting above landslip showing erosion matting displaced by surface water flow

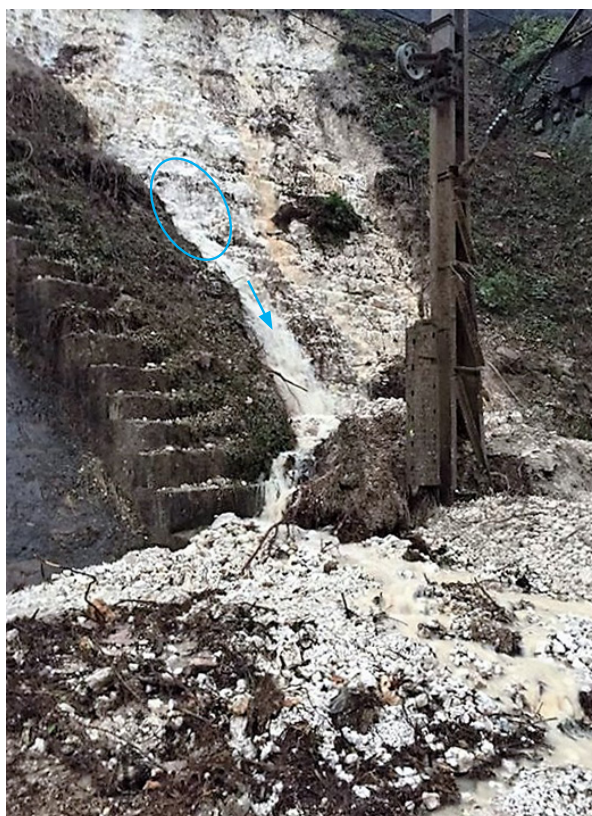
- 83 There is evidence that some water flowed through ground to emerge at the cutting face. Photographs and a video taken from track level by one of the first members of Network Rail staff to arrive on site on 16 September, show a large volume of water appearing to emanate from a point about half-way up the slope (figure 10). This location was adjacent to the south side of an existing masonry structure built to support the cutting face and known as a face wall (refer to paragraph 90).

Figure 10: Image showing water emanating from part-way down the cutting slope (courtesy of Network Rail)

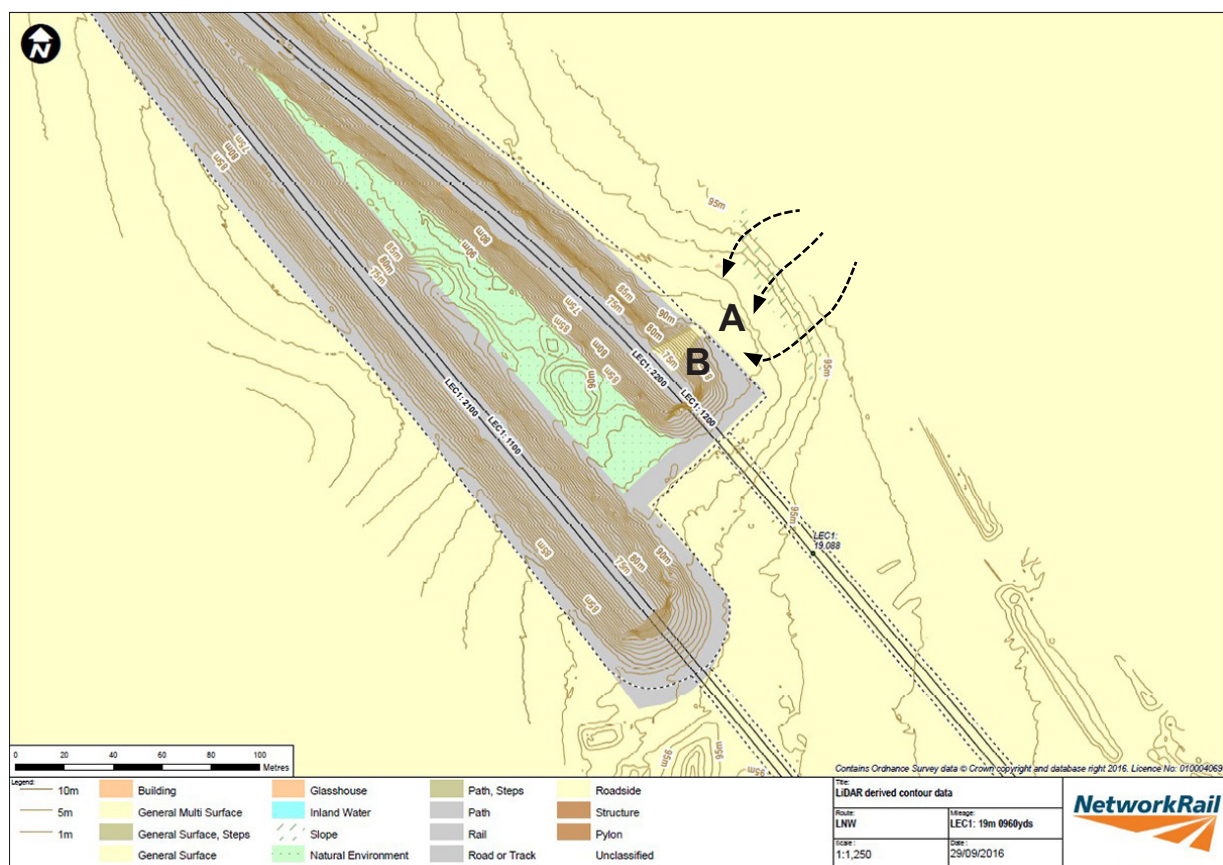
- 37 Immediately after the collision, the driver of train 2K04 contacted the signaller by GSM-R radio to report that his train had derailed and been struck by a train travelling in the opposite direction, and to request emergency assistance. The signaller informed the driver that his train was protected by signals and to await further instructions. The signaller asked the driver if there were any injuries, but the driver was unable to provide this information immediately. Numerous alarms sounded in the cab after being triggered by passengers.

Figure 11: Network Rail LIDAR survey drawing showing contours adjacent to the tunnel portals. The low point is marked 'A' and the position of the landslip is marked 'B'. The approximate surface water flow paths are also shown.

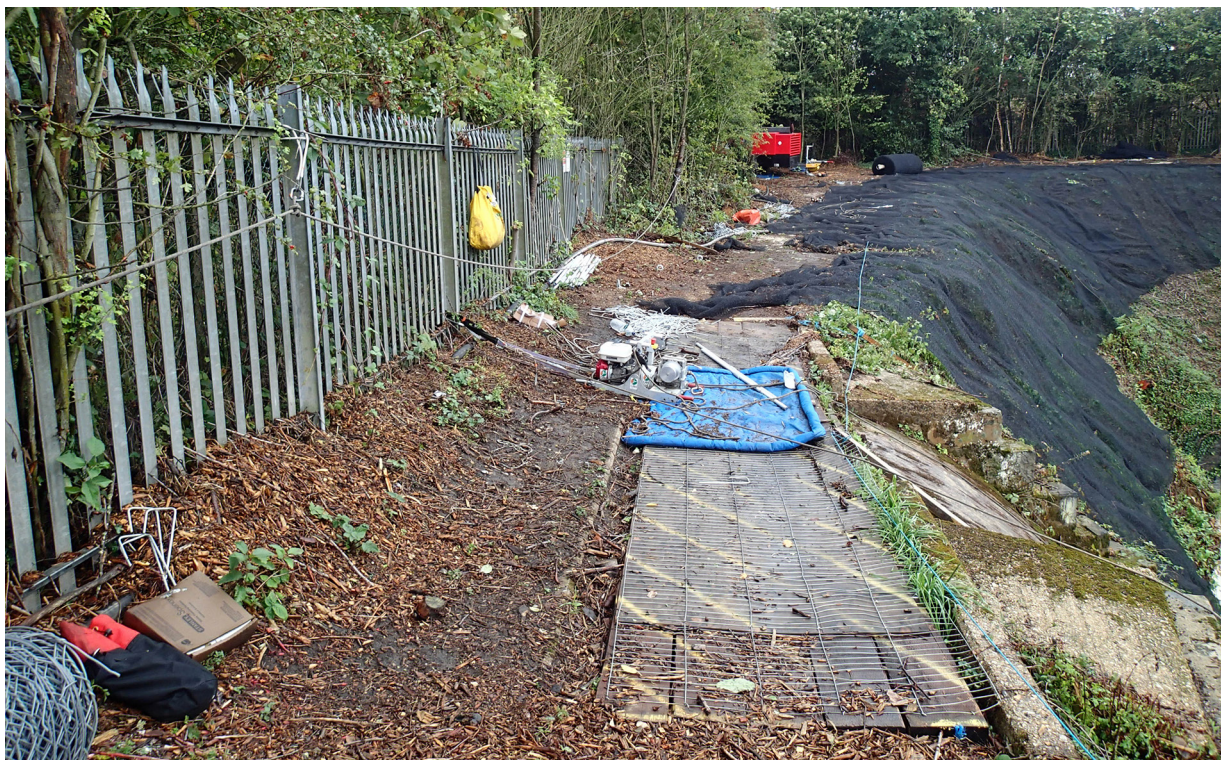
Figure 13: Concrete raft above face wall. Scaffolding boards had been placed inside the raft to remove a tripping hazard during the slope protection works.

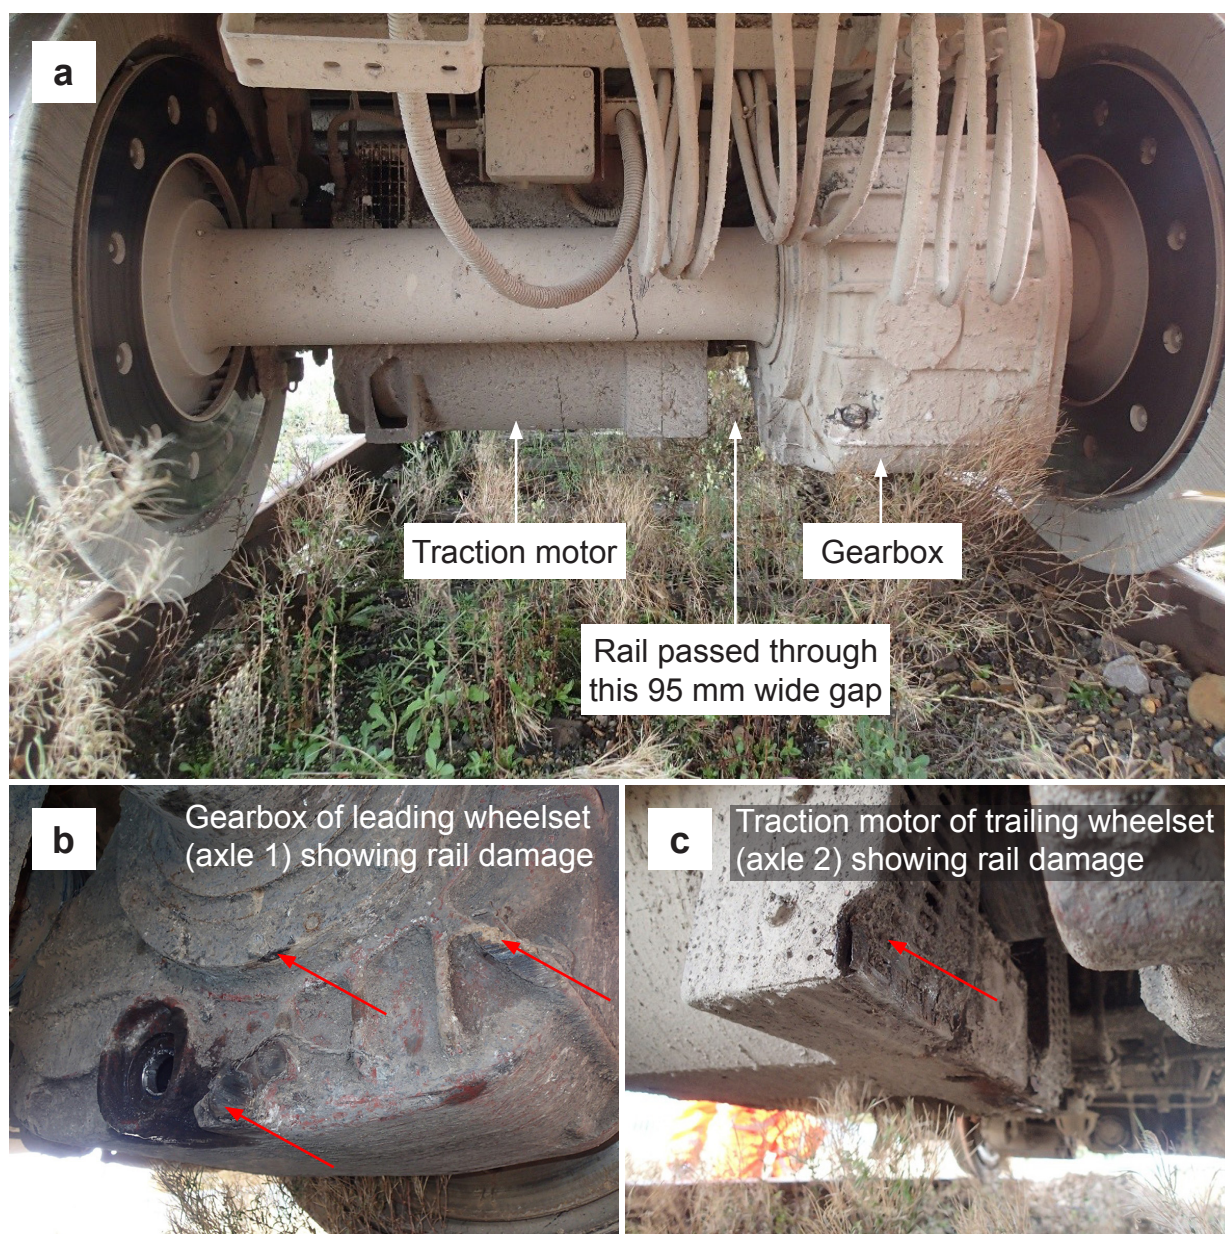
Figures 14a, b and c: Images showing examples of damage caused by interaction between traction equipment and rail during derailment beneath the leading bogie of train 2K04

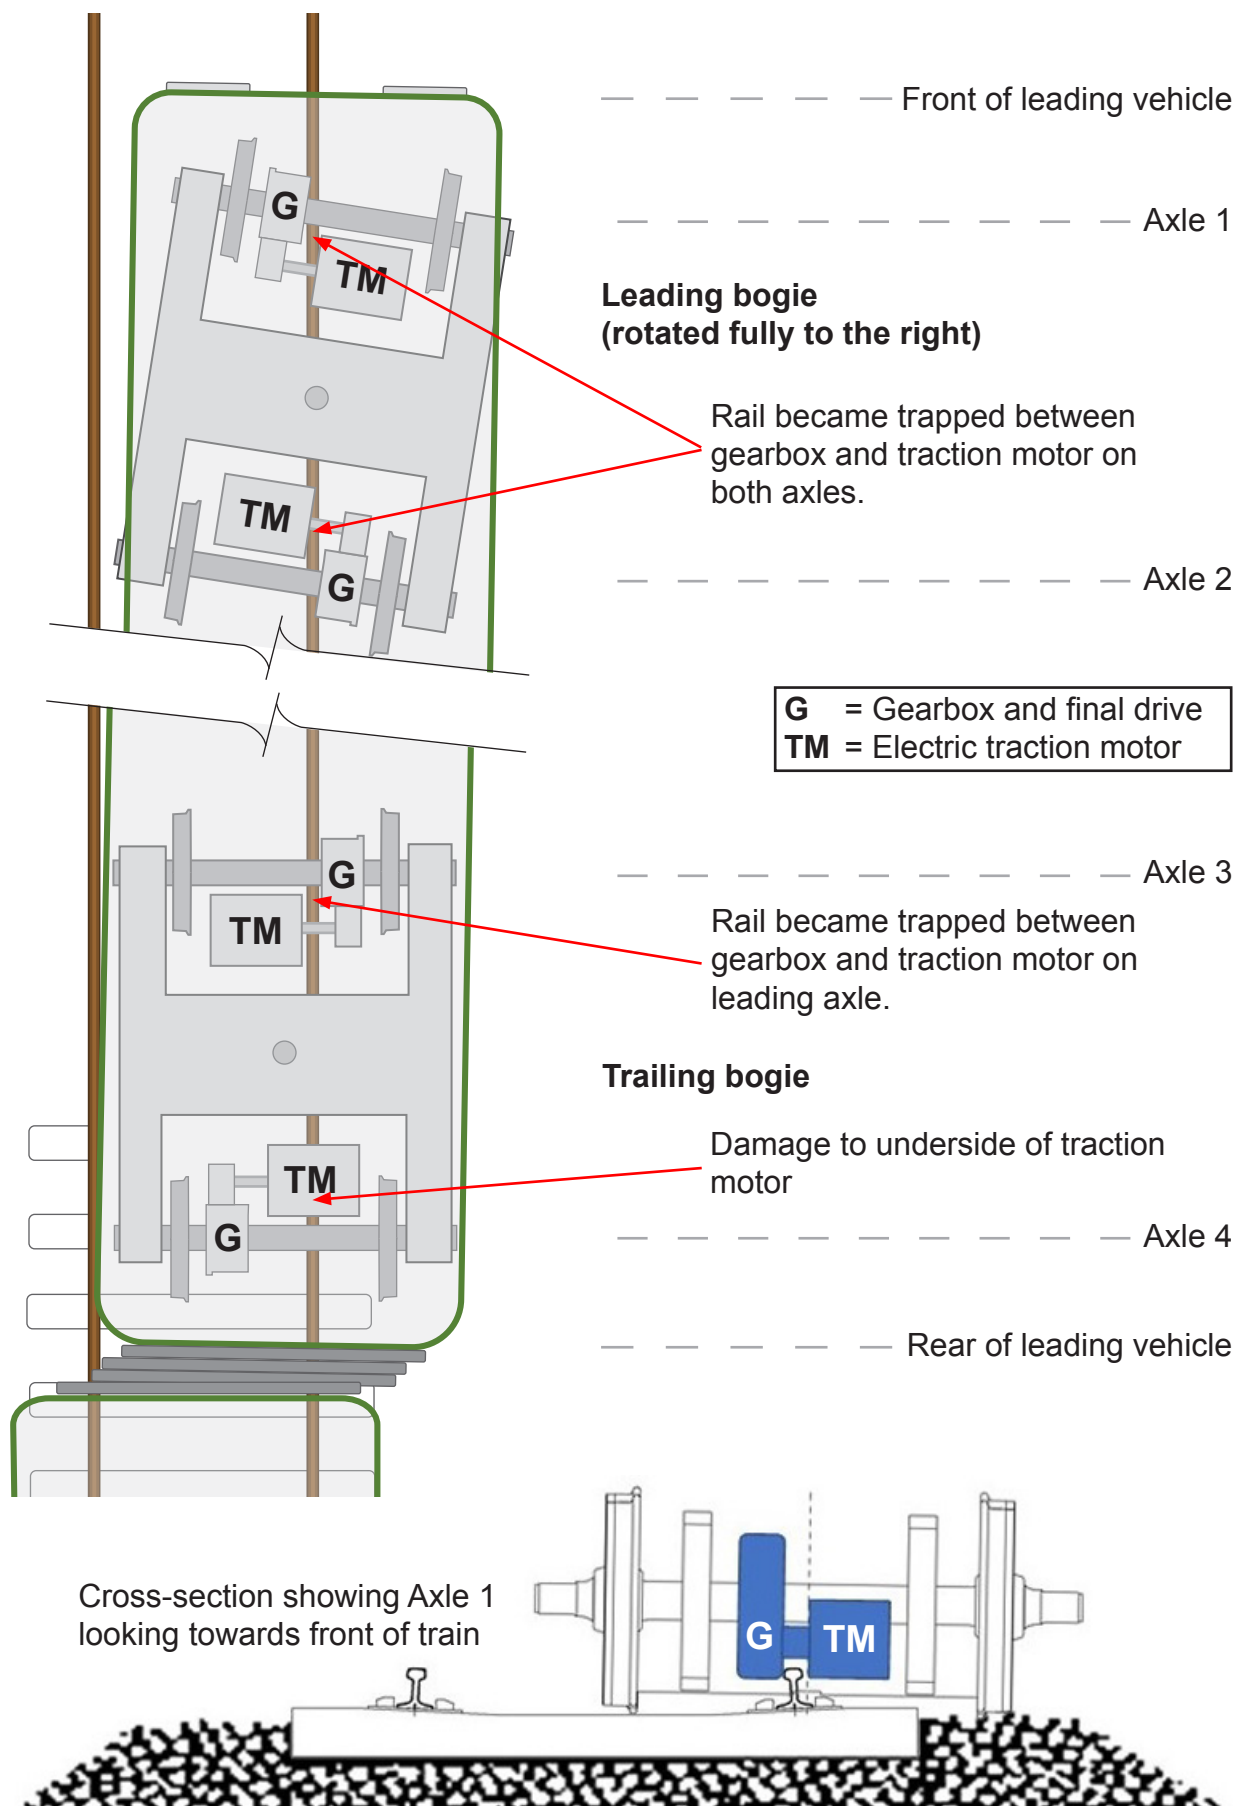
- 52 At 07:20 hrs, the MOM arrived at the Gypsy Lane access gate located adjacent to Gypsy Lane bridge about 400 metres north of the tunnel (figure 7). The MOM was appointed as the Rail Incident Officer (RIO) to facilitate access for the emergency services when they arrived.

Figures 15a and b: Diagrams showing the leading vehicle of train 2K04 and interaction between traction equipment and right-hand rail during derailment. Figure 15b courtesy of RSSB.

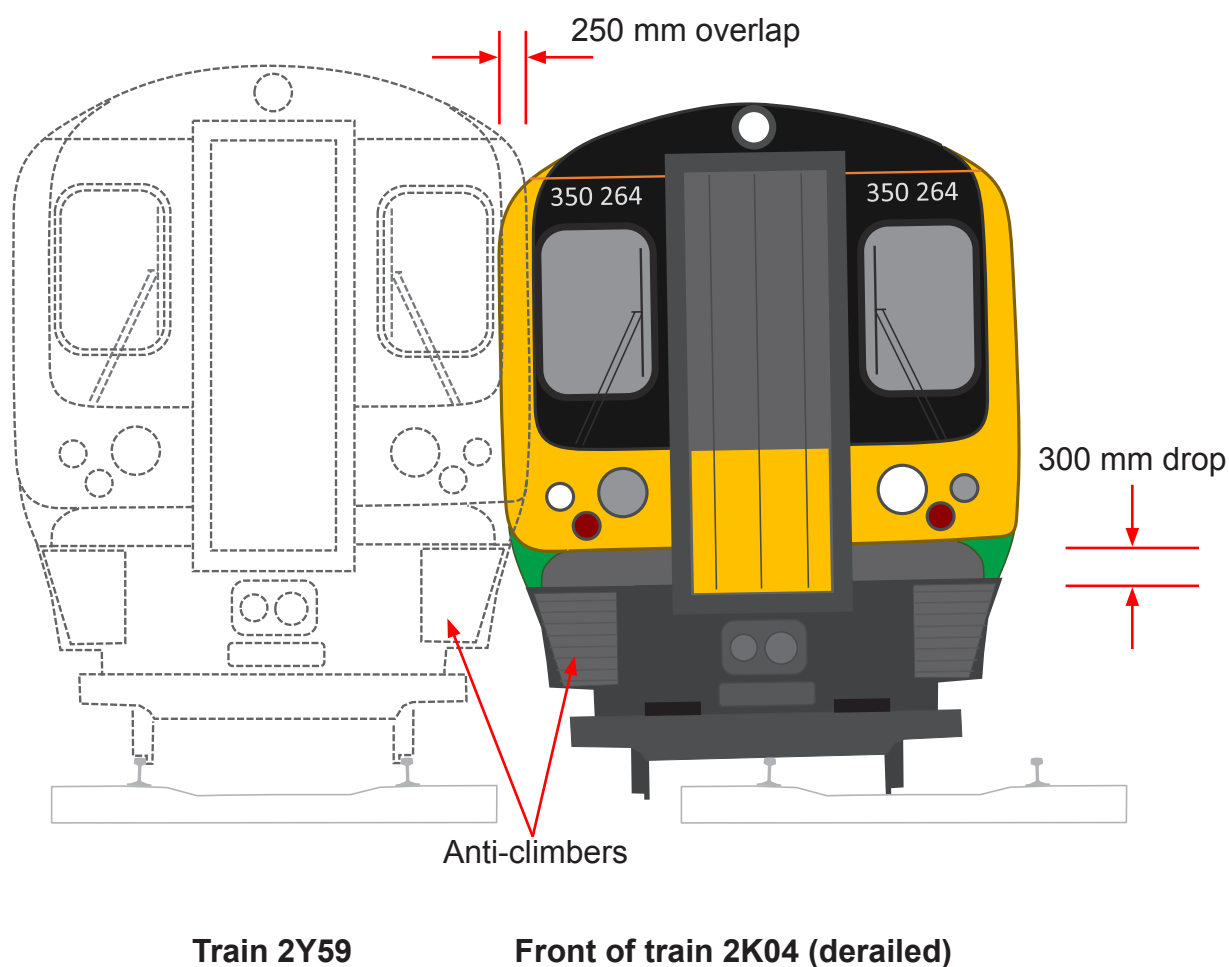
- 54 Until 07:37 hrs, all trains remained stopped in the Watford area. After obtaining confirmation from the RIO that the fast lines were unaffected, the signaller reopened the up and down fast lines at caution (reduced speed). This restriction continued until 09:24 hrs to protect people accessing the accident site.

Figure 16: Diagram showing overlap between trains at moment of collision

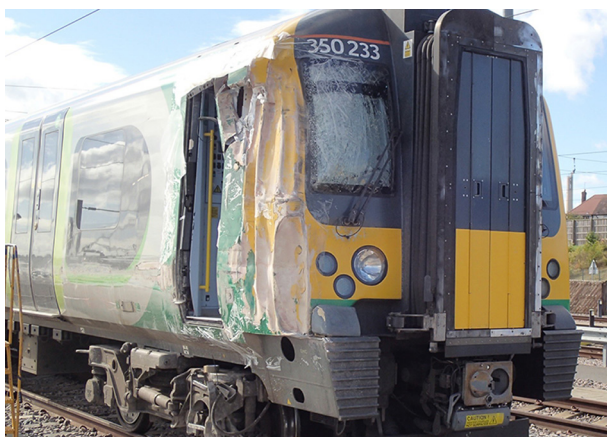
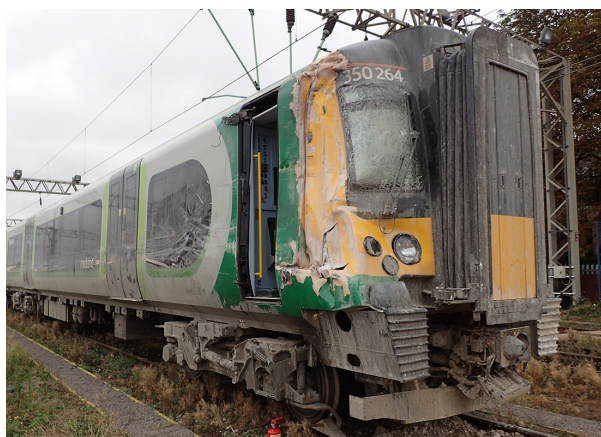
Figure 17a and b: Front view of train 2Y59 (unit 350233) and train 2K04 (unit 350264) following recovery from the tunnel

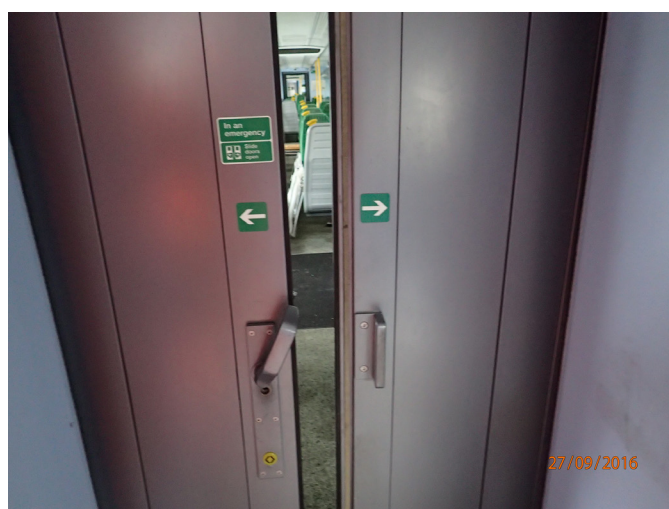
109 The double-leaf sliding doors became jammed in the part-open position (figure 18). This occurred because small stones and screws collected in the lower guide rail during the accident and became trapped under one of the door leaves. Siemens has confirmed that the doors and frame were undamaged. The RAIB observes that debris collecting in this area may be an unavoidable consequence of a collision, and that similar debris could affect a single leaf door in the same way.

Figure 18: Maximum width that the sliding cab-saloon doors could be opened following the accident

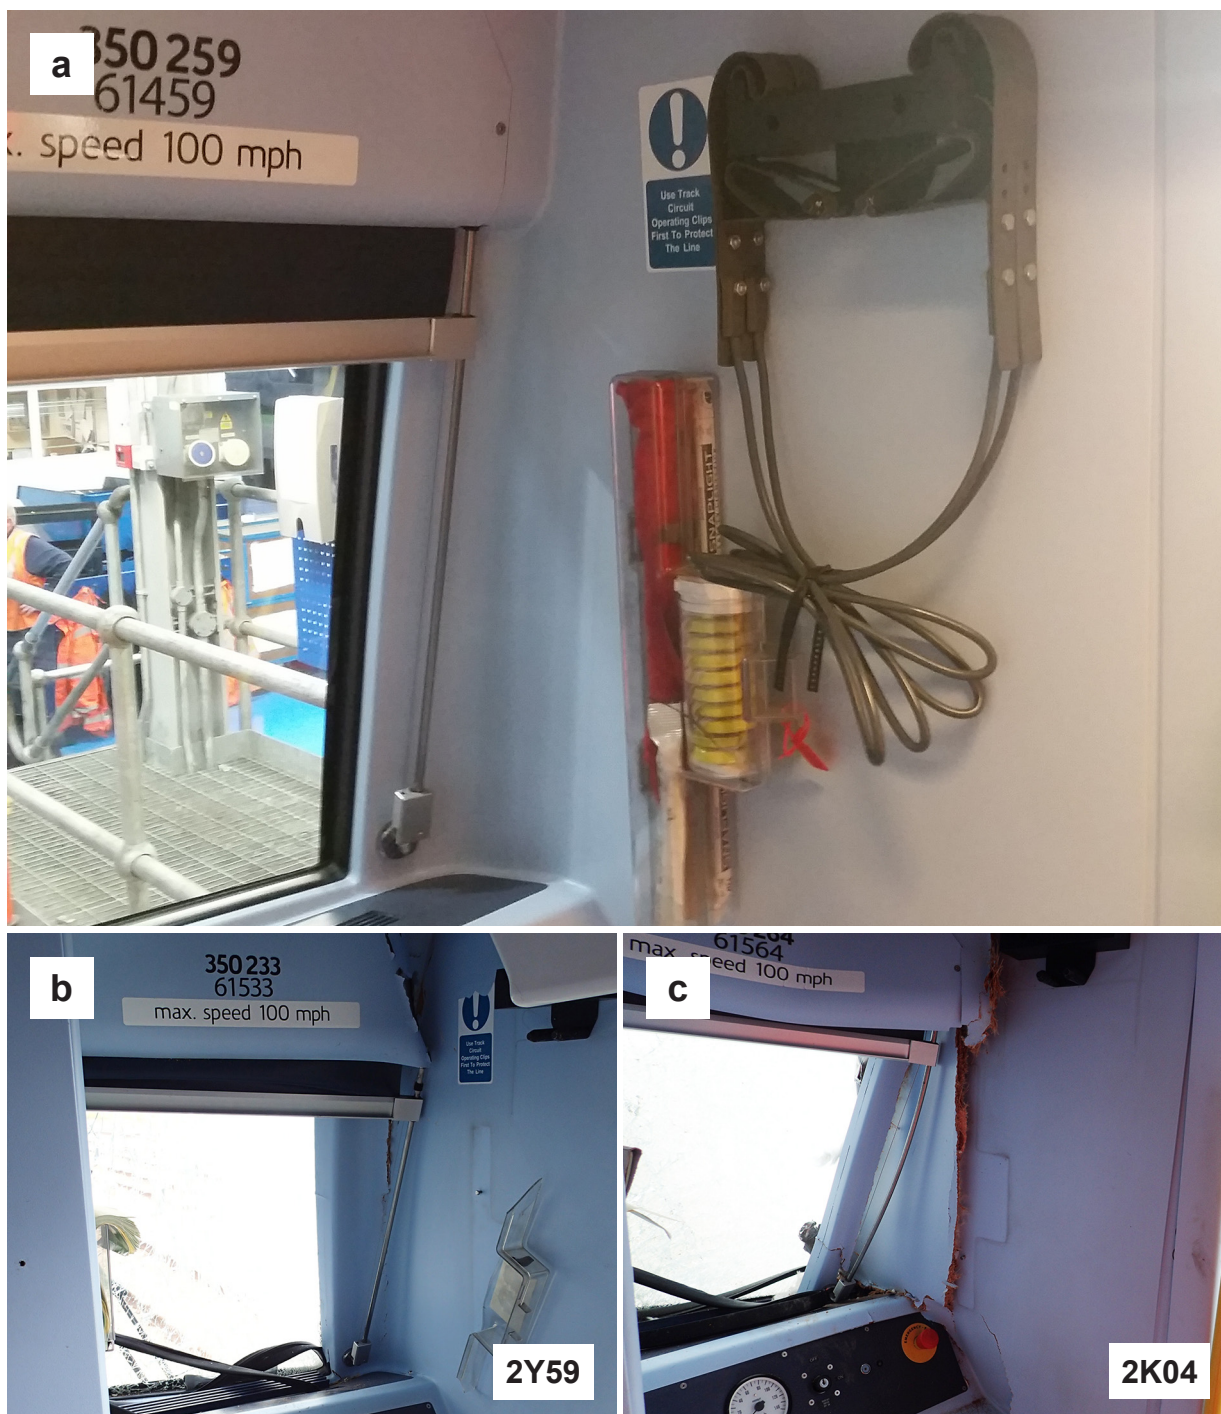
111 Class 350, and other classes of Desiro unit, have a set of emergency equipment attached to the right-hand side wall of the cab. This includes track-circuit operating clips and a clear plastic case containing detonators and flags (figure 19a). Equipment came loose in the cab of train 2Y59 when the case itself broke (figure 19b), and in the cab of train 2K04 when the case broke off the wall (figure 19c). Fortunately this did not cause injury to either driver, but the risk of injury was illustrated in train 2K04 where the equipment hit the back wall of the cab.

Figure 19a, b and c: Photographs showing the location of cab emergency equipment in an unaffected train, and damage to the leading cabs of trains 2Y59 and 2K04

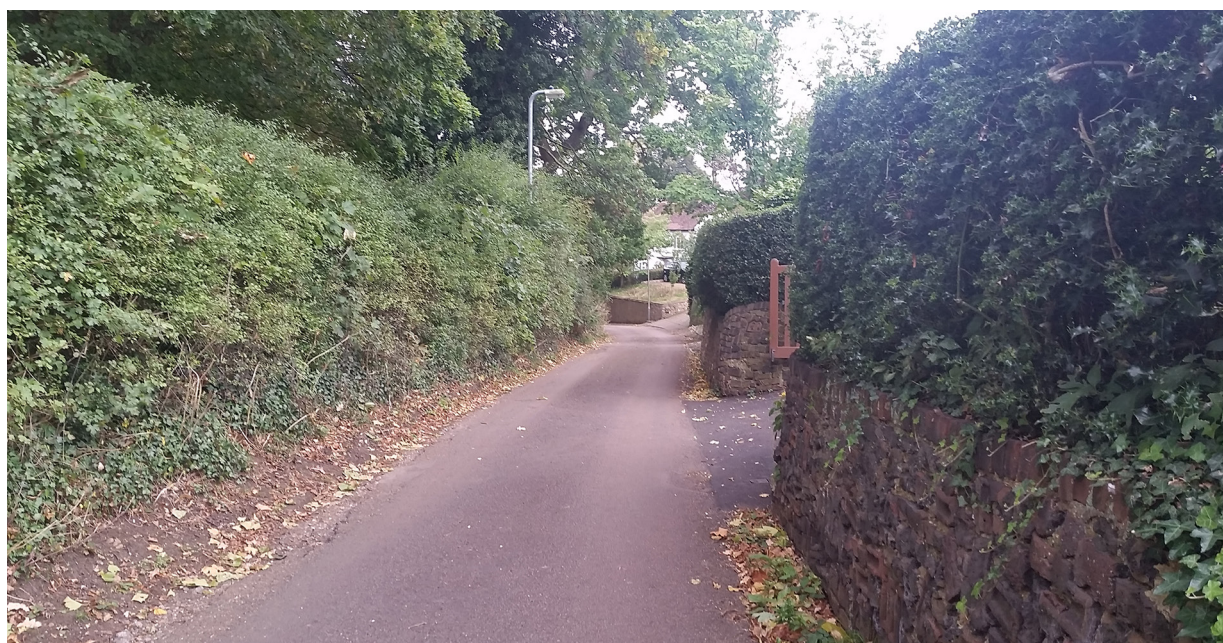
- 63 The driver of train 2Y59 attempted to separate the rear and front units of train 2K04 at 08:37 hrs using uncoupling controls in the driving cab at the front of the rear unit. The attempt was unsuccessful because uncoupling can only be achieved using driving cab controls when the unit is being powered from the overhead line supply and this had been lost at 08:32 hrs (see table 1). Without this supply, uncoupling could only have been achieved manually from track level.

Figure 20: Gypsy Lane, Kings Langley, looking towards the railway access point
