Rail Accident Report

**Serious operational irregularity at Bagillt user
worked crossing, Flintshire, involving an
abnormally heavy road vehicle
17 August 2018**

Serious operational irregularity at Bagillt user worked crossing, Flintshire, involving an abnormally heavy road vehicle, 17 August 2018

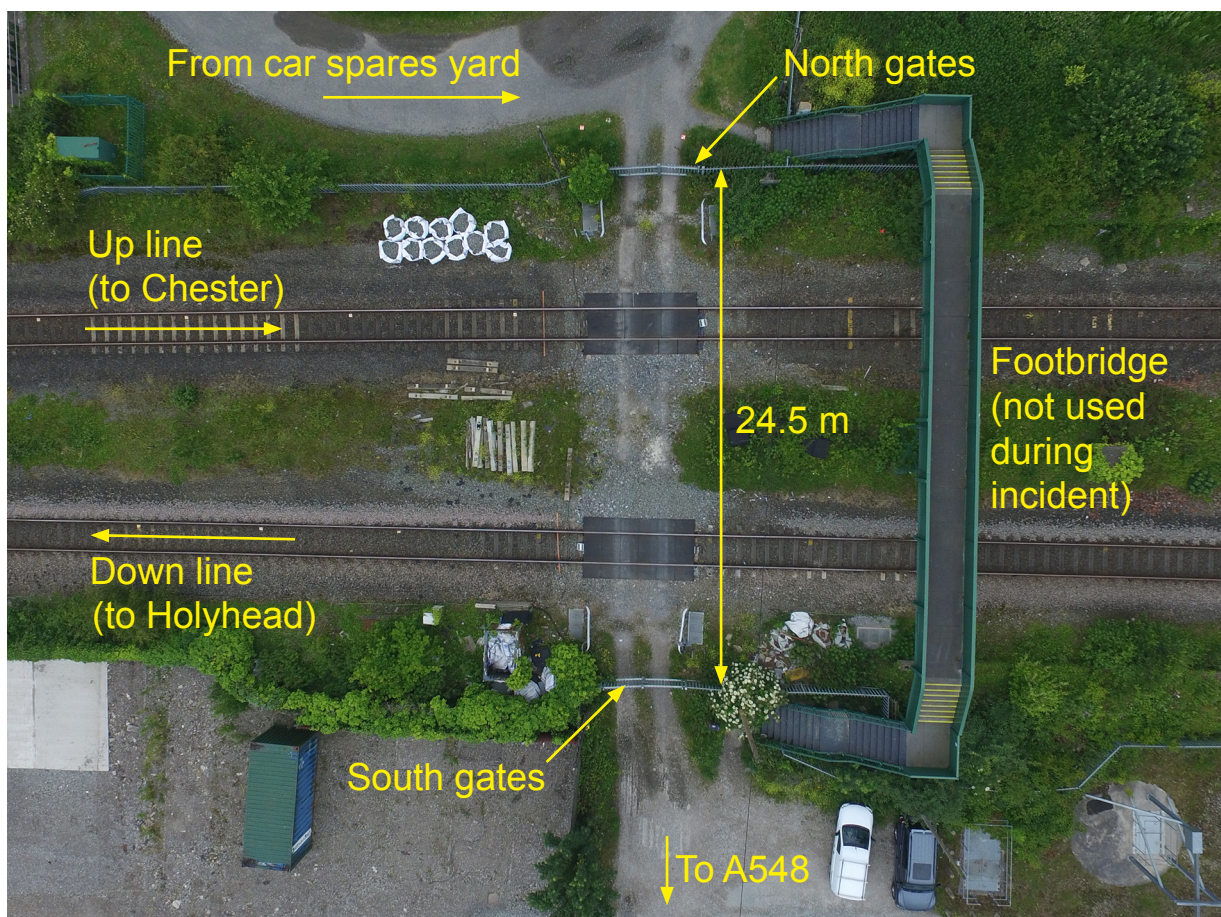
Figure 4: Overview of Bagillt UWC-T

- 16 Bagillt UWC-T has a pair of gates on each side of the railway situated 24.5 metres apart (figure 4). The crossing is equipped with a telephone outside each pair of gates which connect to the signaller's workstation supervising the crossing (figure 6, paragraph 19). Signs positioned inside the gates on both sides of the crossing tell users with vehicles or animals that they must telephone the signaller to obtain permission before opening the gates, crossing the railway and closing the gates. Vehicle users are required to obtain permission because sighting distances along the railway are not sufficient for users to see trains in time to determine if it is safe to cross.

- 117 One of the differences between Bagillt crossing and typical UWC-Ts is the distance between the gates at each end of the crossing. This is 24.5 metres, considerably more than the approximately 13 metres found at typical crossings over two track railways. The RAIB has calculated that the additional distance adds up to about 45 seconds to the time needed for a vehicle crossing, mainly due to the additional time taken by people walking over the crossing to open and close the gates. The actual additional time depends on variables including whether the gates are operated by the vehicle driver or by another person.

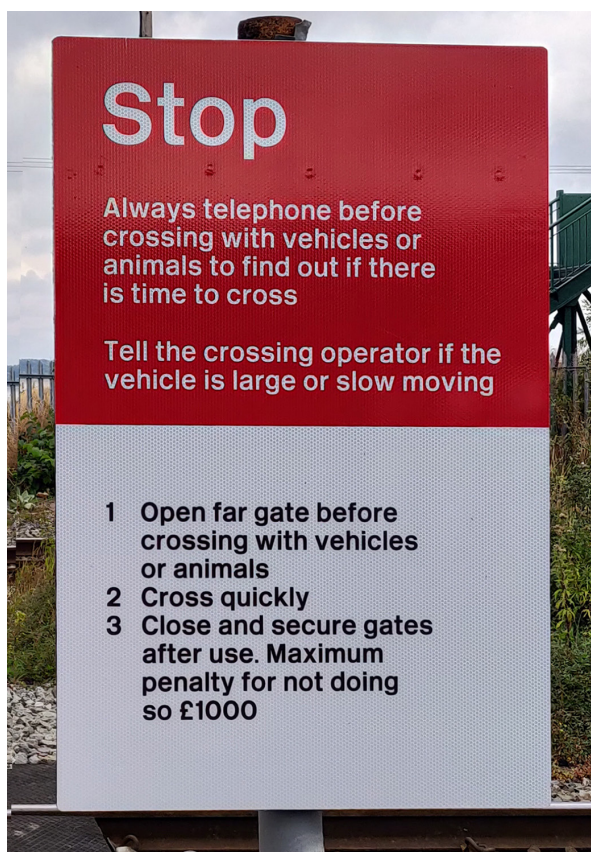
Figure 9: Instruction sign at Bagillt UWC-T

- 52 There is no definition of *'large or slow-moving'* on the signs and no clear definition elsewhere in Network Rail's UWC-T processes (paragraph 79). The crossing assistant routinely assisted articulated lorries used to carry scrap metal over Bagillt UWC-T (figure 10). Although these do not require special precautions when driven on the public highway (and are not abnormal vehicles as described at paragraph 15), the crossing assistant also considered these to be *'large'* and *'slow-moving'*.

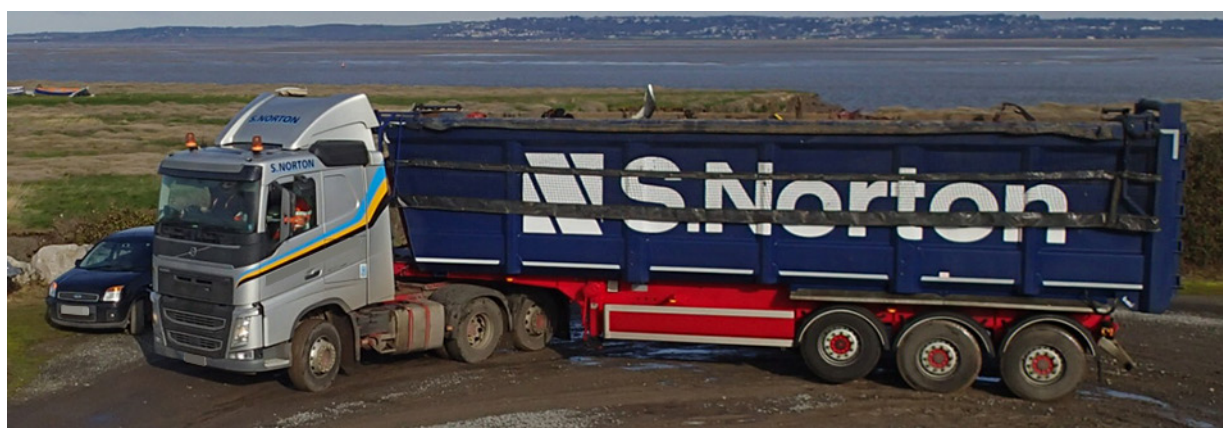
Figure 10: Typical heavy goods vehicle 'HGV' used on Bagillt UWC-T (not subject to special restrictions on the public highway)

- 53 Observations at Bagillt UWC-T showed that the crossing time for scrap metal lorries were only slightly less than the crossing time for the baler. A laden scrap metal lorry took 21 seconds and the baler took 28 seconds to travel from north to south over the crossing.
- 54 The crossing assistant stated that he usually described large vehicles as 'wagons' and that Network Rail staff had not asked him to clarify the size or weight of vehicles when they had previously observed him using the crossing. He also stated that no signaller and no Bagillt Car Spares staff had asked him to clarify the weight or size of the vehicle he was assisting to cross. No one had instructed him to treat the baler differently to the other vehicles used on the crossing, which were not abnormal vehicles.

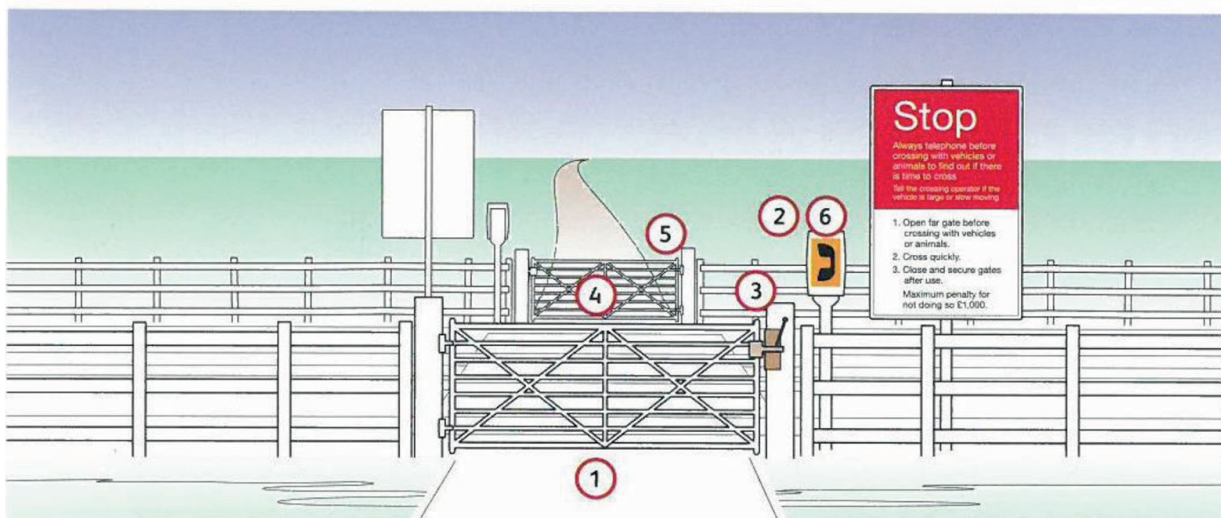
Figure 16: Instruction sheet provided by Network Rail to Bagillt Car Spares

- 112 Current Network Rail signs instruct users to tell the crossing operator (ie the signaller in most instances, including at Bagillt UWC-T) if they are crossing with a large or slow-moving vehicle. However, unlike signs provided for automatic half barrier crossings (paragraph 90), signs at UWC-Ts provide no guidance on what constitutes a large or slow-moving vehicle. This issue is not considered further in the present report as the content of signs at user worked level crossings is addressed by an existing RAIB recommendation (paragraph 156). Network Rail guidance provided to authorised users, for example the instruction sheet provided to Bagillt Car Spares (figure 16), does not provide this information.

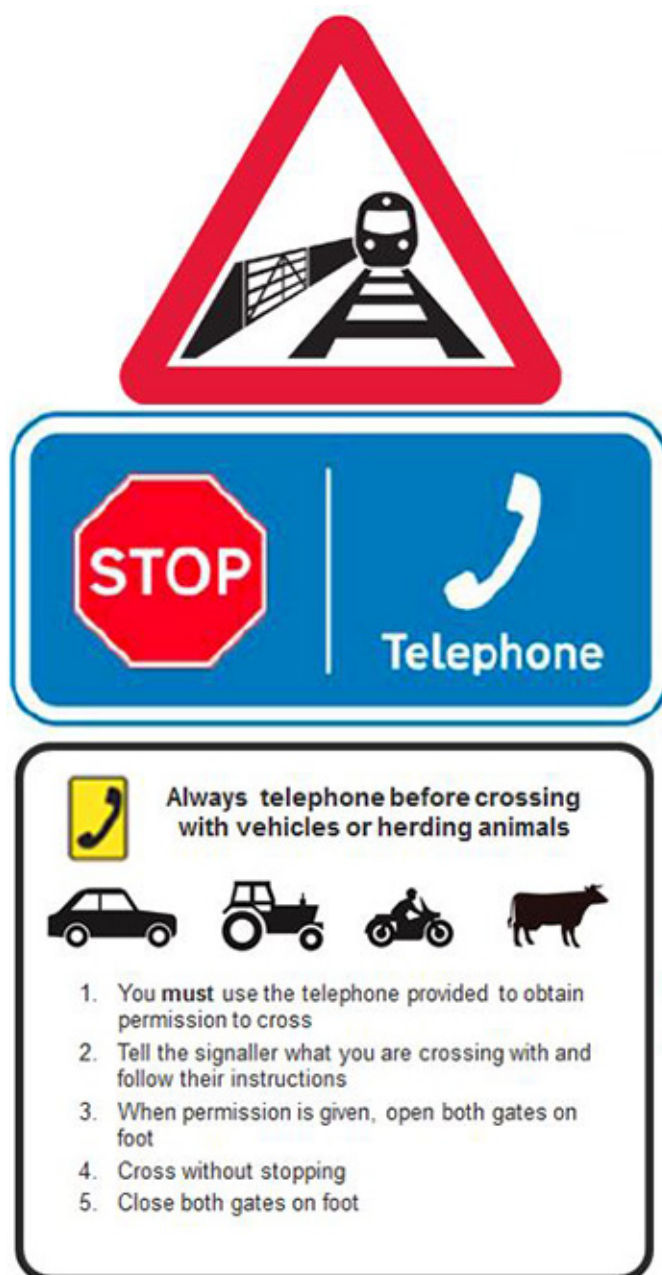
Figure 17: New UWC-T sign being trialled by Network Rail

- 114 Following RSSB research project T983 'Research into signs at private level crossings', dated May 2015, Network Rail has trialled a new sign for use at UWC-Ts (figure 17). The prompt for users to tell the signaller if they are crossing with a large or slow-moving vehicle (figure 9) has been omitted on this new sign. If adopted, this sign will increase the reliance on briefings to authorised users and/or briefings to signallers to ensure that signallers are told when a request to cross relates to a large or slow-moving vehicle.
