Rail Accident Report

Collision with buffer stops at King's Cross 17 September 2015

Report 15/2016
August 2016

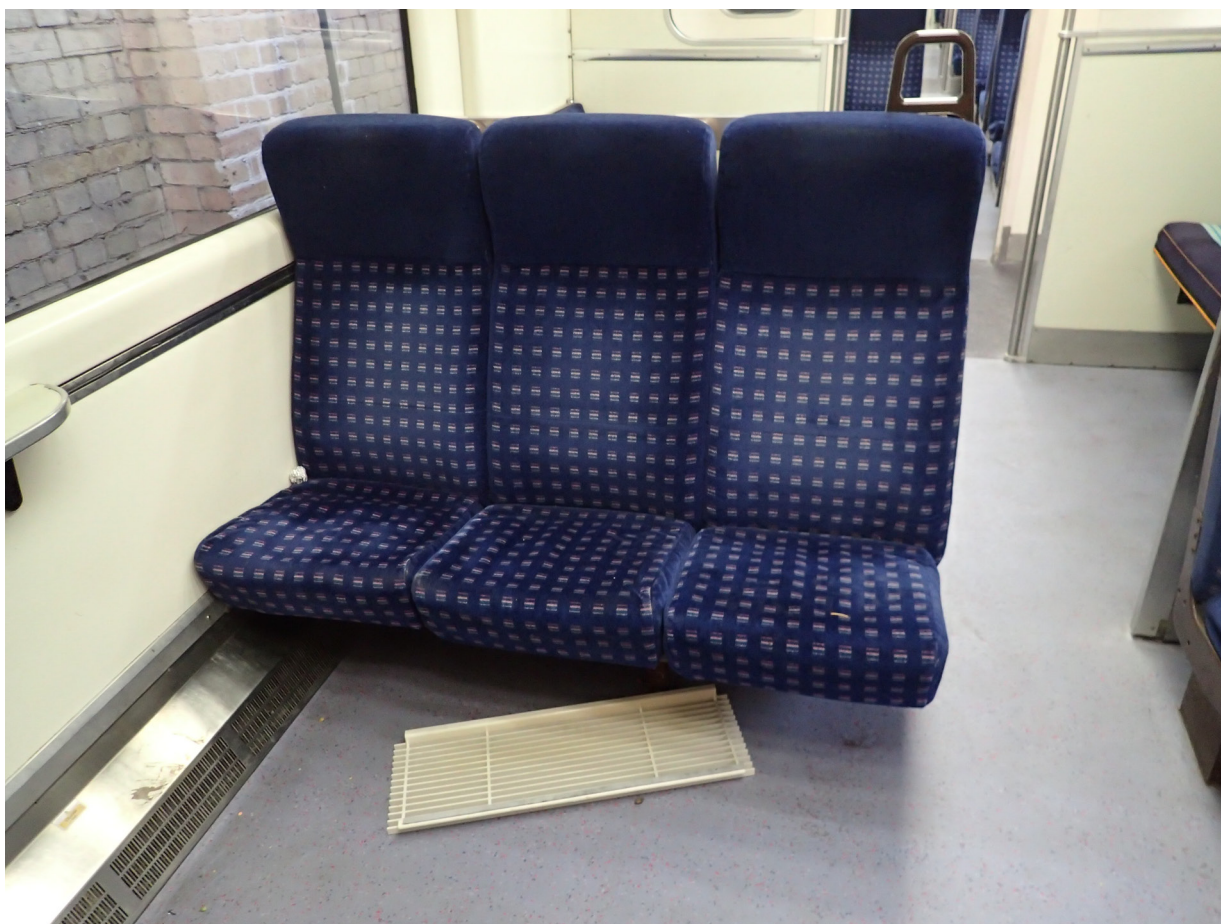
Figure 7: Diffuser on saloon floor following the accident
