Rail Accident Report

Runaway of a maintenance train near Markinch, Fife 17 October 2017

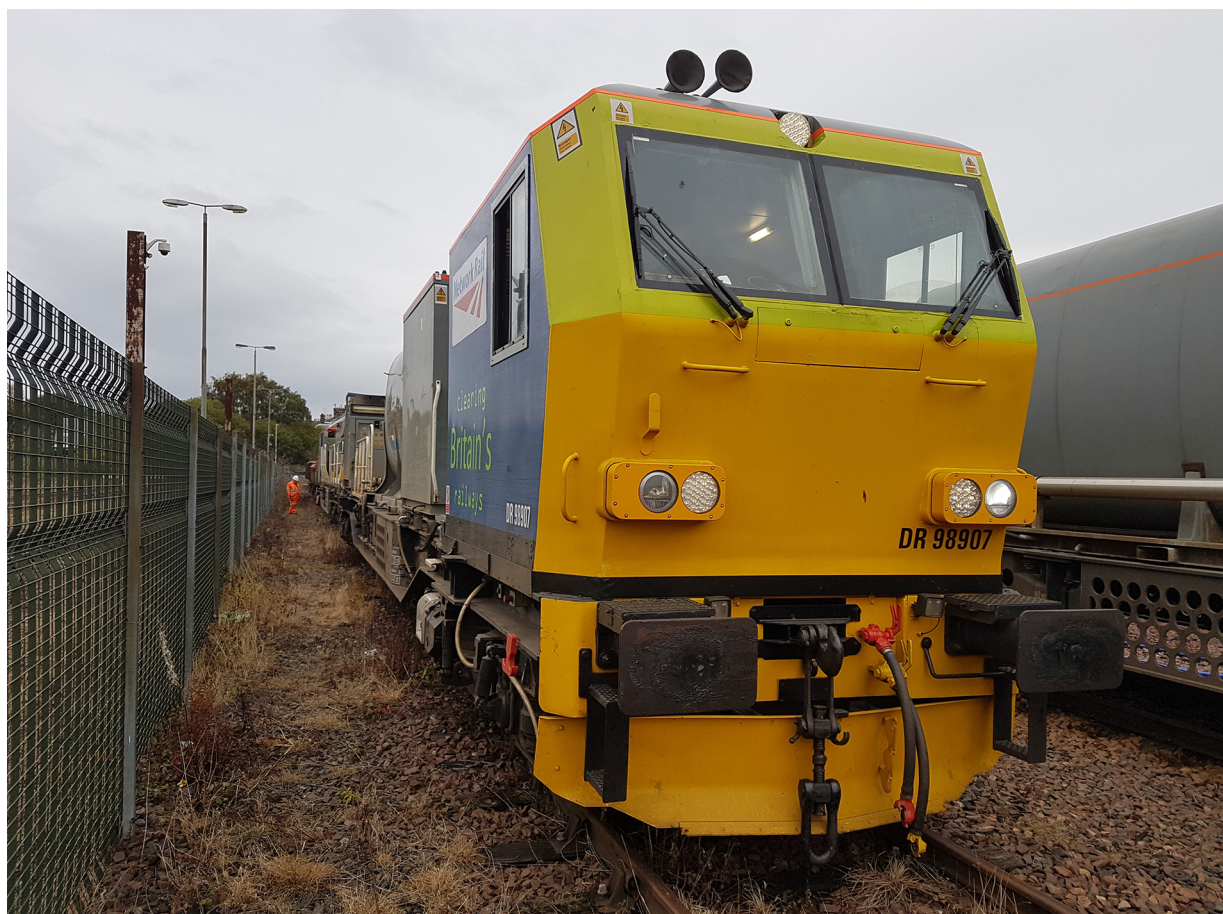
- 6 The train was a *Multi-Purpose Vehicle* (MPV) that was carrying out *Rail Head Treatment Train* (RHTT) duties. It consisted of slave vehicle DR98957, which was leading at the time, and master vehicle DR98907. This type of MPV entered service between 1999 and 2001 and consists of two flat-decked vehicles coupled together, each of which has a driving cab at the outer end (figure 2). The master vehicle is powered in each MPV, while the slave is unpowered.
- 7 The MPVs can be fitted with a variety of modules to undertake different duties, such as weed spraying and de-icing. At the time of the accident, the MPV was fitted with water jetting and *adhesion modifier* spreading equipment. This is intended to clear leaf debris from the tracks and to improve the friction between train wheels and the rails.

Figure 2: The Multi-Purpose Vehicle involved (photographed at Slateford depot)

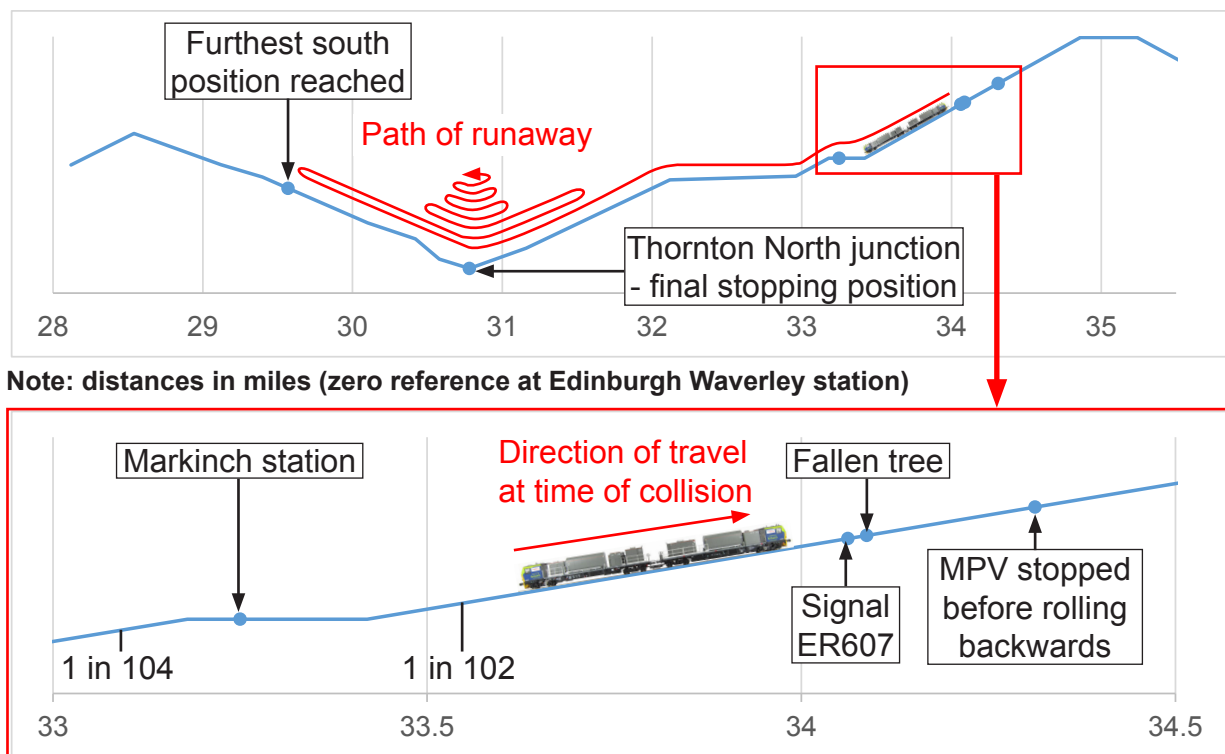
- 10 The MPV had left Slateford depot in Edinburgh just before midnight, with the driver and treatment operator on board, and had treated the lines to Tweedbank, Dunfermline and Kirkcaldy before passing through Markinch en-route to Ladybank. At approximately 04:25 hrs, when approximately 0.8 miles (1.3 km) north of Markinch station, the driver saw the outline of the top of a tree across the track ahead. At this moment the MPV was travelling at about 43 mph (70 km/h) (figure 3).

Figure 3: Diagram showing approximate locations of events (Not to scale)

- 11 The driver immediately pushed the *emergency brake plunger*, and both the driver and the rail head treatment operator dived to the floor under the control console. It is unlikely that the brakes had time to significantly reduce the train's speed before it hit the tree. As soon as the train came to a stop, it started to roll backwards, at which point the driver unsuccessfully tried to use the desk controls to stop the train, despite the emergency brake having already been applied.

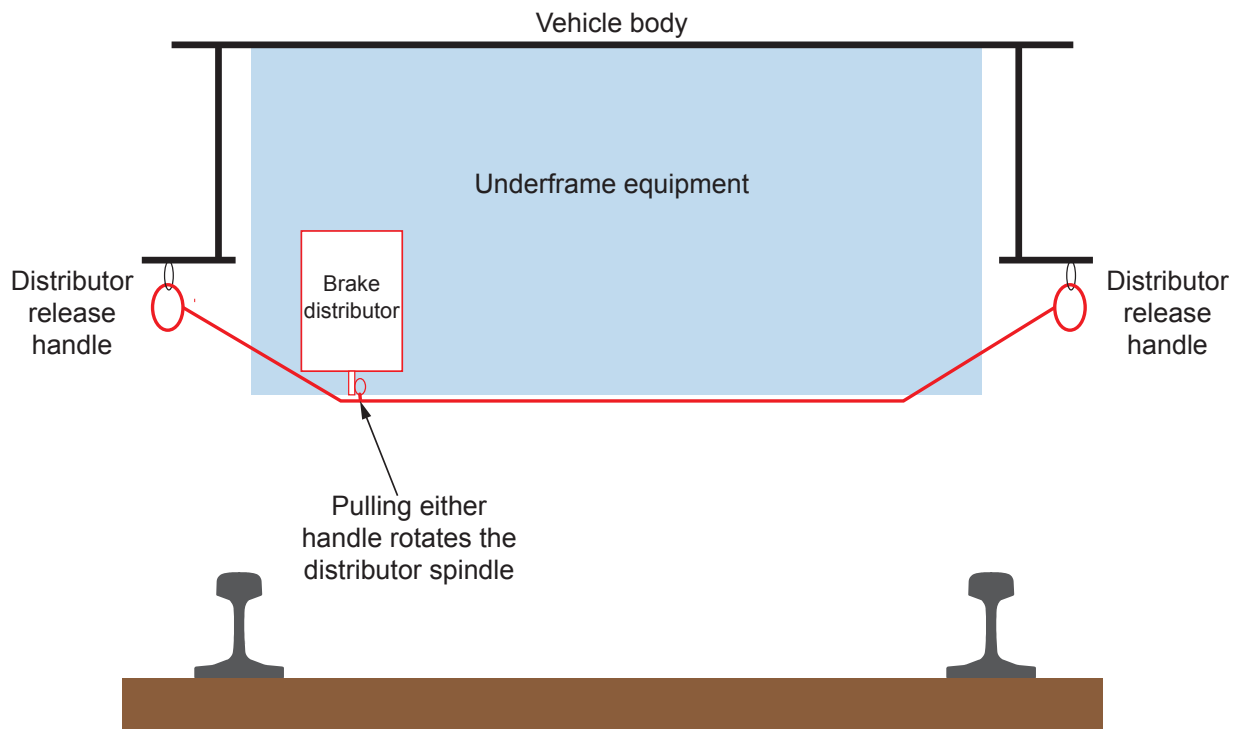
- 20 When the brakes are not applied, the brake pipe pressure is at its highest, and this pressure reduces as the driver requests more braking. In an emergency brake application, the brake pipe is vented to atmosphere, so that all the pressure is released.
- 21 The distributor senses the brake pipe pressure and modulates the air pressure applied to the brake cylinders in response. A reduction in the brake pipe pressure results in an increase in the pressure to the brake cylinders, and thus the amount of braking applied. The manual release handle, when pulled, rotates a spindle on the distributor, which releases a control pressure chamber in the distributor, thus venting the brake cylinder pressure, and releasing the brakes (figure 5). The control pressure chamber is re-pressurised from the brake pipe when the release handle is no longer operated, allowing braking to be re-established.

Figure 5: Diagram of brake distributor release mechanism

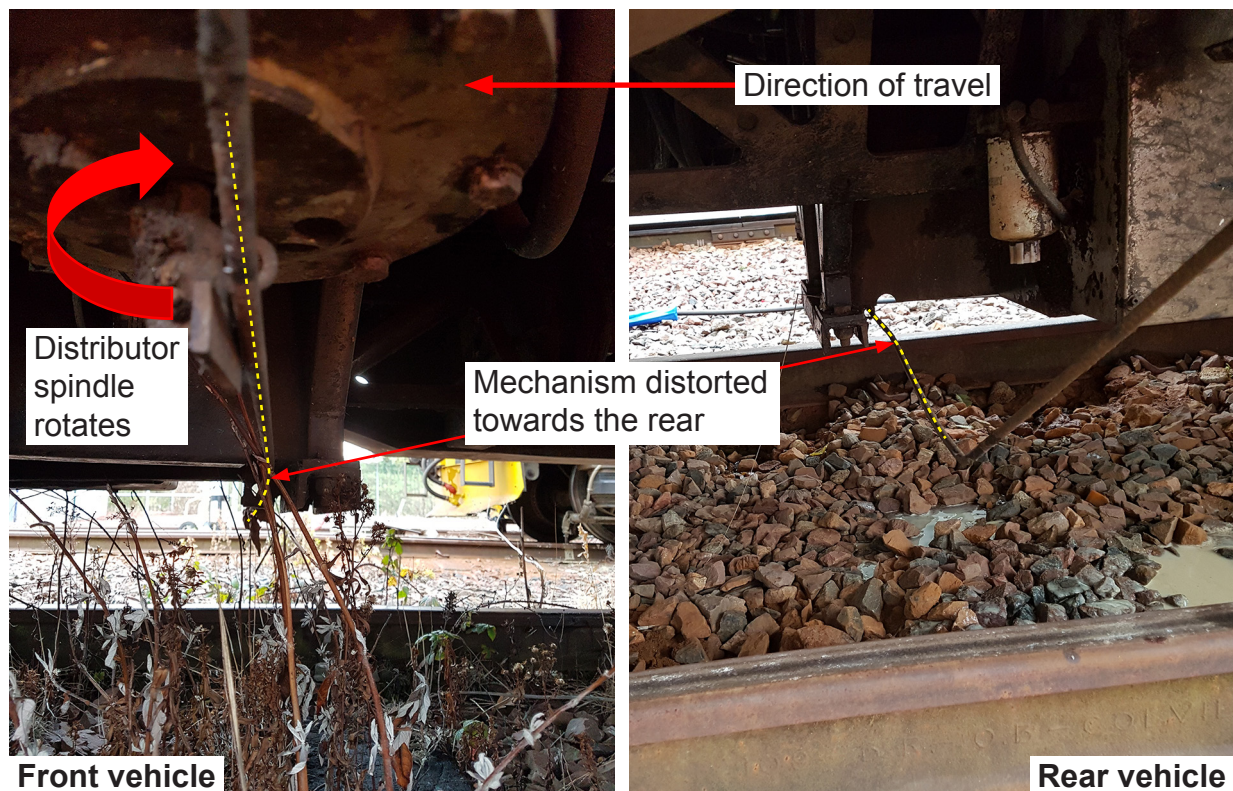
- 29 The brakes were released because the brake distributor release mechanisms were operated on both vehicles by the debris from the tree passing underneath the train.**

- 32 Examination of the front and rear vehicle distributor release mechanisms indicates that both had been distorted towards the rear of the train, as it was travelling at the time of the collision with the tree (figure 6). This is consistent with them having been hit by the tree debris. It is likely that the release spindle (figures 5 and 6) on each brake distributor was rotated briefly during the impact, causing the air pressure to be vented from the brake cylinders for each vehicle and the brakes to be released.

Figure 6: Distortion to brake distributor release mechanisms.

- 42 **The MPV was approved for operation on Network Rail infrastructure with the brake distributor release mechanism vulnerable to operation by obstructions on the track.**

- 45 It is evident that the *approval process* did not recognise that external impacts could be the common cause of operation of the brake distributor release mechanisms on both vehicles and separation of the brake pipe.

Network Rail should identify and implement suitable measures to mitigate the risk of a runaway initiated by multiple unintended operations of the brake distributor release mechanisms on its Windhoff Multi-Purpose Vehicles by objects and debris that might reasonably be encountered on the track during operation.

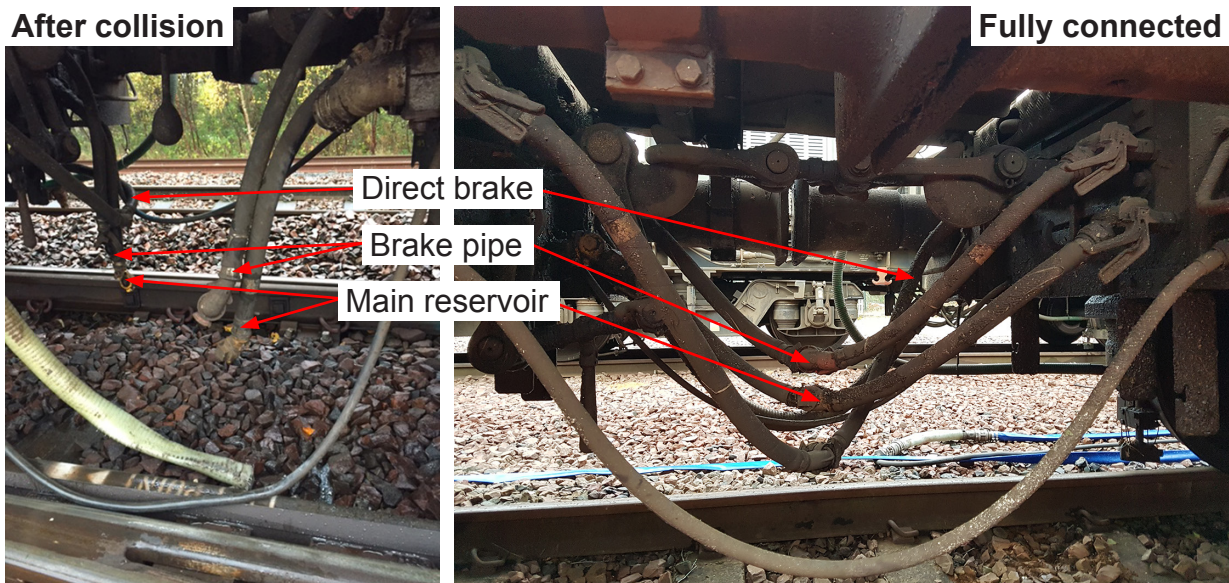
- 33 **The driver was unable to reapply the brakes after the debris from the tree had caused all three brake system pipes to be separated between the vehicles.**

- 35 The driver initially tried several times to apply the brakes using the emergency brake plunger and the brake controller handle. However, these had no effect because the tree debris passing underneath the train had separated all three brake pipes connecting the vehicles (figure 7).

Figure 7: Comparison of normal configuration of brake pipes with that after collision (Post-collision photograph (left) courtesy of Network Rail)

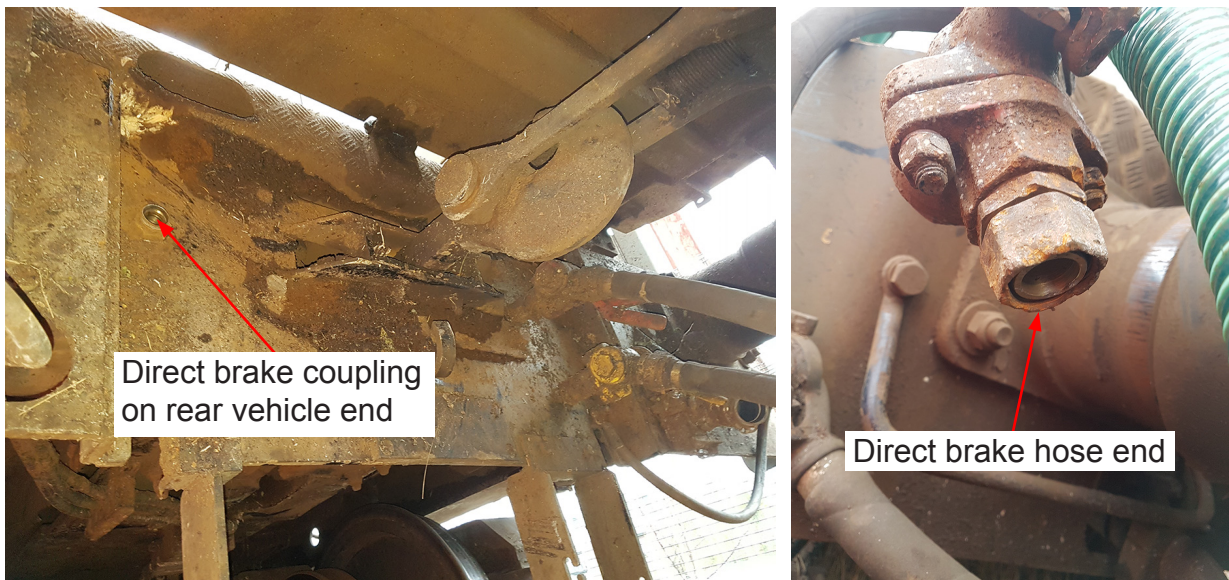
- 36 The main reservoir pipe and the brake pipe had separated at the couplings, but were undamaged. The design is such that the coupling is easily released when the two hoses are perpendicular to each other. It is likely that the tree debris lifted the hanging part of the hoses, rotating the coupling until the two hoses became perpendicular. The direct brake pipe remained coupled but was pulled out of the end of the rear vehicle (figure 8).

Figure 8: Direct brake pipe pulled out

- 40 Separation of the direct brake pipe also had little effect on the operation of the brakes. The system is configured such that the direct brake can be used as an alternative to control via the brake pipe. That means that the direct brake cannot be used while the brake pipe is being used. Selection of which system is active is made using a control on the desk which can only be used when the train is stationary, and therefore was unavailable. Furthermore, the direct brake would not have been operative because the direct brake pipe had separated between the two vehicles.
