Rail Accident Report

Collision between a train and a collapsed signal post at Newbury 17 November 2014

Report 15/2015
September 2015

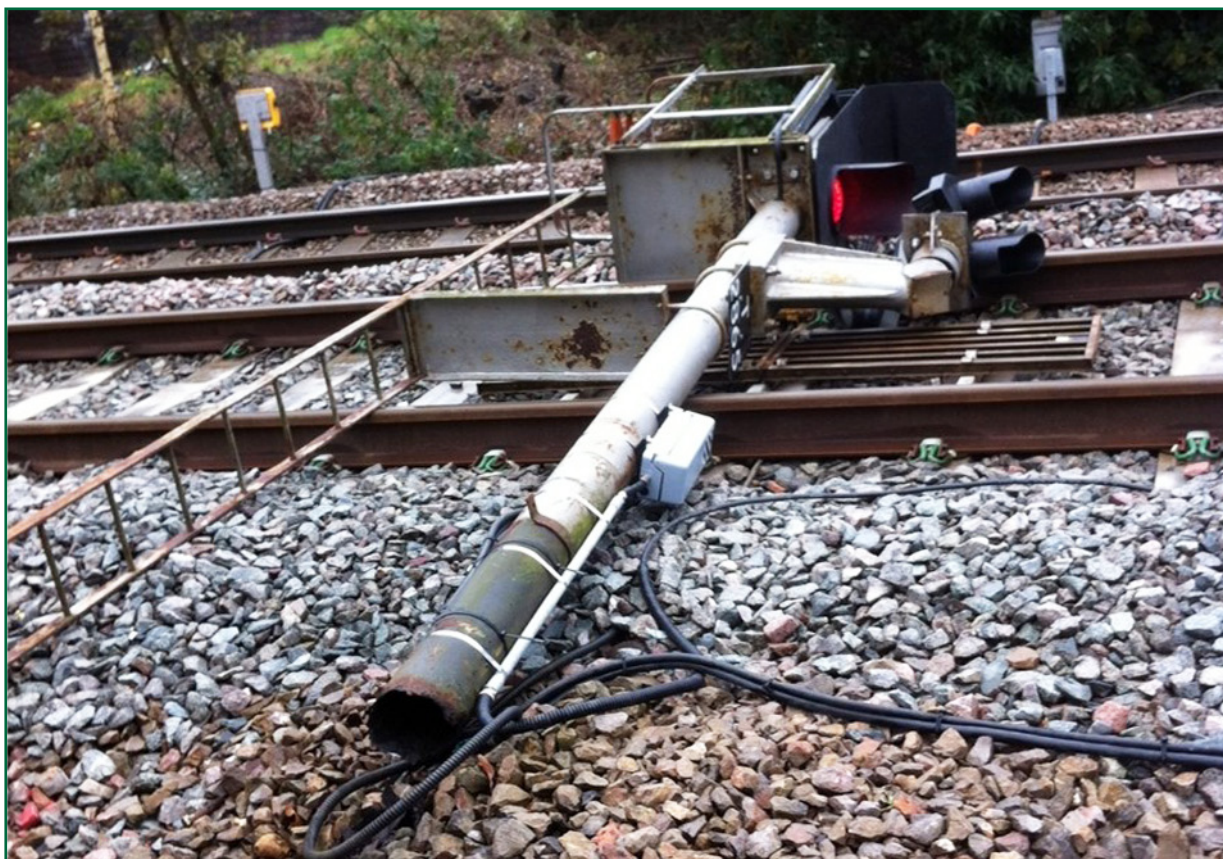
At about 14:35 hrs on Monday 17 November 2014, a train travelling at 110 mph (177 km/h) struck the top of a signal which had collapsed and fallen across the railway line near Newbury. The signal post completely obstructed one track and partially obstructed a second (the one on which the train was travelling). There were no injuries and the train did not derail, but it did sustain some exterior damage. The outcome could have been much more serious if the first train to encounter the signal had been travelling at speed on the line that the signal had completely obstructed.

Figure 2: The fallen signal post after the accident (courtesy of Network Rail). Down Westbury line is closest to the camera, Up Westbury line is furthest away.

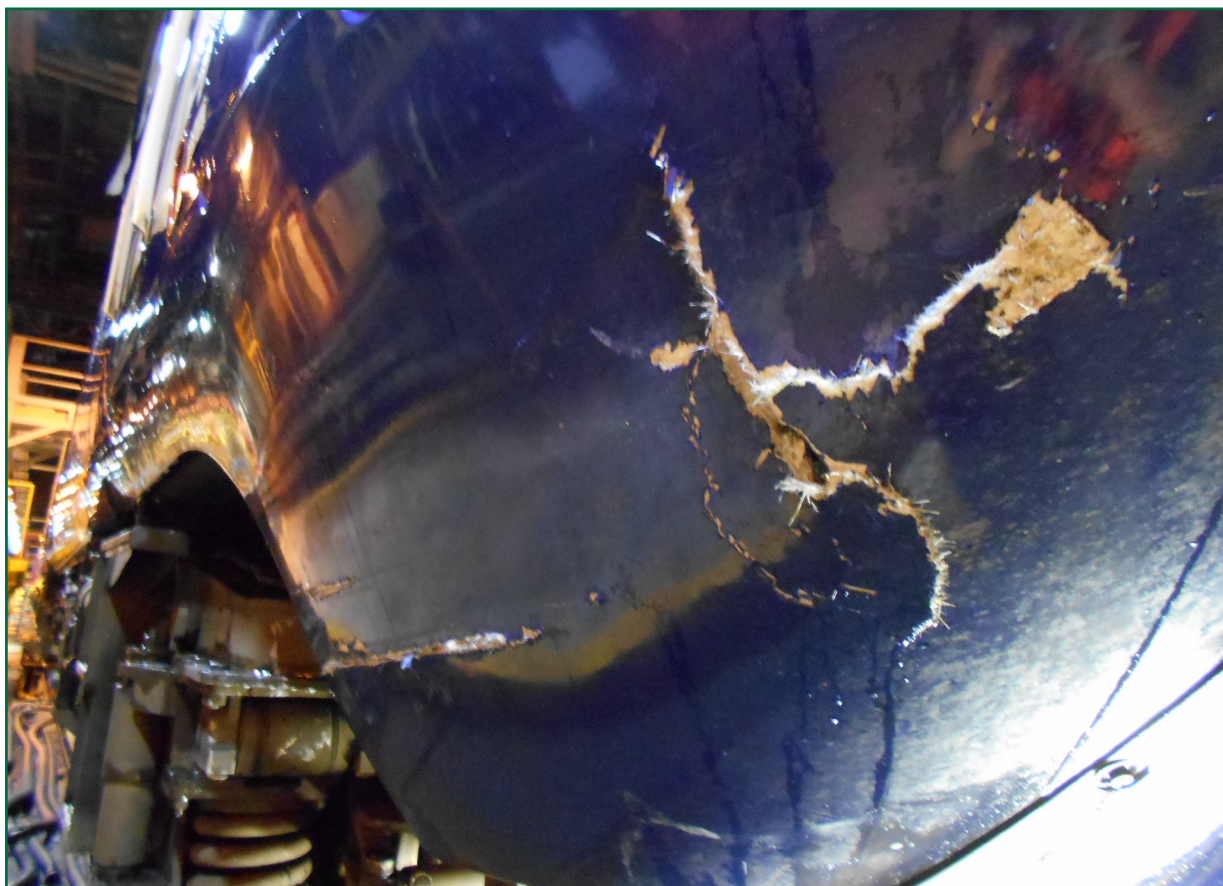
- 12 The train, reporting number 1A83, was the 10:41 hrs First Great Western HST service from Truro to London Paddington.
- 13 The leading power car, vehicle number 43160, sustained exterior body damage (see Figure 4) and a ruptured air pipe.

Figure 4: Damage to power car 43160 (courtesy of First Greater Western)

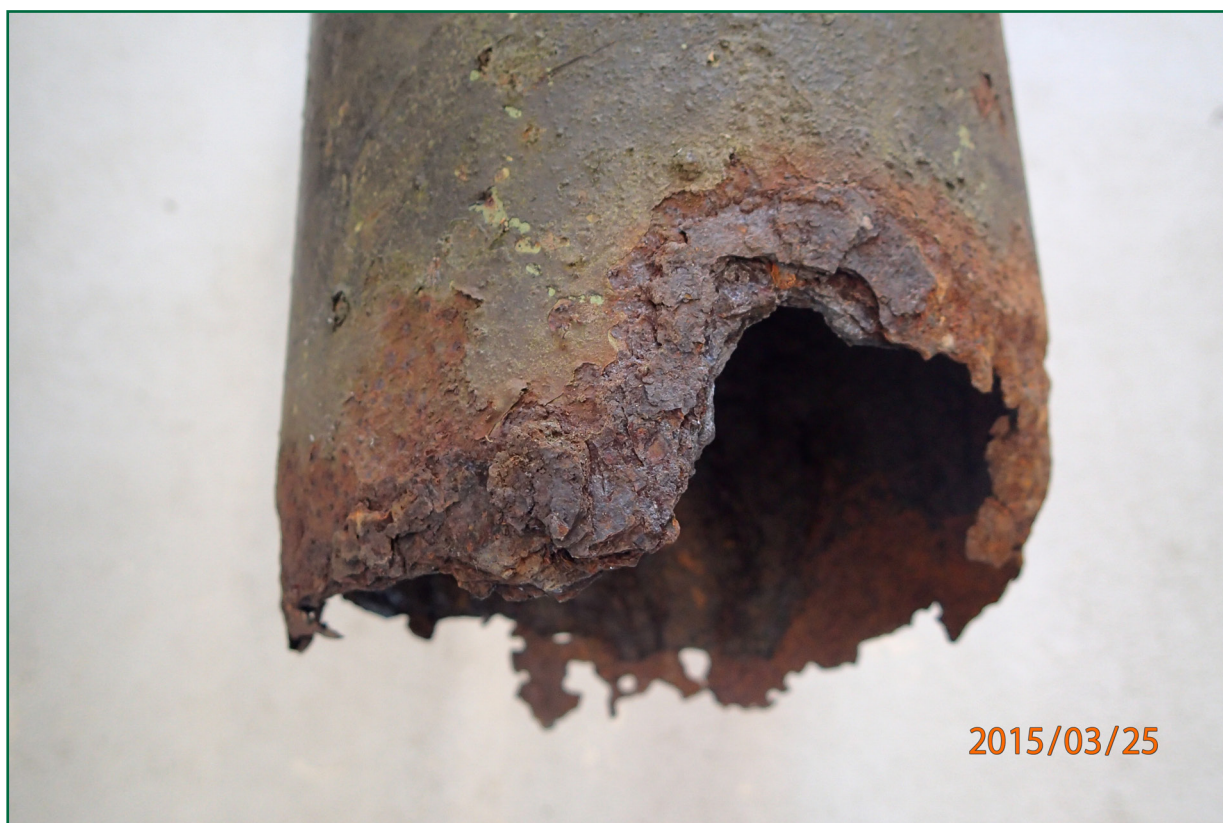
41 The signal collapsed because the base of the post had corroded.

- 43 Corrosion around the base of the post and the ladder had caused severe metal wastage and an almost complete loss of wall thickness at and around the ballast in which the base of the post was buried (see Figures 7 and 8). It is likely that localised sites were perforated (rusted through) before the post collapsed.

Figure 7: Corrosion at the base of the signal post

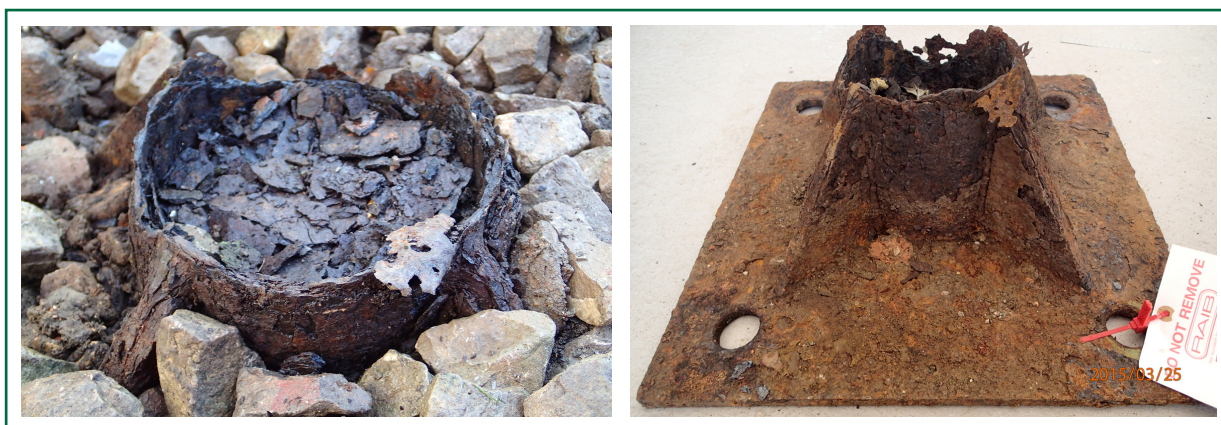
- 47 The ballast would have affected the integrity of the external coating (through abrasion) as well as holding water around the base of the post. Once the corrosion activity was established, it would progressively undermine the surrounding coating.

Figure 8: Corrosion at the baseplate (a) in situ after the accident (left image; note level of ballast) and (b) after removal from site

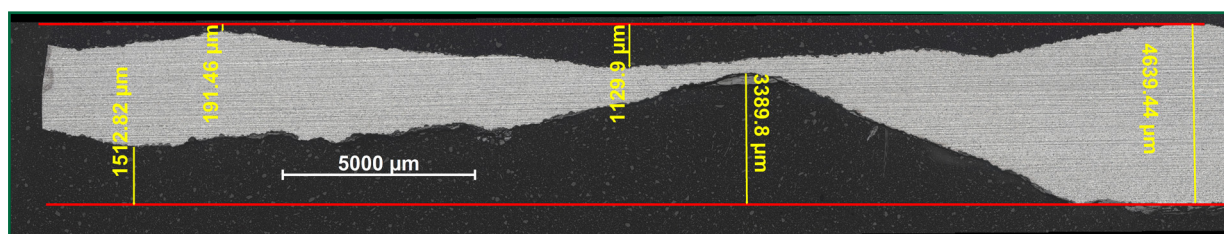
- 44 Corrosion had occurred on both the external and internal surfaces of the post, especially within 250 mm of the rupture site. Remaining wall thickness at the thinnest point measured was around 0.1 mm (see Figure 9), as compared with 6 mm when new (paragraph 16).

Figure 9: Microscopic cross-section through the signal post (seen in grey against black background) at a severely corroded region (internal surface of the post is the top side of the image). Loss of wall thickness indicated at selected sites; original wall thickness represented by red lines.

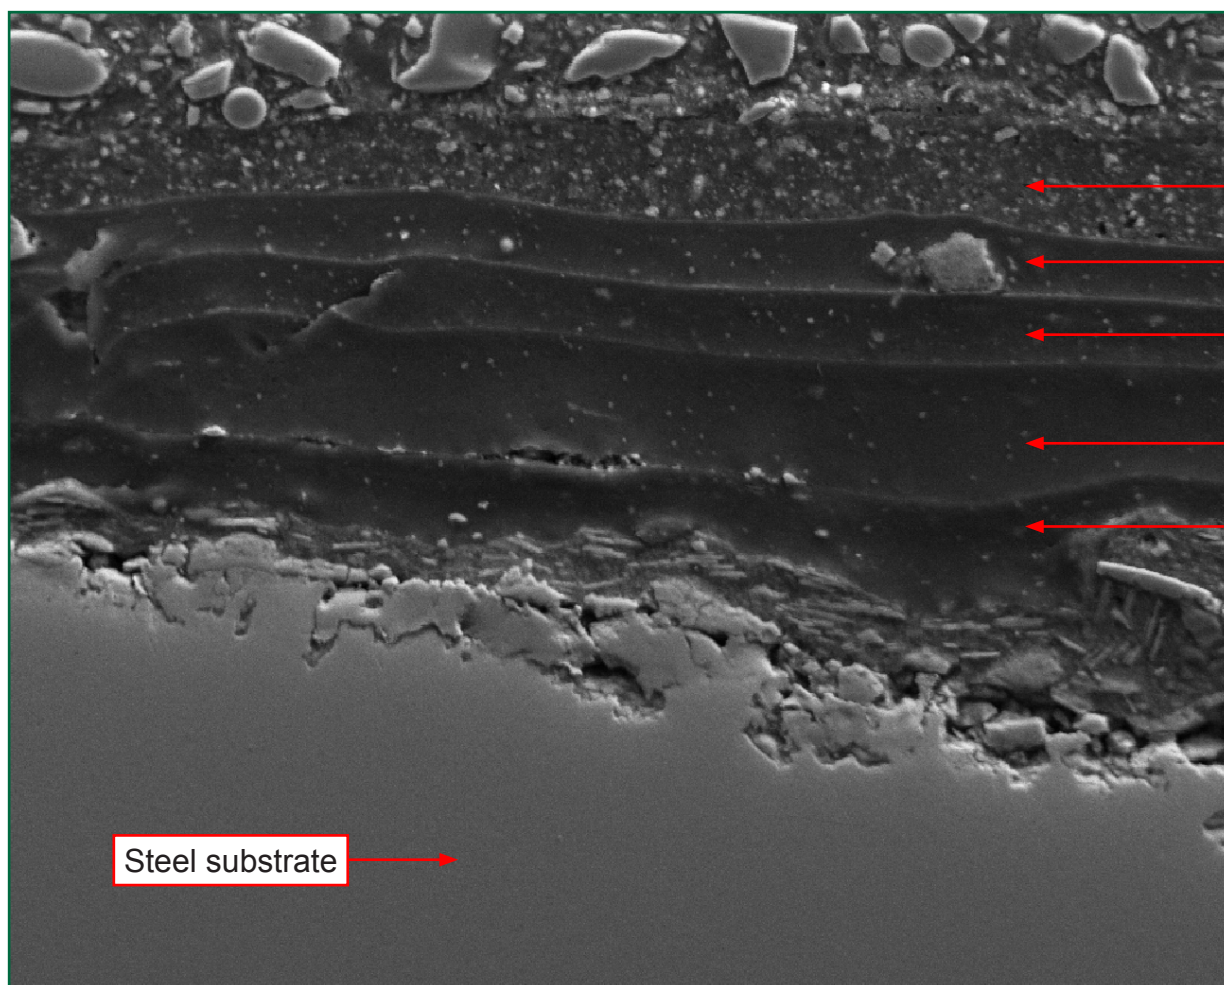
- 45 The external surface had a five-layer organic coating system (see Figure 10), although no zinc galvanised coating was detected. The coating was almost certainly designed to prevent atmospheric corrosion. There was little evidence of any remaining coating on the external surface of the affected region.

Figure 10: SEM micrograph showing cross-section through the signal post illustrating the five layers of the external coating system

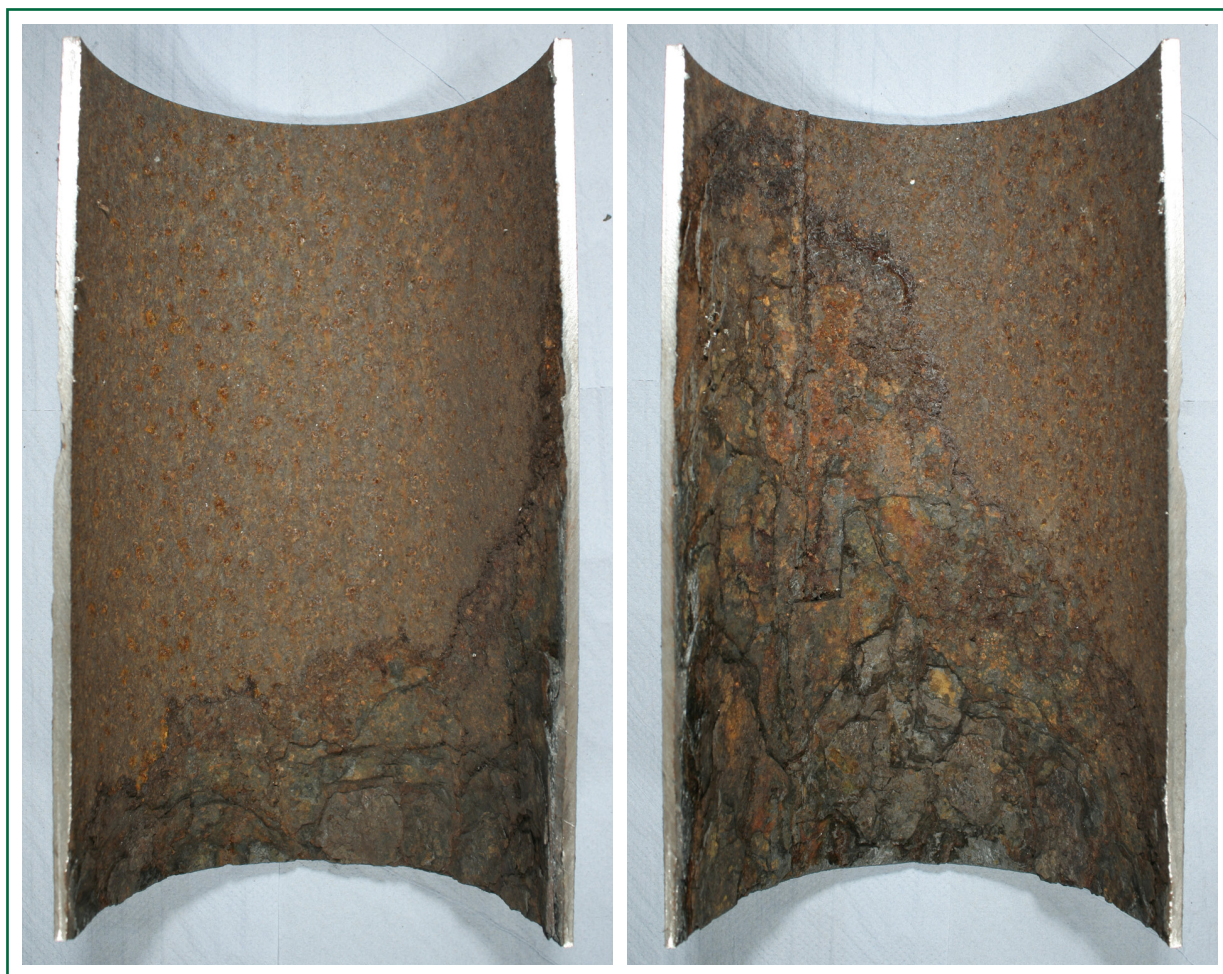
- 48 There was no evidence of any coating on the internal surface, although there was nothing to prevent water getting in (there are several holes in the sides of the post for cable access and there is no cap at the top of the post where the signal head is attached). Corrosion scales (ie rust flakes) were unevenly distributed around the interior of the post, varying from 70 mm to 400 mm above the failure, while metal loss on the internal surface tapered up to around the same point (Figure 11).

- 49 By design, there is no drainage at the bottom of the post where it interfaces with the concrete foundation. It is therefore likely that the internal corrosion occurred due to continual exposure to stagnant rainwater which had entered through the cable holes and the top of the post, and had pooled inside the base. Upon inspection after the accident, the base was full of rust flakes, which would have further impaired the ability of the water to escape.

Figure 11: Internal corrosion of post

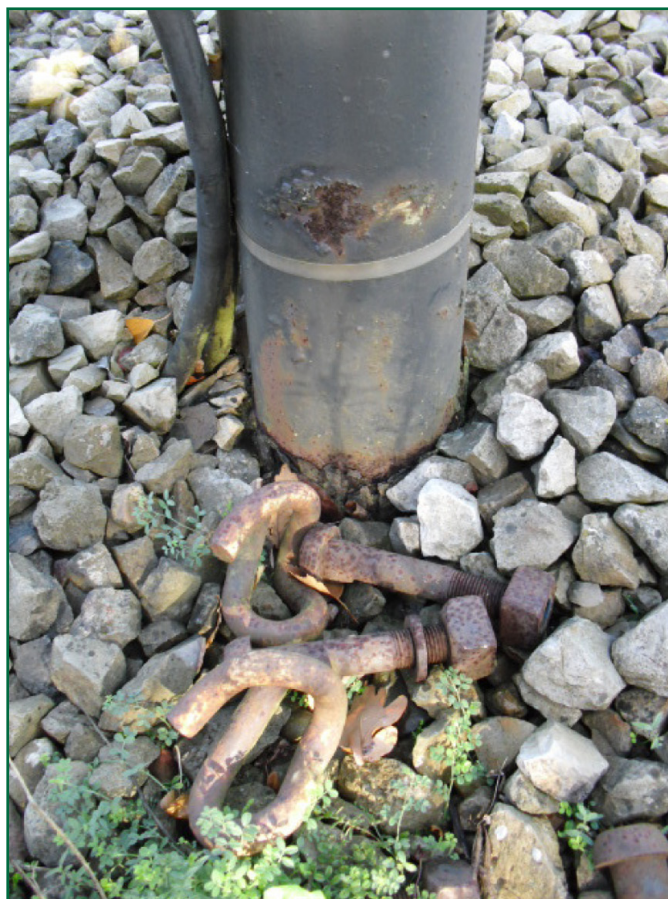
- 62 Arup employed a ‘Link-up’³ approved and competent sub-contractor to conduct its site examinations. Its examiners gave the post of signal TR824 a yellow risk rating (meaning ‘reuse suitable with minor repair works to structure’) for corrosion and for the ladder, and a green risk rating (‘suitable for reuse in existing form’) for paint condition. Upon later review of the report and its associated photographs, Arup decided that the problems appeared more severe, and so changed the ratings for the paint condition and for the ladder to red (‘reuse not recommended on existing structure; recommend renewal’). However, these ratings did not get transferred to a summary table in Arup’s report. Since the summary table was used by Network Rail as the basis for prioritising further actions, it was the less severe ratings that were used to determine whether actions were completed or deferred in the later stages of the project.

- 63 Arup's report noted areas of corrosion to the post and to the ladder, particularly the foot of the ladder which was badly corroded. It also noted that the paint had begun to deteriorate badly at the bottom of the post, but that the base plate and foundations were not inspected because they were buried by ballast (see Figure 13) and were consequently outside of Arup's contractual remit. The report concluded that signal TR824 was serviceable for a further 15 years subject to the paintwork being renewed and the access ladder being replaced.

Figure 13: Photograph from Arup's RORI examinations report showing the base of signal TR824

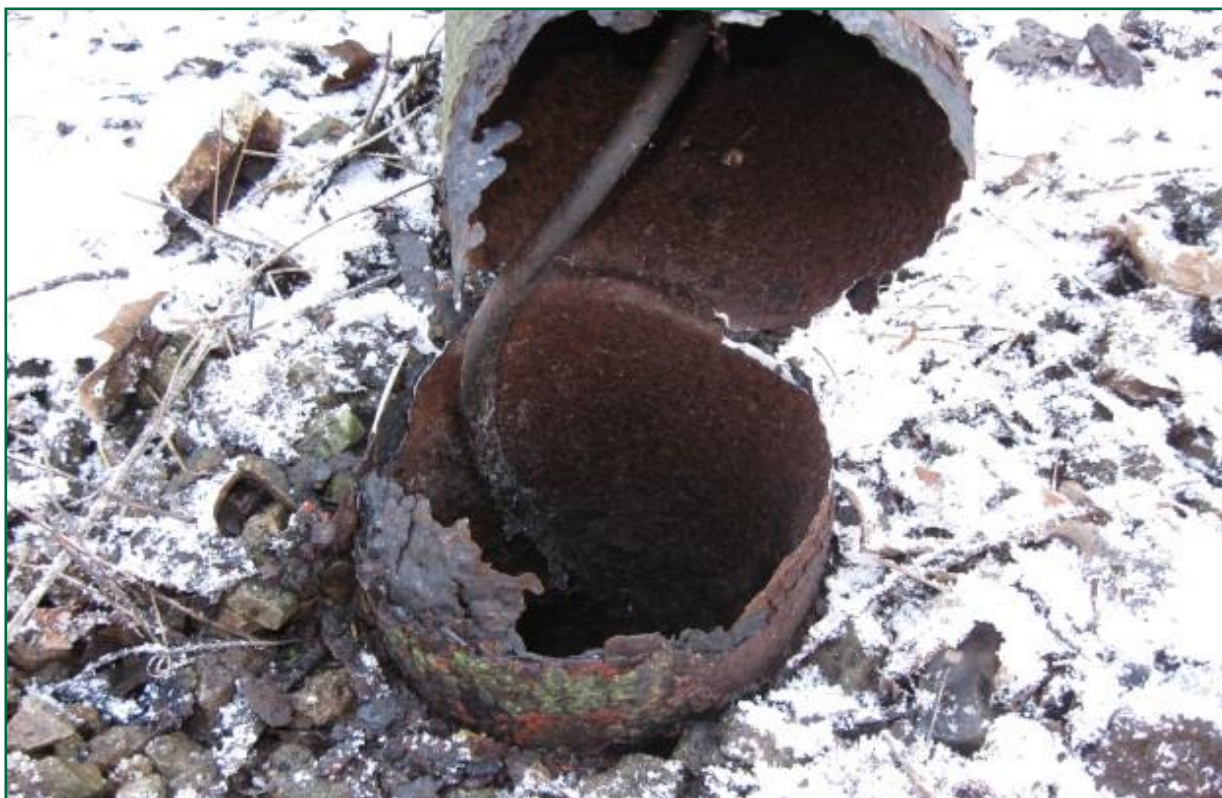
- b. Wymondham (Anglia), 2010: a mechanical signal, approximately 80 years old, was felled on safety grounds due to corrosion at the base of the post (see Figure 14);

Figure 14: Photograph of the failed signal post at Wymondham (courtesy of Network Rail)

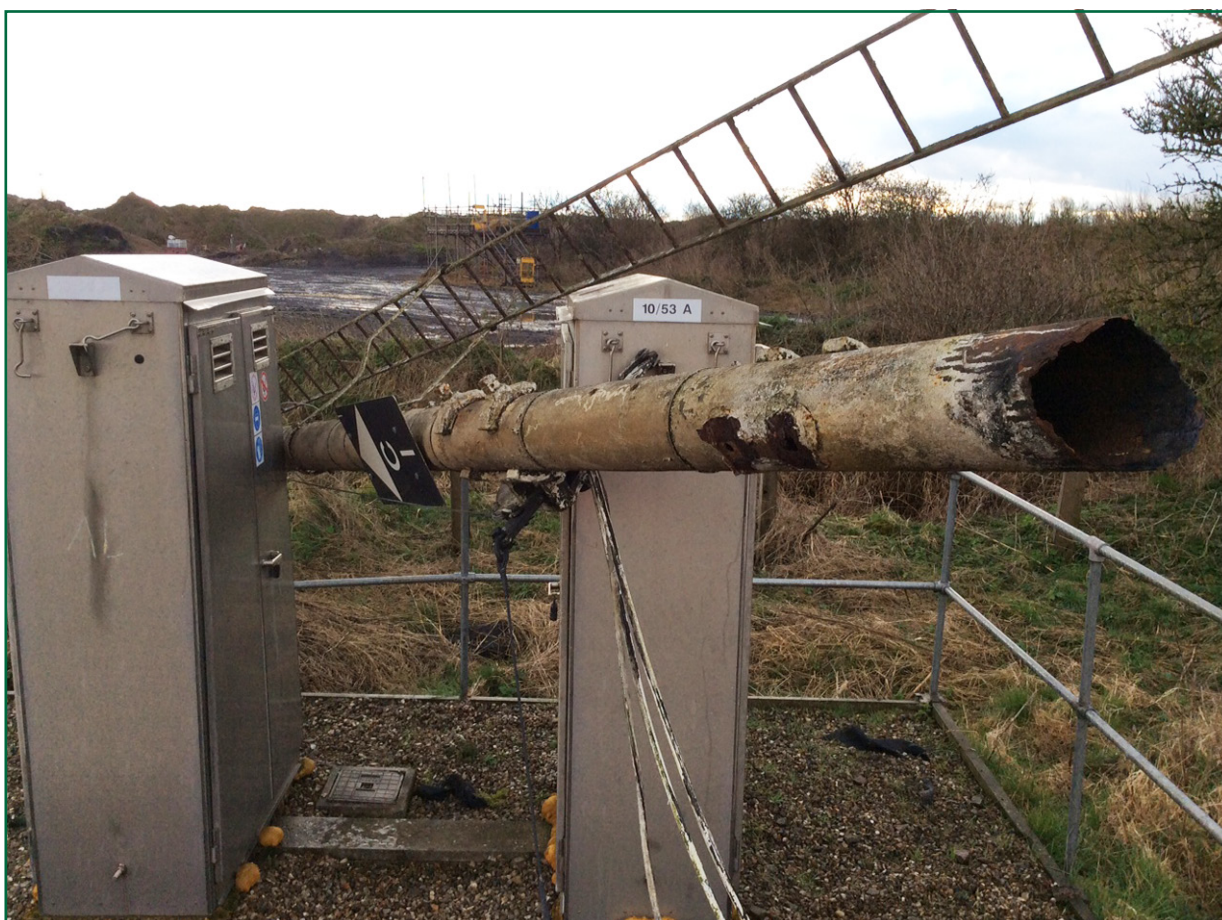
- e. Cantley (Anglia), 29 March 2015: semaphore signal (C1), a *planted post*, collapsed away from the railway due to corrosion at the base just below ballast level (see Figure 15).

Figure 15: Photograph of the failed signal post at Cantley (courtesy of Network Rail)

- 93 Following the incident at Cantley, Network Rail stated that signal posts on the Anglia route were due for renewal and had been under monitoring. In response to the failure of the structure, Network Rail's Anglia route has accelerated its follow-up actions (also taking account of the Newbury accident) and planned to complete enhanced examinations (including removal of ballast from around the base) on all of its signal posts by the end of June 2015. At the time of writing, this work was still in progress but had already identified several signal posts in need of urgent remedial action.
