Rail Accident Report

Collision between two road-rail vehicles at Cholmondeston, Cheshire 19 September 2018

Report 08/2019
July 2019

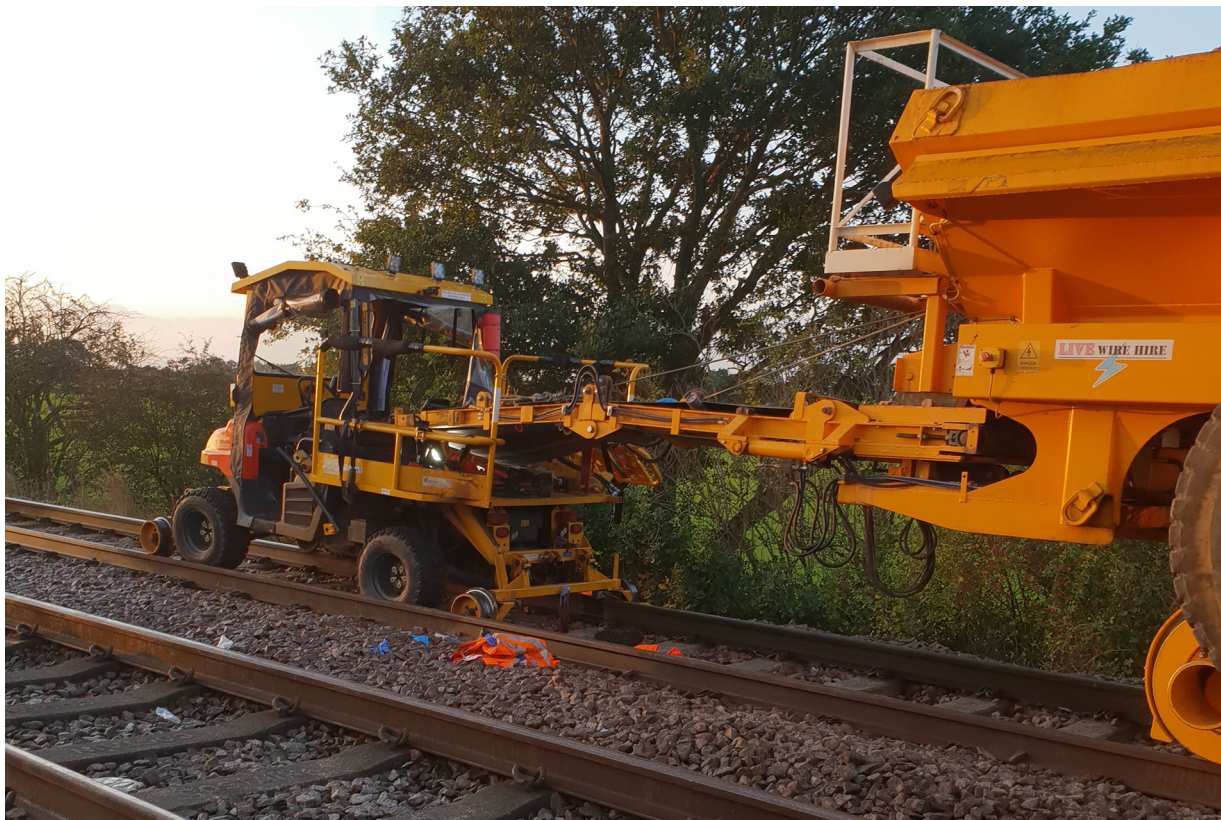
Figure 7: The position of the two vehicles after the collision

- 43 The kubota's machine operator also recognised that the ballast distributor was not slowing down and got into the driving seat to attempt to move it forwards to prevent a collision. The kubota's engine was already running and the machine operator started moving the kubota forwards, but he was unable to prevent the collision from occurring (figure 7).

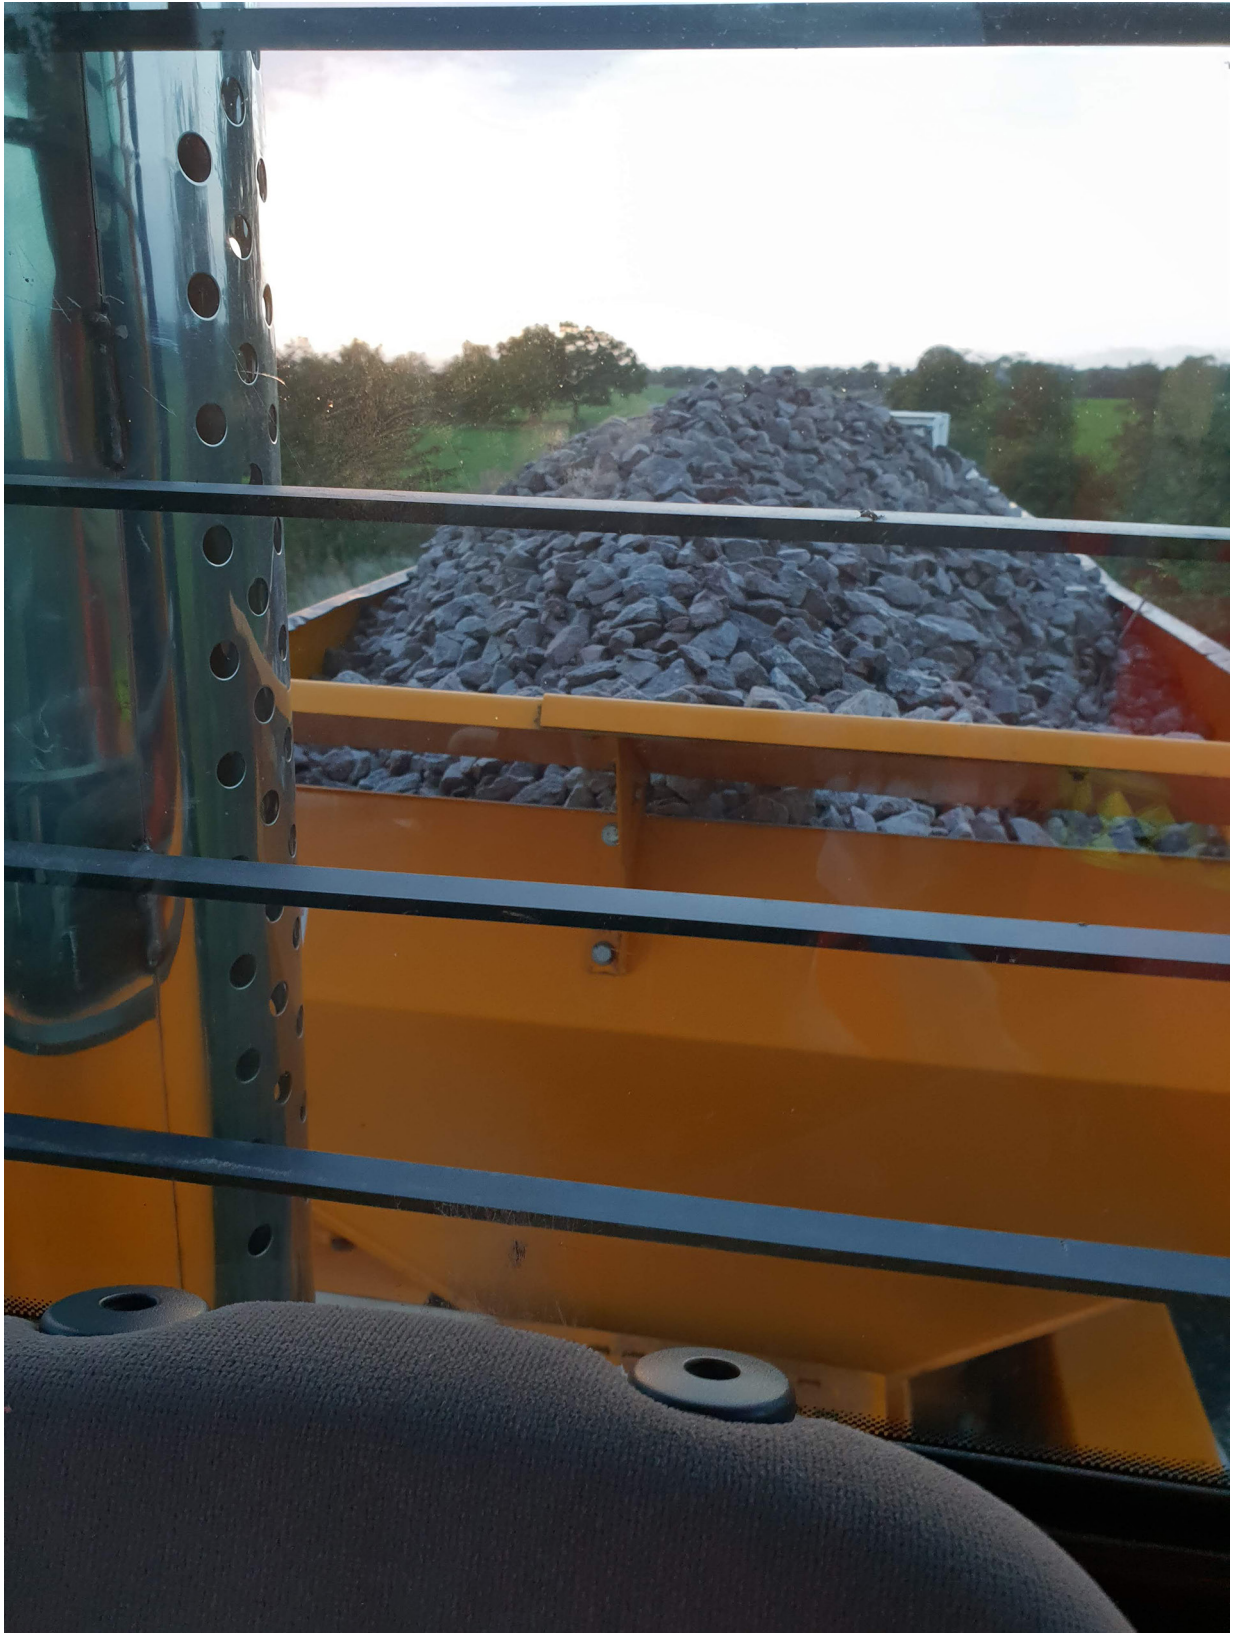
Figure 8: Rear visibility from the driver's cab (as found after the collision)

- 59 The ballast distributor was originally a unidirectional road machine that was converted for bidirectional use on the railway. However, no modifications were made to the cab to improve rear visibility as part of that conversion. This was despite use on the railway requiring routine travel in both directions. The driver's seat and the second person's seat are both fixed facing forward and are positioned at a height that means the view to the rear is obscured by the hopper and any load (figure 8). The need for the driver to operate foot pedals when travelling also limits his ability to turn round to attempt to look towards the direction of travel when reversing.

- 60 Although the ballast distributor is fitted with external rear view wing mirrors, these are not intended to be used to see the line ahead when travelling backwards in rail mode. Handbook 15 of the railway Rule Book (GERT8000 HB15 'Duties of the machine controller and on-track plant operator') states that 'the OTP operator must always have a clear view of the line ahead' and that 'mirrors cannot be used for this purpose'.

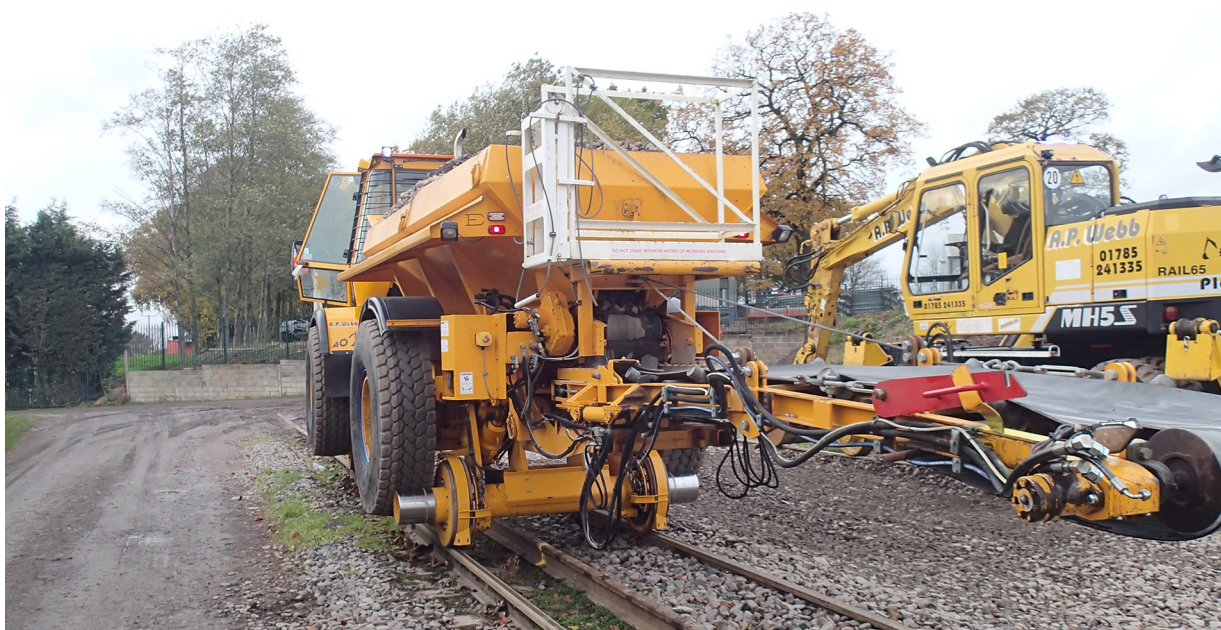
Figure 9: Rear platform on the ballast distributor

- Provision of staff on the ground to control reverse movements.
- 64 Although the ballast distributor has a platform at the rear (figure 9), this was intended to allow personnel access to view the hopper contents. It was not intended for use while moving and was not fitted with any controls or seating.

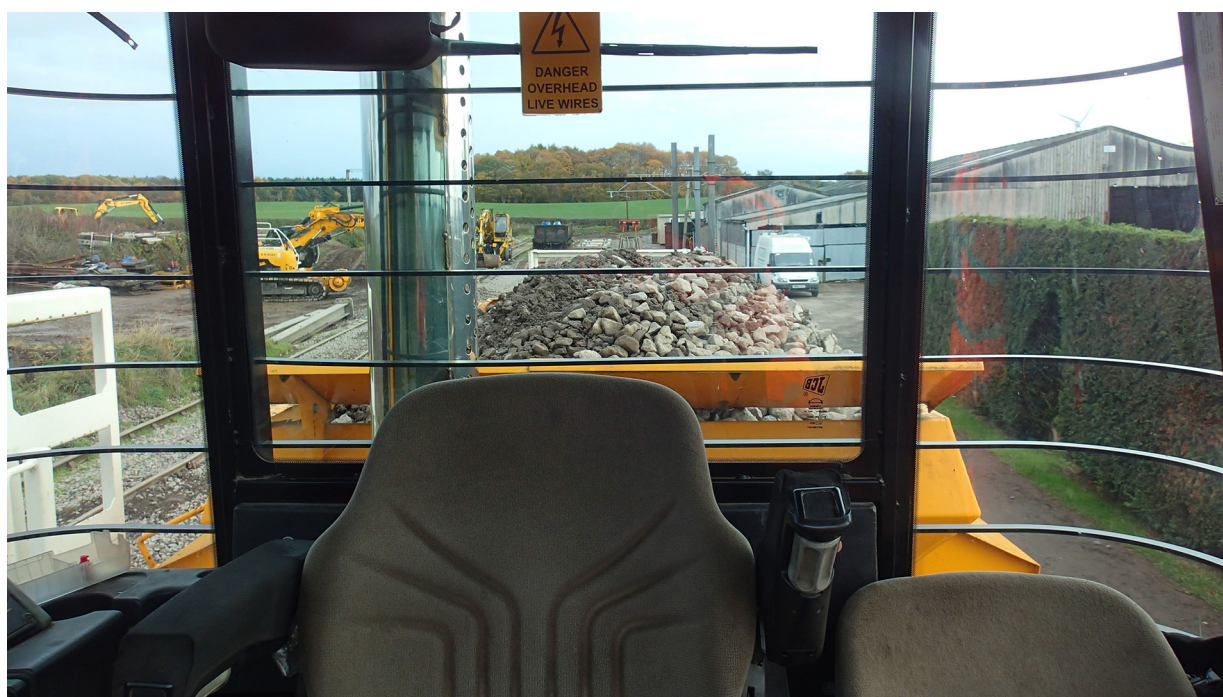
Figure 10: Driver's and second person's seats in the ballast distributor cab

- 83 The presence of a dedicated second seat in the cab (figure 10) is likely to influence the behaviour of machine controllers when travelling. Because it is permitted for machine controllers to ride in the cab when traveling forwards, the convenience and relative comfort, compared to walking alongside the machine, might have led them to lose sight of the ECC and Rule Book limitations in the reverse direction, contributing to riding in the cab becoming the accepted norm.
