Rail Accident Report

**Overspeed at Sandy South Junction,
Bedfordshire
19 October 2018**

Report 10/2019
August 2019

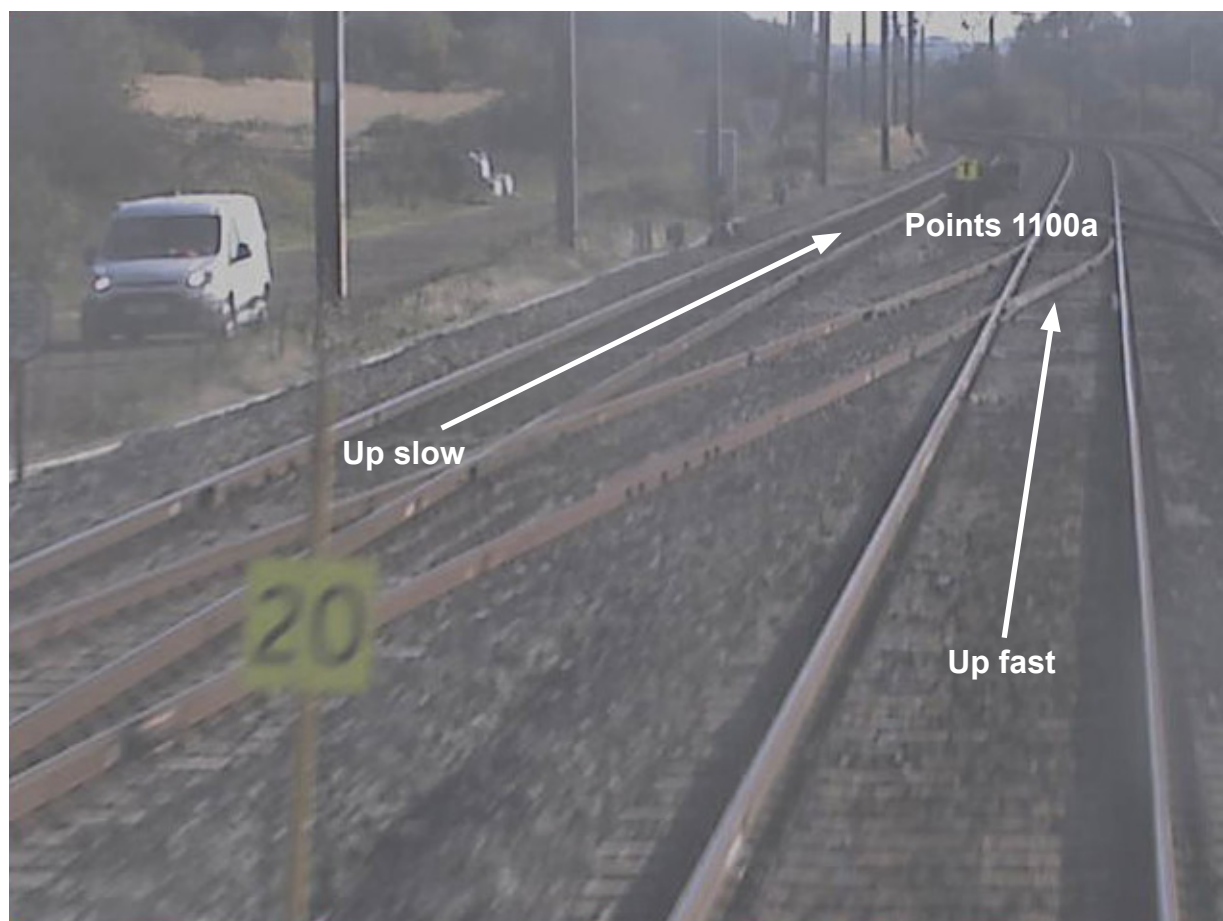
Figure 2: Forward facing closed-circuit television view of points 1100A and its associated crossing on the East Coast Main Line at Sandy South Junction annotated to show key features (image courtesy of LNER)

- 23 On 18 October 2018 at around 10:00 hrs, a Network Rail patroller carrying out a basic visual inspection of the track identified a crack estimated to measure 60 mm long in the crossing of 1100A points at Sandy South Junction.

- 24 Network Rail's maintenance delivery unit sent out a team to implement a 40/70² mph speed restriction, in accordance with the Network Rail company standard governing such situations. Around 13:30 hrs a member of this team measured the crack at 85 mm in length.

- 25 Due to the length of the crack, the 40/70 mph emergency speed restriction was no longer appropriate and, in accordance with Network Rail standard, NR/L2/TRK/1054, a 20 mph (32 km/h) emergency speed restriction was imposed. Hourly line blockages were also imposed to enable an inspection of the crack, and a watchman was appointed to keep a watch on the crossing and the trains traversing the points.

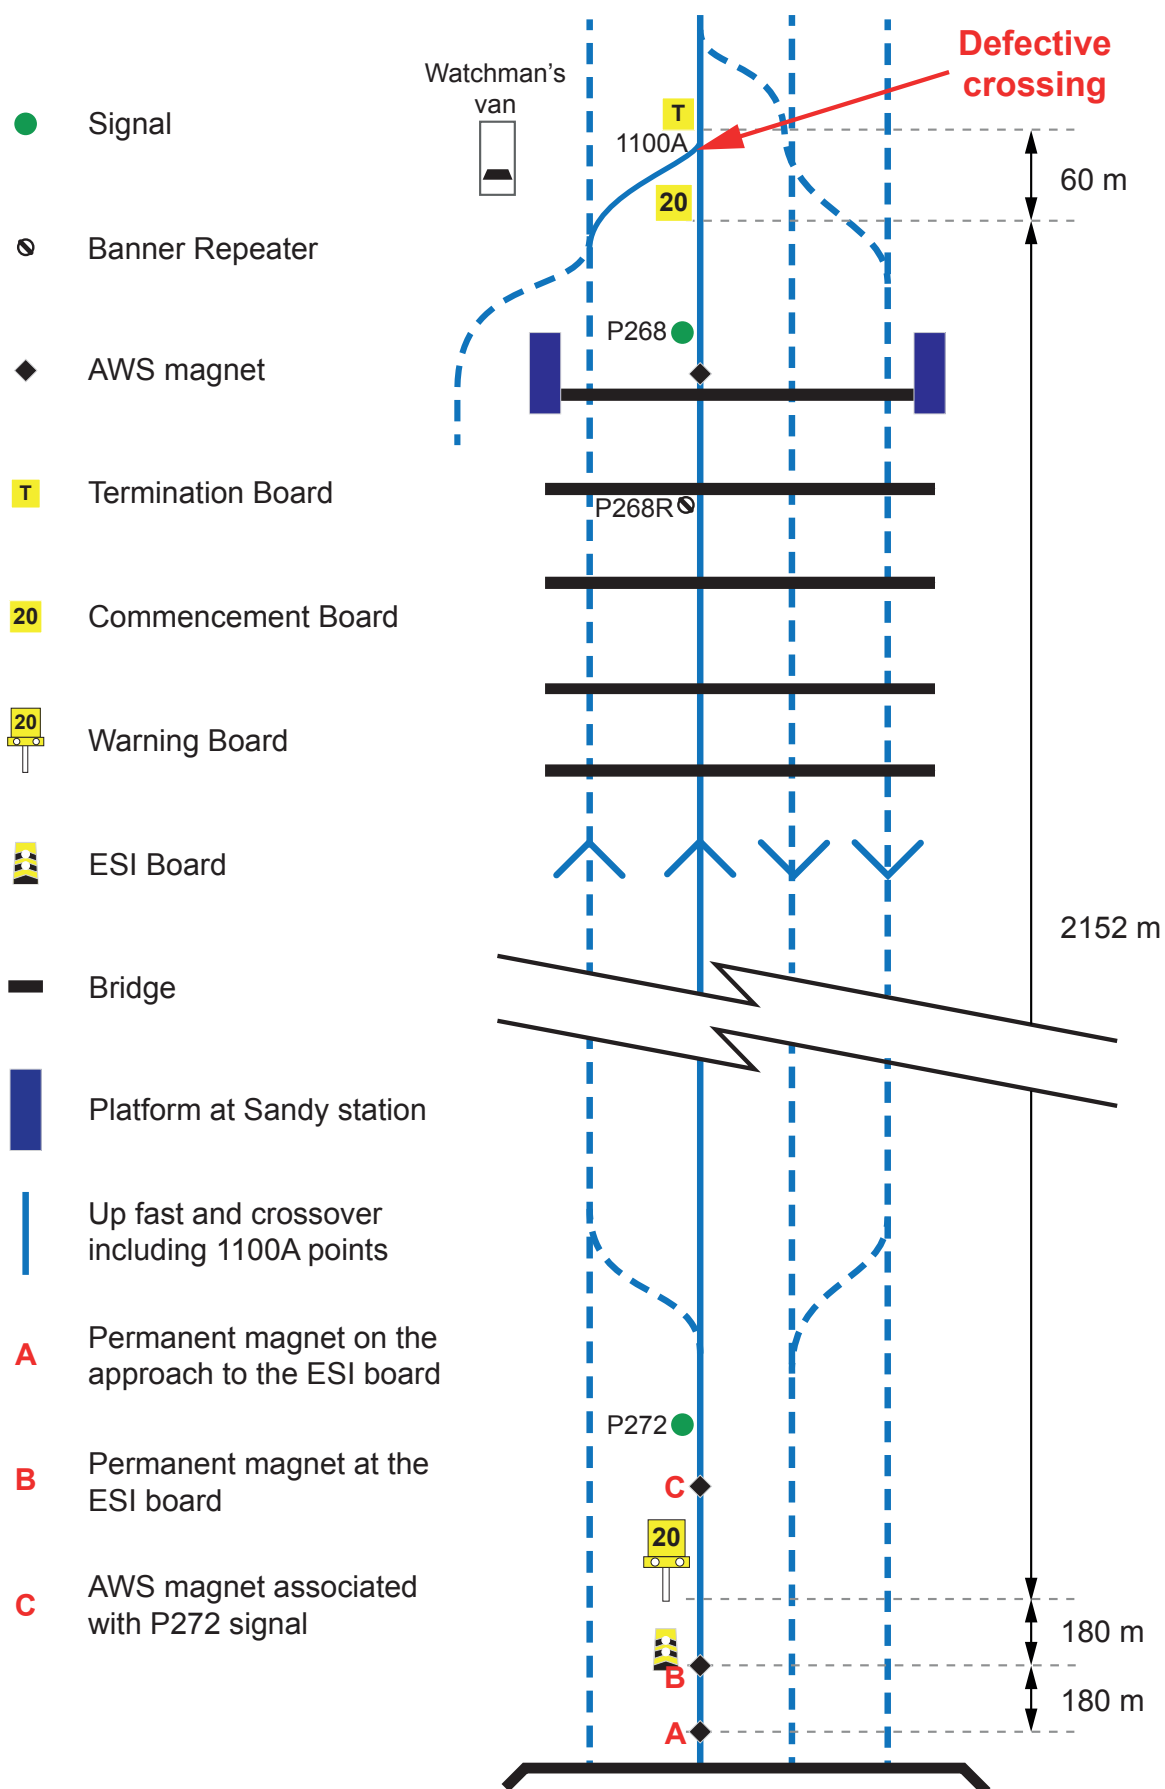
- 15 Emergency speed restriction lineside equipment (figure 5) consists of an AWS permanent magnet, which is intended to alert the train driver to the presence of an emergency speed indicator (ESI) board (figure 6), which is approximately 180 metres further along the track. A second AWS magnet is placed alongside the ESI board, and this is intended to alert the driver to look for the the warning board which describes the speed restriction ahead. The driver must control the speed of the train to the indicated value by the time it reaches the commencement board, which is placed at the point where the restriction begins.

- 16 The speed warning board is placed a prescribed distance from the commencement board; in this case, the distance was 2.17 km. At the end of the restriction there is a termination board, which in this case was 60 metres beyond the commencement board. The train may return to line speed once the rear of the train has passed the termination board. The position of the emergency speed restriction warning equipment at Sandy was in accordance with Railway Group standard GK/RT0075.

Figure 5: Layout of emergency speed restriction equipment at Sandy (not to scale)

- 26 The team installed emergency speed restriction signage in accordance with railway group standard GK/RT0075. Because of the presence of a signal and its associated AWS magnets, the warning AWS magnets and associated boards for the emergency speed restriction were placed further back along the line than the standard distance, giving an additional 221 metres of deceleration distance for trains before they encountered the restriction.

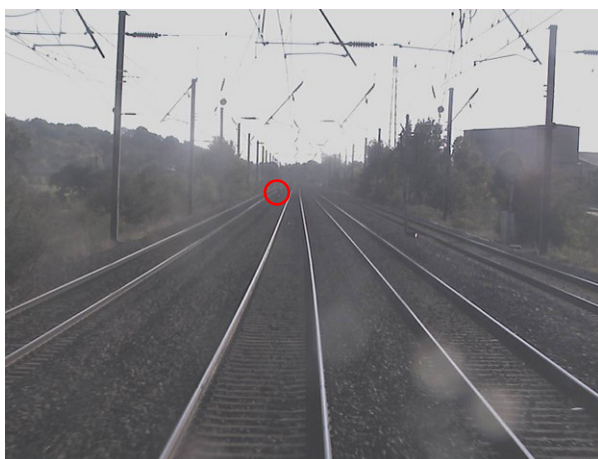
66 The driver stated that he did not see the ESI board. The board would have come into view at a range of around 400 metres, 7 seconds before the train passed it. However, the miniature ESI board is not conspicuous in the forward facing closed circuit television (FFCCTV) footage provided to the RAIB (figures 7a-7d) (see paragraph 69). While the quality of the video recording may not reflect the actual conditions, it is apparent that the sun was shining brightly from behind the ESI board and there was significant shadowing cast over the board by structures and vegetation on the right hand-side of the railway line. There are also some reflections from small unidentifiable items in the space between the up slow and up fast running lines a short distance on the approach to the ESI board, which may have diverted attention from the board itself.

Figure 7a: FFCCTV view of ESI about 5 seconds away from it (image courtesy of LNER)

Figure 7b: FFCCTV view of ESI about 3 seconds away from it (image courtesy of LNER)

Figure 7c: FFCCTV view of ESI about 2 seconds away from it (image courtesy of LNER)

Figure 7d: FFCCTV view of ESI board about a second away from it (image courtesy of LNER)

67 The lights on the board flash with the aim of drawing the driver's attention to the sign. The RAIB conducted some subjective tests with a similar ESI board and found that a slight horizontal rotation of the board made the lights on the board very hard to see, and this could have reduced the conspicuity of the board itself as it made it more difficult to pick the board out from its surroundings.

- 68 Although there is no direct evidence that the board was incorrectly aligned, RAIB found that there is a significant reduction of luminous intensity when the boards are viewed at an angle. This is in line with the requirements of the standard to which the boards are designed (figures 8a and 8b) as it is intended that only the drivers approaching on the line to which the equipment applies should view them as they may cause an unnecessary distraction to drivers on other lines. For free standing units there is no way to accurately align the boards for optimum visibility, and even the type which are held in place using clamps which attach to the rails have no adjustment to take into account any curvature of the line.

- 3 *The intent of this recommendation is to review the design and use of the emergency speed indicator board in order that the flashing lights are clearly visible for as long as possible even when the board is in shadow or bright sunlight.*

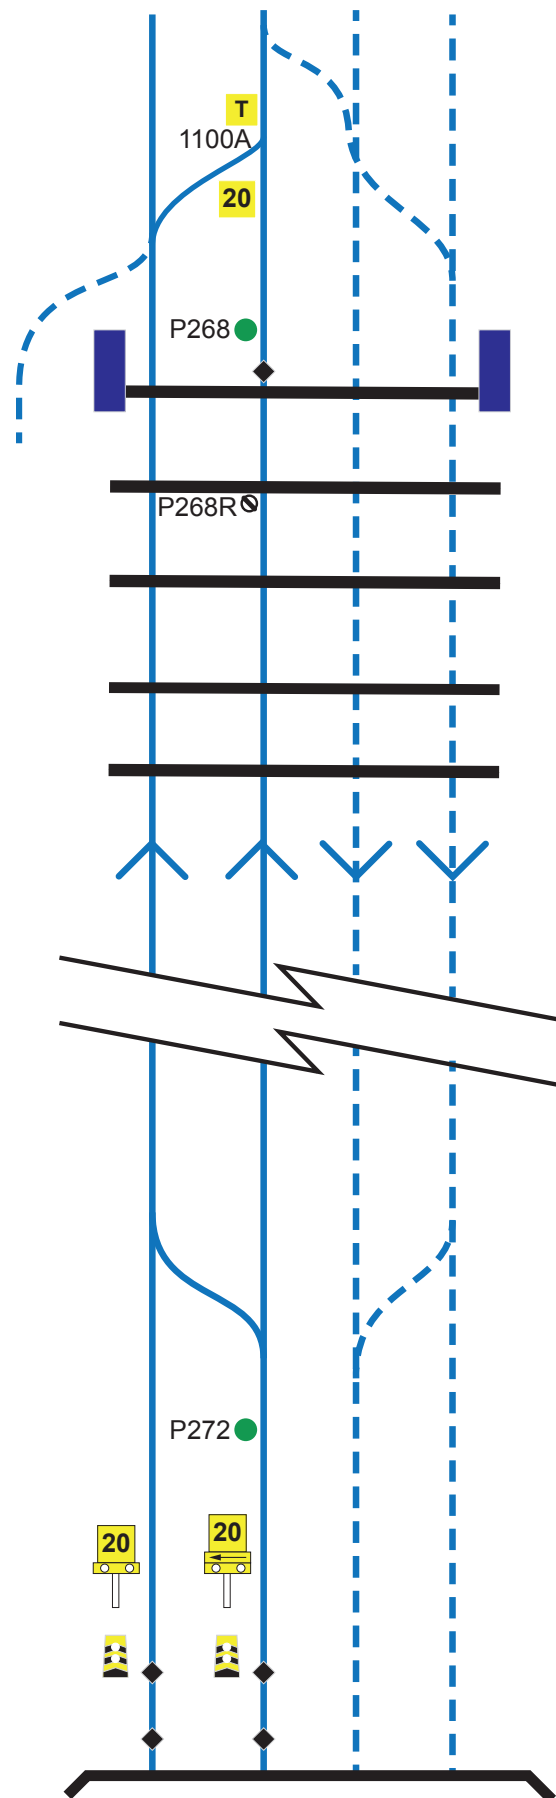
Figure 10: Lineside signage as it would have appeared, had the speed restriction applied in a similar location on the up slow

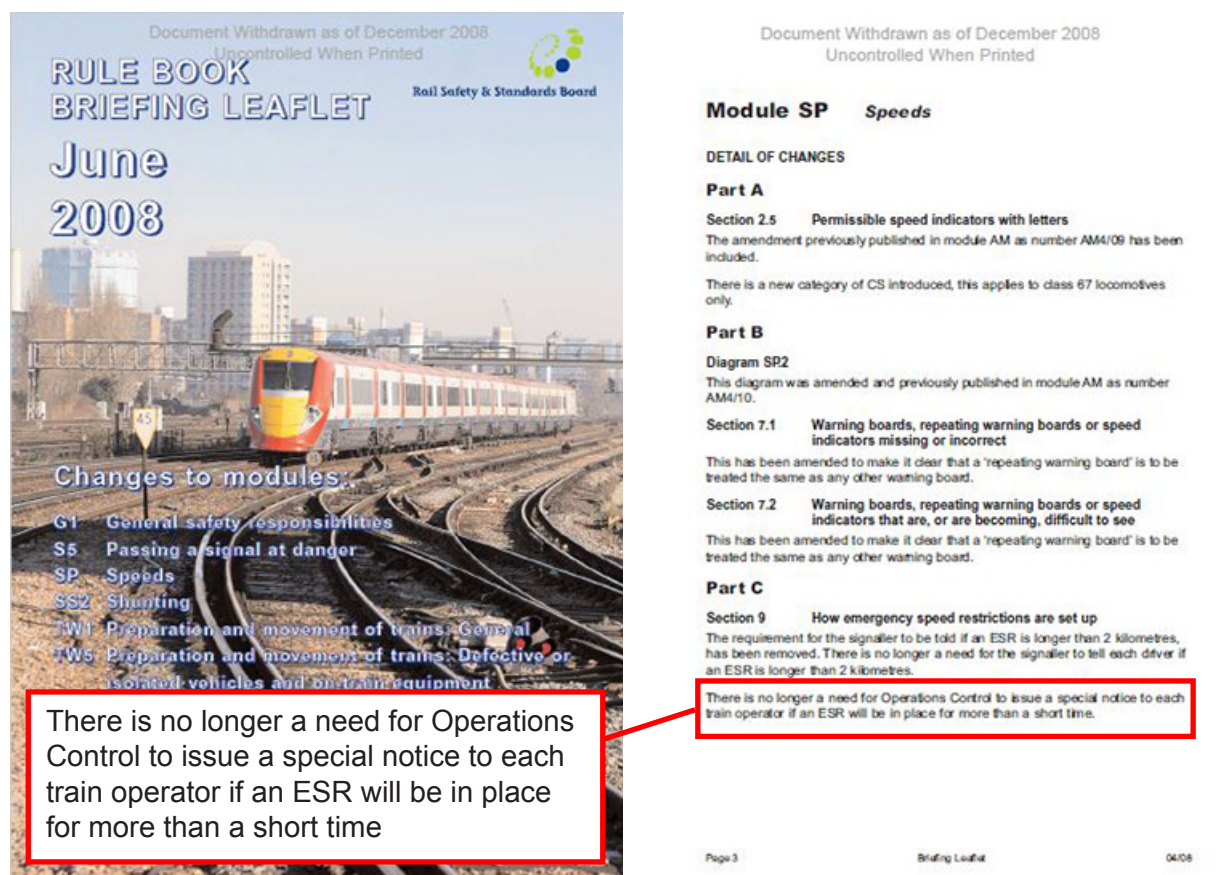
- 90 RSSB produced a leaflet in June 2008 (figure 11) to explain the changes to the rule book for that re-issue.

Figure 11: Extract from the RSSB's Rule book briefing leaflet June 2008

- 5 *The intent of this recommendation is to learn lessons from the 2008 change to the rules relating to emergency speed restrictions and to consider the extent to which these have been addressed by the current processes which are applied by standards committees.*
