Rail Accident Report

Freight train derailment at East Somerset Junction 20 March 2017

Report 19/2017
December 2017

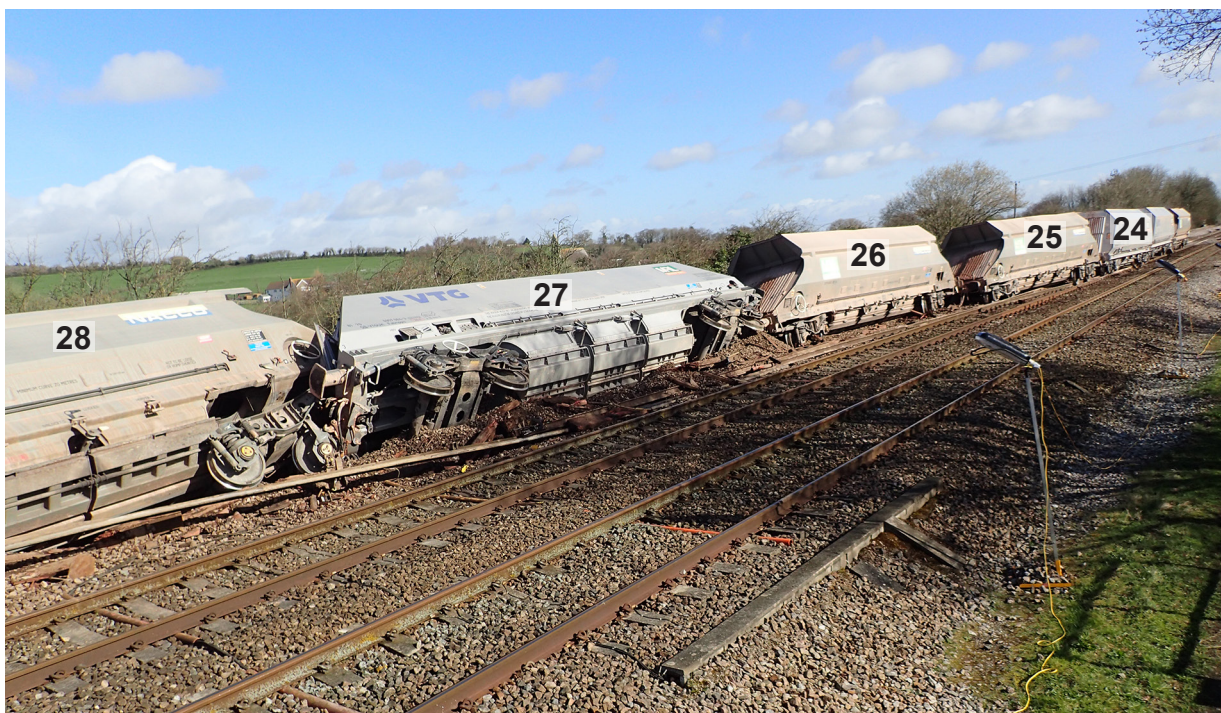
- 5 Six wagons, the 24th to 29th from the front of the train, derailed on the approach to the junction. The 27th and 28th wagons tipped onto their sides (figure 2) and the train divided between the 21st and 22nd wagons. The brakes applied automatically and the front part of the train stopped on the Up Westbury line. There were no injuries.
- 6 Although the Down Westbury line was not directly affected by the derailment, it was blocked to allow the recovery of the wagons and reinstatement of the damaged track. The Up and Down Westbury lines reopened at 23:01 hrs on 24 March, with trains able to access the East Somerset Branch from 04:49 hrs on 25 March.

Figure 2: General view of accident site, showing the numbering of the wagons from the front of the train

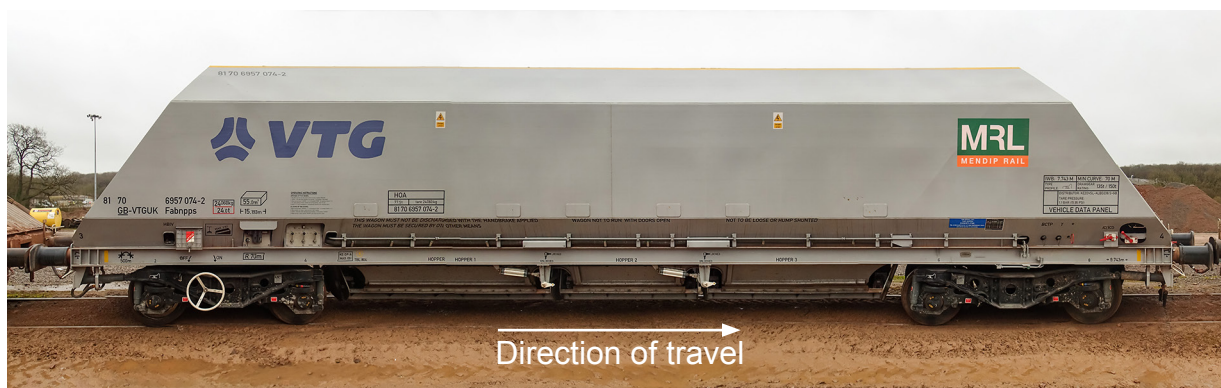
- 16 The first wagon to derail was the 24th from the front of the train; this was a type HOA hopper wagon, no. 706957074-2 (figure 4). The wagon is owned by VTG; it had been manufactured by Astra Rail and was only a few months old at the time of the derailment. It was carrying approximately 77 tonnes of washed sand; weighbridge data from Mendip Rail indicates this was offset so that the load on the left-hand wheels of the leading bogie was 4% higher than the load on the right-hand wheels. This offset is not likely to have been a significant factor in the derailment of the wagon (refer to paragraph 47).

Figure 4: Wagon 706957074-2 (number 24 in train 7Z15) at Merehead Quarry after the derailment

- 17 Subsequent examination of the wagon identified defects consistent with impact damage caused during the derailment:
- the spacing between the wheels on the wagon's leading axle was 4 mm less than when it was assembled (recorded on 4 April 2016), and 3 mm less than the minimum given in Railway Group Standard GM/RT2466, 'Railway Wheelsets';
 - the frame of the leading bogie was twisted by 7.8 mm, compared with 0.9 mm when it was assembled³ (recorded on 29 April 2016); and
 - the frame of the trailing bogie was twisted by 4.1 mm, compared with 0.8 mm when it was assembled (recorded on 28 April 2016).
- 18 The RAIB has found no evidence that the design or condition of the wagon, or the loading or operation of the train, caused or contributed to the accident.

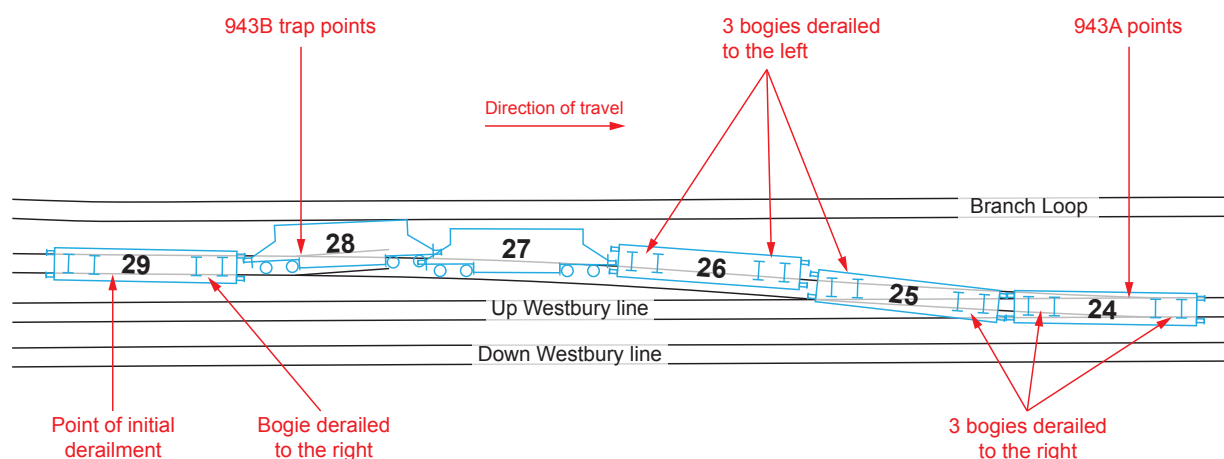
- 30 At around 17:48 hrs, the 24th to 29th wagons derailed as the train passed over the site of the former 945 points, which had connected Witham Sidings to the Link Line; the 27th and 28th wagons turned onto their sides (figure 5). The drag from the derailed wagons caused the coupling between the 21st and 22nd wagons to fail. In turn, this caused the brake pipe to part and the brakes to be applied automatically, stopping the train. The derailed wagons had travelled 79 metres before coming to rest.

Figure 5: Overview of accident site, showing final resting point of derailed wagons

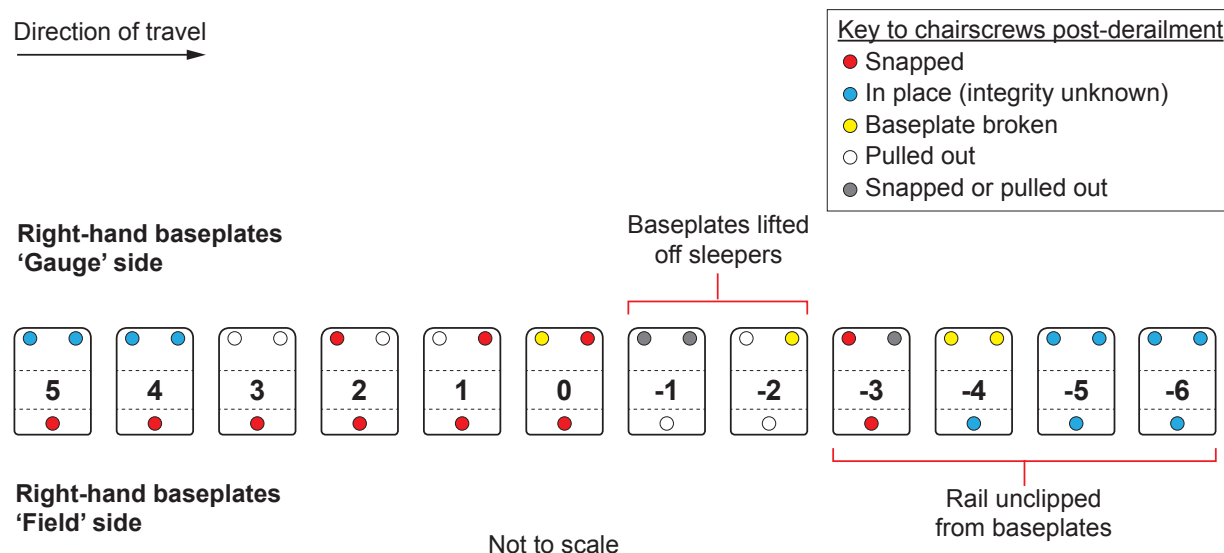
- 39 Examination of the track components after the derailment on 20 March 2017, revealed that *chairscrews* on the right-hand rail had failed to secure the rail, either because they had snapped or because they had been pulled out of their timber *bearers* (figure 6).

Figure 6: Right-hand baseplate fixings post-derailment

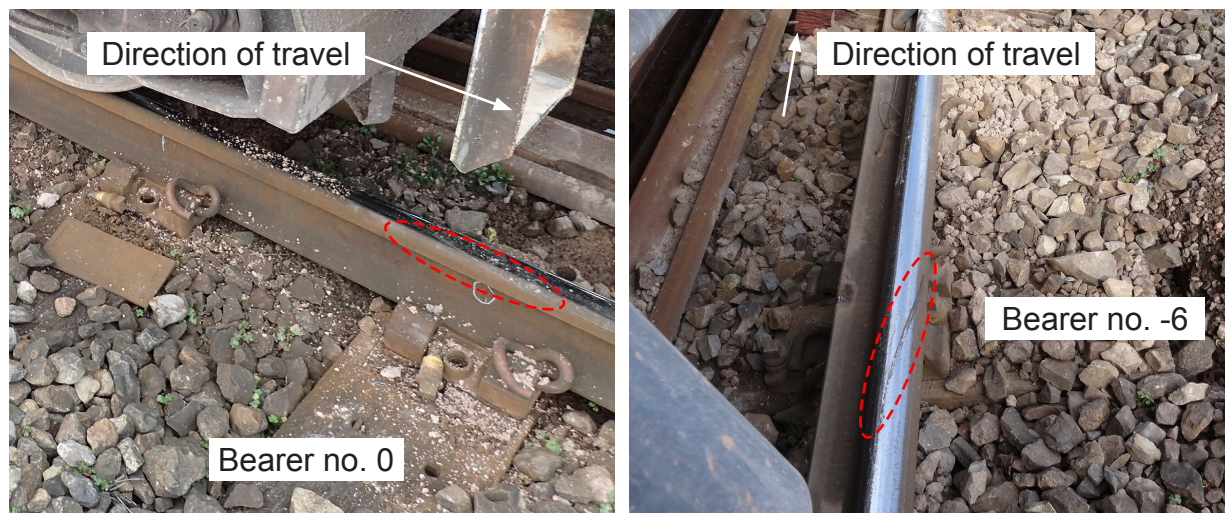
- 40 The bearers were numbered by the site investigation team: bearer no. 0 coincided with a short *flange mark* where the right-hand wheel flange had crossed from the *gauge side* of the rail to the *field side* (figure 7). The left-hand baseplate was also broken at bearer no. 0. Another short flange mark was present close to bearer no. -6, approximately four metres beyond bearer no. 0.

Figure 7: Flange marks on right-hand rail head at bearer nos. 0 and -6

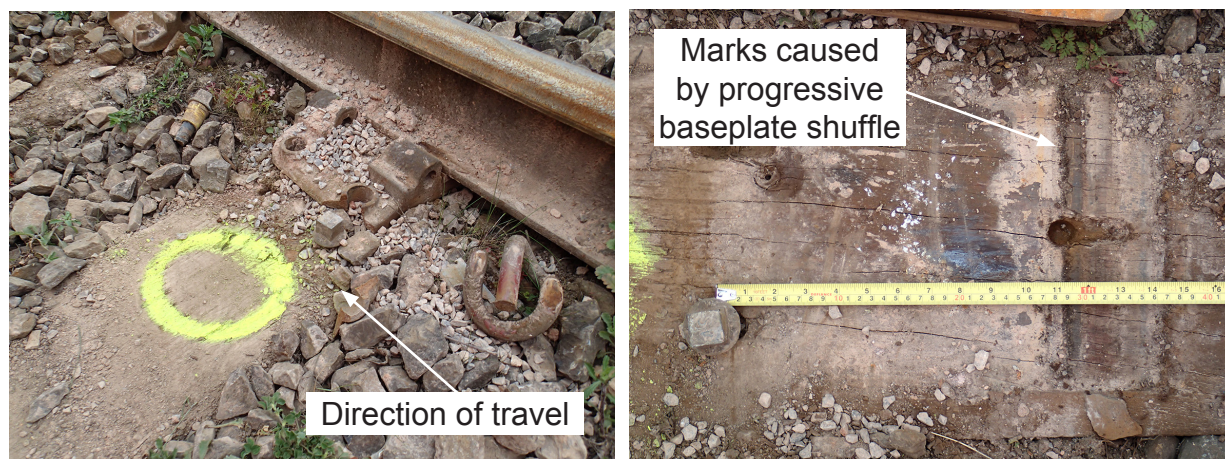
Figure 8: Views before and after removal of right-hand baseplate at bearer no. 0

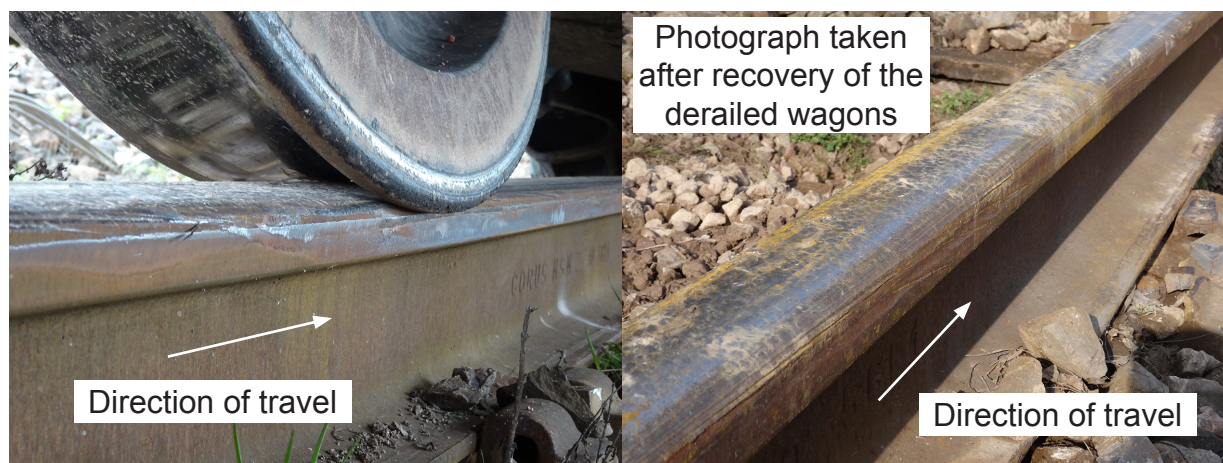
- 42 Witness marks from wheel flanges riding along the gauge corner of the right-hand rail were found at bearer no. -2. Multiple marks from the wheels of the derailed wagons dropping into the *four foot* were present on the left-hand rail in the vicinity of bearer nos. -2 and -4 (figure 9).

Figure 9: Drop-in marks on the gauge corner of the left-hand rail at bearer nos. -2 and -4 (courtesy Network Rail)

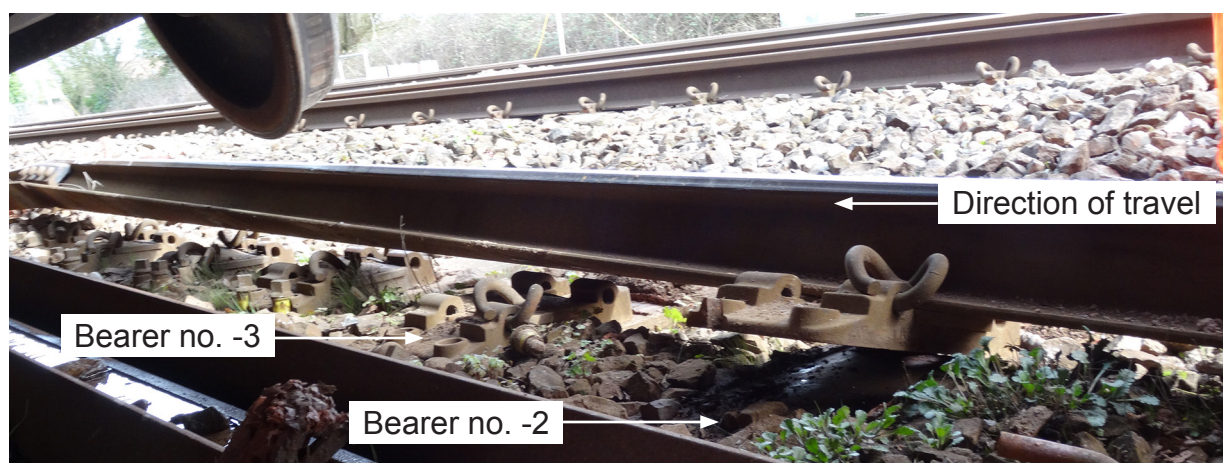
- 43 The right-hand baseplates at bearer nos. 3 through to -2 had lifted and pivoted around the edge on the field side of the rail. From bearer no. -3 onwards the rail had become unclipped from the baseplates, which remained in place on the bearers (figure 10).

Figure 10: View showing outwards rotation of the right-hand rail

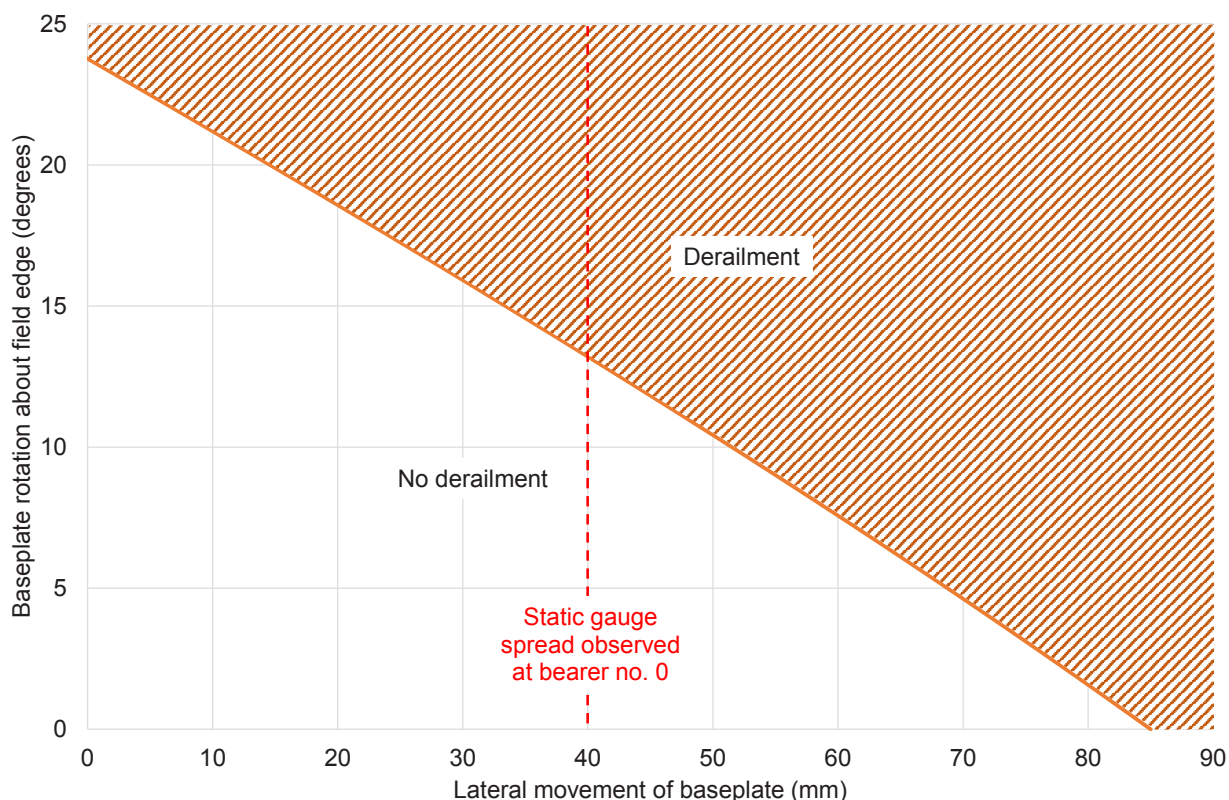
- 44 Although it is not possible to be certain about the exact sequence, the RAIB has concluded that the derailment was probably initiated when the leading left-hand wheel of the 24th wagon dropped into the four foot close to bearer no. -4 as a result of gauge spread. The forces exerted on the outer (right-hand) rail, in conjunction with its lack of fixity (paragraph 39), caused it to move laterally and also to rotate outwards, pivoting about the field side edge of the baseplates. The derailment occurred once the track gauge had increased to approximately 1520 mm; figure 11 shows the relationship between lateral displacement of the right-hand rail and its outwards rotation at which this threshold is reached.

Figure 11: Conditions required for gauge spread derailment (gauge ≥ 1520 mm)

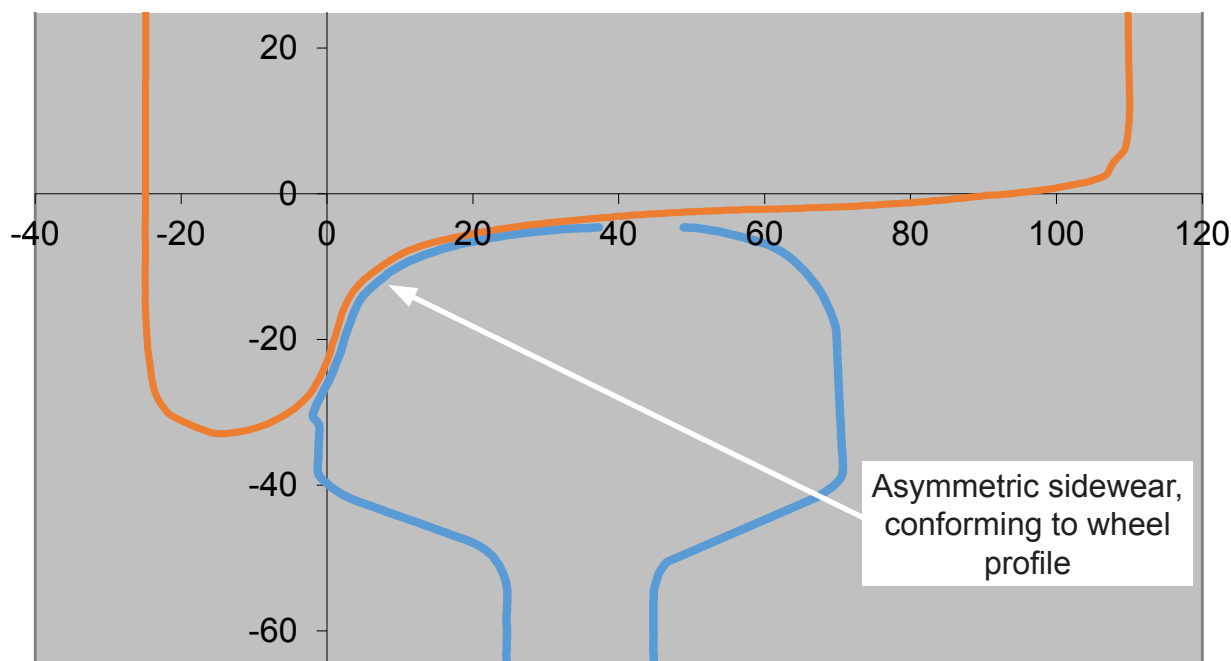
- 58 The failure of chairscrews allowed the outer rail on the curve to move, leading to dynamic gauge spread. This enlarged the clearance between the wheel flange and gauge face allowing an increased 'angle of attack' (the angle of the wheel relative to the rail) of the leading outer wheel on each bogie, and hence the lateral force on the rail, leading to further chairscrew failures and ultimately to the derailment. The *sidewear* that was evident on the outer rail approaching the point of derailment⁸ (figure 12), was consistent with wheels traversing the curve with high lateral contact forces acting between the flange and rail.

Figure 12: Cross-section of right-hand rail head and leading wheel of the 24th wagon at bearer no. 0 (view towards front of train)

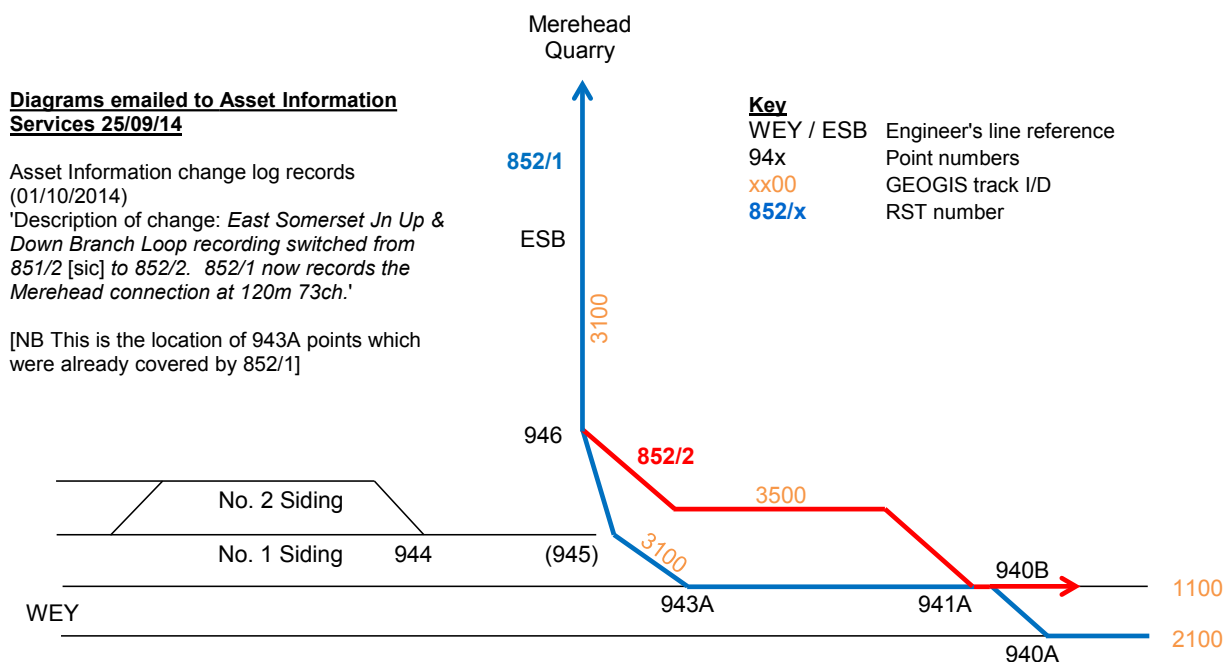
D4 Figure 18 shows the changes requested diagrammatically by the principal technical officer following the meeting at Westbury during August 2014. In practice, the only significant change was to include the crossover from the Down to Up Westbury lines (940 points). The principal technical officer believed the changes to the RSTs were more significant than the diagrams show: he believed the Link Line was not previously included (paragraph 68), possibly because of the incorrect track I/D in RST 852/1. On receipt of the principal technical officer's diagram, AIS translated the change into text and recorded it in their change log, incorrectly transposing the RSTs.

Figure 18: East Somerset Branch RSTs as requested by the PTO September 2014

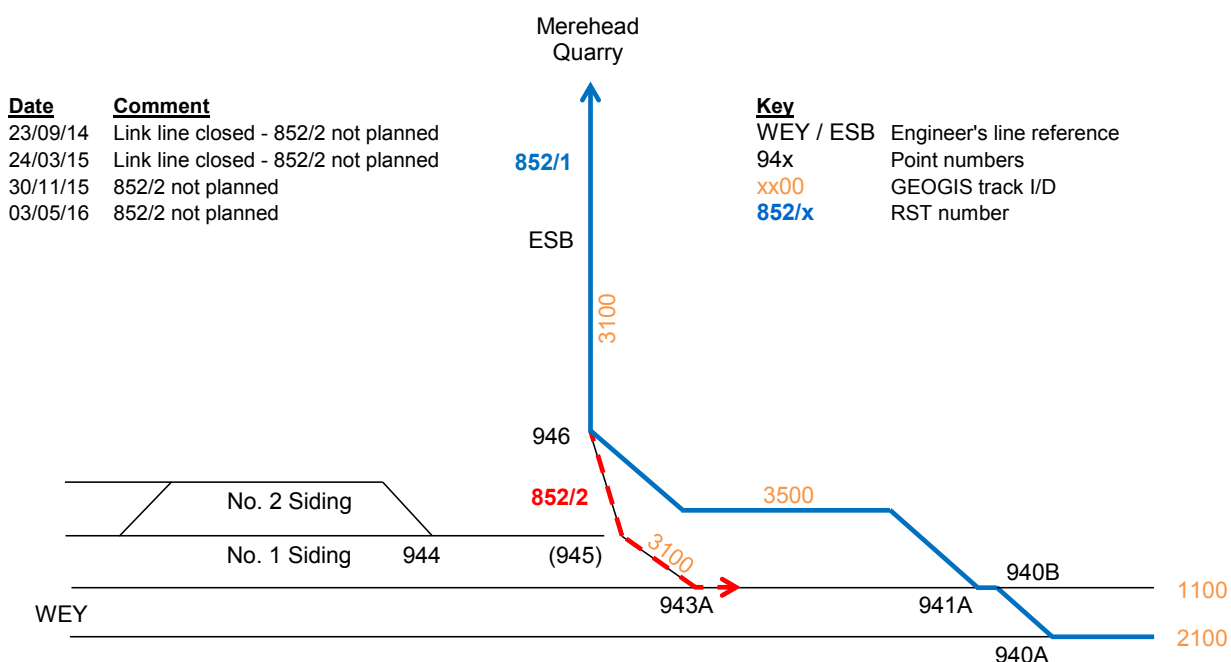
D5 Figure 19 shows the RSTs as amended by AIS in September 2014; these do not reflect the change log record as shown in figure 18 (the Link Line was now covered by RST 852/2 not 852/1).

Figure 19: East Somerset Branch RSTs as at March 2017
