Rail Accident Report

**Near miss between a train and a track worker at
Peterborough
20 July 2018**

Report 04/2019
June 2019

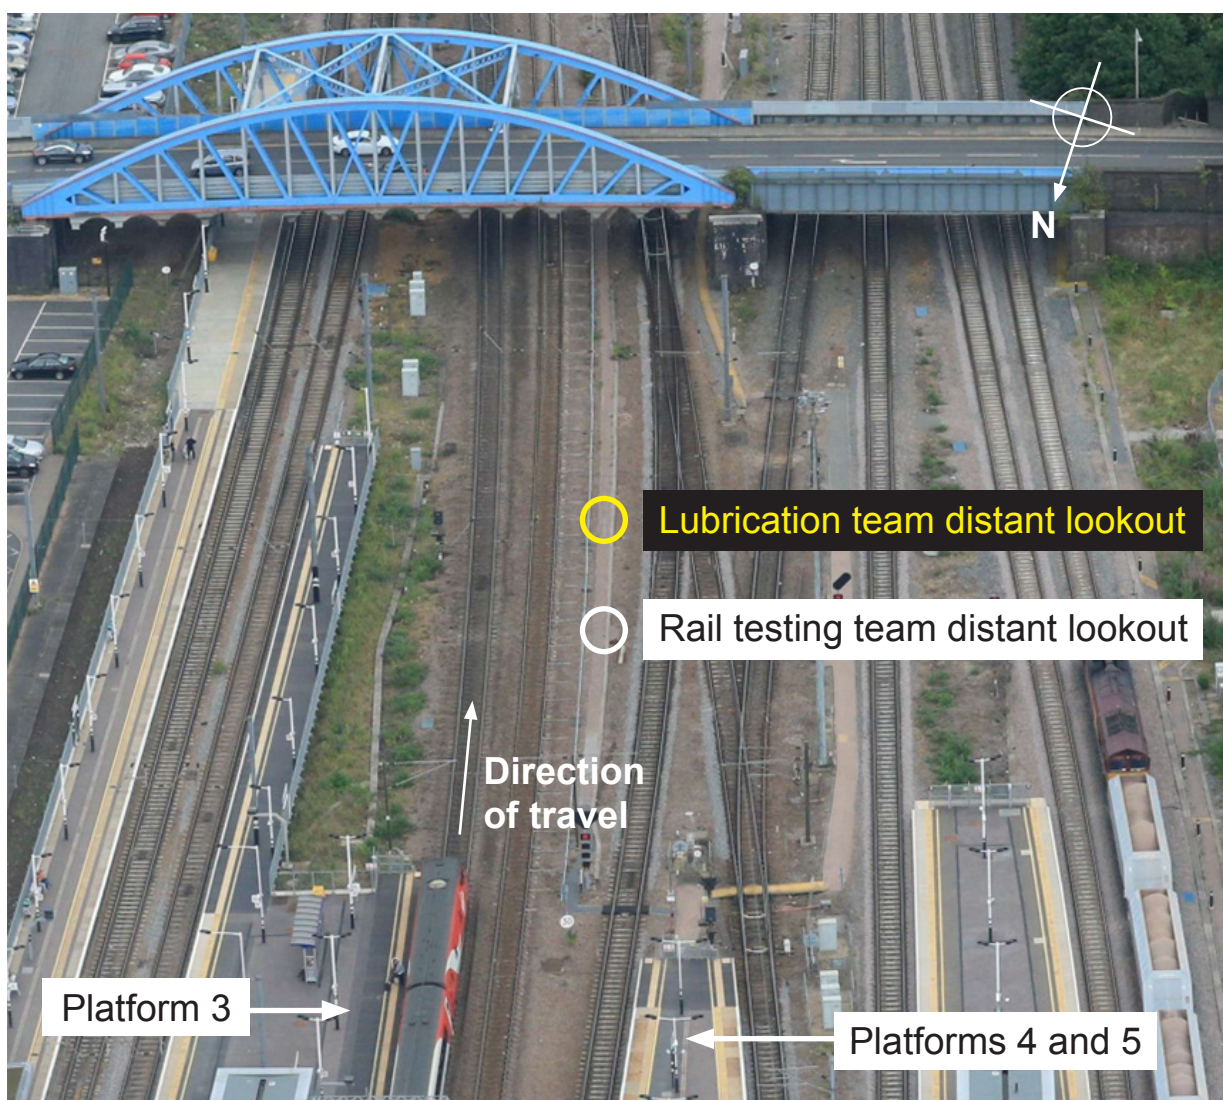
Figure 6: The locations of the distant lookouts

- 26 When track worker B arrived at the end of platforms 4 and 5, he found another distant lookout was already standing where he planned to look out from. This was a distant lookout for a rail testing team, though he was not looking out at the time as his team had just moved to work to the north of the station. Track worker B positioned himself about 10 metres to the south of the other distant lookout (figure 6).

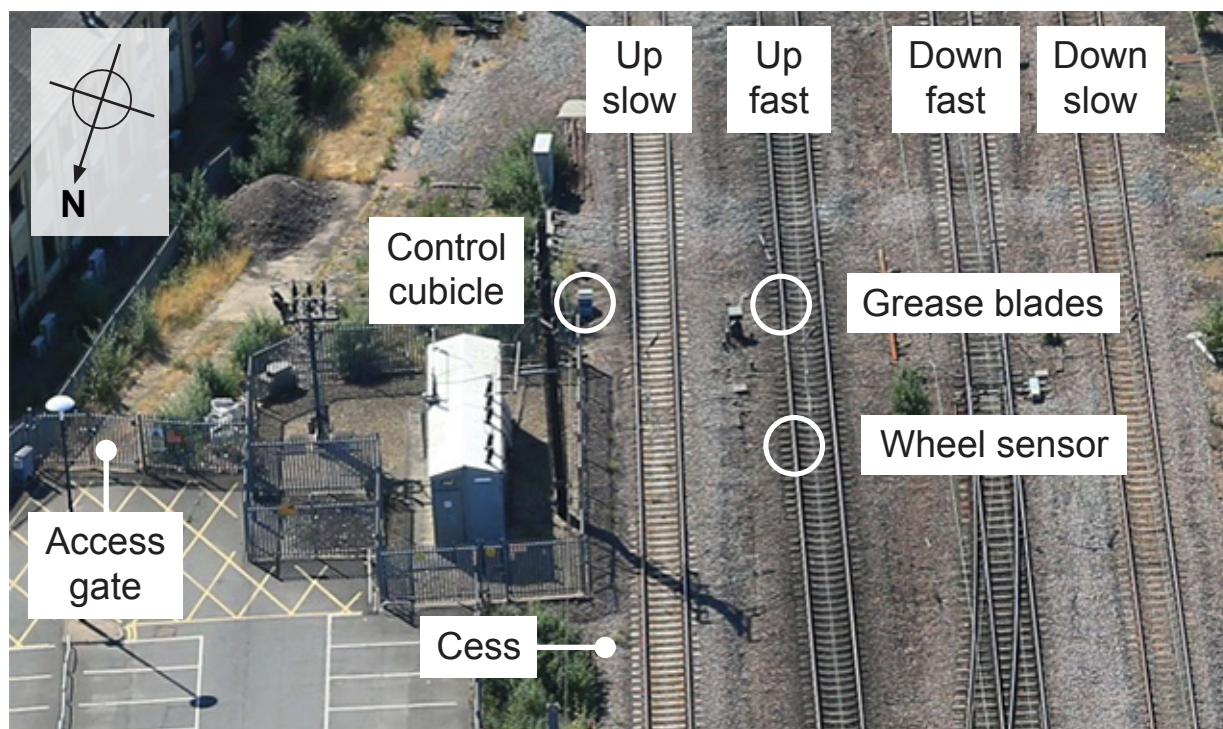
Figure 7: Location of the lubrication equipment to be inspected

- 27 In the meantime, the team leader and track worker A had driven through the station car park to a vehicle access point at the south end. After going through the gate, the team leader gave a further COSS briefing to track worker A who was going to be the site lookout for the inspection at this location. The planned work was to carry out a routine inspection on the lubrication equipment located on both the up slow and up fast lines (figure 7).

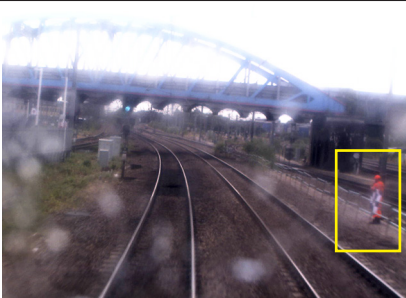
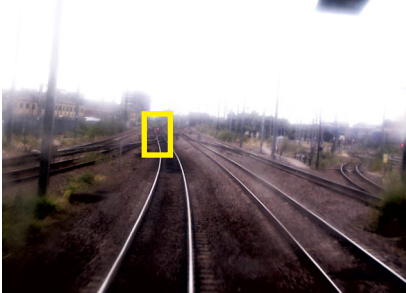
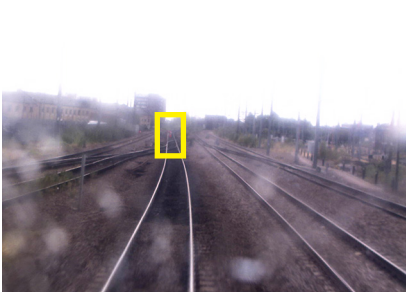
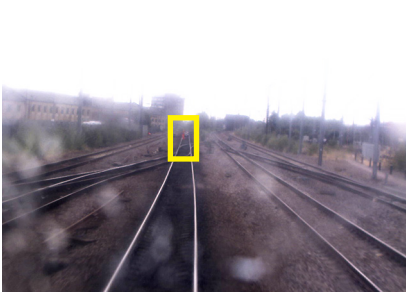
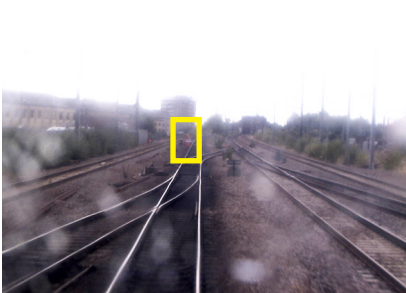
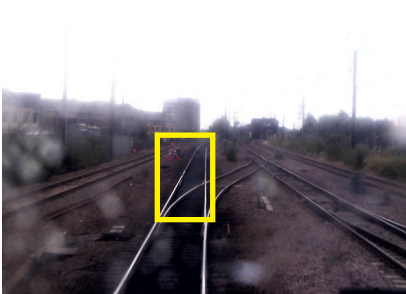
Figure 8: The sequence of events

- 35 At 10:52:04 hrs, train 1A19 entered the north end of the station, 14.7 seconds away from track worker A, who was standing on the up fast line. While the team leader was in the cess working on the control equipment, track worker B was walking back up platform 5 and the track maintenance distant lookout was now standing where track worker B had been. Figure 8 shows the final sequence of events leading up to the near miss, as seen by the forward facing camera on train 1A19.

<p>Time: 10:52:10.7</p> <p>Time to track worker A: 8.8 seconds</p> <p>Train speed: 102 mph (164 km/h)</p> <p>Event: Driver started sounding train horn when she saw track worker A ahead on the up fast line. The distant lookout for the track maintenance team was standing to the right.</p>

<p>Time: 10:52:13.0</p> <p>Time to track worker A: 6.5 seconds</p> <p>Train speed: 102 mph (164 km/h)</p> <p>Event: As train passed under bridge, track worker A was bent over on the up fast line.</p>

<p>Time: 10:52:13.7</p> <p>Time to track worker A: 5.8 seconds</p> <p>Train speed: 102 mph (164 km/h)</p> <p>Event: Driver applied train's brakes just as track worker A started to straighten up.</p>

<p>Time: 10:52:14.7</p> <p>Time to track worker A: 4.8 seconds</p> <p>Train speed: 101 mph (163 km/h)</p> <p>Event: Track worker A started to move and wave his lookout flag.</p>

<p>Time: 10:52:15.7</p> <p>Time to track worker A: 3.8 seconds</p> <p>Train speed: 101 mph (163 km/h)</p> <p>Event: Driver stopped sounding train horn and track worker A stepped out of the up fast line.</p>

<p>Time: 10:52:16.9</p> <p>Time to track worker A: 2.6 seconds</p> <p>Train speed: 99 mph (159 km/h)</p> <p>Event: Track worker A has now moved more than 2 metres from the up fast line.</p>

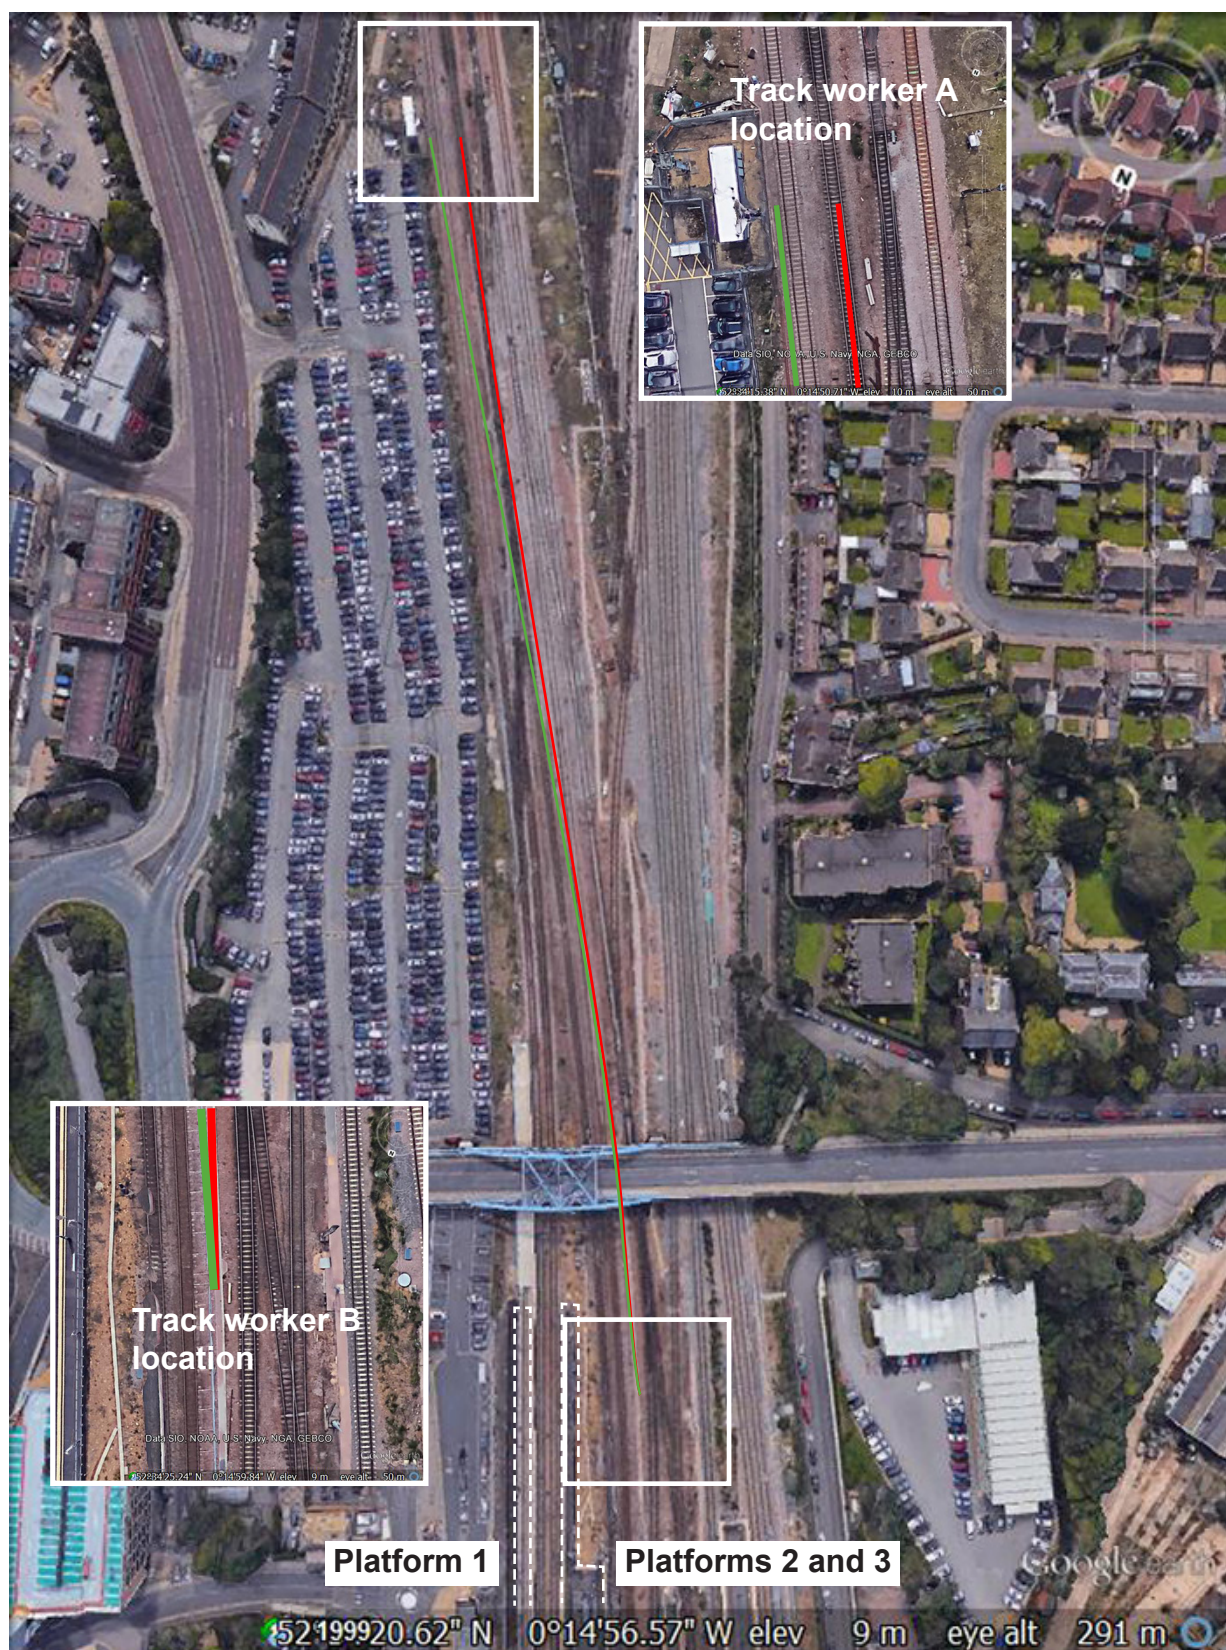
Figure 9: Sighting of the distant lookout by the site lookout

- 56 Track worker A also reported that he thought standing on the up fast line gave him a better view of his distant lookout. Figure 9 shows that the difference in the angle for sighting the distant lookout from the up fast line and from the cess is very slight. The increased personal risk is, however, significant.

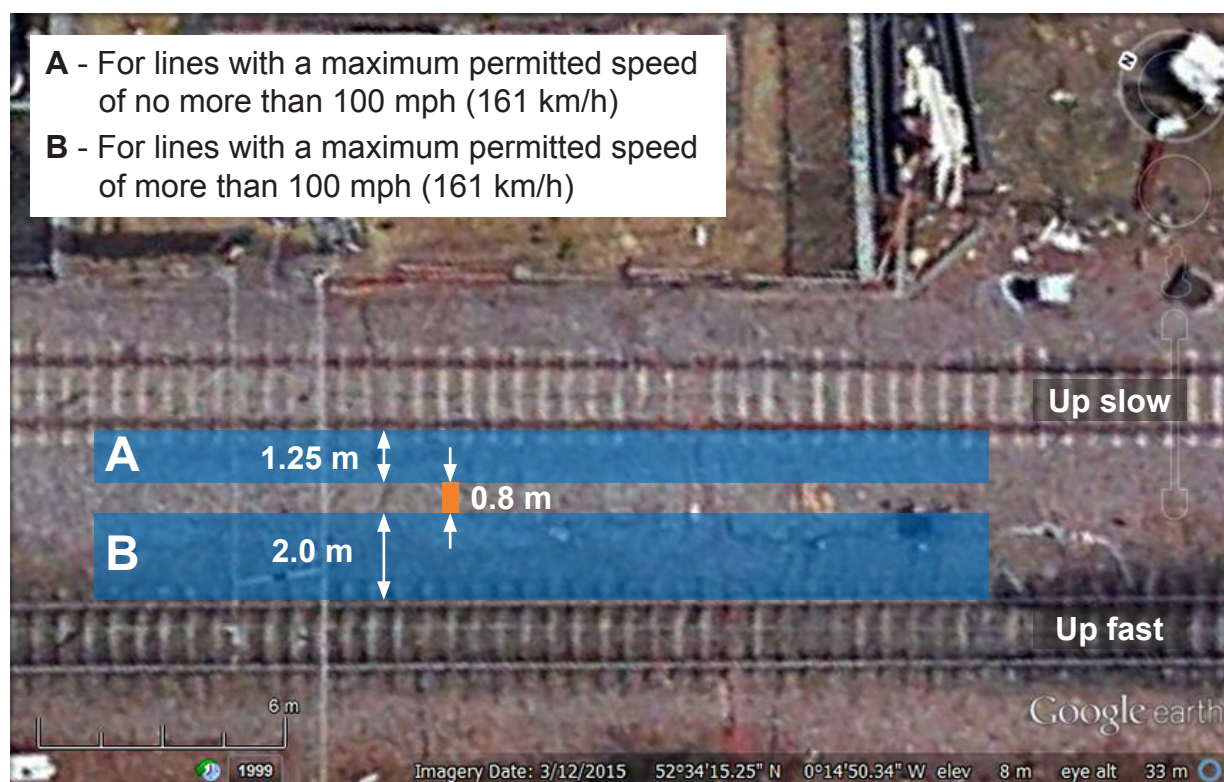
Figure 10: The space between the up slow and up fast lines

- 57 Other Network Rail staff who were familiar with carrying out site lookout duties at this location, reported to the RAIB that they did not stand on the up fast line. They indicated that they could see a distant lookout just as well from the cess or from the space between the up fast and slow lines. Figure 10 shows that the latter is just wide enough for a site lookout to stand between the up slow and up fast lines and still be in a position of safety.

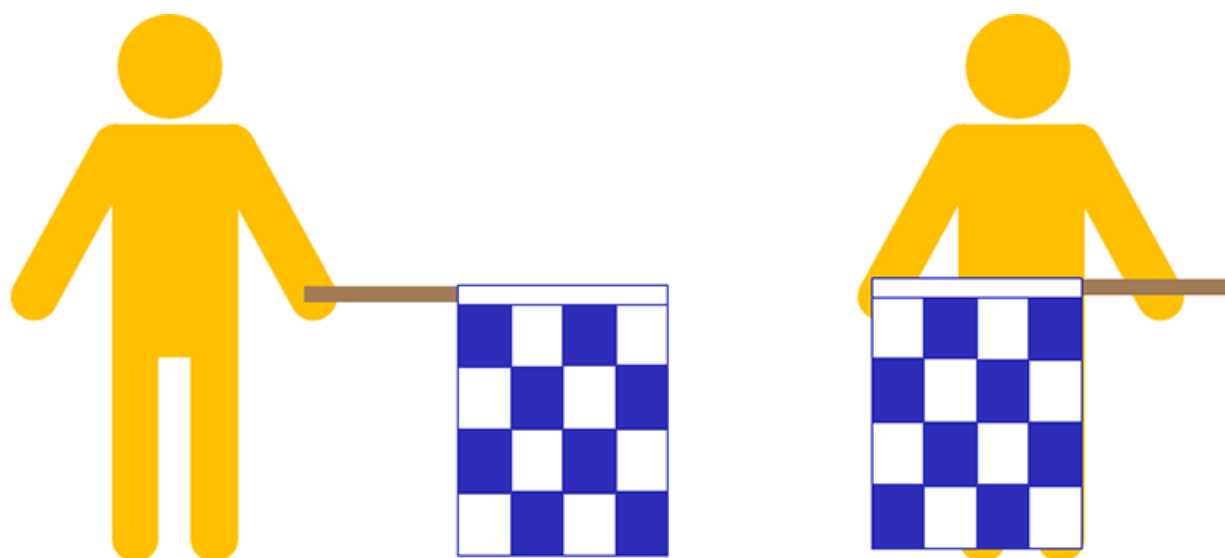
Figure 12: Unofficial lookout flag signals used to communicate 'all clear'

- 73 The first unofficial flag signal is used by lookouts to communicate that it is 'all clear', meaning that no trains are approaching, so that work can start or resume. The RAIB found that some distant lookouts hold their lookout flag out briefly and then, once acknowledged by the site lookout, both lookouts gather their flag up and hold it in against the flag pole. Other site and distant lookouts were found to hold the flag out all the time, either to the side or across their body, to give a continuous all clear signal to each other (figure 12).

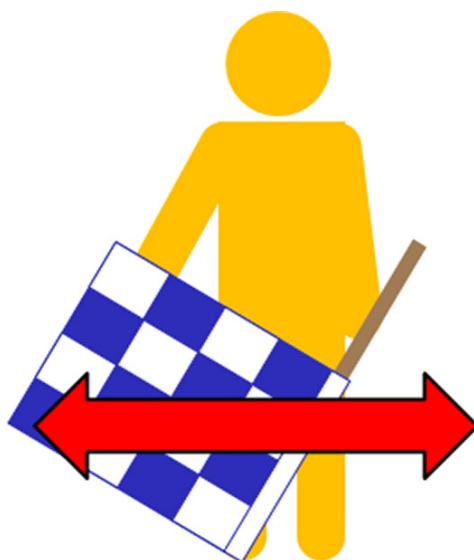
Figure 13: Unofficial lookout flag signal used to communicate that work is complete

- 75 A second unofficial flag signal is used by lookouts to communicate that work is complete so they can stand down the safe system of work and leave their post. When the safe system of work can be stood down, the COSS tells the site lookout who then waves their lookout flag low across their knees. This is known as an 'under wave' (figure 13). When a distant lookout sees an under wave flag signal, he acknowledges by doing the same. Both lookouts then stop waving and know they can stop looking out for trains and leave their position.

- 76 On the day of the incident, track worker B believed he saw an under wave, albeit 'flimsy', from track worker A. Track worker B reported that he gave an under wave in response, packed up and left his position. However, just before this happened, track worker A had been moving about a lot as he was following the team leader around (paragraphs 53 and 54). Track worker A was still holding the flag out across his body while he did this as the COSS had not told him to do otherwise. It is probable that track worker B mistook a movement by track worker A and his flag as the under wave signal. By that time, track worker B was expecting the inspection to end soon as it had already gone on for much longer than planned; the timing of the apparent under wave fitted in with his expectation.

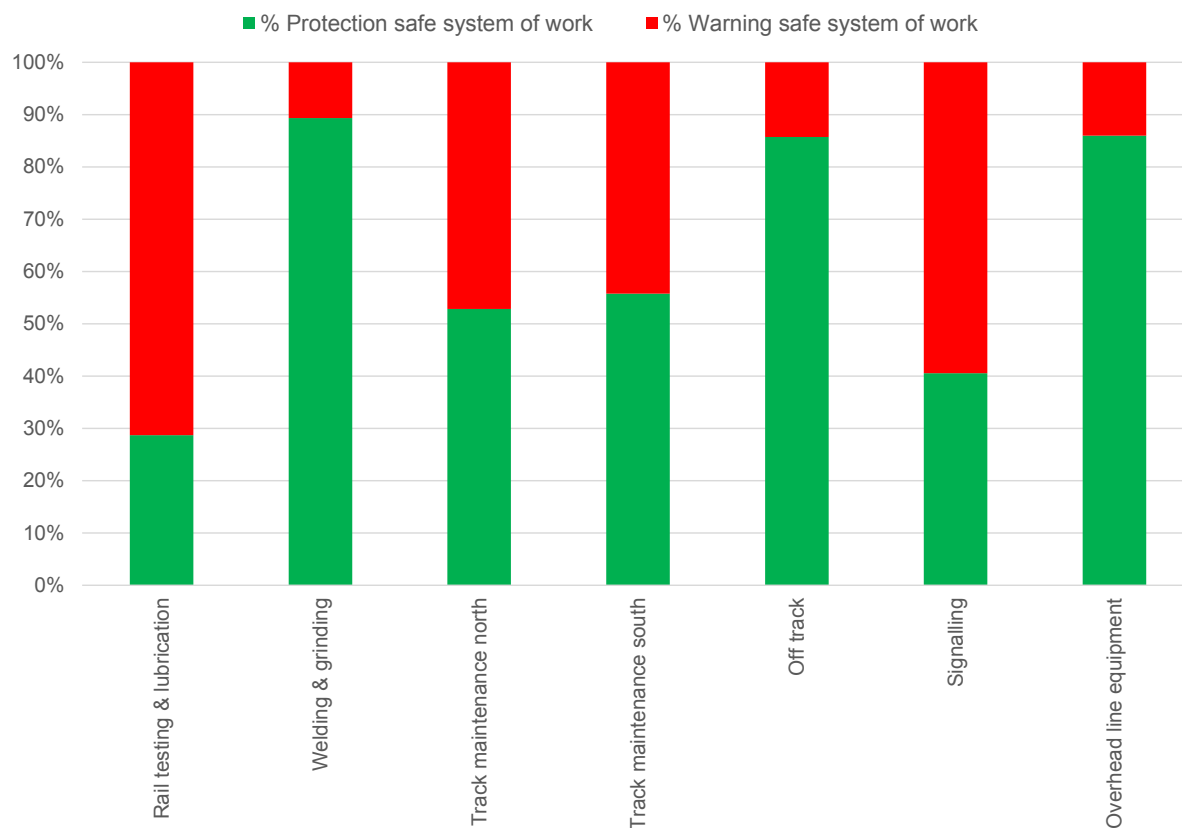
Figure 15: Graph showing the amount of work carried out using protection safe systems of work by each maintenance section within Peterborough delivery unit

- 101 At the time of the incident, the Peterborough rail testing and lubrication section was carrying out about 70% of its work using a warning safe system of work, primarily using lookouts rather than equipment (figure 15). A large proportion of this section's work is responding to suspected rail defects within a specified timescale, so this rail testing work often cannot be planned into engineering possessions or line blockages. However, this is not the case for the work of the lubrication team, as almost all of its work consists of cyclic inspections.
