Rail Accident Report

Near miss with track workers at Pelaw North Junction 21 February 2018

Report 13/2018
August 2018

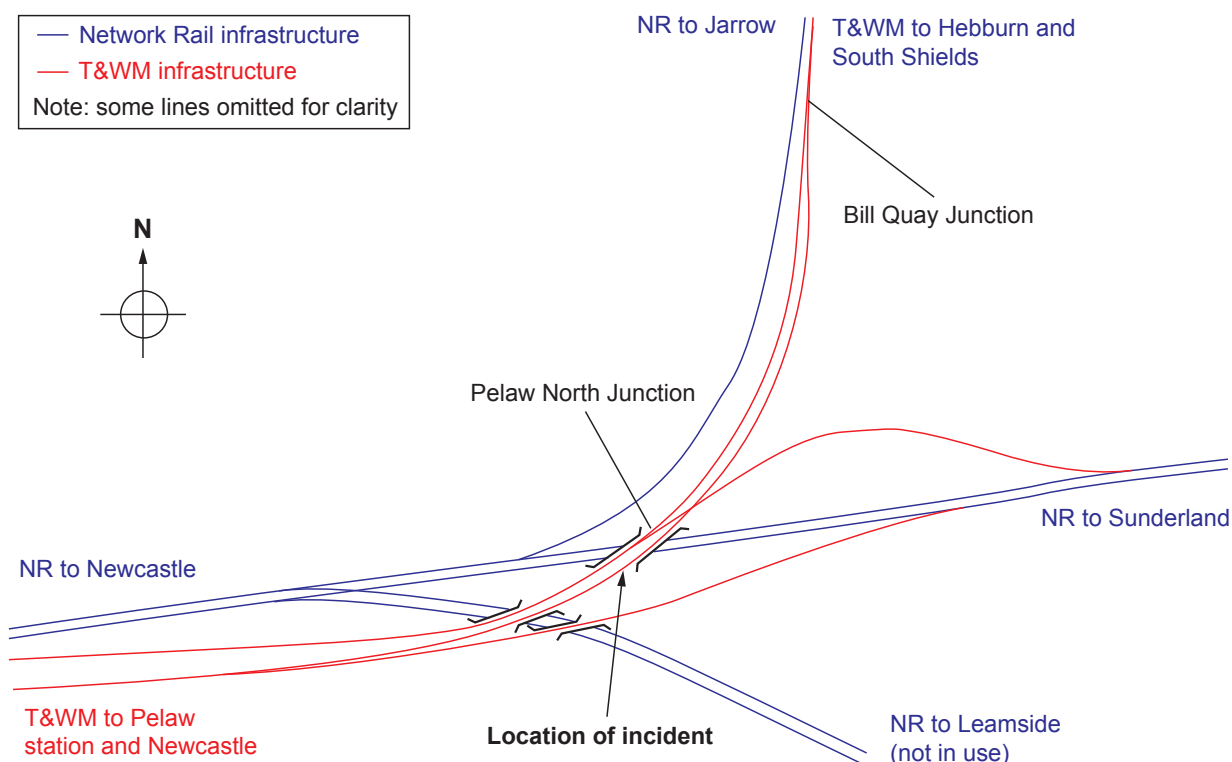
Figure 3: Schematic diagram of railway lines in the area

- 18 Track circuit 'RM' is located in the track section where the inbound line towards Sunderland crosses the outbound line from South Shields (figure 3). It is a 'reed-type' track circuit which means that it operates by the generation, transmission and detection of an electrical signal of a given frequency. The presence of a train interrupts the transmission process, and hence indicates the presence location of trains to the signalling system.
- 19 The track circuit used at Pelaw North Junction requires Insulated Block Joints (IBJs) to electrically isolate the section of track covered by track circuit 'RM' from those surrounding it. The track circuit also uses track bonds to physically connect cables from the lineside equipment to the rails.

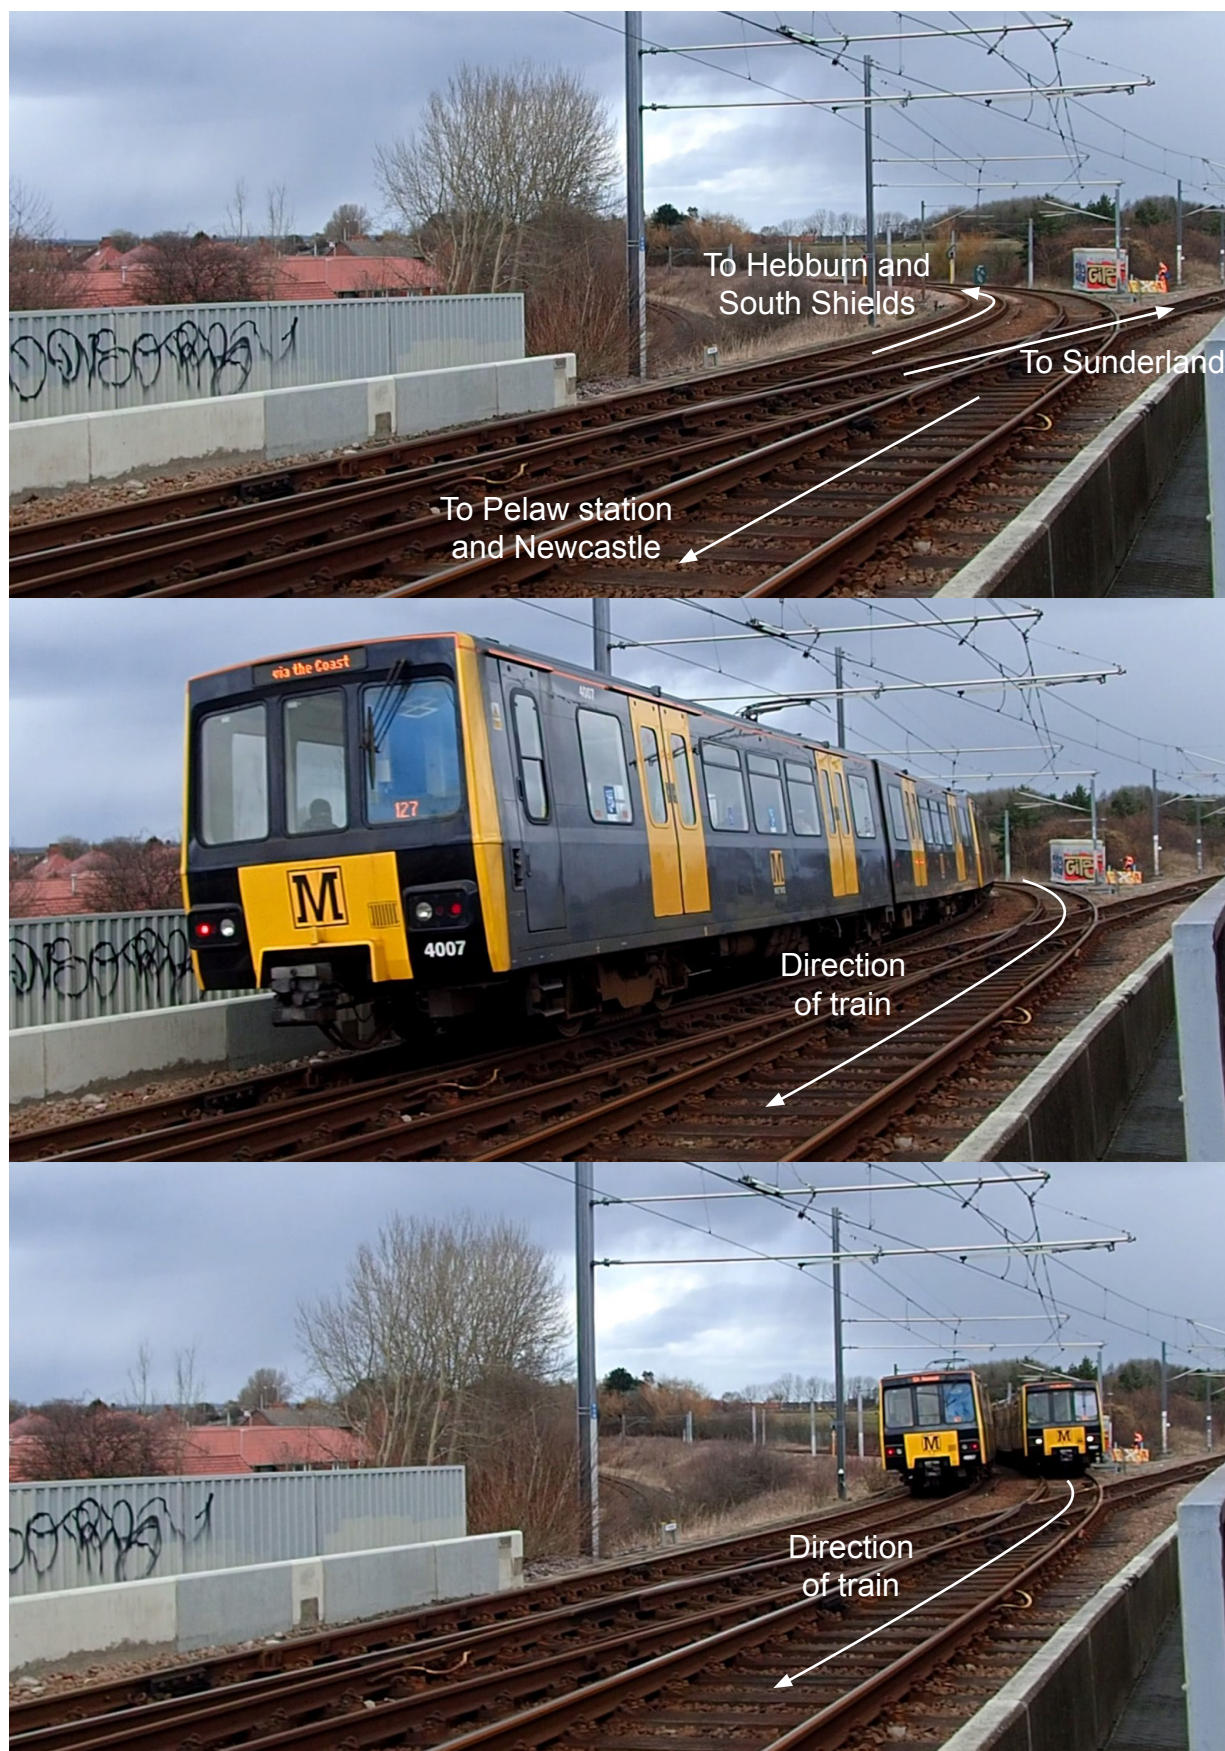
Figure 6: Images taken from the approximate location of the lookout at the time of the incident. It can be seen how an inbound train (second image) obscures the view of an oncoming outbound train (visible in third image).

- 56 The local conditions at Pelaw North Junction, specifically the track curvature restricting the view of approaching trains (paragraph 50), meant that the WSC could not have established an effective safe system of work with just one lookout.

Nexus Rail should identify, by means of risk assessment, and taking into consideration the lessons from this incident, locations on the Tyne and Wear Metro system where multiple lookouts are required to establish a safe system of work, and make this information available to work site controllers and in its hazard directory.

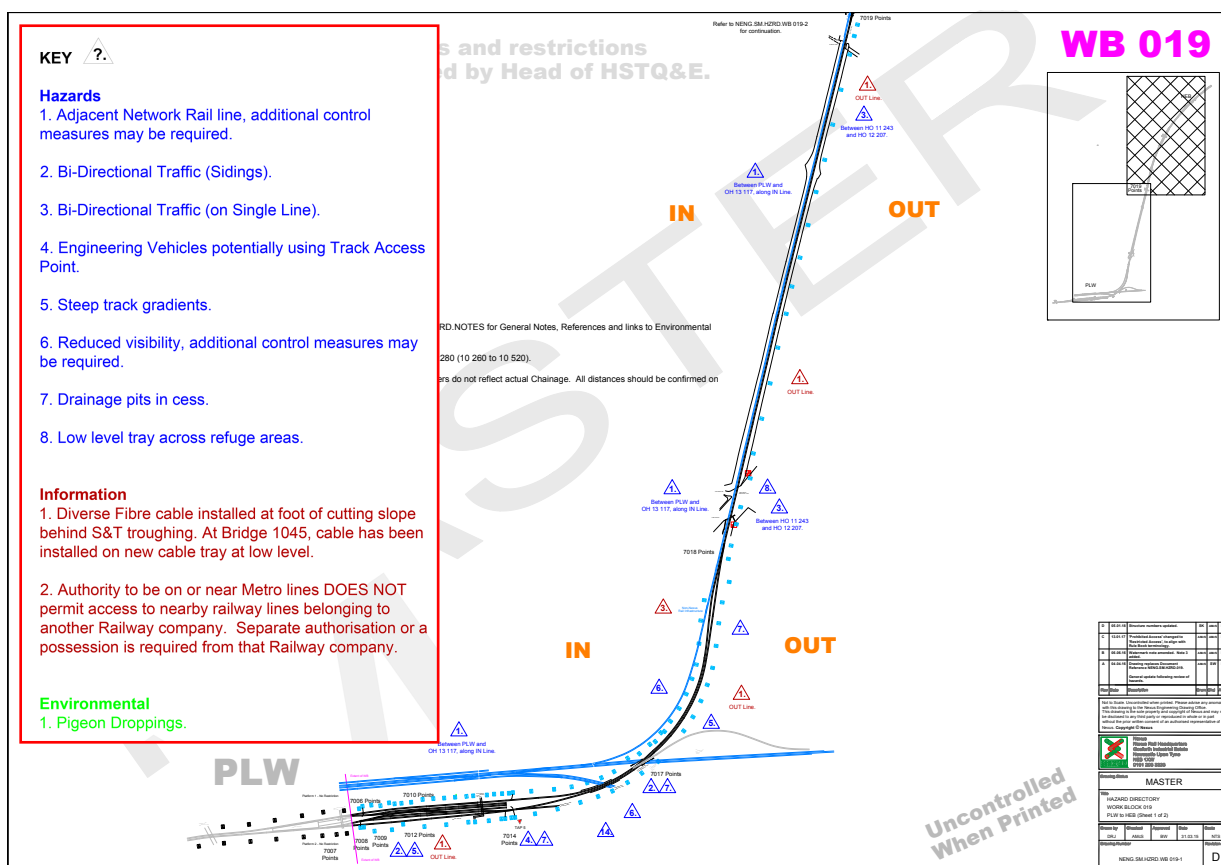
Figure 7: The section of the hazard directory which covers Pelaw North Junction

- 53 Site-specific hazards for Pelaw North Junction which are listed in the hazard directory include:
 - 'Steep track gradients'; and
 - 'Reduced visibility; additional control measures may be required'.

- 54 The hazard directory is an on-line document and therefore access to the Nexus Rail computer system is necessary in order to view its contents. Mobile staff, such as the two track workers involved in the near miss at Pelaw North Junction, are not provided with any means to directly access the contents of the hazard directory.

- 55 In order to overcome the lack of direct access afforded to mobile staff, the NIM is required¹² to provide site-specific information from the hazard directory to the WSC. In the case of the near miss at Pelaw North Junction, the NIM did not provide this information, due to an oversight. However the WSC, who required this information to compile an effective safe system of work, did not correct the oversight by requesting the information from the NIM.

Nexus Rail should provide its mobile staff, including fault finding teams, with remote access to the hazard directory to enable them to set up safe systems of work and alert them to sighting hazards.
