Rail Accident Report

**Near miss involving track workers near Hest
Bank, Lancashire
22 September 2014**

Report 08/2015
July 2015

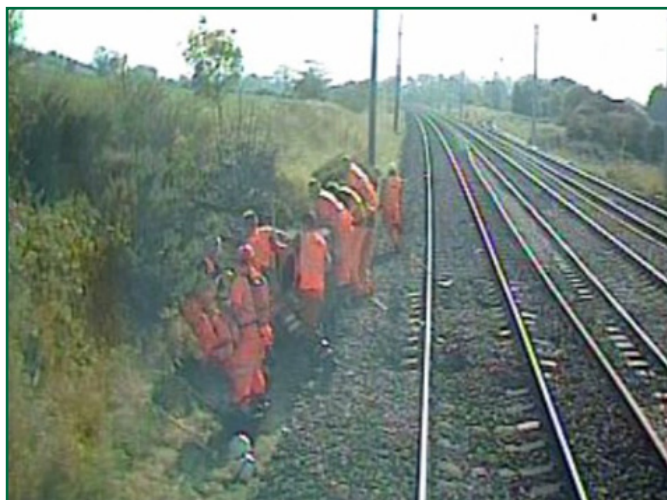
- 5 The COSS saw the train approaching on the up main line when it was just over three seconds away and shouted an urgent warning. Staff took rapid evasive action, but some members of the workgroup were on the bridge and were unable to reach the designated position of safety, instead pressing themselves against the bridge parapet (figure 2). The last member of the workgroup was not clear of the line until about one second before the train passed (figures 2 and 9).

Figure 2: Image of workgroup from forward-facing CCTV camera fitted to train 1M97 (courtesy of FTPE)

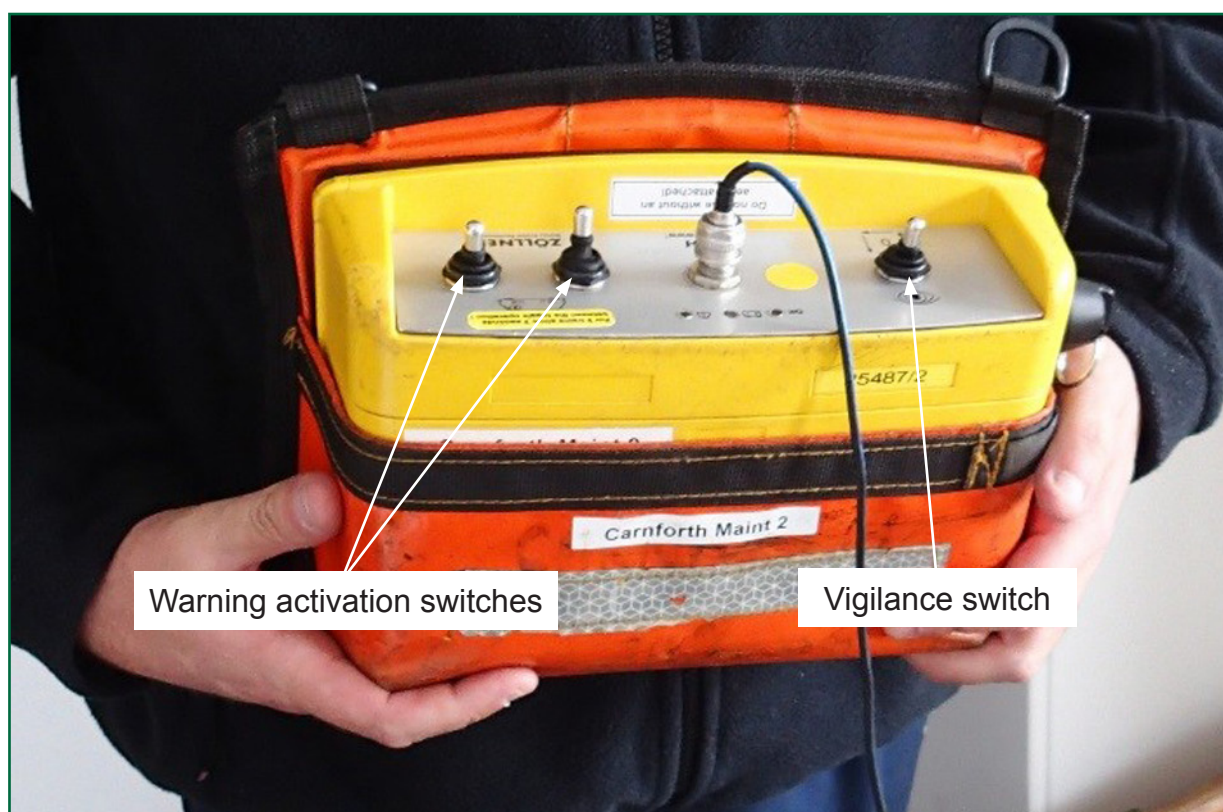
- 17 Each Zöllner ZPW-LOWS set comprised a ZPW control unit incorporating a radio receiver (figure 5) and up to four ZFH lookout operated transmitters (figure 6) equipped with booster aerials, spare batteries and harnesses. The set included a paper log book to record usage, routine testing and faults. The radio system fitted to ZPW-LOWS version 1 equipment is uni-directional, so cannot transmit messages from the ZPW control unit to the lookout's ZFH transmitter. Each set of Zöllner equipment is therefore supplied with dedicated mobile phones which allows communication between the site of work and the lookouts³. The ZPW control unit has an internal data logger which records incoming warnings and system error messages. The ZFH transmitter units do not contain a data logger.

Figure 6: ZFH lookout operated transmitter unit

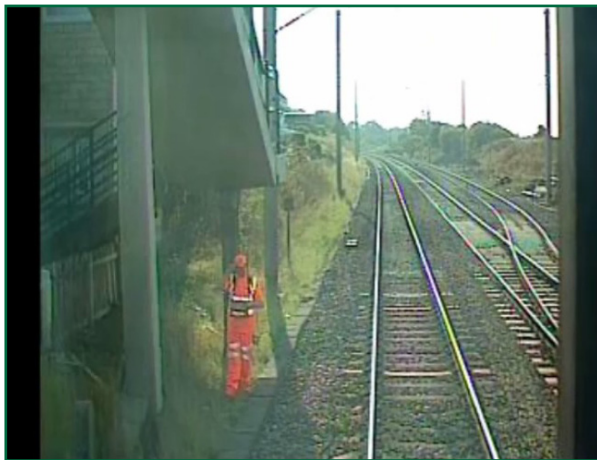
- 41 At 14:23:51 hrs⁶, train 1M97 passed Hest Bank level crossing travelling at 101 mph (162 km/h), and then passed Lookout 1 standing beside the up main line approximately 10 metres beyond the crossing. The CCTV recordings from the train shows that he was in position next to the track and facing the train when it passed (figures 7 and 8). It shows him wearing the ZFH lookout unit on a neck strap and holding onto his hard hat to prevent this being blown off by the train. The train driver states that he gave a warning using the train's horn, and that the lookout had acknowledged this by raising his arm as it approached.

Figure 7: Image of Lookout 1 from forward-facing CCTV camera fitted to train 1M97 (courtesy of FTPE)

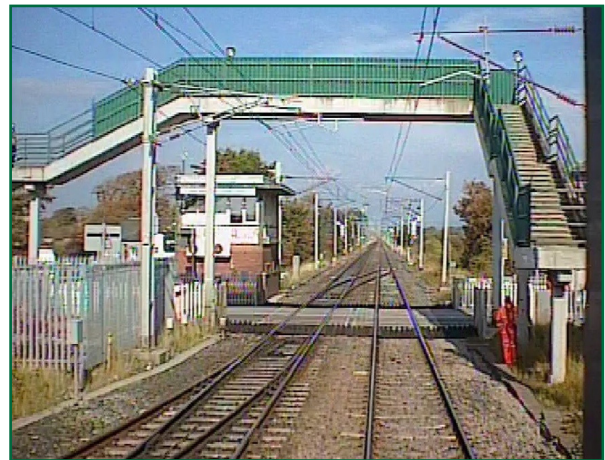
- 27 Weather records for Bolton-le-Sands, located between Carnforth and Hest Bank, indicate that conditions were dry and mild (18°C), with a 10 mph southerly wind. The rearward facing CCTV camera on the incident train showed that no haze, glare or other environmental factors were impairing the view of a lookout looking north from Hest Bank level crossing (figure 8).

Figure 8: Image of Lookout 1 from rear-facing CCTV camera fitted to train 1M97 (courtesy of FTPE)

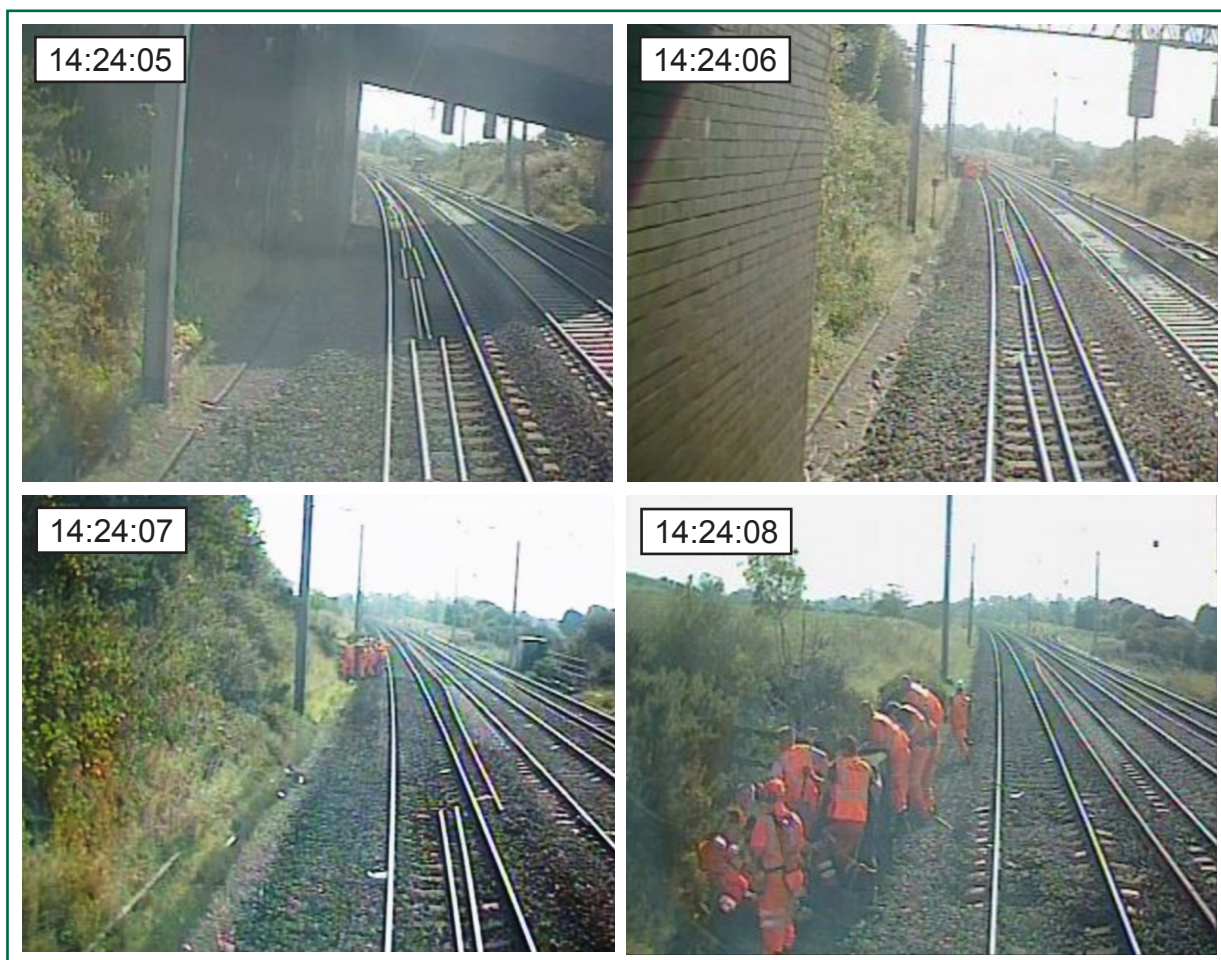
- 42 Fourteen seconds later, at 14:24:05 hrs, train 1M97 approached the A5105 road bridge (figure 9). The driver states that passing under the bridge, he saw staff working directly in the path of his train and sounded the horn. The COSS, who was placing ballast under the sleepers with a shovel while the cess rail was raised on the jack, saw the train at about the same time and immediately shouted a warning. The train at this point was just over three seconds away. The COSS had not heard the train approaching and the LOWS had not given a warning. The workgroup rapidly evacuated the tracks, dropping tools and leaving the jack in position (figure 10). The jack collapsed under the weight of the passing train (as intended by the jack's design). A witness reports that the train hit a shovel.

Figure 9: Images of workgroup from forward-facing CCTV camera fitted to train 1M97 while approaching under the A5105 bridge (courtesy of FTPE). Clock times are based on OTDR data.

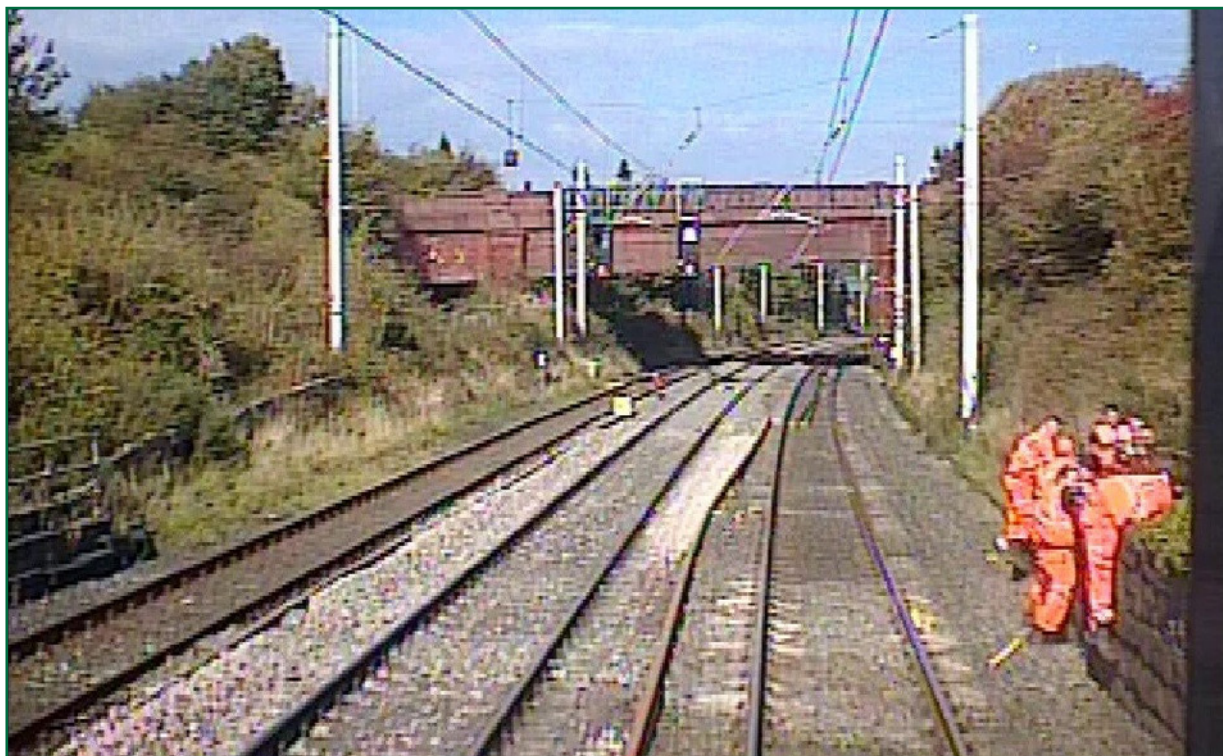
Figure 10: Image of workgroup from rear-facing CCTV camera fitted to train 1M97 showing yellow jack beneath right-hand rail (courtesy of FTPE)

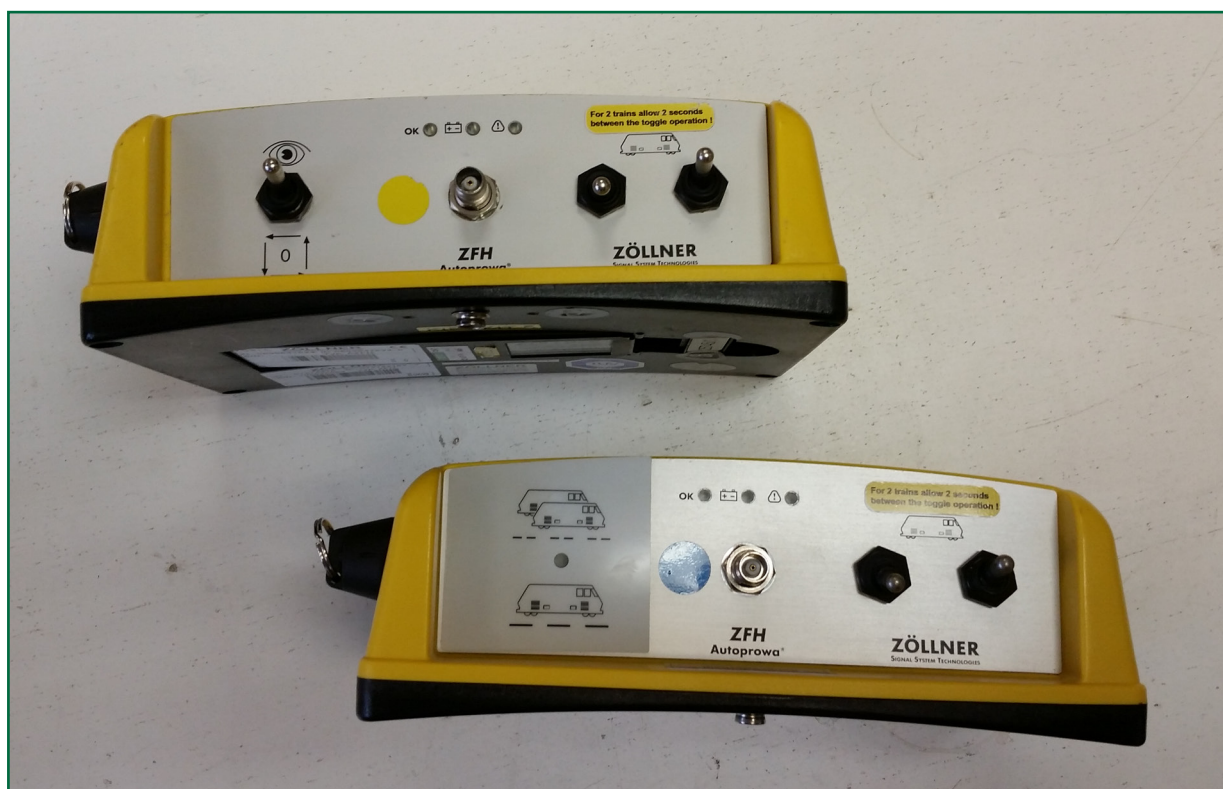
Figure 11: ZFH version 1.4 lookout unit (left) and ZFH version 1.5 lookout unit (right); note absence of vigilance switch on version 1.5 unit

- 116 The version 1.5 ZFH lookout operated transmitter unit includes the following modifications (figure 11):
- removal of the vigilance switch and replacement by a motion sensor which detects whether the lookout stops moving;
 - provision of an LED indicator which displays for 10 seconds to confirm to a lookout that a warning has been given; and
 - provision of a data logger function.
